Insular Schools: Assessment
of Buildings and Classrooms

CONDITION ASSESSMENT REPORT FOR GUAM PUBLIC SCHOOLS Overview of Costs, Major and Common Issues, and Discipline-Specific Summaries

August 2021

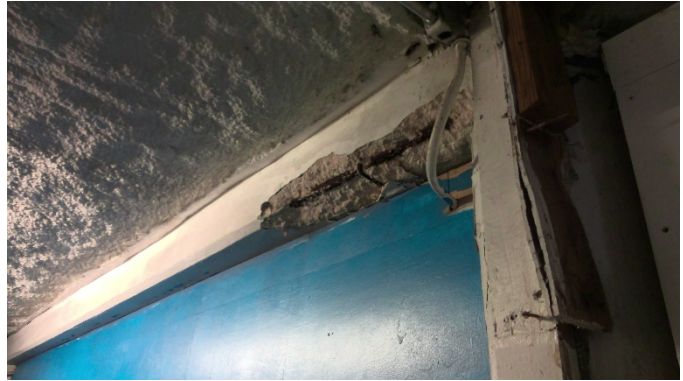
Problems caused by water leaks: The most common building type is defined by low-slope concrete roofs and reinforced concrete masonry walls. This building type generally performs well but issues arise if water proofing over the slab fails and allows water to seep through the concrete. Due to the higher porosity and higher chloride content of the coralline aggregate concrete that appears to have been used for these building, depending on how well the aggregate was washed initially, moisture penetration may lead to accelerated deterioration compared to other concrete types, especially corrosion of the reinforcing and spalling (fracturing) at the soffits (underside) of the slabs or beams. This issue is prevalent with concrete slab covered walkways as well. Spall repairs for these buildings have been done and generally appear to have been done well, but these repairs must be done in conjunction with addressing the root cause of the deterioration; that is any failed roofing. This deterioration can result in dangerous concrete debris falling in classrooms or from walkway roofs. Roofing material and application recommendations are addressed in the Architectural Assessment Summary report.

Figure 4 - Agana Heights ES Buildings 1 and 3 beam spall

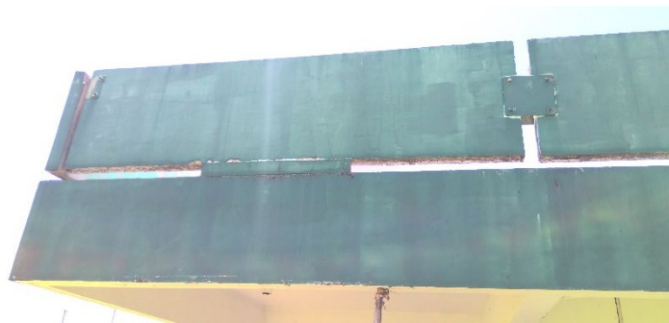
Parapet walls: There are a few cases where concrete buildings have an occupiable roof deck and precast concrete parapet panels have been used to provide a safety railing. In some cases, these parapet panels have a deteriorating connection to the slab below, making them highly susceptible to failure during a wind or seismic event. These are considered very unsafe and need to be addressed urgently, perhaps by simply removing the panels and any general access

Figure 5 - P.C. Lujan ES Building 9 roof parapet - potential imminent collapse hazard

to the roof decks, or replacement with a new railing system. These conditions are known to occur at P.C. Lujan Elementary School Building 9 and Captain Price Elementary School Building 2. All similar conditions should be assessed for safety.

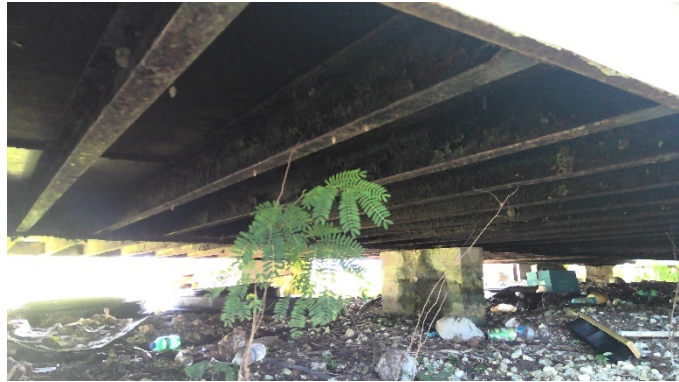
Wood Framed Classroom Buildings Elevated on CMU Piers: In cases where the first floor is not adequately raised above grade, the floor framing is subject to dry rot. The commonly used metal or plywood siding do not hold up well long-term. The cladding of these buildings deteriorates quite quickly in Guam’s environment. There is isolated but not widespread evidence of termite damage and rot where the roofing or siding has deteriorated. Some of the foundation anchorage issues were addressed with retrofits but most are not adequately anchored nor designed for high winds and are vulnerable to typhoons. When not adequately maintained, these buildings become irreparable very quickly. When they have reached end-of-service life it would be best to demolish them completely to avoid safety risks.

Figure 6 - Jose Rios MS B1 corroded steel floor joists and exterior beams

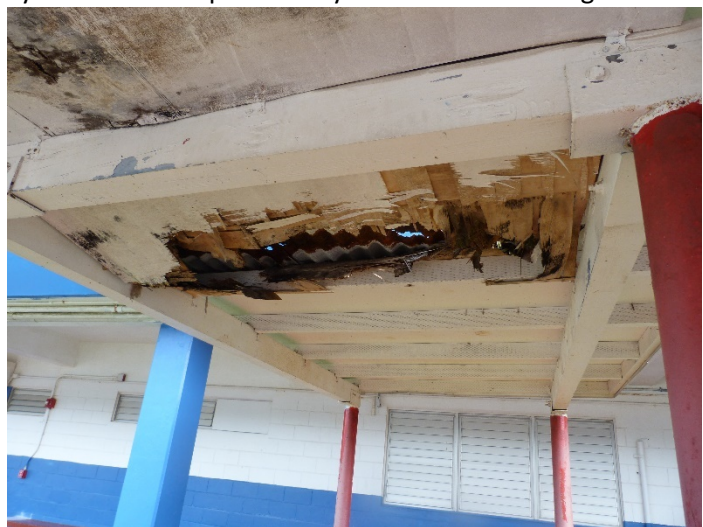
Covered Walkways: The most significant structural issues at many schools were observed at covered walkways. Three basic structural walkway types included: wood framed, steel framed, and concrete. The wood framed and steel framed walkways tended to be in various states of deterioration. Damaged wood framing from rot or termites were commonly observed and pose safety issues. Steel framing exhibited corrosion at cold formed steel sections (collected and trapped water) and steel pipe columns that extend straight to the ground level rather than being elevated on concrete pedestals; corrosion was severe in various locations. Repairing these steel framing issues is not recommended because the corrosion would re-occur. Complete replacement with upgraded roof and framing design, appropriate for the atmospheric conditions and avoiding cold-formed sections, is recommended. The concrete framed walkways are generally in better condition, but they do still need both roofing and drainage to

Figure 7 - Oceanview MS Walkway (23) wood roof damage.

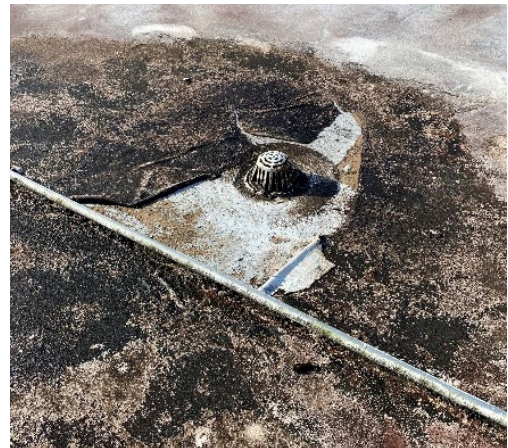
Low-sloped roofs: Blistering and failing roof membranes at low slope roofs were ubiquitous throughout the facility inventory. Inadequate slope causes rainwater to pond and leads to deterioration of the roofing material. This condition is typically compounded by clogged roof drains from plants and/or debris build up. Furthermore, acrylic roof membranes were used widely and are not acceptable for roofs that have ponding water.

Figure 8 - Roofing damage on low-slope roof

Recommendations include conducting regular visual inspection and maintenance or avoiding acrylic coatings on flat or low slope roofs that do not have regular maintenance. Use of an alternative roofing material for flat/low-sloped roofs, e.g., an 80-mil rolled TPO (light) or EDPM (dark) may be appropriate for roofs with few penetrations, or a 40-mil fluid applied polyurethane, or silicone may be appropriate for low slope roof with multiple penetrations.

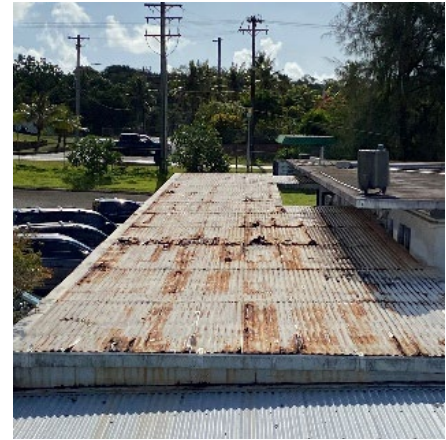
Corrugated metal/non-galvanized steel: Corrugated steel roofing and non-galvanized steel fasteners have a high deterioration rate. Corrosion of fasteners and roof edges was observed frequently. These conditions contributed to roof-panel rusting and resultant leaks that led to failure of wood substrate and structure. Deteriorated wood substrates and metal roofs ultimately become safety hazards.

Figure 9 - Corrugated steel roofing rusting

Recommendations: replace wood walkway roof structure with galvanized, painted structure. ☐ Replace corrugated steel roof with aluminum standing seam roof. Provide gutters, downspouts, and splash blocks. Good design examples to replicate include the new walkways at Agueda Johnston MS.

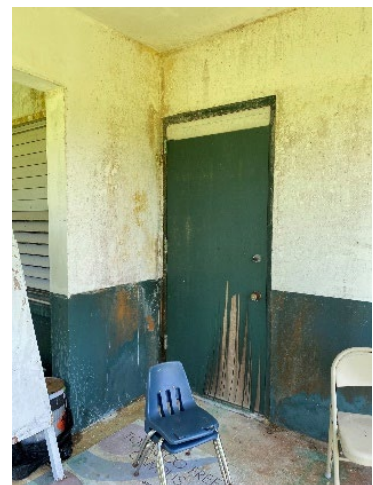
Delaminating wood doors, rusting steel doors, inoperable windows: It is common that veneer wood doors delaminate. This was observed often at GDOE schools and accelerated delamination was observed at exposed elevations, or ‘back’ of buildings. Similarly, cheap replacement wood doors delaminate, rot, and become termite infested. Steel doors, frames, hardware, and closers are rusting and/or corroding. It is recommended that facility managers replace deteriorated doors with aluminum and/or FRP doors. Rusting hardware should be replaced with commercial grade, rust-inhibiting hardware. All replacement door handles should be commercial grade lever-type handles. Residential hardware should not be used.

Figure 10 - Delaminating wood door

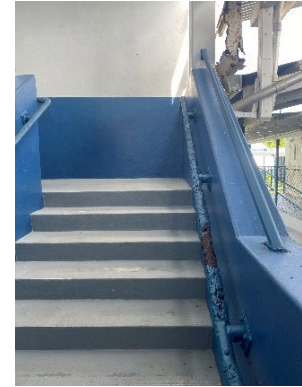
Ramps, stairs, walkways, and railings: Uneven walkway surfaces as well as surfaces that get slippery from rainwater or AC condensate were observed, both of which create injury hazards and should be repaired to address these issues. Stairs were observed that were cracked, cracking, or missing nosing. Steep and uncovered ramps were also observed, along with railings that were rusted to an extent that could cause injury. Correction of these issues and installation of code-compliant railings are required.

Figure 11 - Rusted railing

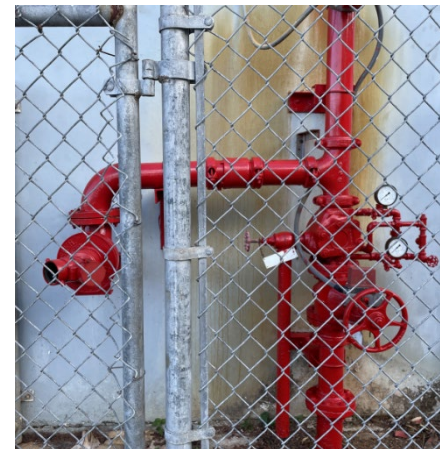
Immediate safety hazards that need to be corrected: Some fire protection/alarm systems were observed to be inoperable. Fire protection systems and fire alarm systems require regular inspection, testing, and maintenance. Locations where impaired fire protection systems were observed and require replacement include: fire sprinkler system at Jose Rios Middle School and fire alarm system of Building 15 at Southern High School.

Figure 12 - Jose Rios MS sprinkler pipe leaks; system is shut down.

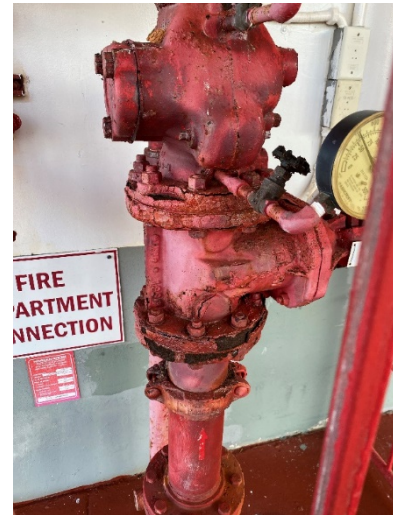
Figure 13 - Astumbo ES corroded fire protection infrastructure

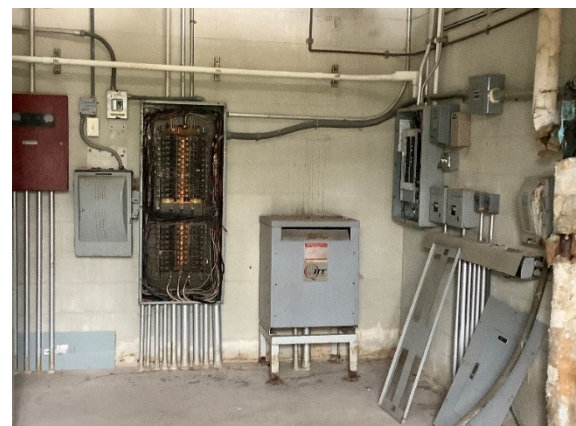
Exposed live electrical conductors shall be protected and enclosed (Building 10 at Agueda Johnston Middle School).

Figure 14 - Exposed panelboards with no cover plates at Agueda Johnston MS

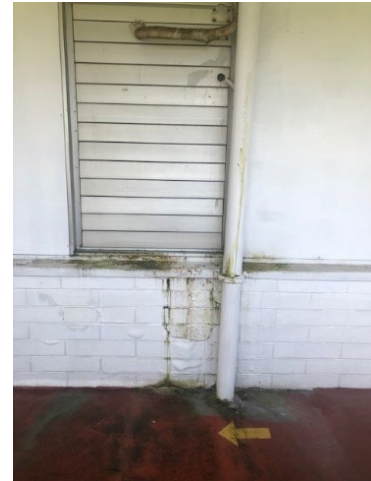
Outdoor air provision, ventilation, and building envelop improvements: The provision of outside air to classrooms is inadequate and should be addressed when replacing AC units. Some restrooms do not have mechanical ventilation; installation is required where absent. Improving the building envelope tightness and thermal resistance will reduce the energy cost. Improving daylighting to classrooms (e.g., replacing plexiglass covered jalousie louvers with double-pane windows) will improve student health, allow for fresh air provision, and potentially reduce energy costs because these windows can provide better sealing and installation than plexiglass over jalousie louvers.

Figure 15 - Closed louvers and mold from leaking condensate at Capt. Price ES

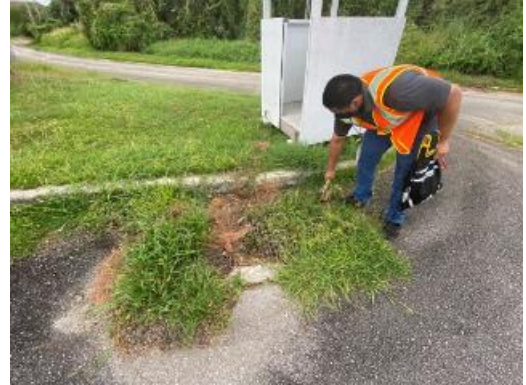
Storm water drainage systems: Conditions and needs vary amongst schools. Generally, maintenance of drainage systems, retention basins, drainage ditches, rain gutters and downspouts, swales, and culverts is inadequate and additional attention in the short term and with regular frequency is required. General maintenance should include, but is not limited to:

Figure 16 - Storm drain clogged with vegetation and debris at Inarajan ES

- a. Removal of debris from the drain inlets and outlets and flushing of drain lines.
- b. Clearing and regrading of retention basins to remove silt and restore basins to original depth to ensure proper basin function.
- c. Removal of debris and vegetation blocking pipes, regrading of surrounding areas to match bottom elevation of culverts and flushing of culverts to ensure proper culvert function.
- d. Cleaning and regrading of existing swales and ditches to ensure proper function of swales and ditches.
- e. Clearing and removal of debris from the rain gutters and downspouts. Repair and/or replace disconnected rain gutters and downspouts.

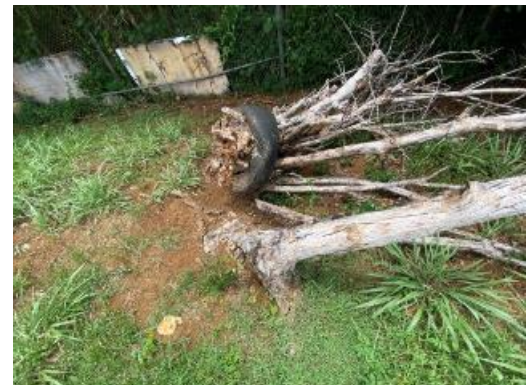
- d. There are trees and palms that were planted with a vehicle rubber tire around the base that restricts growth as the trees mature. Several have fallen because of this. All trees with tires around the trunk will eventually die or topple over due to the unbalanced, top-heavy tree. Tires must be removed from tree trunks where present.

Figure 17 - Girdled dead trees at Astumbo ES

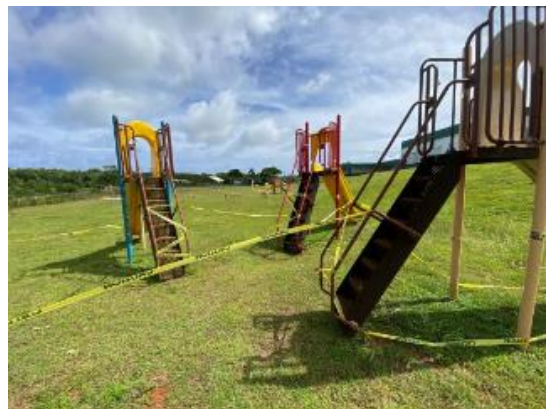
Playground Equipment: Existing equipment is rusted and corroded beyond repair, and, in some cases, caution tape was placed around equipment to keep kids off.

Protruding, sharp rusting metal can cause severe injuries.

Figure 18 - Unusable playground equipment at Upi ES

Recommend removal of such play equipment. Existing outdoor play areas at all elementary schools lack resilient play surfacing that meets industry standards for playground structures. These issues limit students' ability to play, which is known to be beneficial to students mental and physical health, and present safety risks

(e.g., sharp metal; falls on the hard exposed coral outcrops). Existing equipment should be removed and replaced with age-appropriate play structures with

resilient play surfacing that meets the safety guidelines from the IPEMA Certified (International Play Equipment Manufacturers Association and to ASTM F1292 for Impact Attenuation of Surface Systems) installed under and around playground equipment per safety standards for each product installed.

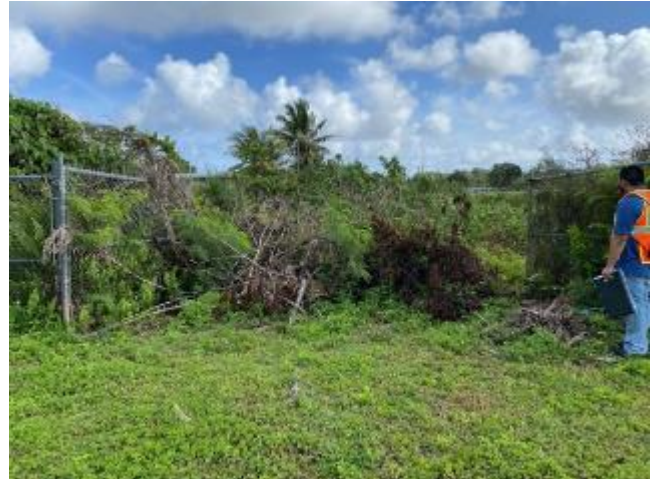
Fences: Almost all schools have fence lines that are rusting, damaged and/or overgrown with vegetation that needs to be cleared and the deteriorated and/or damaged fencing repaired or replaced.

Figure 19 - Broken fence overtaken by vegetation at Astumbo ES

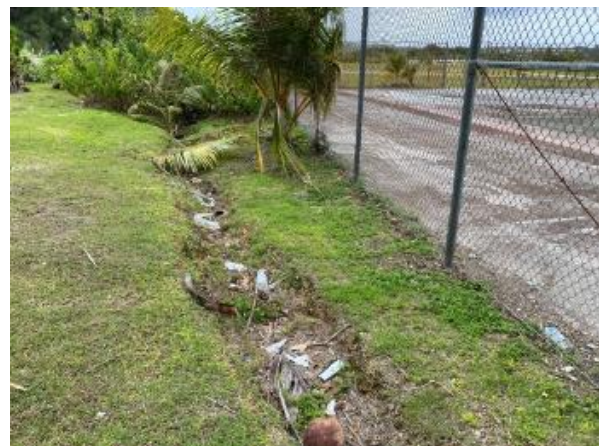
Figure 20 - Debris-filled drainage swale at Simon Sanchez HS
