# **INSULAR ABC'S INITIATIVE**

## **Phase III Task 1 Findings and Recommendations**

### **American Samoa**

October 2015

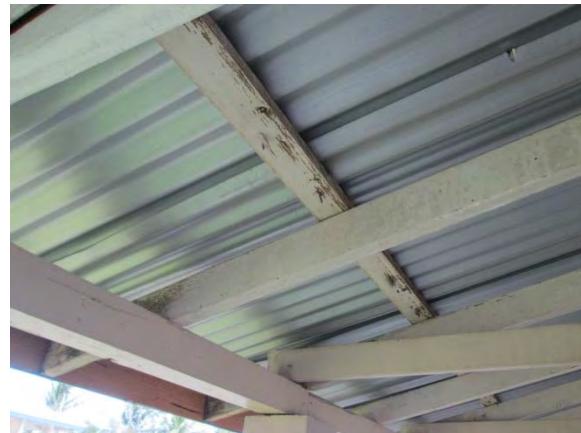
Building 1 is closed and is currently not in use, as the termite damage there has worsened. Damage is apparent in structural members as well as in roof sheathing, purlins, and other non-structural elements.

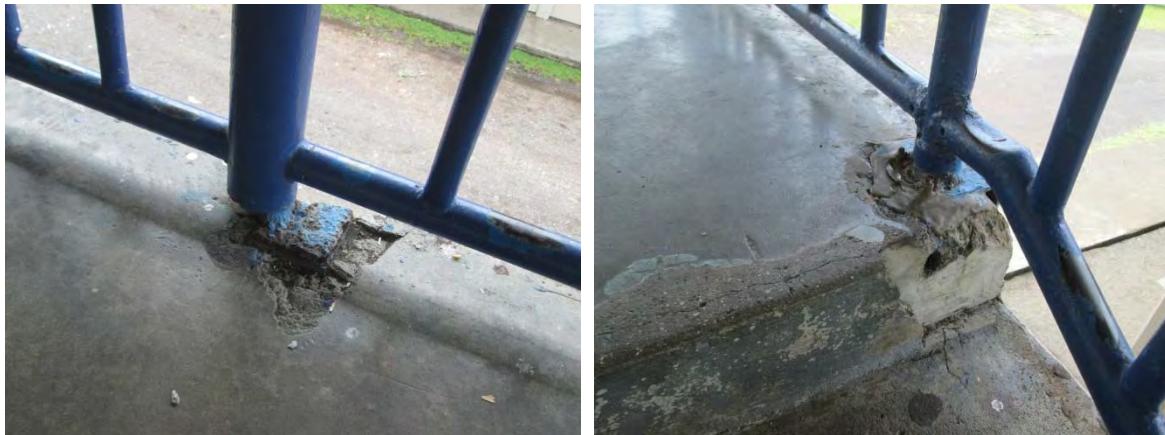
At Building 3, the concrete at the base of the metal railing posts is spalling in many locations. Some areas have been patched, but more remain and require patching. The spalled concrete at the rail post connections will allow the railing to become loose, which would be a safety hazard.

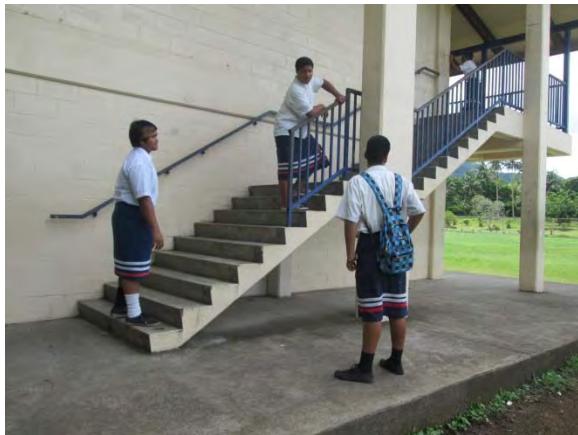
At Building 16, the missing handrail at the exterior stair, which was identified in Phase 2 as a safety hazard, is still missing.

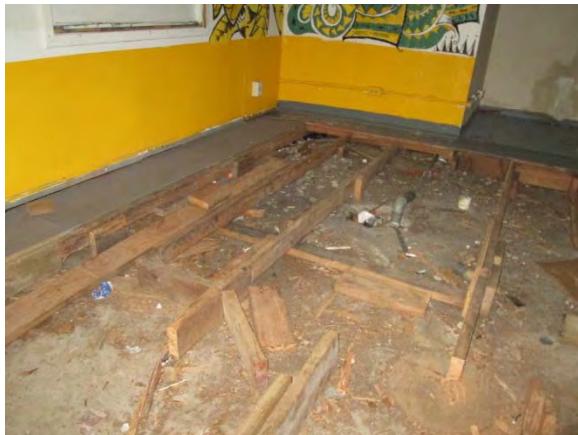
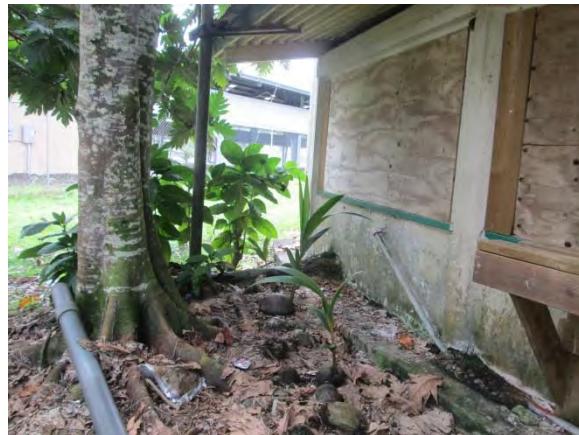
Building 3, previously used for ROTC, is currently not in use due to termite damaged wood floors. Staff said that the building previously had a concrete slab wood floor, and a wood floor was built on top to use the building as restroom (presumably to run the plumbing under the wood floor). It appears that the wood floor structure could be removed and the building reused with the concrete floor. There is some other deteriorated roofing and other elements, but nothing that couldn't be fairly easily repaired

or replaced if the school desires to use this building. There are two trees growing very close to the building that should be removed to prevent future damage.

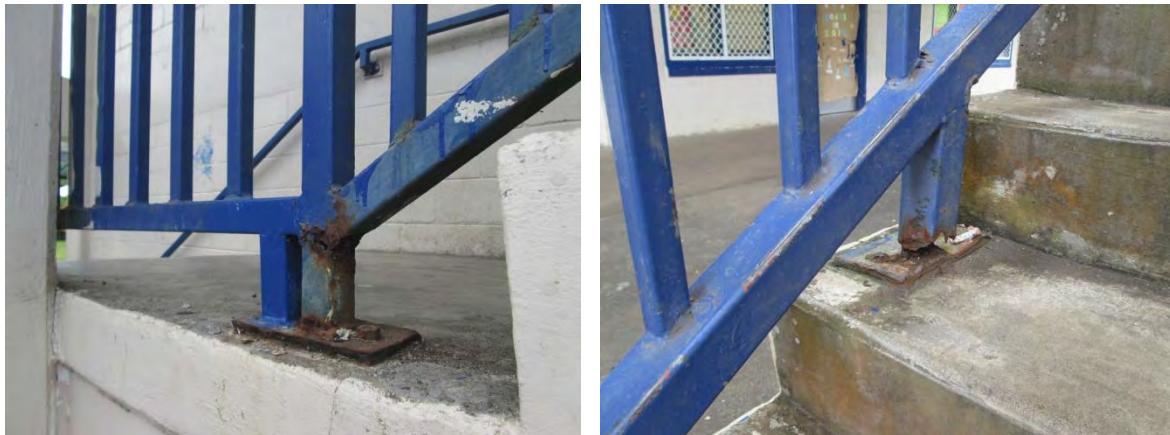
The spalled concrete at the base of the metal railings at Building 3 have been repaired and some of the rusted portions of the rail were patched. There are some heavily rusted areas of the rail, but it is no

longer loose. Repairs are still needed at the rusted metal base of the railing at the stair between Buildings 3 and 4.

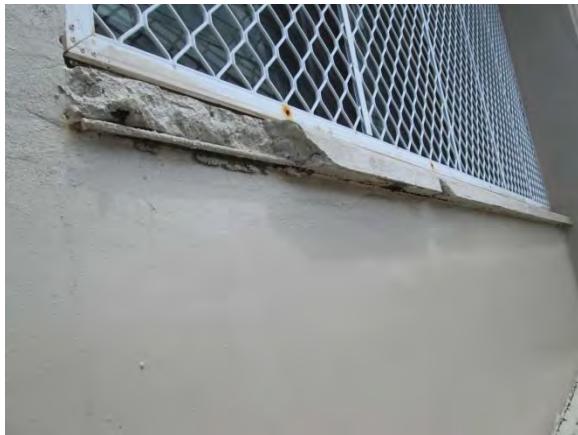
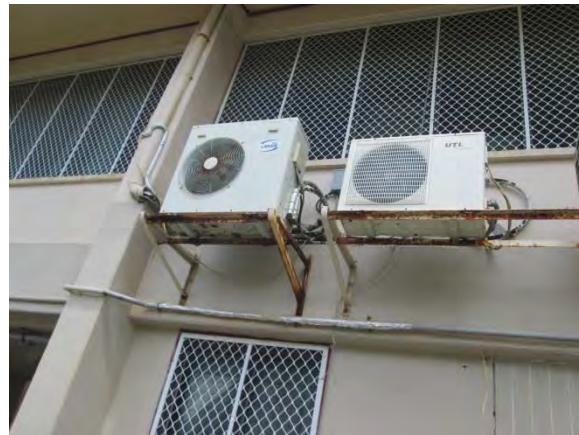
Building 8 has two safety hazards: the concrete window sills are spalling, and pieces of concrete could fall down onto someone below. These sills need to be repaired and the amount of concrete coverage over the reinforcing bars should be increased to help prevent future spalling. Also, one of the wall-mounted A/C units supports is heavily deteriorated and the support and unit are in danger of falling.

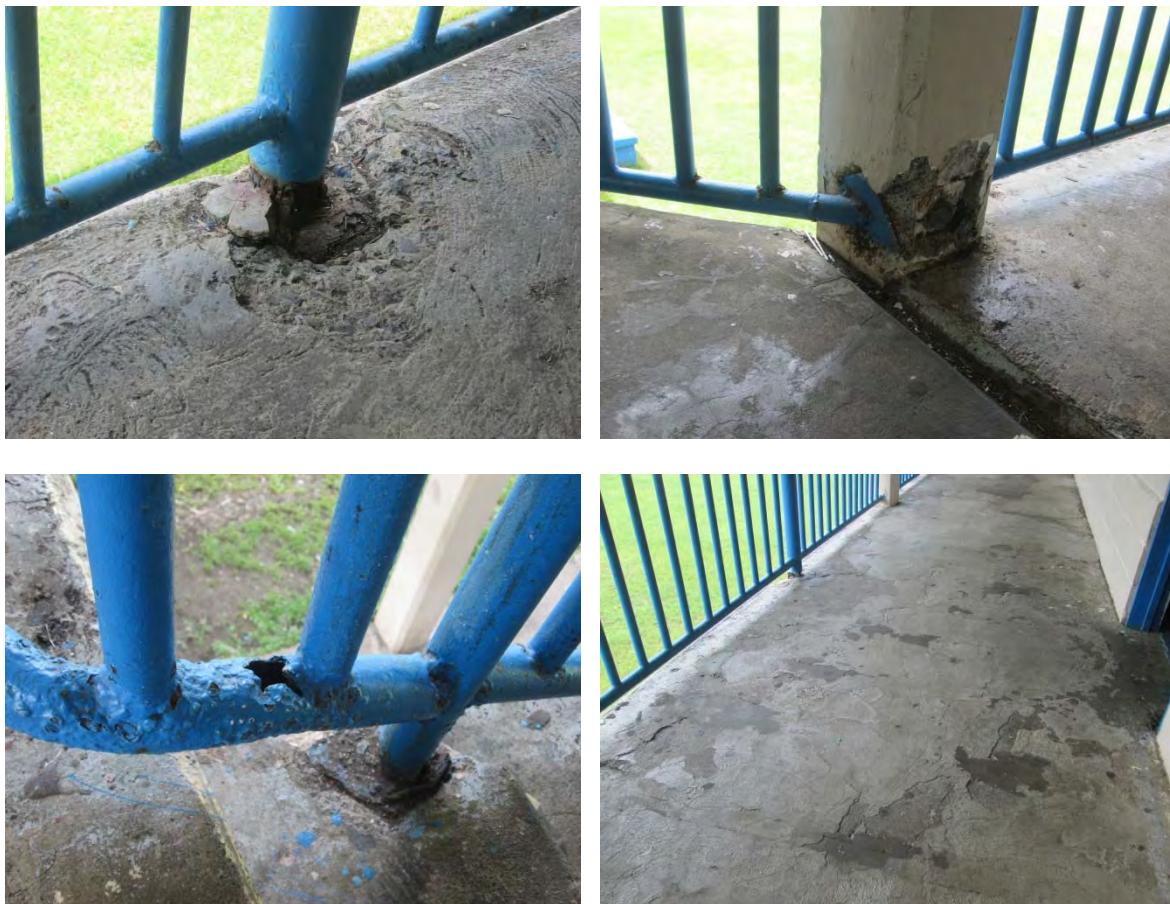
Railing repairs were completed at Building 5, but more rusted locations at Building 5 and 9 still require repair, as do locations where the concrete is spalling at the base of the railing vertical posts. The joints of the metal railing at the ramp between Buildings 7 and 8 are very rusted and need repair. The railing at the bottom of the stair at Building 7 is rusted all the way through and is completely detached.

The spalling concrete at the walkway at Building 7 was patched and is no longer a safety hazard.

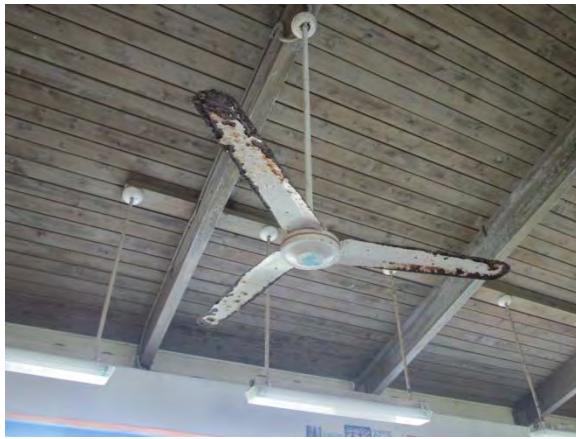
Building 8 still has very rusted ceiling fans, which are a safety hazard.

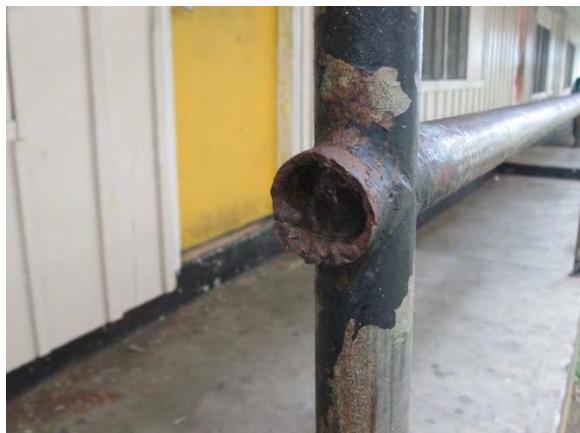
Building 1 received numerous repairs, including new ceilings, windows, siding and lights. Some roofing was replaced, but the corrugated metal roofing on the back side of the building is still in bad shape and needs to be replaced. Some of the metal railings at the front entries have missing pieces and there are jagged rusted portions, which are a safety hazard.

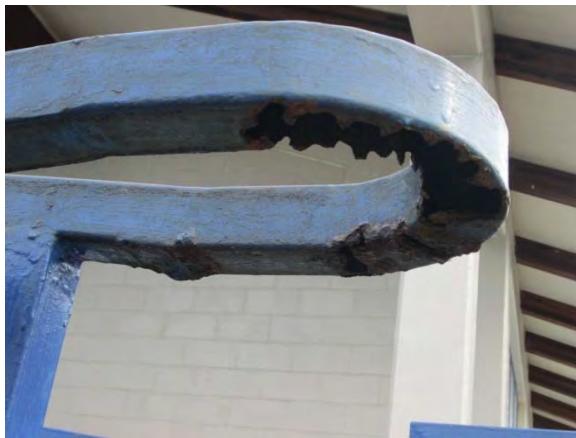
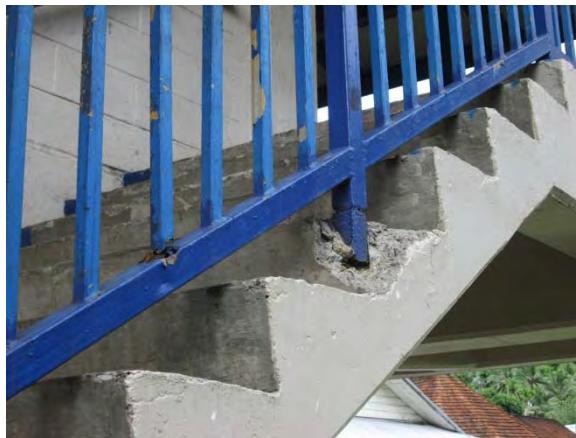
At Building 23, the metal railing is very rusted in places and is loose. It is a safety hazard and should be repaired. Also, the concrete is spalling at the base of the handrail in some locations, and should be repaired.

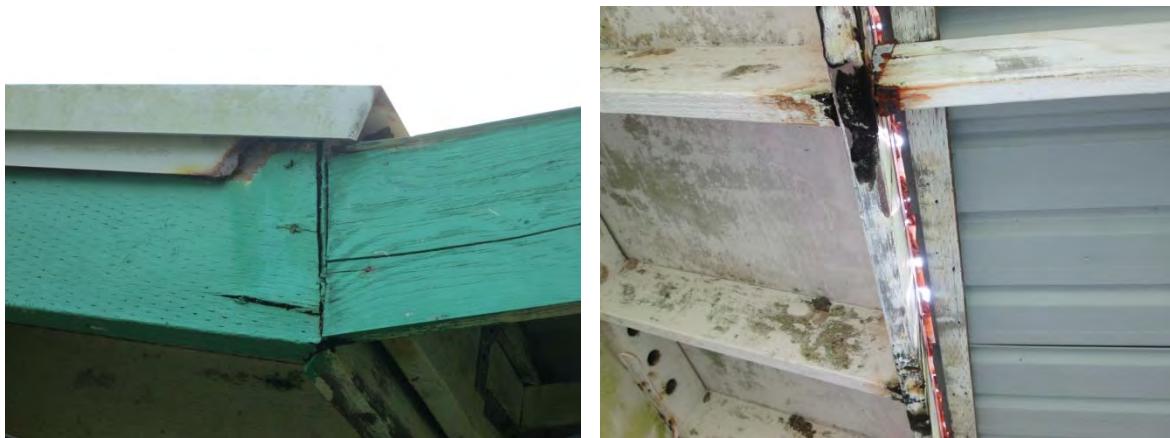
This school is about 20 years old; the roof covering over the exterior walkways was added about 5 years ago. At the joint between the end of the building rafters and the top of the walkway roof rafters, no flashing was installed, and the building roofing extends only a few inches past the end of the building rafters. Water often gets into this joint, pouring down on the walkway below. Metal flashing/roofing should be installed under the end of the building roofing, going at least 6" under the roofing, and extending at least 6" over the walkway roofing.

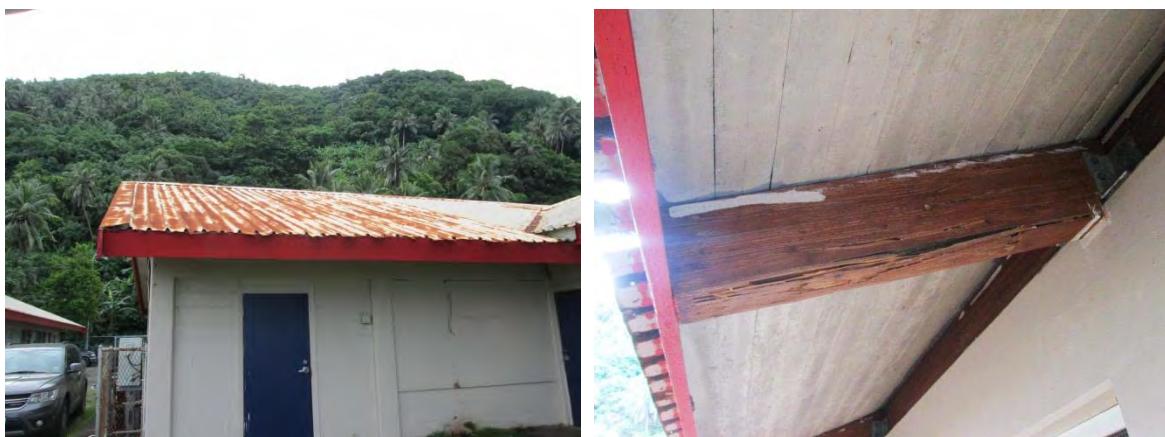
Roofing repairs were done at building 16 recently, but there continues to be some leaking; this may be due to deteriorating fasteners. Building 17 received new roofing, windows, and flooring. Building 18 has been demolished. The roofing at Building 2 is in poor condition and should be replaced; the gluelam roof structure at building 2 is quite termite damaged.

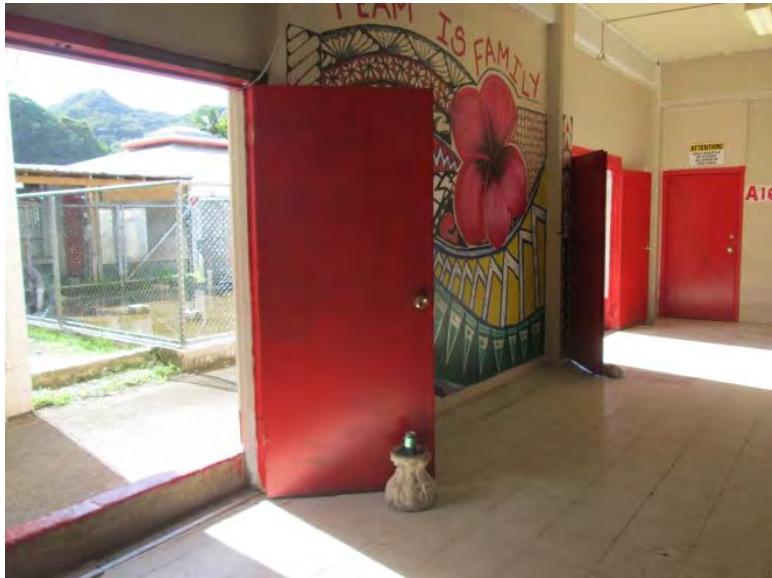
Building 9 still has doors that open inward. On one side of the building the doors have a large concrete curb in front of the doors to keep water from getting in the building. This is an exit safety hazard, as exit doors should open out and should have panic hardware. There are also several A/C drains that pour water onto the side of the building, damaging the paint and concrete walls, and onto the sidewalk below, creating a potential slip hazard.

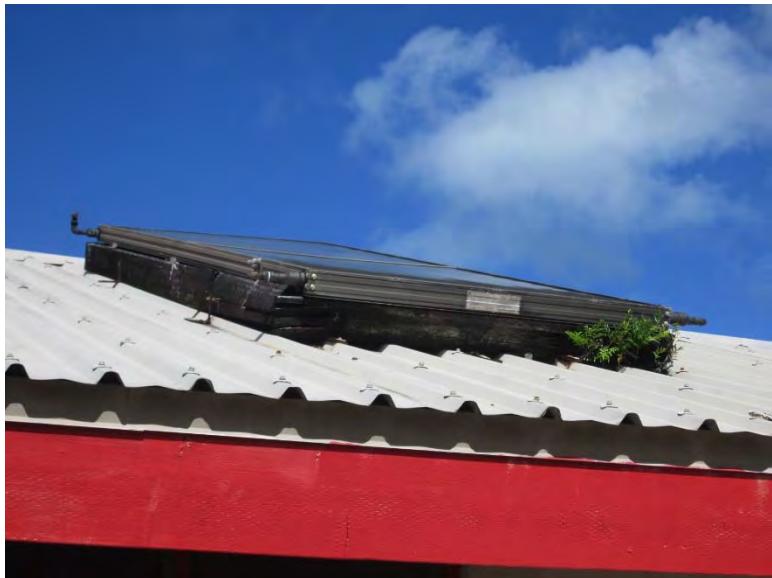
The solar water heating system on top of Building 6 appears to have a heavily deteriorated frame. This should be repaired if the system is still planned to be used.

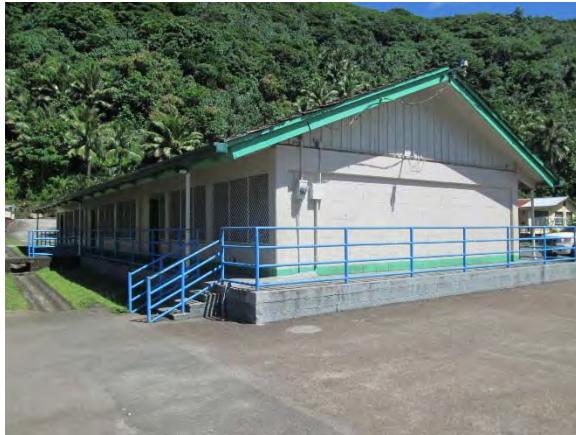
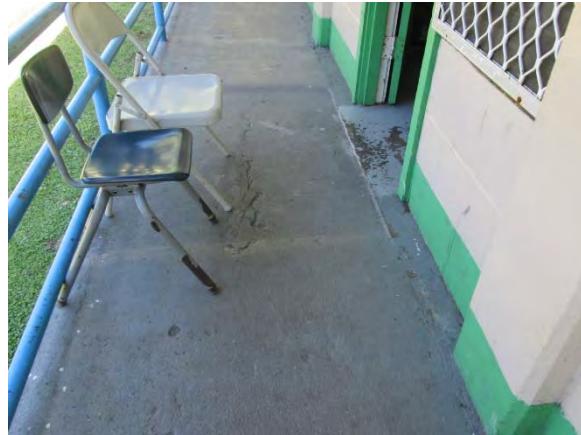
Building 2 has a new gutter and downspout, but has no flooring and the windows are missing some jalousie panes, and the concrete floor at the exterior walkway is beginning to spall.

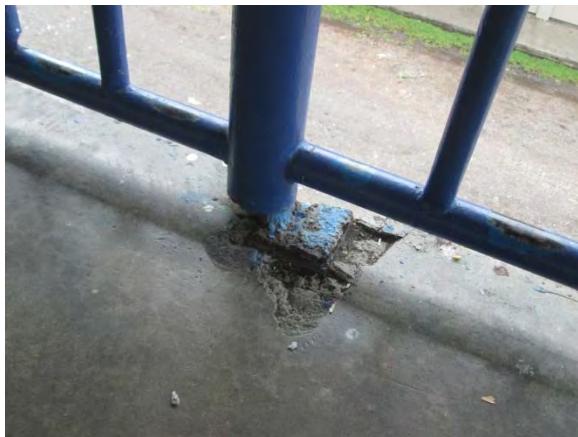
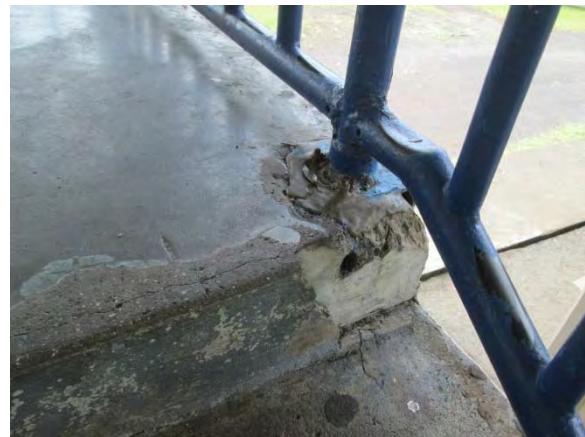
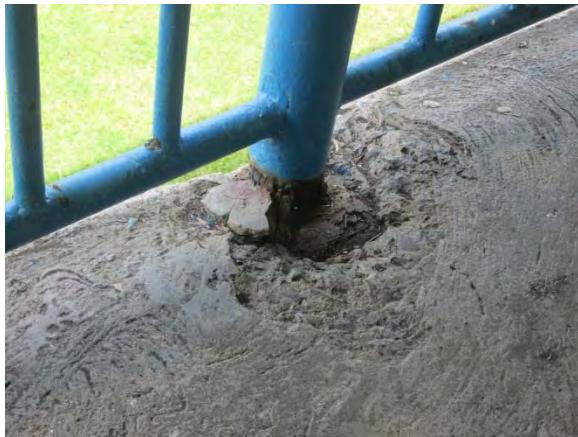
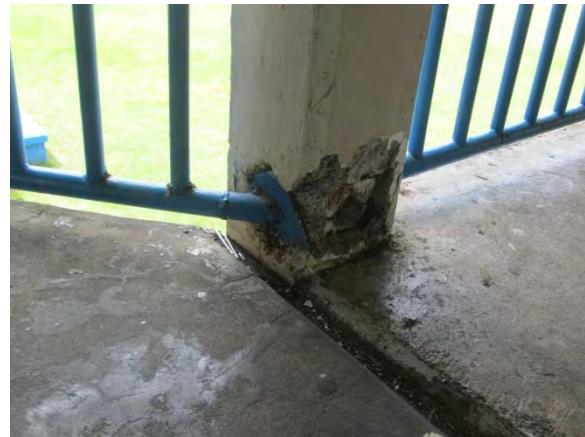
### 1. Spalled or damaged concrete at railing base

The concrete at the stair and walkway at the base of the railing posts is spalling in several areas. This will eventually allow the railing to become loose, which is a safety hazard. The concrete should be repaired.

Where the concrete is spalling at the walkway or column:

- Remove all loose concrete
- Clean concrete and steel thoroughly
- Remove rust from any exposed steel and treat with a rust-preventing compound
- Pour new hydraulic concrete and make surface flush

For a spalled stair tread corner:

- Cut railing off at each base and remove railing
- Cut out the metal bases in concrete and remove all loose concrete
- Install new metal railing bases in concrete with hydraulic concrete. Locate new railing base further back from tread edge.
- Weld bases to railing such that railing is required height.

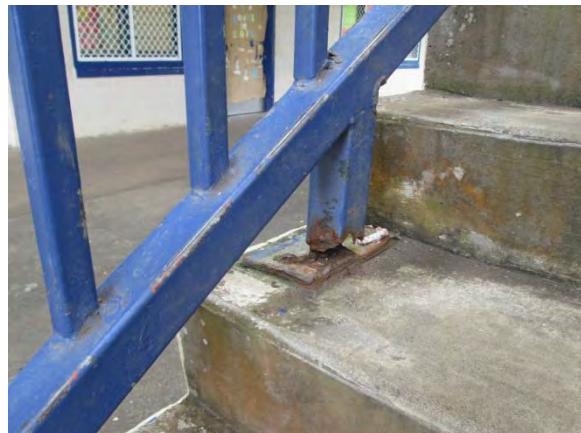
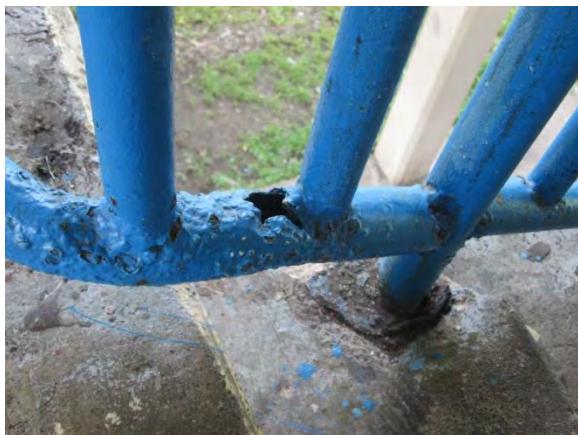
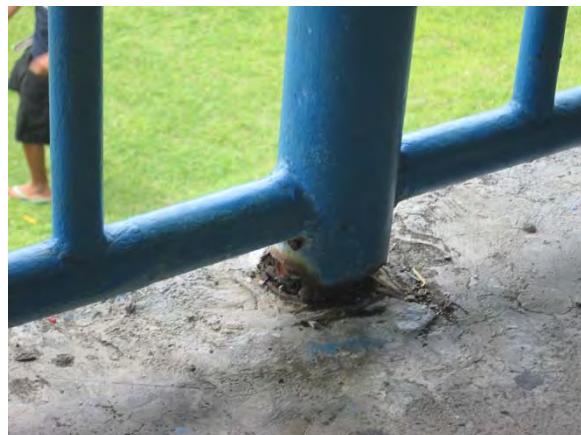
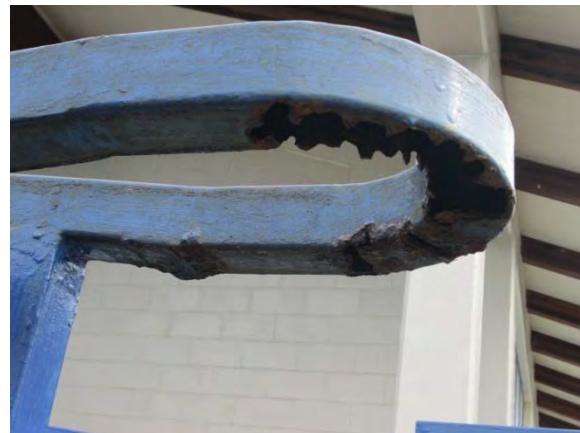
2. Rusted metal railings at concrete stairs/walkways/ramps

The metal railings at the stairs and walkways are heavily rusted at the base; in some locations the connection to the concrete is completely gone.

Where railings are rusted at the base, the railing must be removed and a new metal railing base installed in the concrete.

- Cut railing off at each base and remove railing
- Cut out the metal bases in concrete and remove all loose concrete
- Install new metal railing bases in concrete with hydraulic concrete. Weld bases to railing such that railing is required height.

Where railings are rusted at horizontal portions or at pickets:

- Remove rusted metal and clean rail surface
- Weld railing as required to repair and ensure required strength

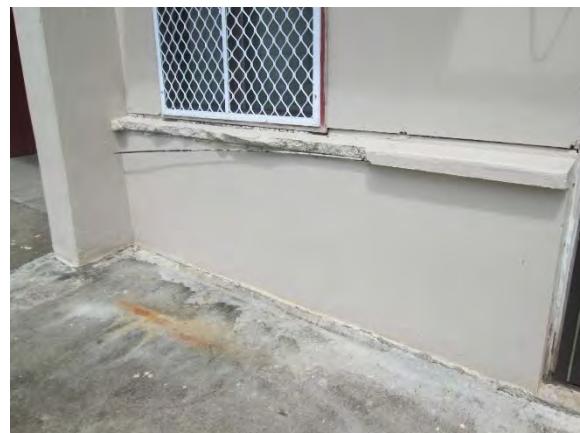
### 3. Spalling window sills

The concrete sills below the windows on the northeast side are spalling. This appears to be due to a lack of adequate concrete cover over the steel reinforcing bars; moisture has gotten to the steel bars, causing them to rust and expand, which then causes the concrete to spall. As this is occurring on the second floor windows as well as the first floor, it is a safety hazard due to the concrete falling from above.

- Remove entire concrete sill and steel reinforcing bar
- Clean concrete surface
- Install stainless steel nails into wall perpendicular to sill at 24" O.C.
- Attach fiberglass reinforcing bar to nails at center of sill (equal distance to bottom and top, equal distance to wall and outer edge)
- Pour new concrete sill

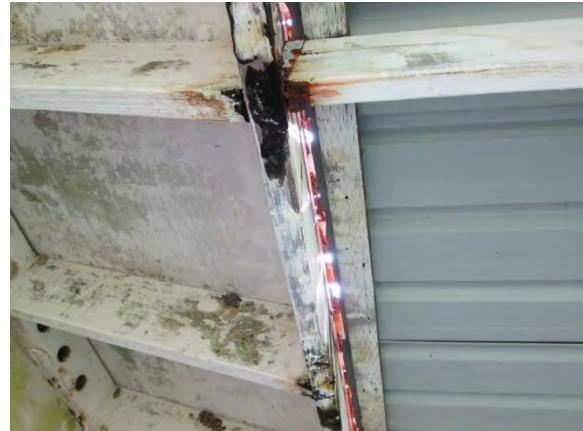
**4. Leaking exterior walkway roof**

This school is about 20 years old; the roof covering over the exterior walkways was added about 5 years ago. At the joint between the end of the building rafters and the top of the walkway roof rafters, no flashing was installed, and the building roofing extends only a few inches past the end of the building rafters. Water often gets into this joint, pouring down on the walkway below

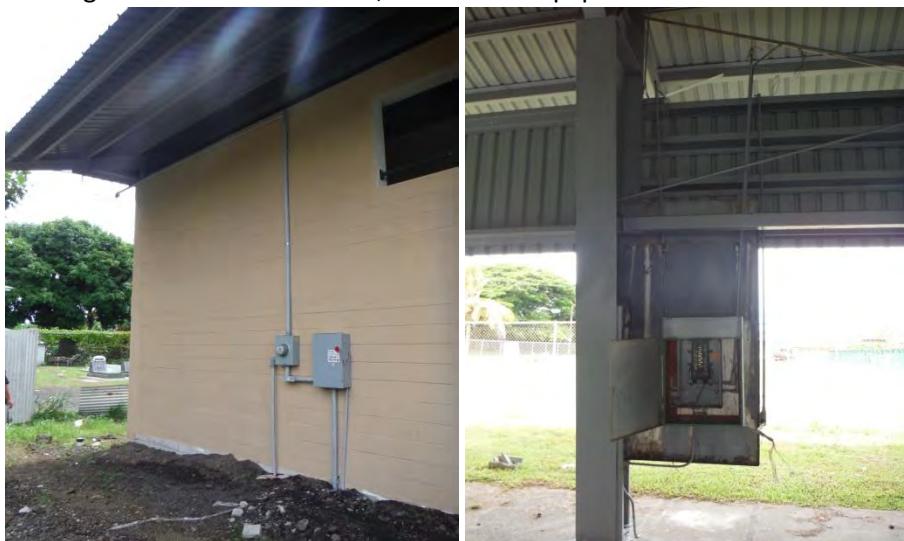
Building 01 – New ASPA Service, Old service equipment not removed

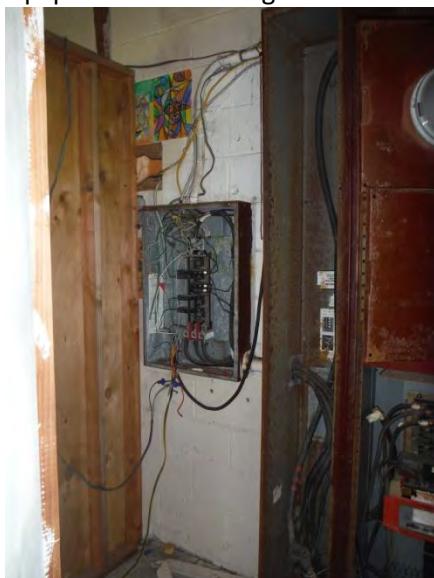
Equipment still missing covers

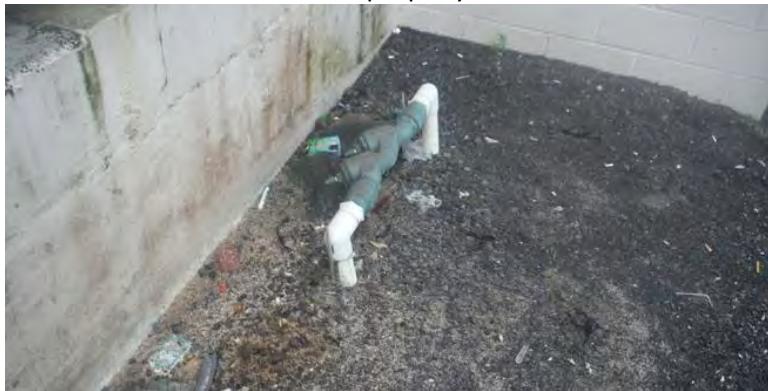
OIA Phase III survey found the backflow preventer was installed side-ways and should be corrected in order to function properly.

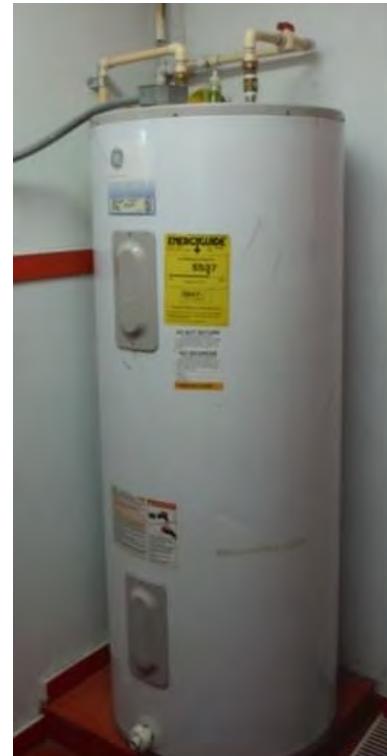
2. Building 07

OIA Phase III survey found electric hot water heater was not secured and pressure/ temperature relief valve was not piped properly and simply drained to floor. This poses a safety hazard to occupants and should be corrected.

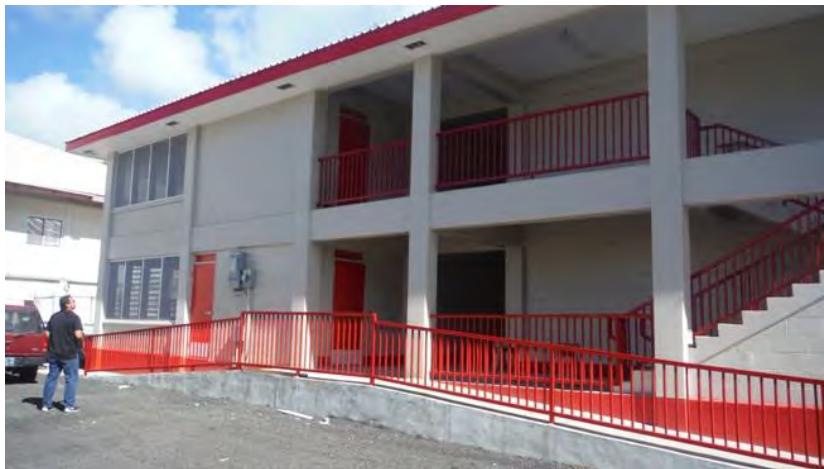
##### 5. Fire alarm

OIA Phase II survey found no fire alarm system in the campus, and no fire alarm system was installed in OIA Phase III survey. Neither the new 2 story building constructed in 2014 consisted of 8 classrooms, has fire alarm system. This poses a safety hazard to the occupants. New fire alarm system should be provided throughout the campus.

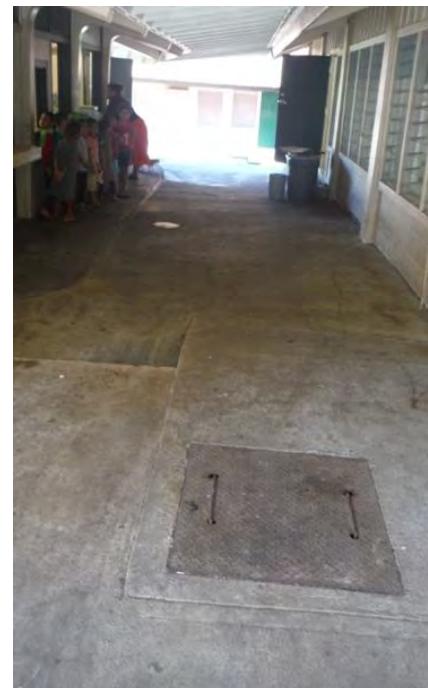
OIA Phase II survey found the gease trap was overflowing and continuously running-off to the walkway. This created both health and slipping hazard. Grease trap and drainage was repaired. Walkway was cleaned in OIA Phase III survey.

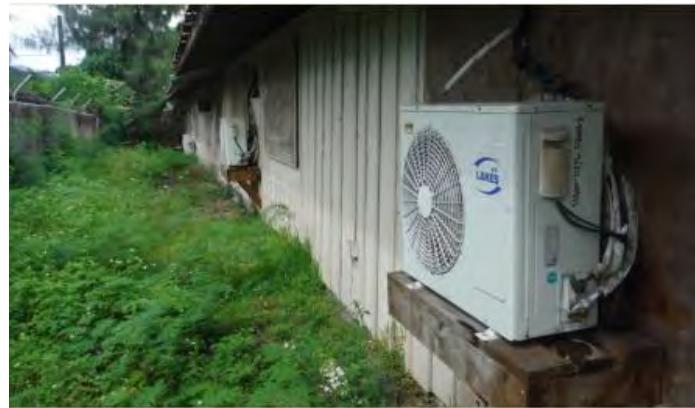
Location: Lauli'i ES building 6, kitchen and Nu'uuli Polytechnic building 1, classroom – wooden AC equipment supports.

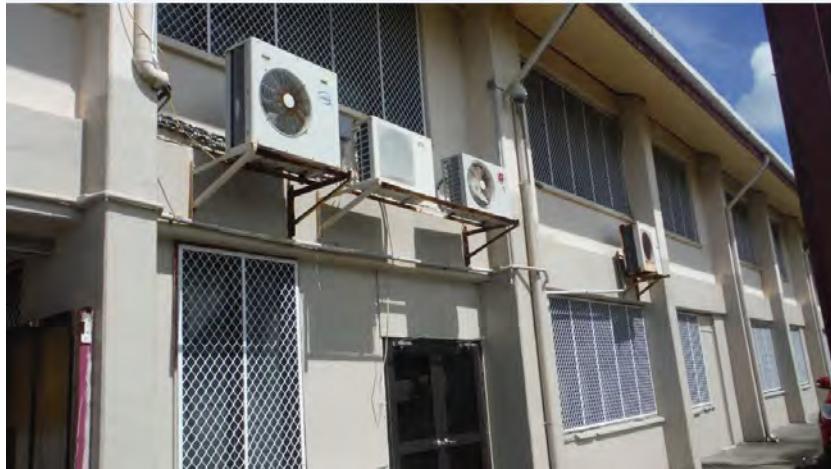
- Remove old air conditioning equipment and seal all unused penetrations.  
Location: Tafuna HS Building 8, Classroom / Office, had abandoned AC equipment on exterior wall over the walkway. AC equipment casing and supports were heavily corroded and posed hazards.

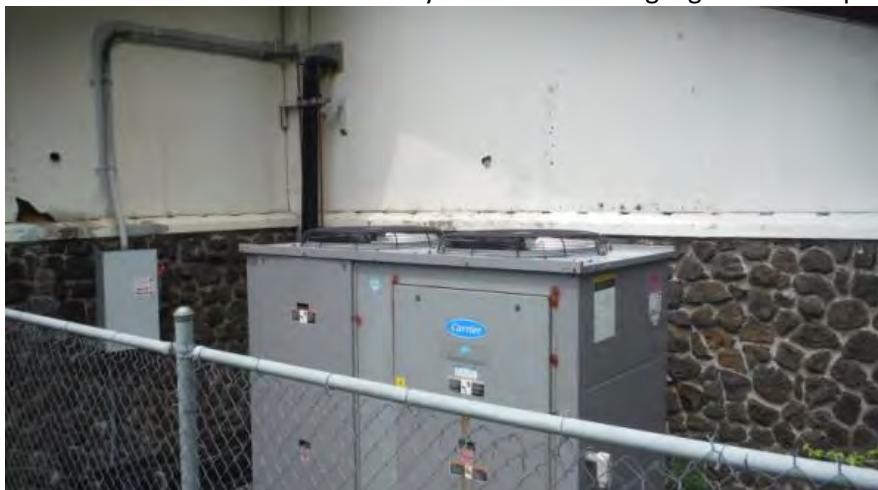
Air conditioner to science laboratory was down causing high room temperature and humidity.

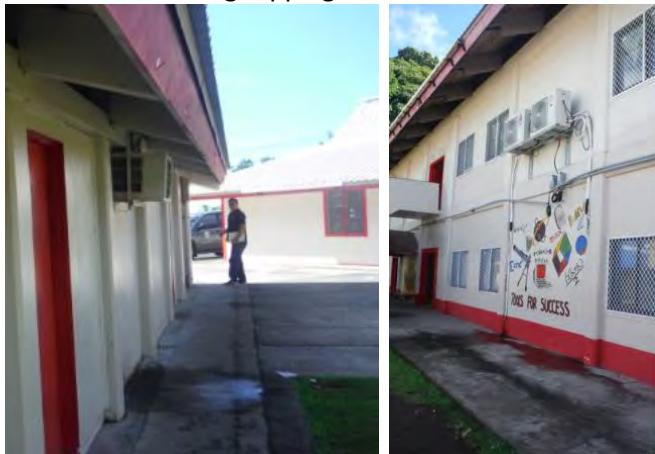
Location: Faga'itua HS building 5, office; building 9, classrooms - Condensate drains discharged to sidewalks causing slipping hazards.

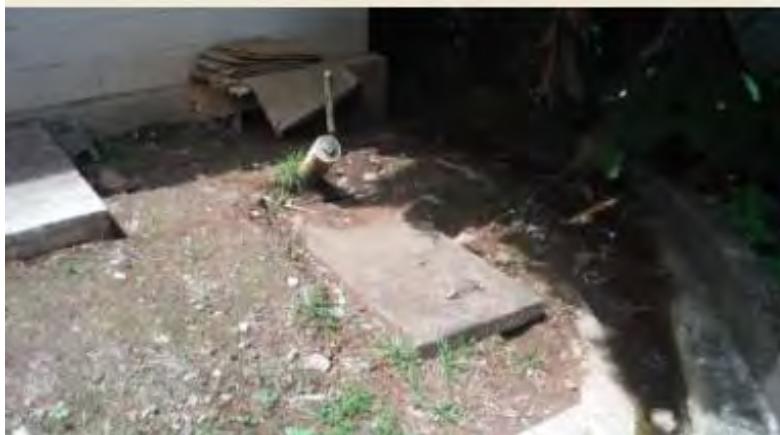
Location: Alataua ES building 3, kitchen – grease trap cover is not fully sealed.

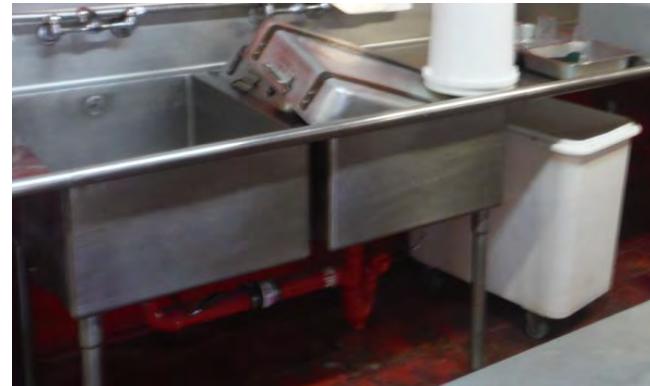
Location: Faga'itua HS building 7, kitchen – lack of indirect waste connection at kitchen sink

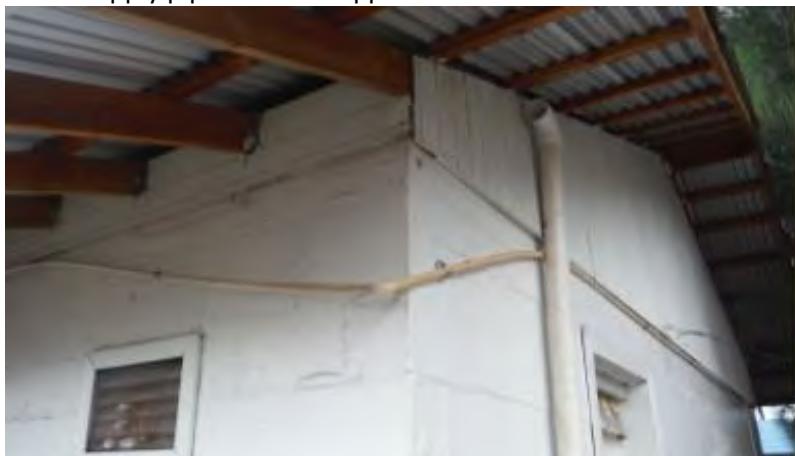
Water supply pipe was not supported.

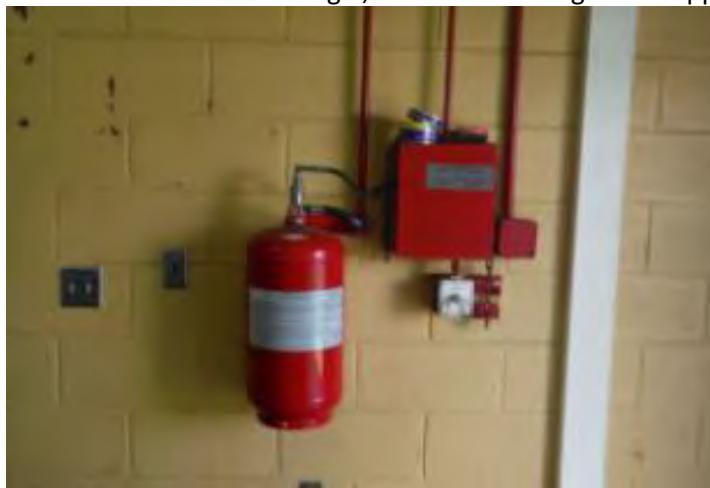
Location: Tafuna HS building 1, kitchen – cooking hood suppression system should be serviced.

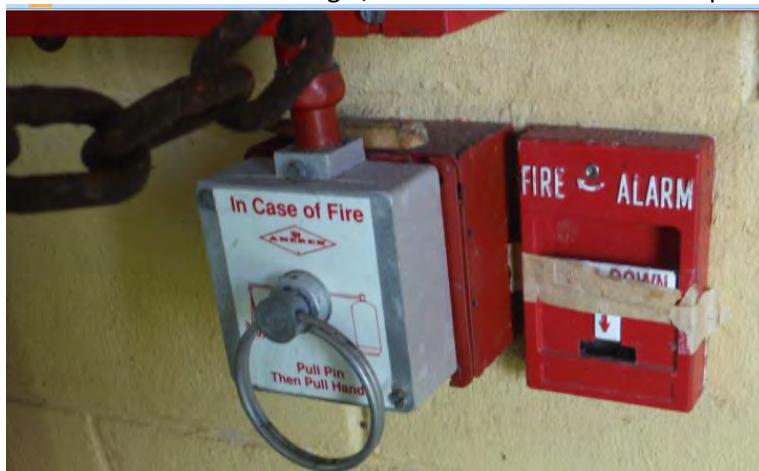
Location: Tafuna HS building 1, kitchen – Pull station was taped. Fire alarm system was not serviced.

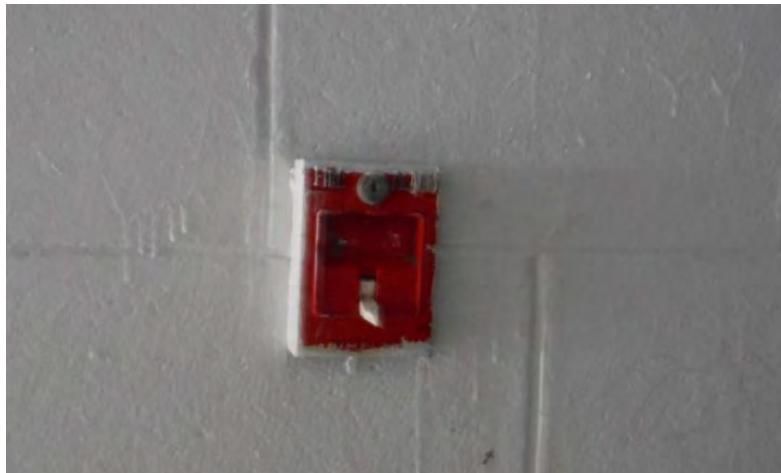
Location: Samoana HS building 2, classroom – Pull station was damaged. Fire alarm system was not services.

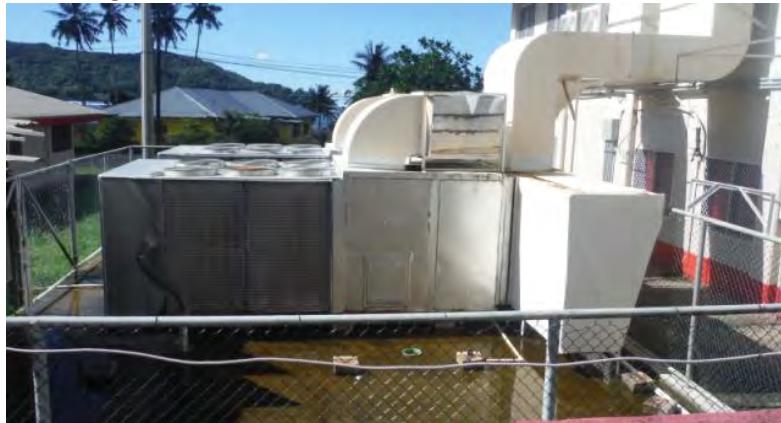
Location: Faga'itua HS building 9 – Lack of duct smoke detector to shut down air conditioner exceeding 2,000 CFM.
