INSULAR ABC'S INITIATIVE

Phase III Task 1 – Civil Engineer Findings

AMERICAN SAMOA

Civil Site Maps for Required Projects

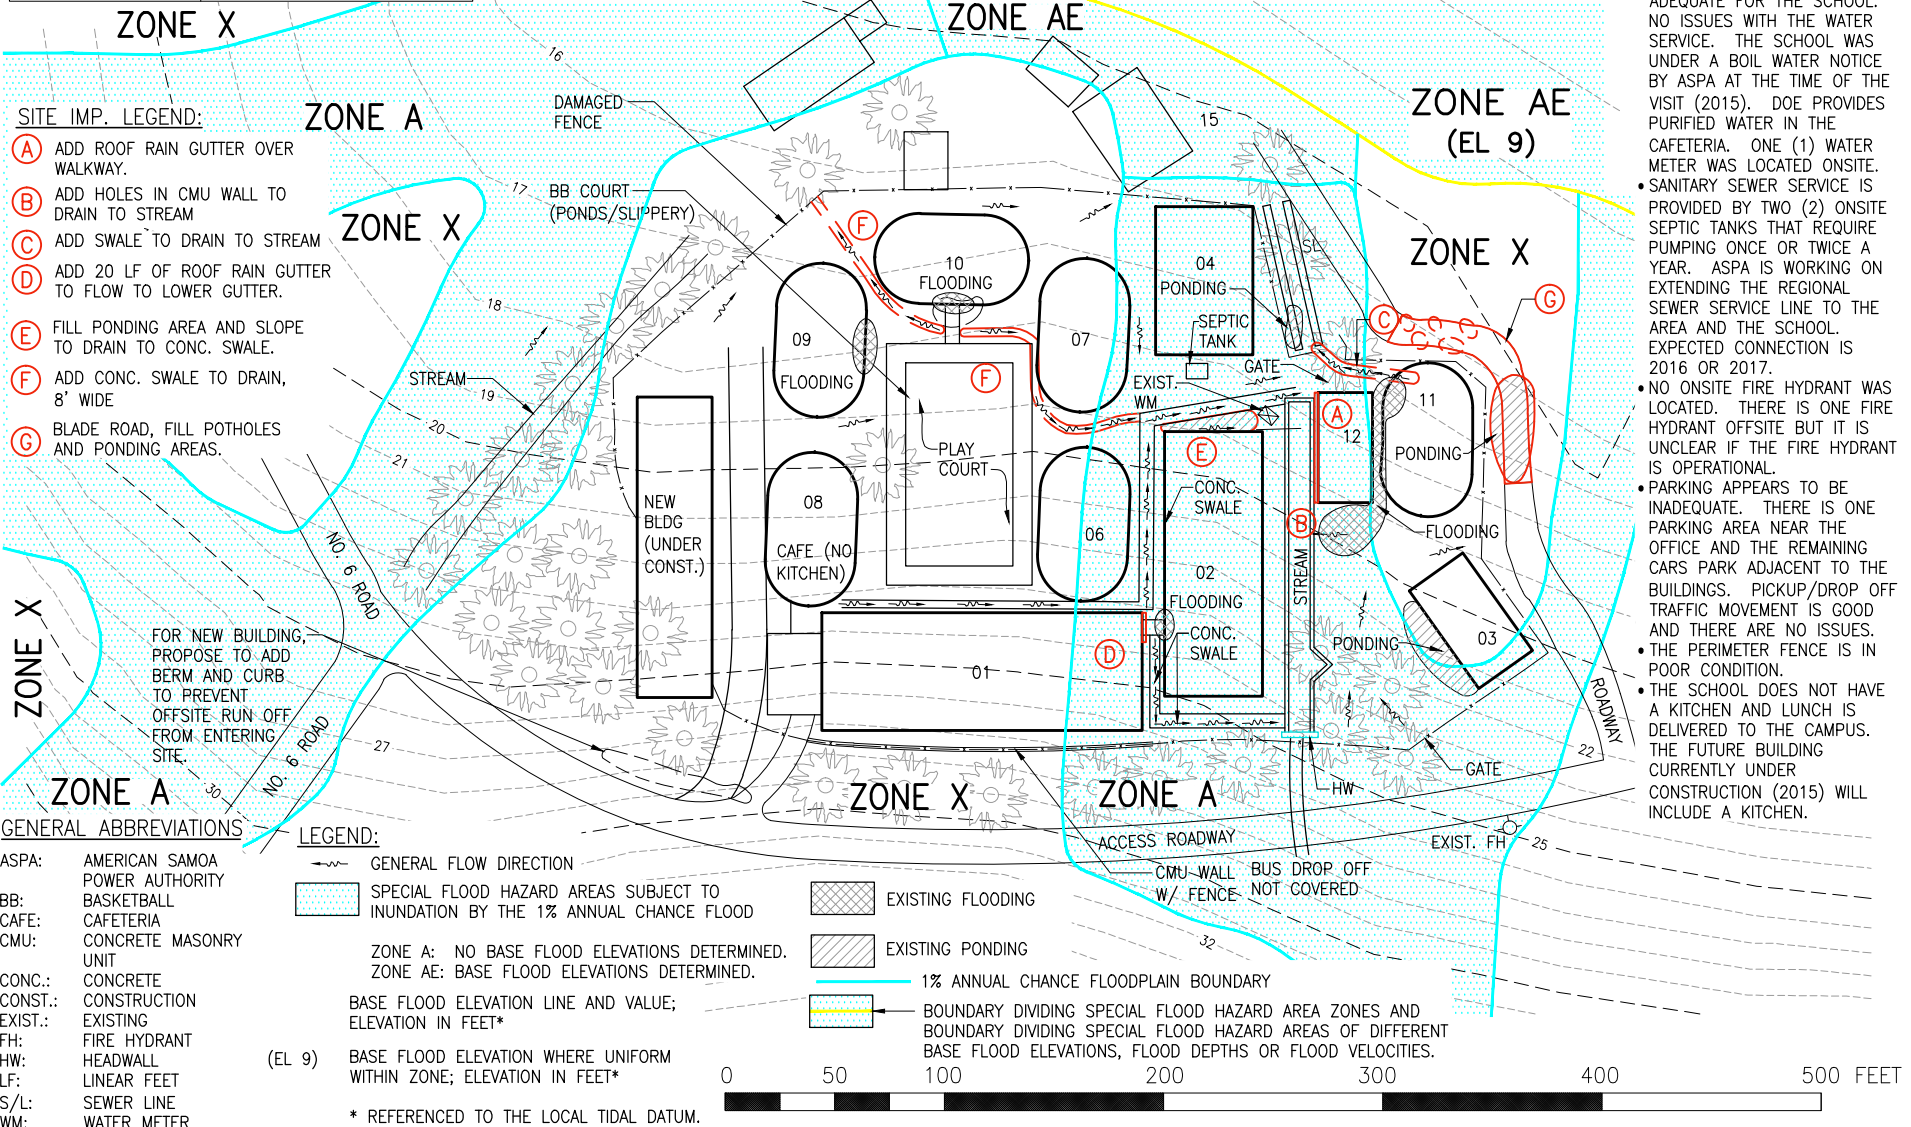
03

SITE NOTES:

- POTABLE WATER SERVICE IS PROVIDED BY THE ASPA WATER SYSTEM. WATER PRESSURE IS ADEQUATE FOR THE SCHOOL. NO ISSUES WITH THE WATER SERVICE. THE SCHOOL WAS UNDER A BOIL WATER NOTICE BY ASPA AT THE TIME OF THE VISIT (2015). DOE PROVIDES PURIFIED WATER IN THE CAFETERIA. ONE (1) WATER METER WAS LOCATED ONSITE.

- SANITARY SEWER SERVICE IS PROVIDED BY TWO (2) ONSITE SEPTIC TANKS THAT REQUIRE PUMPING ONCE OR TWICE A YEAR. ASPA IS WORKING ON EXTENDING THE REGIONAL SEWER SERVICE LINE TO THE AREA AND THE SCHOOL. EXPECTED CONNECTION IS 2016 OR 2017.

- NO ONSITE FIRE HYDRANT WAS LOCATED. THERE IS ONE FIRE HYDRANT OFFSITE BUT IT IS UNCLEAR IF THE FIRE HYDRANT IS OPERATIONAL.
- PARKING APPEARS TO BE INADEQUATE. THERE IS ONE PARKING AREA NEAR THE OFFICE AND THE REMAINING CARS PARK ADJACENT TO THE BUILDINGS. PICKUP/DROP OFF TRAFFIC MOVEMENT IS GOOD AND THERE ARE NO ISSUES.

- THE PERIMETER FENCE IS IN POOR CONDITION.
- THE SCHOOL DOES NOT HAVE A KITCHEN AND LUNCH IS DELIVERED TO THE CAMPUS. THE FUTURE BUILDING CURRENTLY UNDER CONSTRUCTION (2015) WILL INCLUDE A KITCHEN.

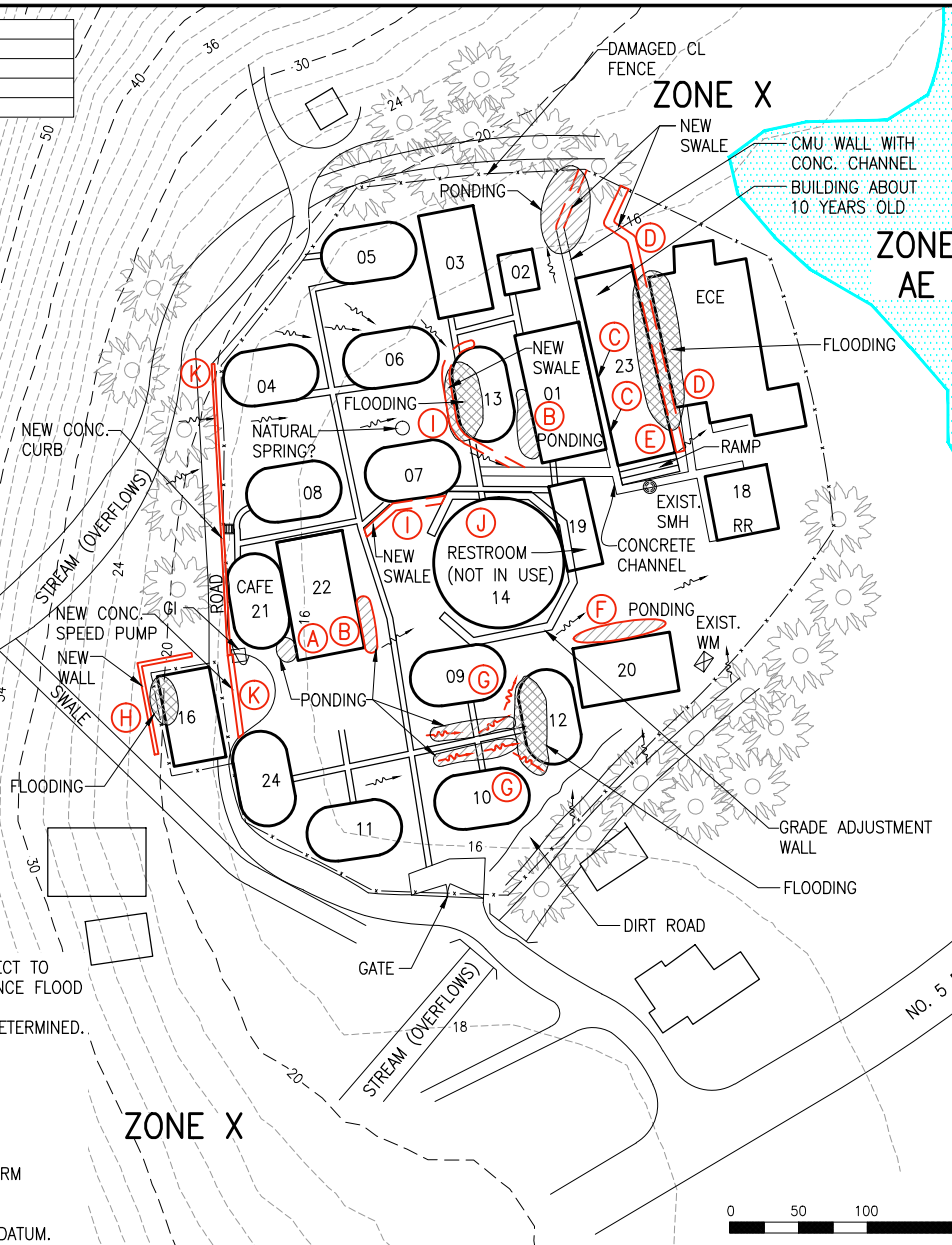
FIGURE
04

SITE NOTES:

- POTABLE WATER SERVICE IS PROVIDED BY THE ASPA WATER SYSTEM. WATER PRESSURE IS ADEQUATE FOR THE SCHOOL. ASPA LIFTED THE BOIL WATER NOTICE BUT STUDENTS STILL DO NOT DRINK FROM THE TAP. DOE PROVIDES A PURIFIED BOTTLED WATER STATION IN THE CAFETERIA. ONE (1) WATER METER WAS LOCATED ONSITE.
- SANITARY SEWER SERVICE IS PROVIDED BY THE ASPA SEWER SYSTEM. NO ISSUES WITH THE SEWER SERVICE OR GREASE INTERCEPTOR.
- NO ONSITE FIRE HYDRANT WAS LOCATED. THERE IS ONE FIRE HYDRANT OFFSITE ALONG NO. 5 ROAD BUT IT IS UNCLEAR IF THE FIRE HYDRANT IS OPERATIONAL.
- FLOODING WAS IDENTIFIED BY STAFF AT VARIOUS CLASSROOMS. THE STAFF ALSO NOTED THAT WHEN THE STREAM THAT ROUTES AROUND THE SCHOOL OVERFLOWS, WATER FLOWS INTO THE SCHOOL AND OFTEN FLOODS THE CLASSROOMS.
- PARKING APPEARS TO BE INADEQUATE AND THERE IS NO DROP OFF AREA.
- SOME OF THE EXIST. FENCE IS DAMAGED.

SITE IMP. LEGEND:

- (A) REPLACE DOWNSPOUT PIPING TO WALL PIPE AND ROUTE TO SOUTH AWAY FROM DOORWAY
- (B) BACKFILL TO ELIMINATE PONDING. SLOPE TO DRAIN
- (C) CLEAN CONC. SWALE OF DIRT AND DEBRIS.
- (D) ADD CONC. SWALE 6' WIDE SLOPE TO DRAIN TO STREAM (6" TO 12" DEEP). EXCAVATE MATERIAL TO BE 4" BELOW EDGE OF S/W AND FFE OF BUILDING 23.
- (E) ADD SIDEWALK CULVERT TO DRAIN PONDING TO NEW CONC. SWALE
- (F) FILL SUMP TO SLOPE TO DRAIN
- (G) LOWER GROUND 3" BELOW EDGE OF S/W SLOPE TO DRAIN TO EARTH SWALE
- (H) PROVIDE A 3' HIGH CMU WALL TO DIVERT STREAM RUNOFF AWAY FROM OFFICE
- (I) ADD 4'-WIDE CONC. SWALE TO ROUTE RUNOFF AROUND BUILDING 13. SLOPE TO DRAIN
- (J) BACKFILL AND REMOVE TOP WALL BLOCK. SLOPE TO DRAIN
- (K) INSTALL A CONC. SPEED BUMP AND CONC. CURB

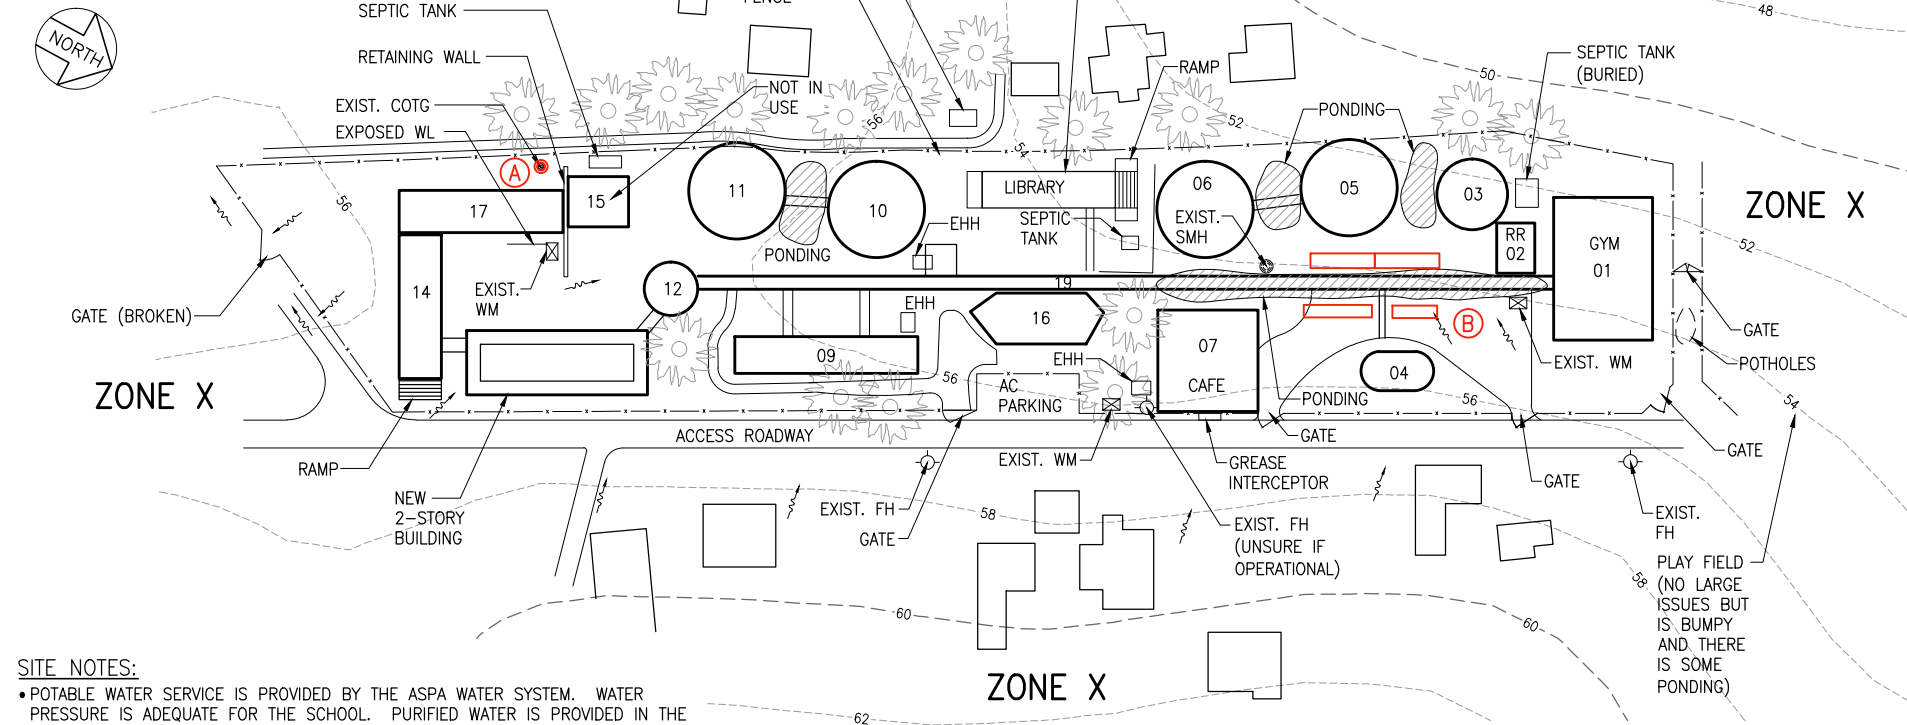
SITE NOTES:

- POTABLE WATER SERVICE IS PROVIDED BY THE ASPA WATER SYSTEM. WATER PRESSURE IS ADEQUATE FOR THE SCHOOL. PURIFIED WATER IS PROVIDED IN THE CAFETERIA. NO ISSUES WITH THE WATER SERVICE. THREE (3) WATER METERS WERE LOCATED ONSITE.

- THERE ARE NO RETAINING WALLS.
- THERE IS NO DESIGNATED PARKING AREA AND THE MAJORITY OF STUDENTS WALK TO THE MAIN ROAD TO CATCH THE BUS.
- THERE IS DAMAGE TO THE EXISTING FENCE.

- GENERAL FLOW DIRECTION
- EXISTING PONDING
- ZONE X: AREAS DETERMINED TO BE OUTSIDE THE 0.2% ANNUAL CHANCE FLOODPLAIN
- (A) REPLACE COTG COVER
- (B) ADD UNDERGROUND RETENTION CHAMBERS.

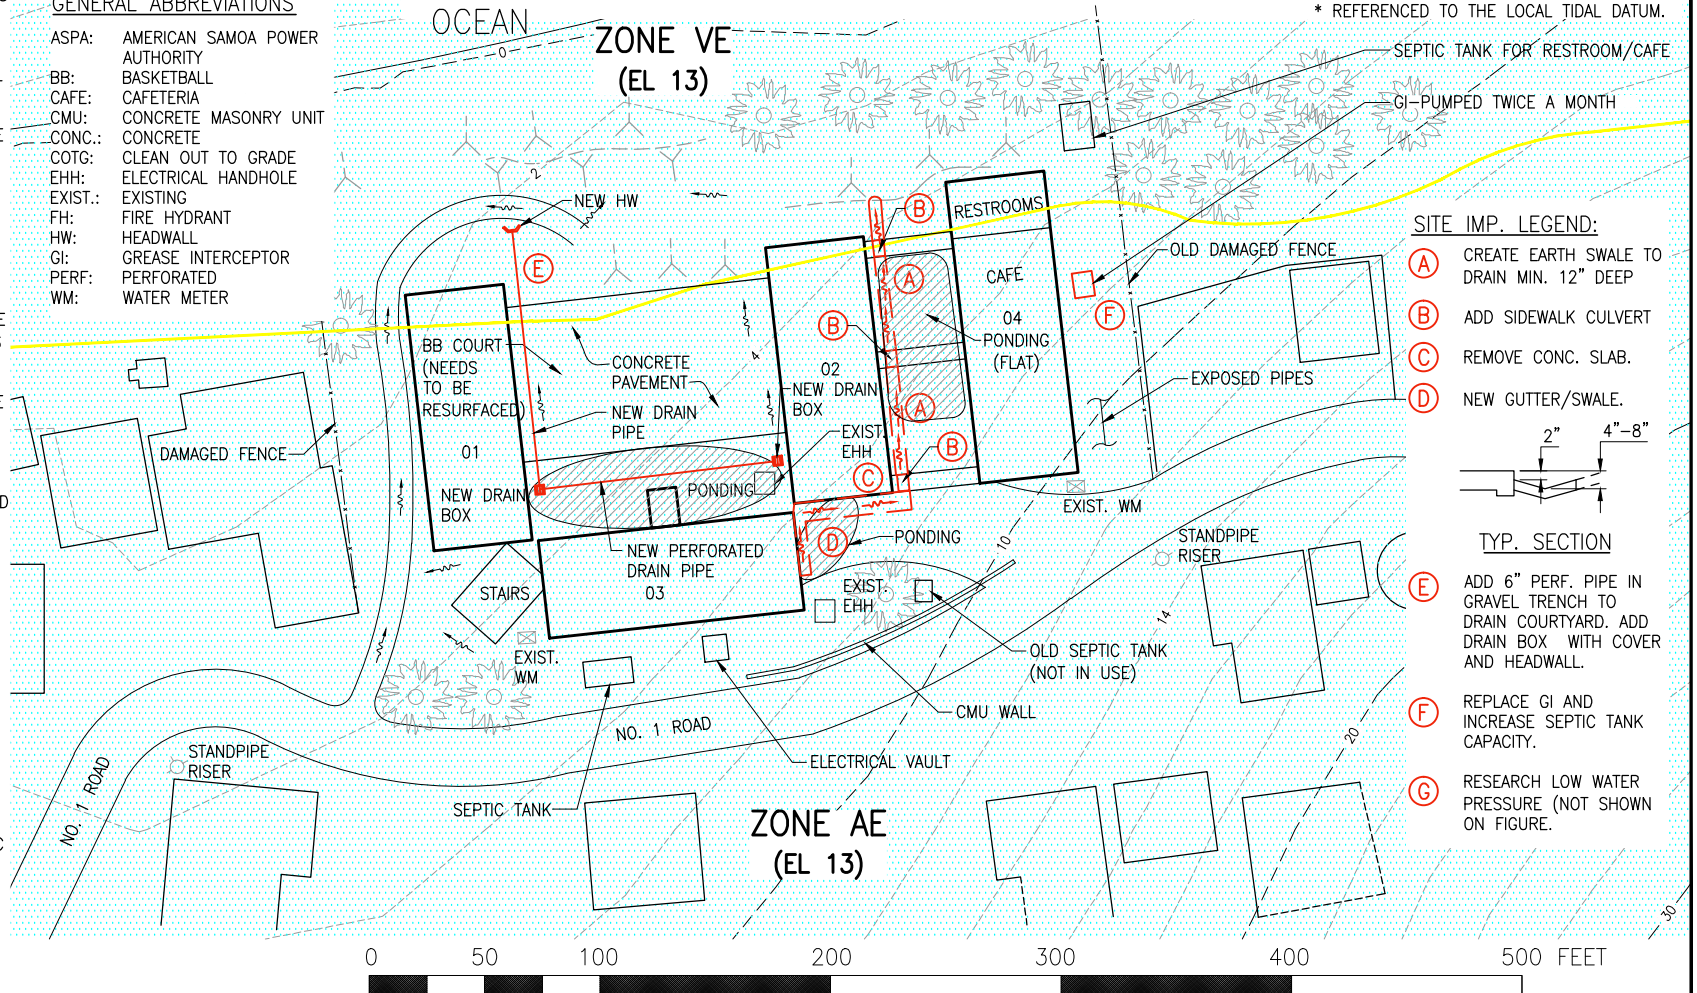
- A MAJORITY OF THE STUDENTS WALK OR ARE BUSED TO SCHOOL. PICKUP/DROP OFF TRAFFIC MOVEMENT FOR CARS/BUSES IS POOR.
- THE SCHOOL IS PARTIALLY SURROUNDED BY A PERIMETER FENCE; HOWEVER THE EXISTING FENCE IS IN POOR CONDITION.

SITE IMP. LEGEND:

- (A) CREATE EARTH SWALE TO DRAIN MIN. 12" DEEP
- (B) ADD SIDEWALK CULVERT
- (C) REMOVE CONC. SLAB.
- (D) NEW GUTTER/SWALE.
- (E) ADD 6" PERF. PIPE IN GRAVEL TRENCH TO DRAIN COURTYARD. ADD DRAIN BOX WITH COVER AND HEADWALL.
- (F) REPLACE GI AND INCREASE SEPTIC TANK CAPACITY.
- (G) RESEARCH LOW WATER PRESSURE (NOT SHOWN ON FIGURE).

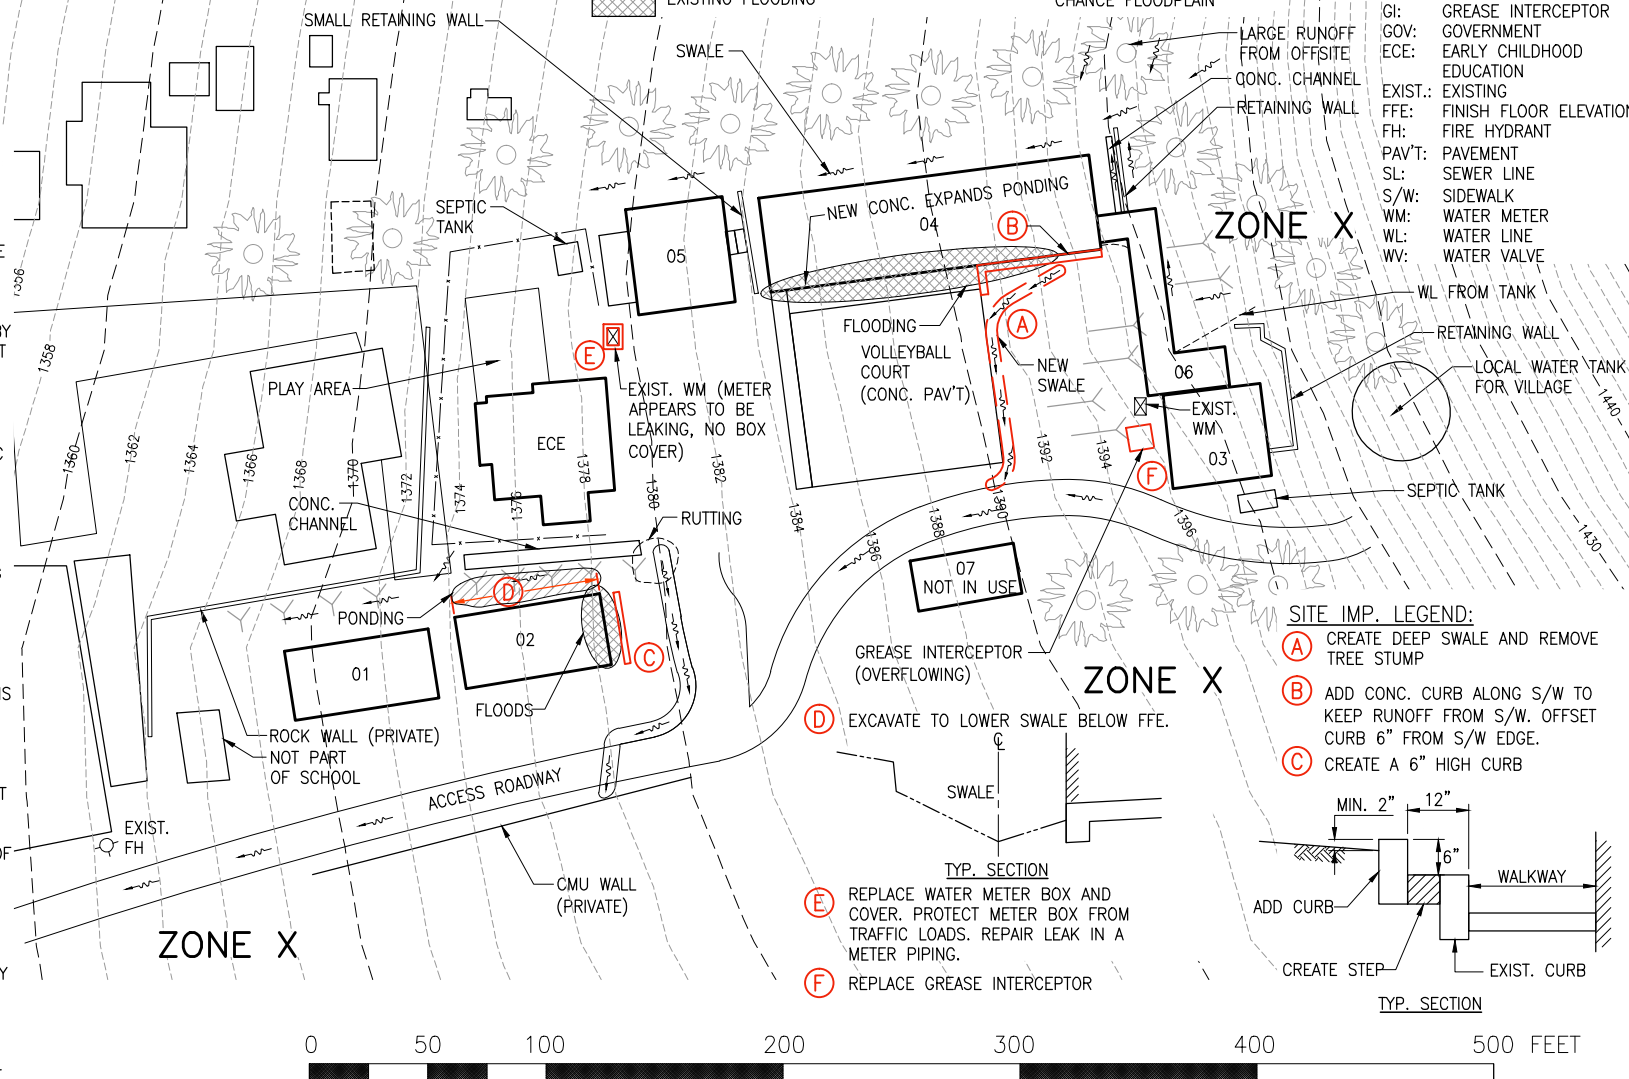
- POTABLE WATER SERVICE IS PROVIDED BY THE ASPA WATER SYSTEM. WATER PRESSURE IS GOOD FOR THE SCHOOL. THE WATER METER ADJACENT TO THE ECE WAS EXPOSED TO TRAFFIC LOADING AND WAS MISSING A COVER. THE SCHOOL WAS UNDER A BOIL WATER NOTICE BY ASPA AT THE TIME OF THE VISIT (2015). DOE PROVIDES DRINKING WATER TO THE STUDENTS.

- SANITARY SEWER SERVICE IS PROVIDED BY AN ONSITE SEPTIC TANK. THE SEPTIC TANK REQUIRES PUMPING THREE TO FOUR TIMES PER YEAR. NO ISSUES WITH THE SEWER SERVICE. THE EXIST. GREASE INTERCEPTOR WAS OVERFLOWING AND REQUIRES PUMPING ONCE OR TWICE PER MONTH AND SHOULD BE REPLACED.

- THERE IS NO DESIGNATED PARKING AREA AND STAFF CURRENTLY PARK BY THE ADJACENT HOUSES. A MAJORITY OF THE STUDENTS WALK. PICKUP/DROP OFF TRAFFIC MOVEMENT IS ADEQUATE AND THERE ARE NO ISSUES.

- THERE IS NO PERIMETER FENCE

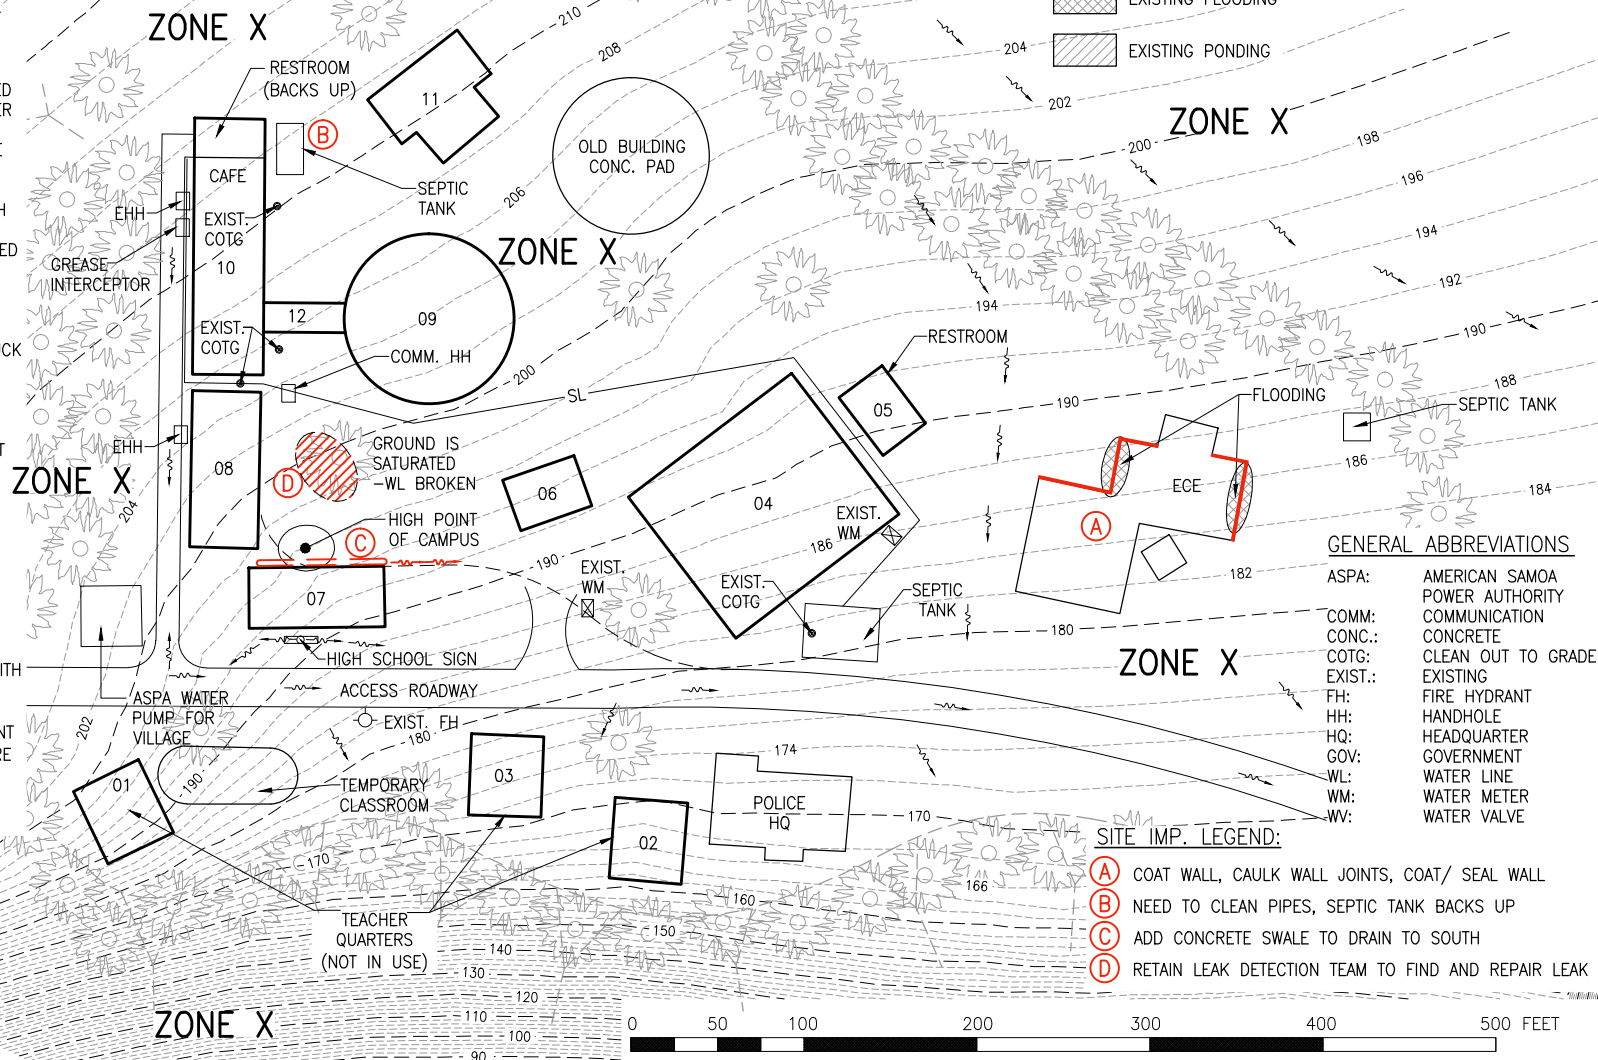
- POTABLE WATER SERVICE IS PROVIDED BY THE ASPA WATER SYSTEM. WATER PRESSURE IS ADEQUATE FOR THE SCHOOL. THE WATER LINES MAY BE BROKEN AS AN AREA SOUTH OF BUILDING 08 AS AREA IS ALWAYS SATURATED. NO OTHER ISSUES WITH THE WATER SERVICE.

- SANITARY SEWER SERVICE IS PROVIDED BY AN ONSITE SEPTIC TANK. THE SEWER PIPING POSSIBLY CAUSES BACKUPS TO THE BATHROOMS IN BUILDINGS 05, 10 AND THE ECE. THERE IS NO ON-ISLAND PUMP TRUCK SERVICE. NO ISSUES WITH THE GREASE INTERCEPTOR. DOE IS RESPONSIBLE FOR MAINTENANCE OF THE GREASE INTERCEPTOR.

- THERE IS ONE ONSITE FIRE HYDRANT ALONG THE ACCESS ROAD BUT IT IS UNCLEAR IF THE FIRE HYDRANT IS OPERATIONAL.
- THE ECE FLOODS FROM RAINFALL INFILTRATING THE BUILDING WALL. THERE IS STANDING WATER AND THE GROUND IS SATURATED FOR SOME AREAS OF THE CAMPUS.

- (A) COAT WALL, CAULK WALL JOINTS, COAT/ SEAL WALL
- (B) NEED TO CLEAN PIPES, SEPTIC TANK BACKS UP
- (C) ADD CONCRETE SWALE TO DRAIN TO SOUTH
- (D) RETAIN LEAK DETECTION TEAM TO FIND AND REPAIR LEAK

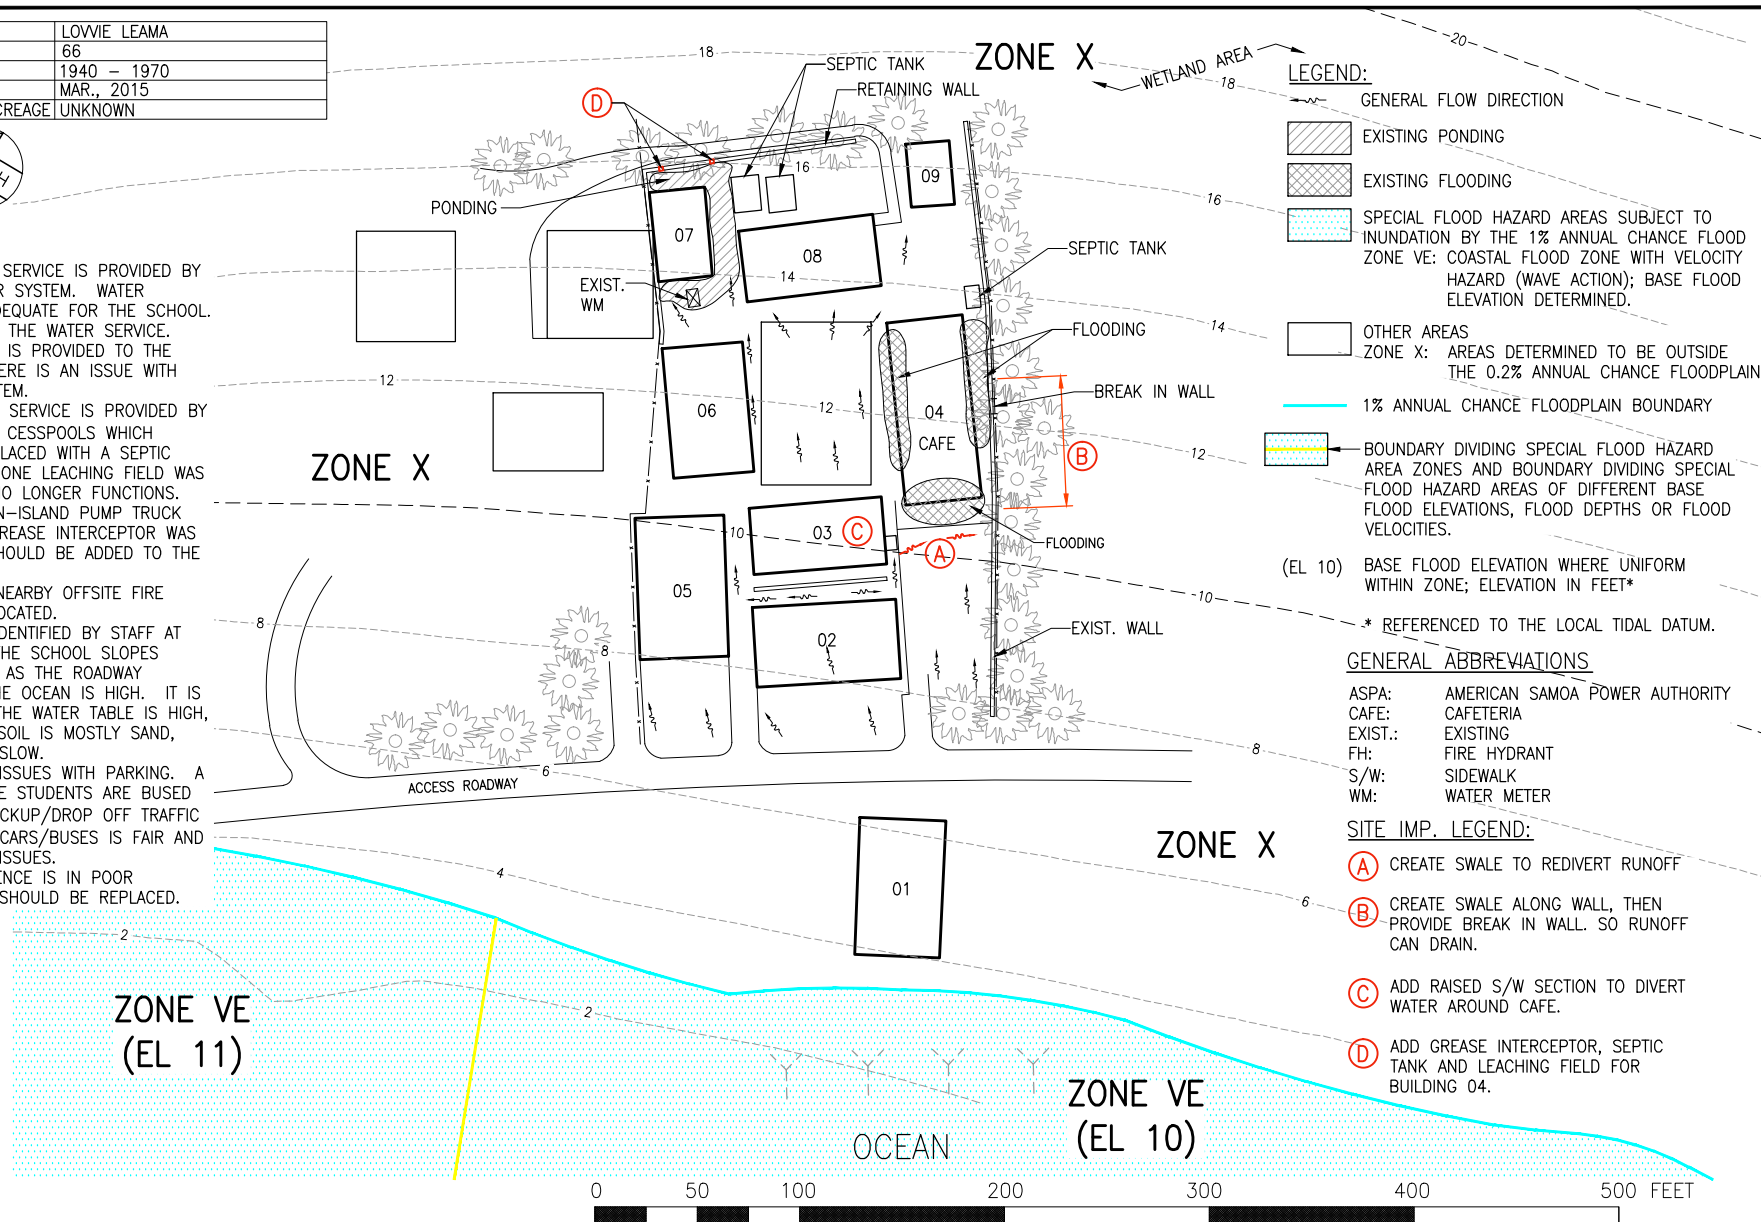
- SANITARY SEWER SERVICE IS PROVIDED BY TWO (2) ONSITE CESSPOOLS WHICH SHOULD BE REPLACED WITH A SEPTIC TANK SYSTEM. ONE LEACHING FIELD WAS ADDED BUT IT NO LONGER FUNCTIONS. THERE IS NO ON-ISLAND PUMP TRUCK SERVICE. NO GREASE INTERCEPTOR WAS LOCATED AND SHOULD BE ADDED TO THE SCHOOL.

- NO ONSITE OR NEARBY OFFSITE FIRE HYDRANT WAS LOCATED.
- FLOODING WAS IDENTIFIED BY STAFF AT BUILDING 04. THE SCHOOL SLOPES FRONT TO BACK AS THE ROADWAY ADJACENT TO THE OCEAN IS HIGH. IT IS BELIEVED THAT THE WATER TABLE IS HIGH, ALTHOUGH THE SOIL IS MOSTLY SAND, INFILTRATION IS SLOW.

- THERE ARE NO ISSUES WITH PARKING. A MAJORITY OF THE STUDENTS ARE BUSED TO SCHOOL. PICKUP/DROP OFF TRAFFIC MOVEMENT FOR CARS/BUSES IS FAIR AND THERE ARE NO ISSUES.

- THE EXISTING FENCE IS IN POOR CONDITION AND SHOULD BE REPLACED.
