# INSULAR ABC'S INITIATIVE

Phase III Task 1 - Civil Engineer Findings

## COMMONWEALTH OF NORTHERN MARIANA ISLANDS Civil Site Maps for Required Projects

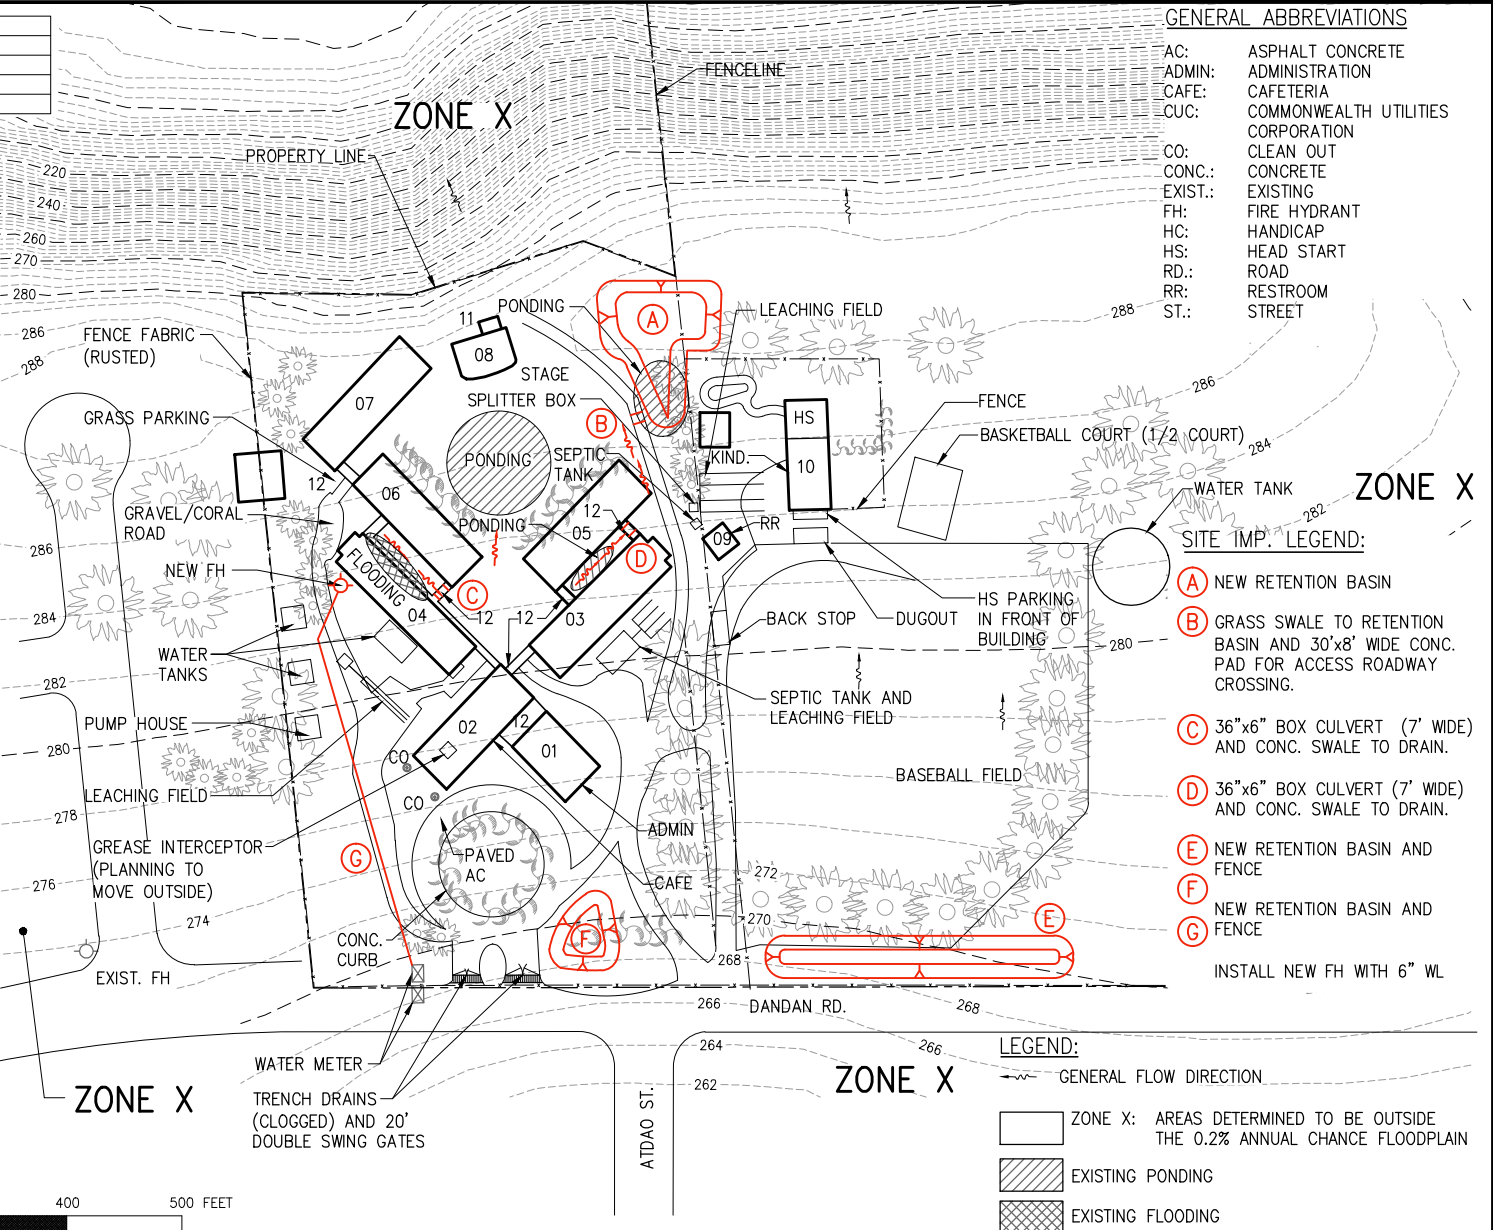
- POTABLE WATER SERVICE IS PROVIDED BY THE CUC WATER SYSTEM. WATER PRESSURE IS LOW FOR THE SCHOOL. THERE IS AN EXISTING TWO TANK PUMP BACKUP SYSTEM ONSITE; HOWEVER, CONFIRMATION OF WHETHER OR NOT THE WATER TANKS OPERATE AUTOMATICALLY IS REQUIRED. NO OTHER ISSUES WITH THE WATER SERVICE.

- SANITARY SEWER SERVICE IS PROVIDED BY TWO ONSITE SEPTIC TANKS. ONLY BUILDINGS 02 AND 04 ARE CONNECTED TO THE SOUTH SEPTIC TANK. THE SCHOOL HAS BEEN OPENED FOR 12 YEARS AND THE SEPTIC TANKS WERE PUMPED ONCE 5 YEARS AGO. NO ISSUES WITH THE SEWER SERVICE. FACILITIES MAINTENANCE IS PLANNING ON RELOCATING THE EXISTING GREASE INTERCEPTOR OUTSIDE OF THE KITCHEN. NO ISSUES WITH THE GREASE INTERCEPTOR OTHERWISE.

- NO ONSITE FIRE HYDRANTS WERE LOCATED. ONE OFFSITE FIRE HYDRANT IS LOCATED SOUTH OF THE SCHOOL ALONG DAN DAN ROAD, BUT IT IS UNCLEAR IF THE FIRE HYDRANT IS OPERATIONAL. EMERGENCY VEHICLE ACCESS APPEARS TO BE GOOD TO ALL AREAS OF THE CAMPUS.

- FLOODING AND PONDING WERE IDENTIFIED BY STAFF. THE PIPE CULVERTS UNDER THE SIDEWALKS ADJACENT TO BUILDINGS 05 AND 12 ARE CLOGGED AND THE OUTLET SWALES ARE FILLED IN CAUSING FLOODING OF BUILDING 04 AND 06 AND PONDING IN THE COURTYARDS OF BUILDINGS 05 AND 12.

- THE FIELD RESTROOMS BEHIND THE BACKSTOP ARE NOT USED.
- PLAY EQUIPMENT SWINGS ARE BROKEN.

- (A) RESET CONC. WALKWAY
- (B) ADD CONC. CULVERT 8"
- (C) RESET SWALE
- (D) ADD GRASS SWALE / REGRADE
- (E) ADD GRASS SWALE
- (F) EXTEND RETENTION BASIN 40' EAST
- (G) ADD CONC. SWALE
- (H) REPLACE CONCRETE COVER WITH GRATE
- (I) ADD 2-12" CULVERTS AND RAMP OVER
- (J) RESET SWALE
- (K) ADD ROOF GUTTER
- (L) ADD ROOF GUTTER
- (M) ADD CONC. SWALE
- (N) REPLACE GRATES, 2' WIDE PANELS
- (O) CLEAN RETENTION BASIN
- (P) REMOVE TREE

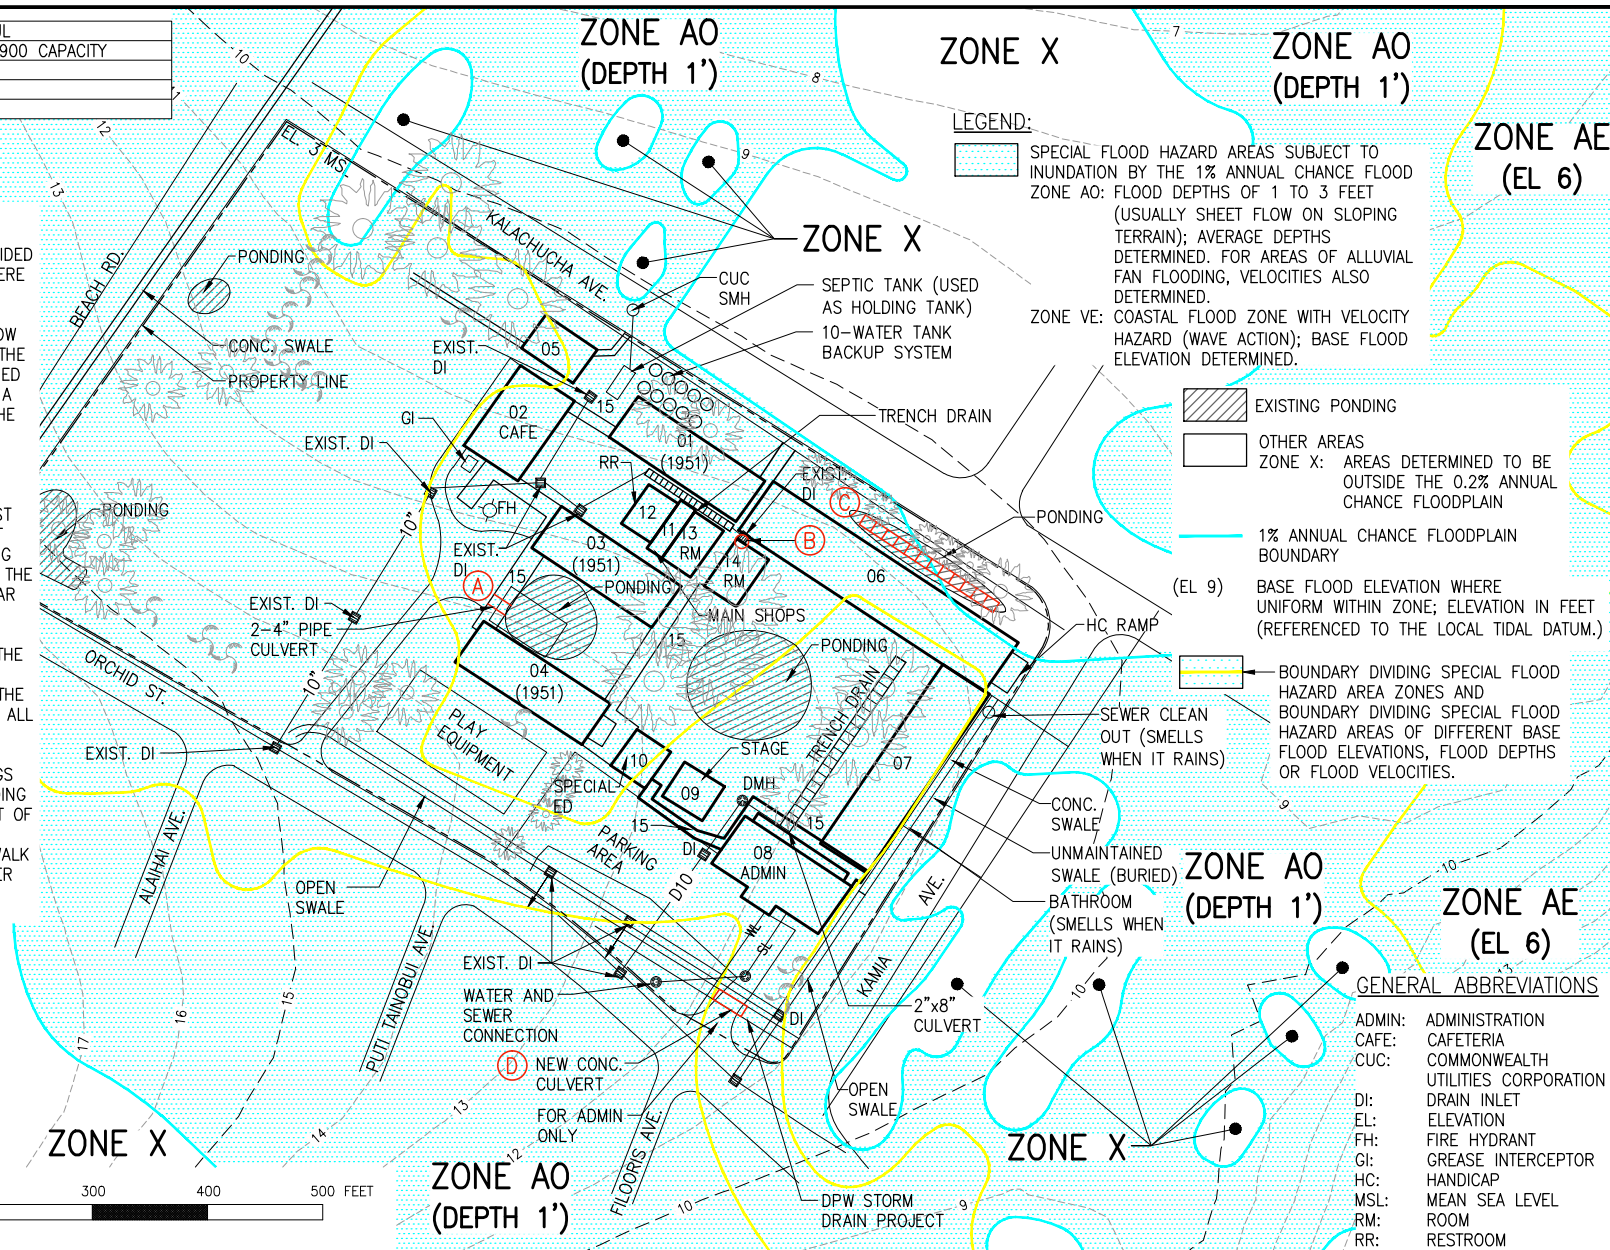
04

- POTABLE WATER SERVICE IS PROVIDED BY THE CUC WATER SYSTEM. THERE IS AN EXISTING TEN TANK PUMP BACKUP SYSTEM ONSITE. WATER PRESSURE FOR THE SCHOOL IS LOW FROM TIME TO TIME. PER STAFF, THE TANK AND PUMP SYSTEM IS TURNED ON APPROXIMATELY THREE TIMES A YEAR. NO OTHER ISSUES WITH THE WATER SERVICE.

- SANITARY SEWER SERVICE IS PROVIDED BY THE CUC SEWER SYSTEM. PER STAFF, THERE IS A SMELL FROM THE SEWER LINE EAST OF BUILDING 07 AND IN THE REST ROOMS IN THE MIDDLE OF BUILDING 07. THERE ARE NO ISSUES WITH THE GREASE INTERCEPTOR BUT REGULAR MAINTENANCE IS REQUIRED.

- ONE ONSITE FIRE HYDRANT WAS LOCATED, BUT IT IS UNCLEAR IF THE FIRE HYDRANT IS OPERATIONAL. EMERGENCY VEHICLE ACCESS TO THE SCHOOL APPEARS TO BE FAIR TO ALL AREAS OF THE SCHOOL.

- NO CLASSROOMS FLOOD. PONDING WAS IDENTIFIED BETWEEN BUILDINGS 03 AND 04, NORTHEAST OF BUILDING 06, AND IN THE COURTYARD WEST OF BUILDING 07.
- THERE IS AN ONGOING DPW SIDEWALK PROJECT NEAR THE SOUTH CORNER OF THE CAMPUS (2015).

- (A) ENLARGE CULVERT TO 6"x18" CULVERT
- (B) CONNECT DOWNSPOUT TO DI
- (C) ADD TRENCH DRAIN (OPEN BOTTOM)
- (D) ADD 6"x8" CULVERT

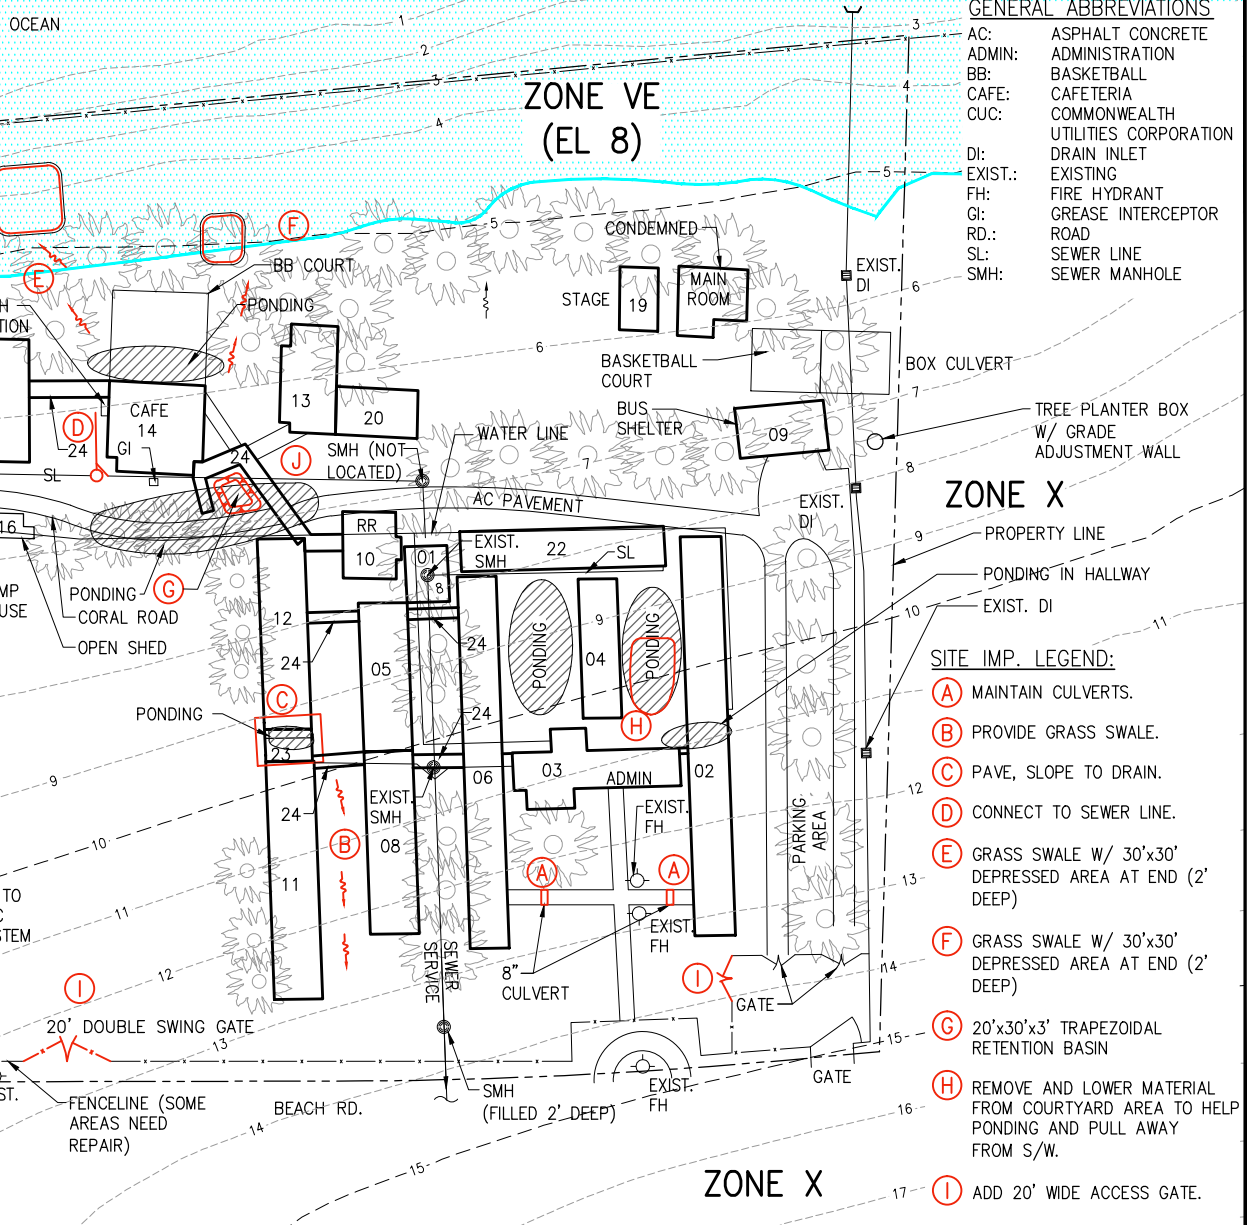
FIGURE  
**05**

- POTABLE WATER SERVICE IS PROVIDED BY THE CUC WATER SYSTEM. THERE IS A 10 TANK PUMP BACKUP SYSTEM ONSITE, BUT PER STAFF, IT IS NOT USED THAT OFTEN. WATER PRESSURE FOR THE SCHOOL IS LOW FROM TIME TO TIME.

- SANITARY SEWER SERVICE IS PROVIDED BY THE CUC SEWER SYSTEM. NO ISSUES WITH THE SEWER SERVICE. THE SCHOOL DOES NOT COOK AT THIS LOCATION. THE EXISTING GREASE INTERCEPTOR IS CLEANED TWICE A YEAR. NO ISSUES WITH THE GREASE INTERCEPTOR.

- THREE ONSITE FIRE HYDRANTS WERE LOCATED, BUT IT IS UNCLEAR IF THE FIRE HYDRANTS ARE OPERATIONAL. EMERGENCY VEHICLE ACCESS TO THE SCHOOL APPEARS TO BE FAIR TO ALL AREAS OF THE SCHOOL, BUT A 20'-WIDE GATE SHOULD BE ADDED TO HELP FACILITATE ACCESS.

- NO CLASSROOMS FLOOD AND PONDING WAS IDENTIFIED EAST OF BUILDING 14 ALONG THE CORAL ROADWAY, BETWEEN BUILDINGS 11 AND 12, 04 AND 24 AND EAST OF BUILDING 03. DRAINAGE AT THE SCHOOL IS GOOD AS INFILTRATION IS GOOD DUE TO THE SAND BASE.

- THE RAIN WATER CATCHMENT TANKS AROUND THE BUILDING ARE NOT IN USE.
- THERE IS ONE RESTROOM DESIGNATED FOR STUDENTS AND TWO OTHERS FOR STAFF.

- #### SITE IMP. LEGEND:
- (A) MAINTAIN CULVERTS.
  - (B) PROVIDE GRASS SWALE.
  - (C) PAVE, SLOPE TO DRAIN.
  - (D) CONNECT TO SEWER LINE.
  - (E) GRASS SWALE W/ 30'x30' DEPRESSED AREA AT END (2' DEEP)
  - (F) GRASS SWALE W/ 30'x30' DEPRESSED AREA AT END (2' DEEP)
  - (G) 20'x30'x3' TRAPEZOIDAL RETENTION BASIN
  - (H) REMOVE AND LOWER MATERIAL FROM COURTYARD AREA TO HELP PONDING AND PULL AWAY FROM S/W.
  - (I) ADD 20' WIDE ACCESS GATE.

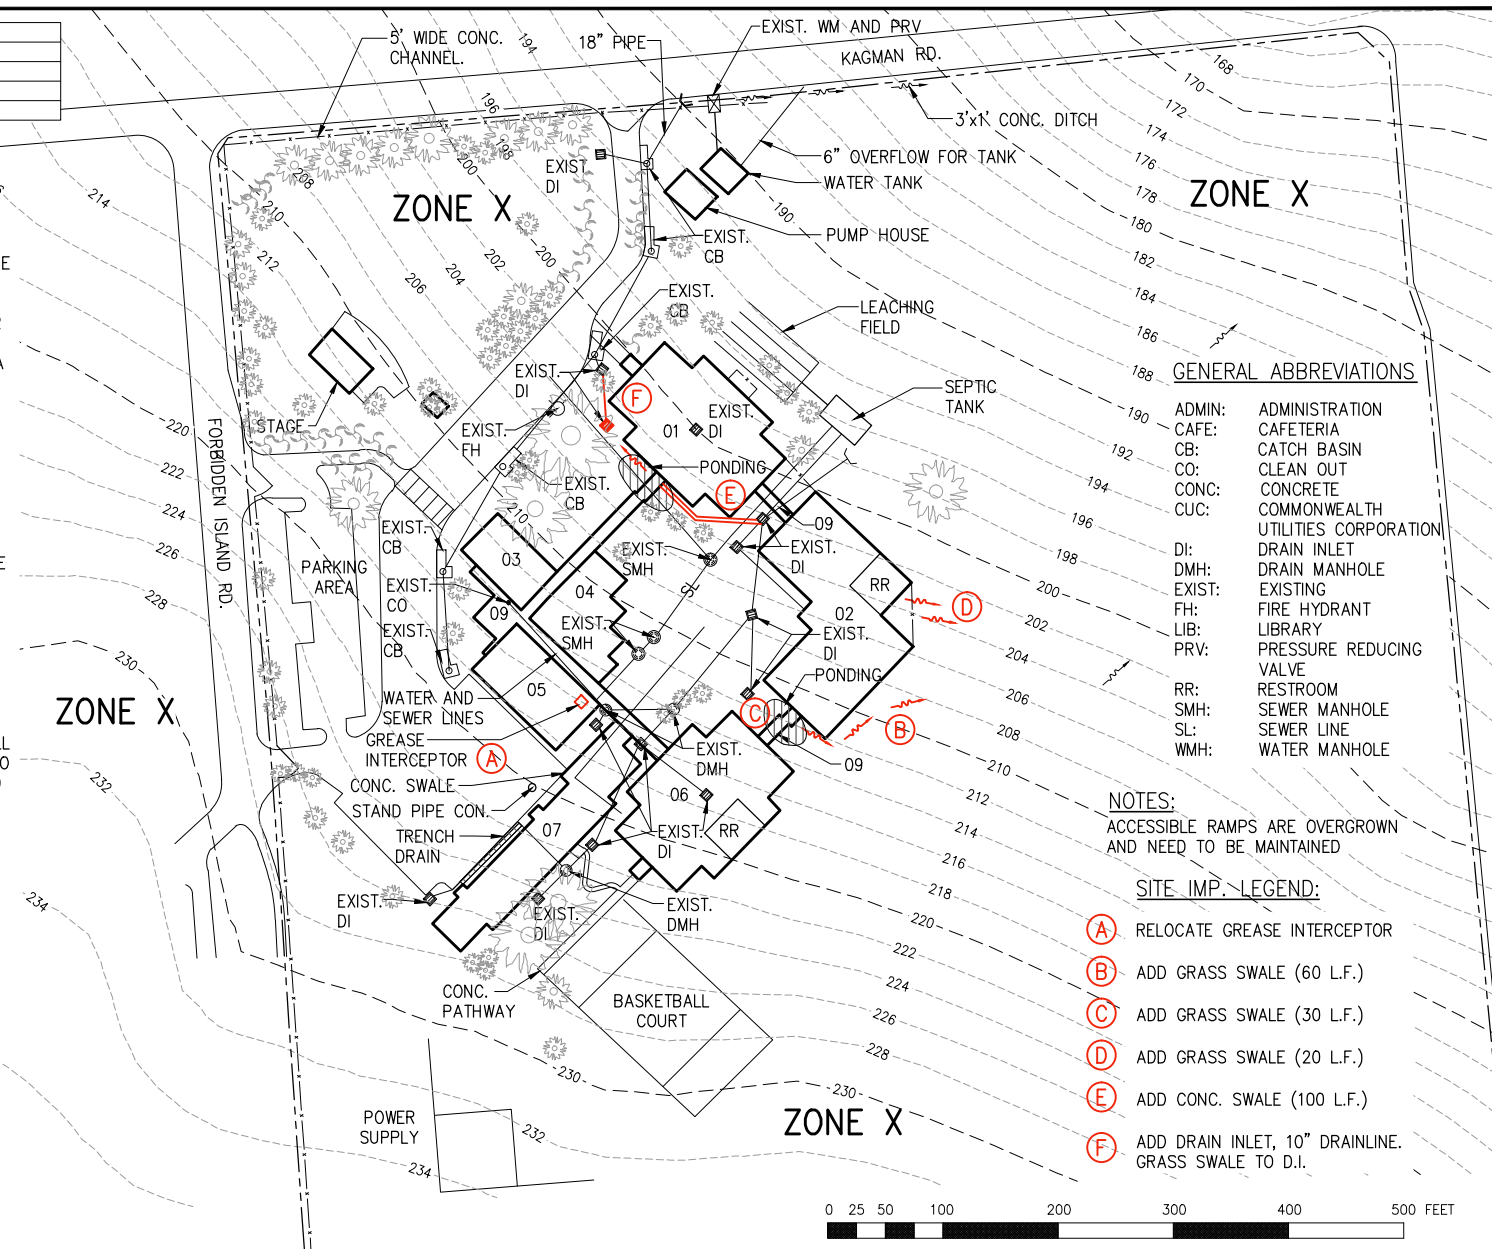
06

- POTABLE WATER SERVICE IS PROVIDED BY THE CUC WATER SYSTEM. THERE IS AN EXISTING 38K GALLON TANK AND PUMP BACKUP SYSTEM ONSITE. THE AUTOMATIC VALVE FOR THE SYSTEM CANNOT BE USED. WATER PRESSURE FOR THE SCHOOL IS TOO HIGH. A P.R.V. MAINTAINED BY THE CUC WAS INSTALLED TO HELP LOWER PRESSURE. NO OTHER ISSUES WITH THE WATER SERVICE.

- SANITARY SEWER SERVICE IS PROVIDED AN ONSITE SEPTIC TANK AND LEACHING FIELD THAT WAS DRAINED ONCE IN 2012. NO ISSUES WITH THE SEWER SERVICE. THE GREASE INTERCEPTOR IS LOCATED INSIDE OF BUILDING 05, BUT FACILITIES MAINTENANCE WOULD LIKE TO RELOCATE IT OUTSIDE OF THE BUILDING. THE GREASE INTERCEPTOR IS PUMPED FOUR OR MORE TIMES A YEAR AND THERE IS A POSSIBILITY THAT THE GREASE INTERCEPTOR LEAKS.

- ONE ONSITE FIRE HYDRANT AND ONE STAND PIPE RISER WERE LOCATED, BUT IT IS UNCLEAR IF THE STAND PIPE RISER IS OPERATIONAL. EMERGENCY VEHICLE ACCESS TO THE SCHOOL APPEARS TO BE FAIR TO ALL AREAS OF THE SCHOOL; HOWEVER ACCESS TO THE EAST SIDE OF THE SCHOOL APPEARS TO BE DIFFICULT DUE TO THE TERRAIN.

- NO CLASSROOMS FLOOD AND PONDING WAS IDENTIFIED SOUTHWEST OF BUILDINGS 01 AND 02.
- PER STAFF, THE DOWNSPOUTS SHOULD BE REPLACED (BUILDING ISSUE).
- PER STAFF, THERE IS A POSSIBLE SEWER BLOCKAGE IN THE URINAL IN BUILDING 04 (BUILDING ISSUE).

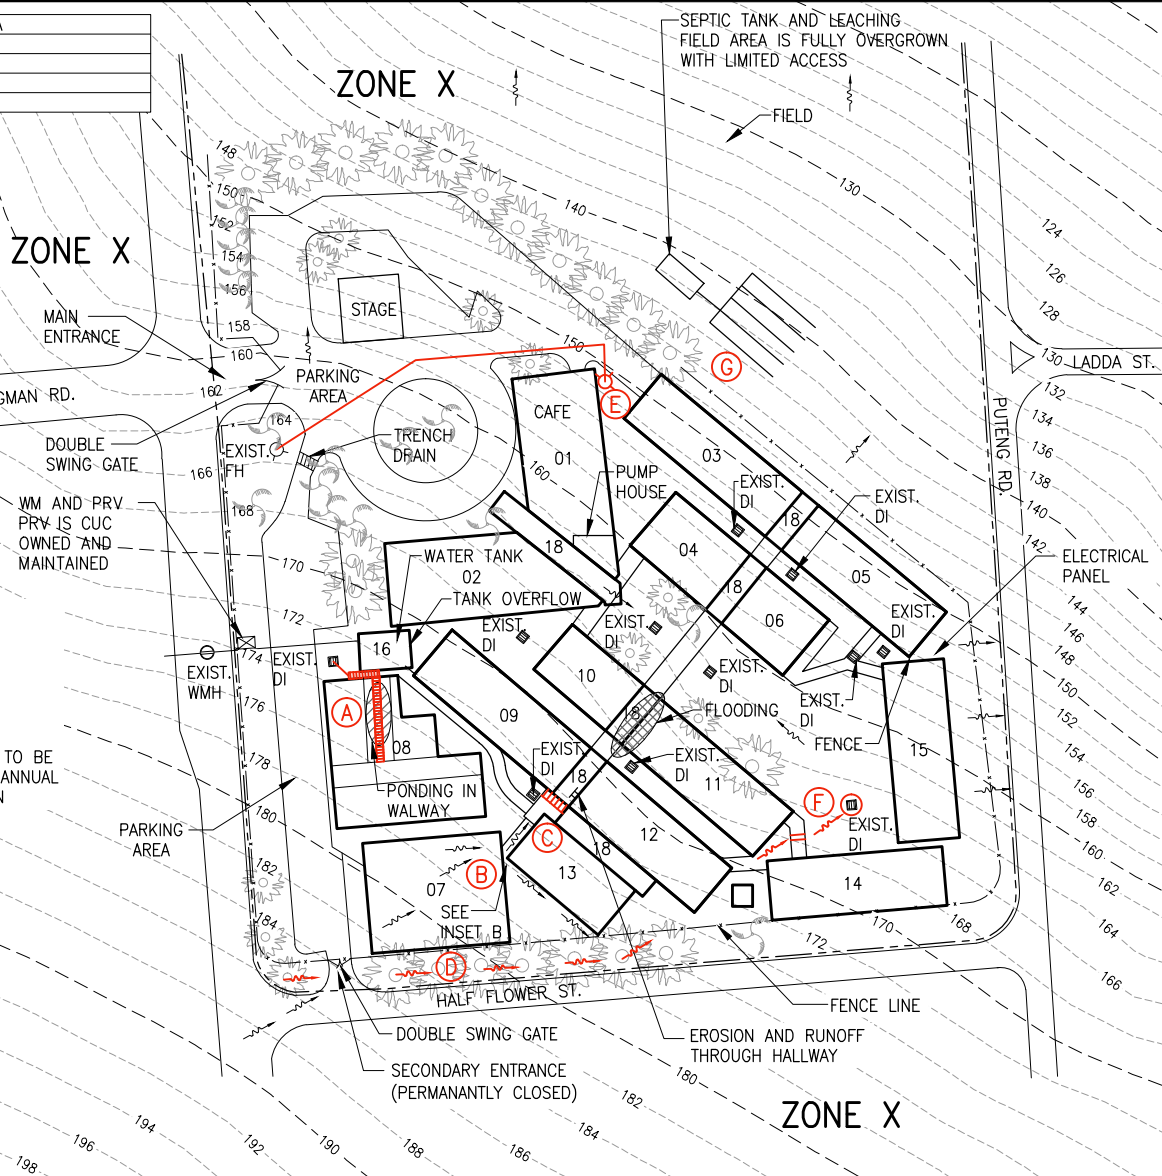
07

- POTABLE WATER SERVICE IS PROVIDED BY THE CUC WATER SYSTEM. THERE IS AN EXISTING WATER TANK PUMP BACKUP SYSTEM ONSITE THAT IS ALSO USED FOR WHEN THE SCHOOL ACTS AS AN EMERGENCY SHELTER. WATER PRESSURE IS HIGH FOR THE SCHOOL. A PRV MAINTAINED BY THE CUC WAS INSTALLED TO HELP LOWER PRESSURE IN 2013. THE PRV WAS REPLACED IN 2014. NO OTHER ISSUES WITH THE WATER SERVICE.

- SANITARY SEWER SERVICE IS PROVIDED BY AN ONSITE SEPTIC TANK AND LEACHING FIELD. PER STAFF, THE SEPTIC TANK HAS NEVER HAD TO BE PUMPED, BUT THE LEACHING FIELD CONSTANTLY OVERFLOWS. THE SEPTIC TANK AND LEACHING FIELD AREA IS OVERGROWN AND SHOULD BE MAINTAINED. NO OTHER ISSUES WITH THE SEWER SERVICE. THE SCHOOL DOES NOT COOK AT THIS LOCATION. PER STAFF, THE SCHOOL DOES NOT HAVE A GREASE INTERCEPTOR.

- THERE IS ONE FIRE HYDRANT ONSITE BUT IT IS UNCLEAR IF THE FIRE HYDRANT IS OPERATIONAL. EMERGENCY VEHICLE ACCESS TO THE SCHOOL APPEARS TO BE FAIR TO MOST AREAS OF THE SCHOOL; HOWEVER ACCESS TO THE EAST SIDE OF THE SCHOOL APPEARS TO BE DIFFICULT.

- FLOODING WAS IDENTIFIED ON THE NORTHWEST SIDE OF BUILDING 11 AND PONDING WAS IDENTIFIED ON THE BUILDING 08. OFFSITE RUNON FLOWS ONTO THE BASKETBALL COURT ON THE SOUTHWEST SIDE OF THE SCHOOL AND RUNS DOWN THE HALLWAY BETWEEN BUILDINGS 09 AND 12.

- (A) ADD TRENCH DRAIN (40 LF) AND CONNECT EXIST. DI WITH 8" PIPE
- (B) ADD TRENCH DRAIN (20 LF), DI, 4'-6" CURB - 8" PIPE (25 LF)
- (C) ADD 8" WIDE TRENCH DRAIN.
- (D) ADD CONC. SWALE (200 LF) AND SPEED BUMP.
- (E) INSTALL FH WITH 6" WL
- (F) CLEAR OUT EXIST. 6" PIPE & REGRADE EXIST. SWALE TO ENSURE PROPER DRAINAGE.
- (G) REPLACE LEACHING FIELD

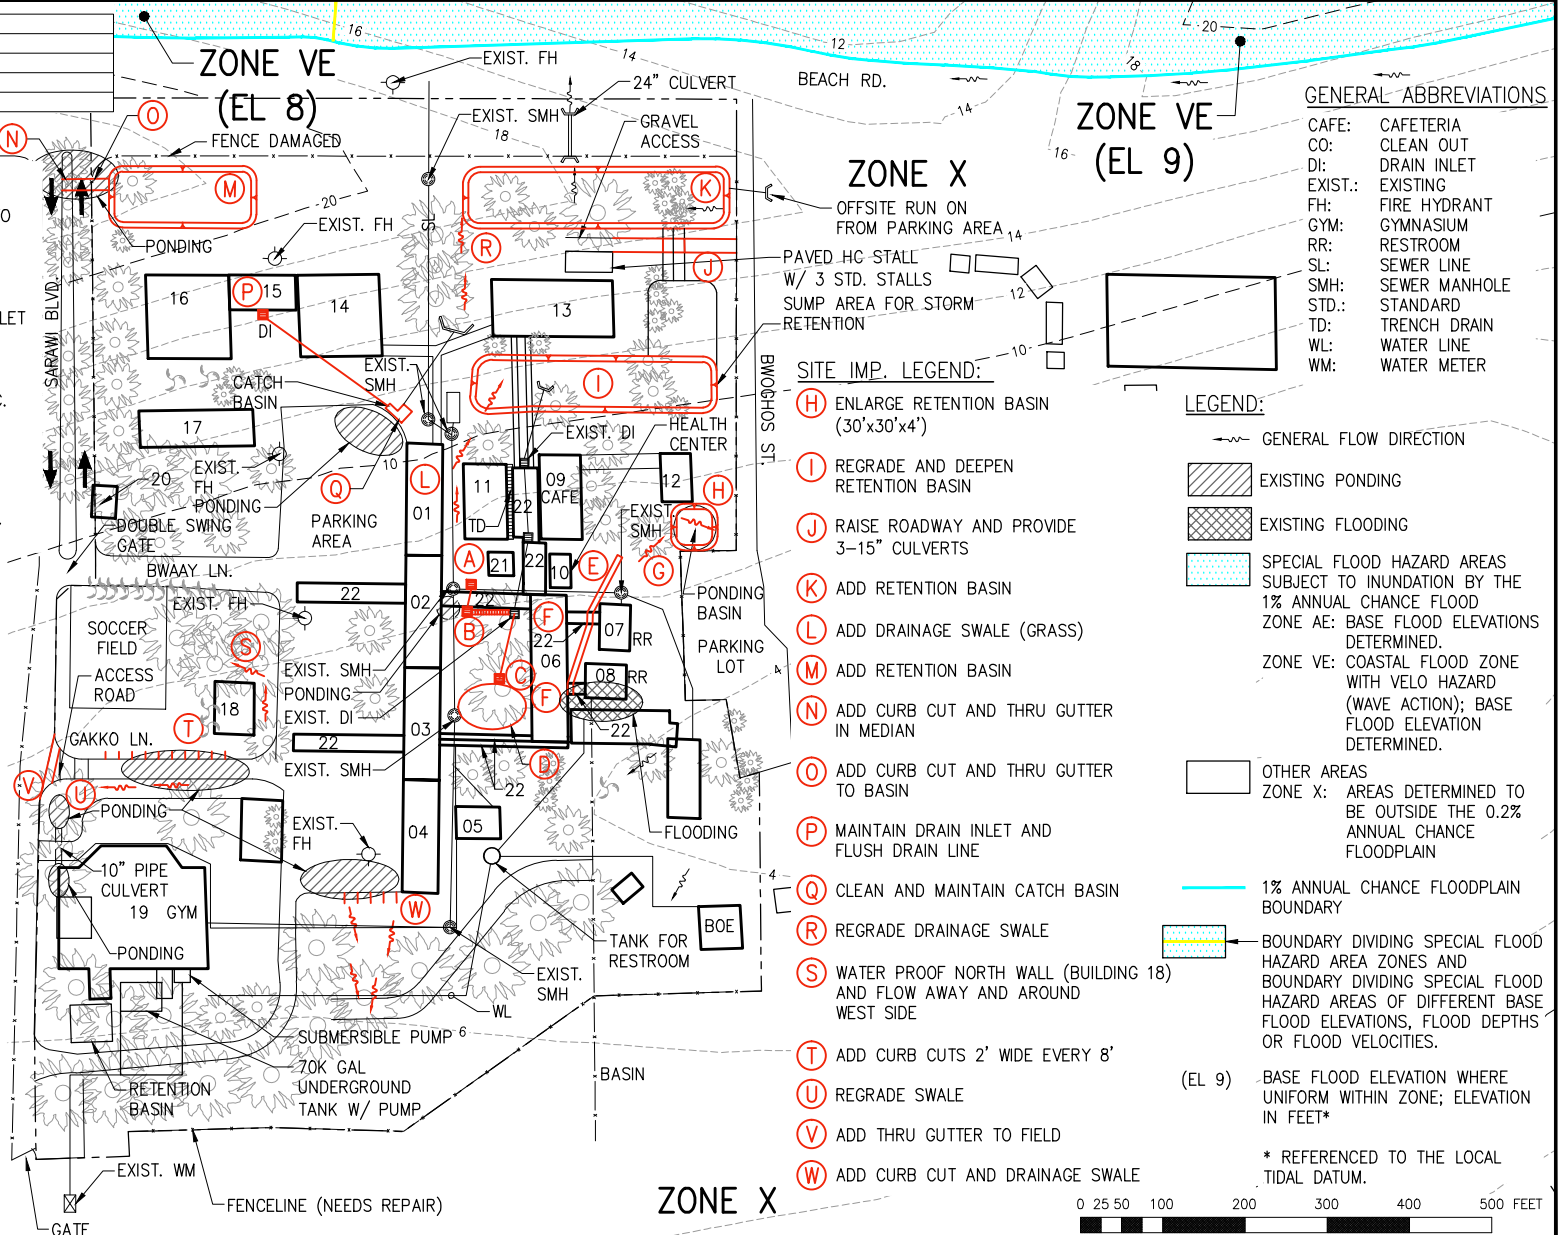
09

- POTABLE WATER SERVICE IS PROVIDED BY THE CUC WATER SYSTEM. CUC SYSTEM FILLS A 14K GALLON TANK AND PUMP SYSTEM THAT PROVIDES WATER TO THE CAMPUS. THE CUC SUPPLIED WATER CAN BYPASS THE TANK AND PUMP SYSTEM, HOWEVER THE WATER PRESSURE IS LOW IN THIS CONFIGURATION. NO OTHER ISSUES WITH THE WATER SYSTEM.

- SANITARY SEWER SERVICE IS PROVIDED BY THE CUC SEWER SYSTEM. THERE IS POSSIBLE RUNOFF INFILTRATION INTO THE SEWER SYSTEM AS SEWER BACKS UP DURING HEAVY RAINS. IT WAS UNCLEAR IF THERE WAS A GREASE INTERCEPTOR ON SITE. IF PRESENT, THERE ARE NO ISSUES WITH THE GREASE INTERCEPTOR BUT REGULAR MAINTENANCE IS REQUIRED.

- FOUR ONSITE FIRE HYDRANTS WERE LOCATED. BUT IT IS UNCLEAR IF THE FIRE HYDRANTS ARE OPERATIONAL. EMERGENCY VEHICLE ACCESS TO THE SCHOOL APPEARS TO BE GOOD TO ALL AREAS OF THE SCHOOL.

- FLOODING WAS IDENTIFIED ON THE EAST SIDE OF BUILDING 08. PONDING WAS IDENTIFIED IN THE EAST PARKING AREA, SOUTH OF BUILDING 04, NORTH OF BUILDING 02, WEST OF BUILDING 19, SOUTH OF BUILDING 01, AND AT THE ENTRANCE TO THE SCHOOL AT BEACH ROAD.

- (A) ADD DRAIN INLET
- (B) ADD DRAIN INLET W/ TRENCH DRAIN TO EXIST. DRAIN INLET
- (C) ADD NEW DRAIN INLET W/ 18" LINE
- (D) ADD REGRADE AREA TO NEW DRAIN INLET
- (E) ADD CONC. SWALE
- (F) ADD 24"x6" BOX CULVERT (2-4' CONC. S/Ws)
- (G) ADD GRASS SWALE
