# **INSULAR ABC'S INITIATIVE**

## **Phase III Task 1 Findings and Recommendations Commonwealth of the Northern Mariana Islands**

October 2015

ARCHITECTURAL SUMMARY REPORT  
COMMONWEALTH OF THE NORTHERN MARIANA  
ISLANDS  
October 2015

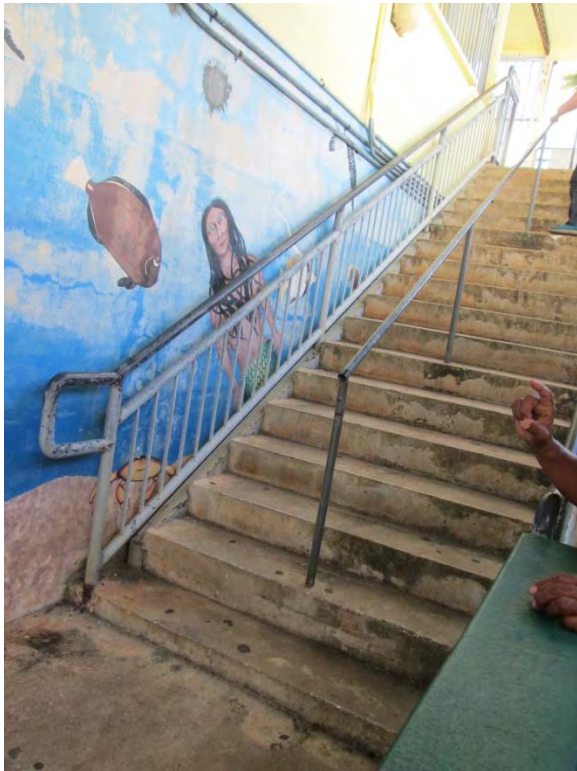
Concrete was installed over the rusted metal stair at building 4. This appears to be functional, except that the top and bottom steps are not equal in height to the other steps (which violates building code).

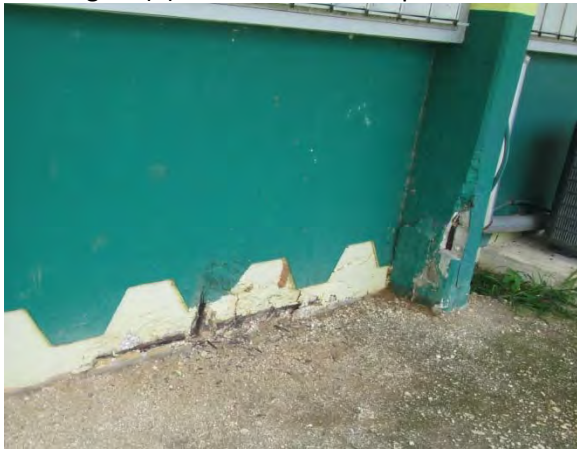
Building 10 (K) still has concrete spalls at the columns and walls.

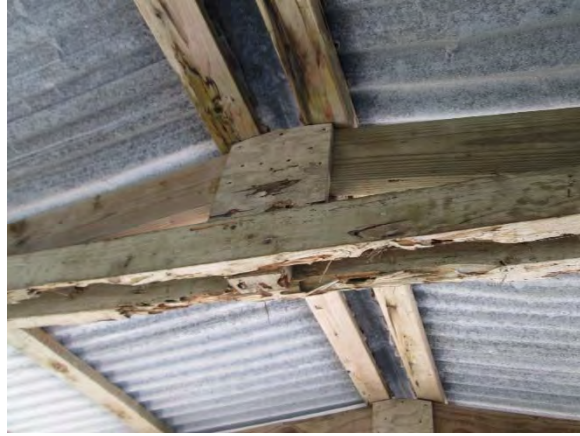
Some work has been done to repair the covered walkways, while parts are still damaged and need repair. Some of the spalled areas at the concrete floor have been patched.

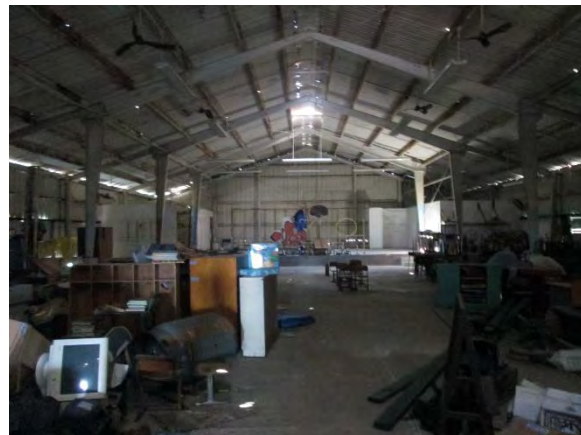
Building 12, the Maintenance building, is still in poor condition. Whether or not this building will be repaired and retained is undecided, but the building is currently full of stored items that can't be thrown away and must be properly disposed of (like computers), so likely nothing will occur until these items are dealt with.

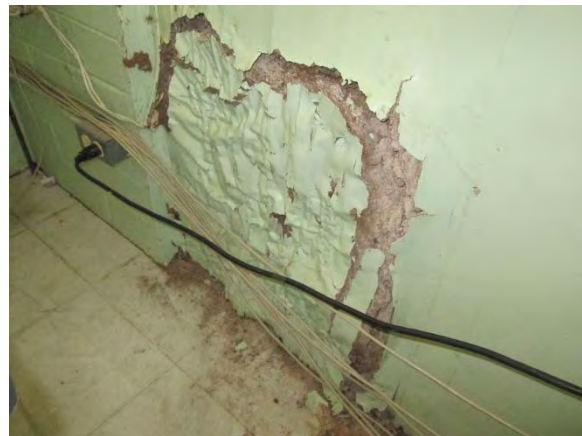
The school has problems with termites, and several buildings including 2, 4, 7, 8, and 10. Termites are causing damage to building structure, interior walls, furniture and books in the classroom. School staff stated that they are not permitted to spray termite treatment on the ground due to the proximity to the ocean.

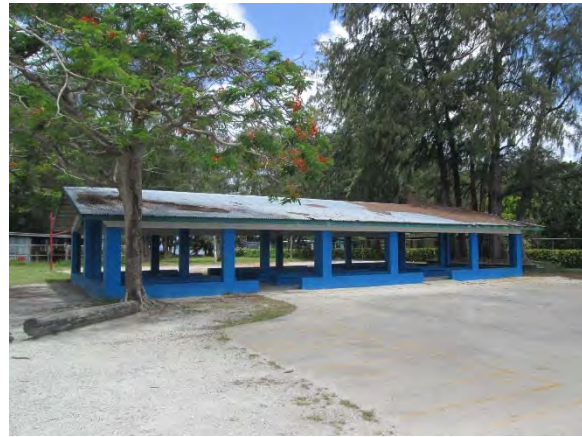
The deterioration of the corrugated metal roofing at Building 9 is likely being accelerated by the pine needles that collect on the roof, deposited there by a nearby Ironwood tree. The needles should be cleaned off, particularly in wet periods, to help prolong the life of the roofing.

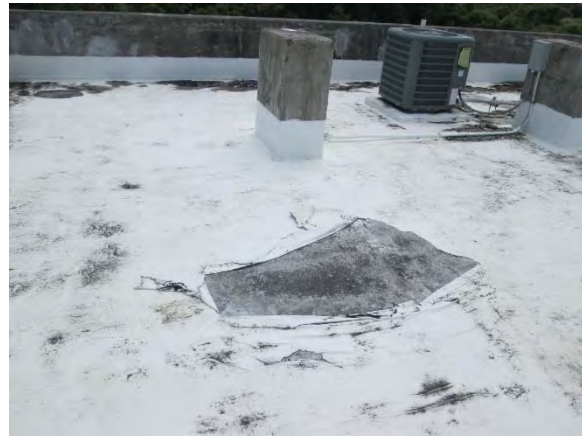
The roofing at Building 2 is in poor condition; reroofing is planned for the summer 2015, and is reportedly under warrantee.

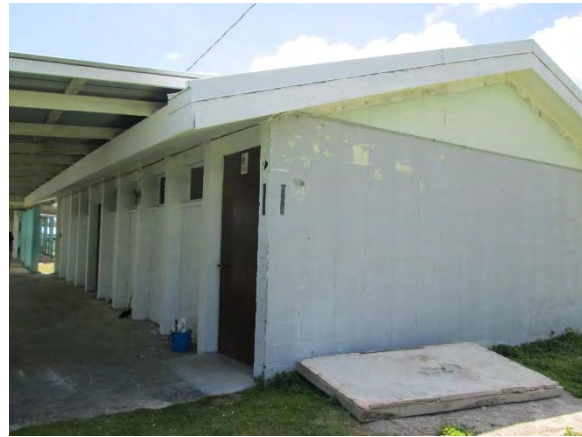
Building 10 (J) is currently under renovation. The bathroom (Building 9) has new roofing and has been renovated on the interior. Concrete spalls on this building were repaired by a contractor.

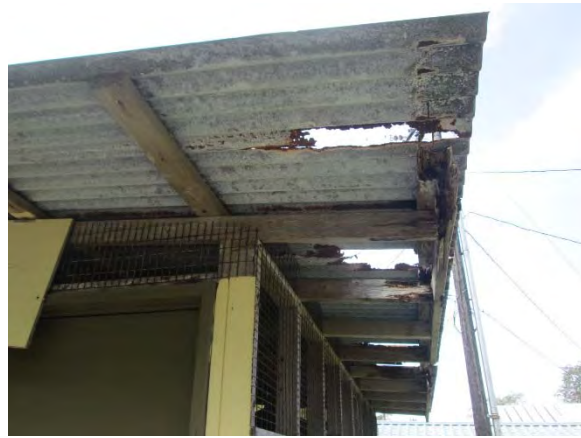
Maintenance staff stated that there are currently no roof leaks, but deteriorated metal roofing was noted in the covered walkways, and Buildings 9 and 13.

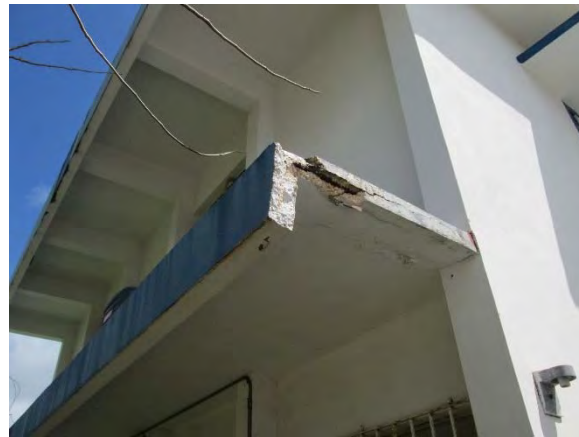
### 3. Spalling concrete (non-structural elements)

The concrete is spalling at several locations at this building. The spalling is typically caused by moisture getting into the concrete and rusting the steel reinforcing, which expands as it rusts and causes the concrete to crack and eventually break off. Where cracked and spalling concrete is on ceilings or is on columns or walls above, it is a safety concern as they create a falling hazard to the building occupants.

Recommended Scope of Work:

To repair non-structural concrete spalling, the following steps should be taken:

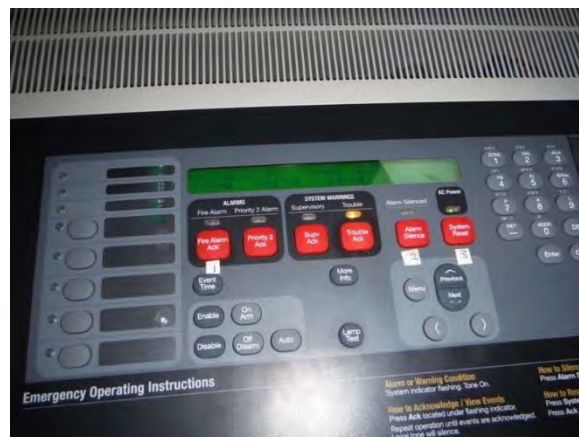
OIA Phase III survey found the fire alarm panel had trouble signals. The fire alarm system required services and repairs to ensure its functions and performance meet fire safety requirements.

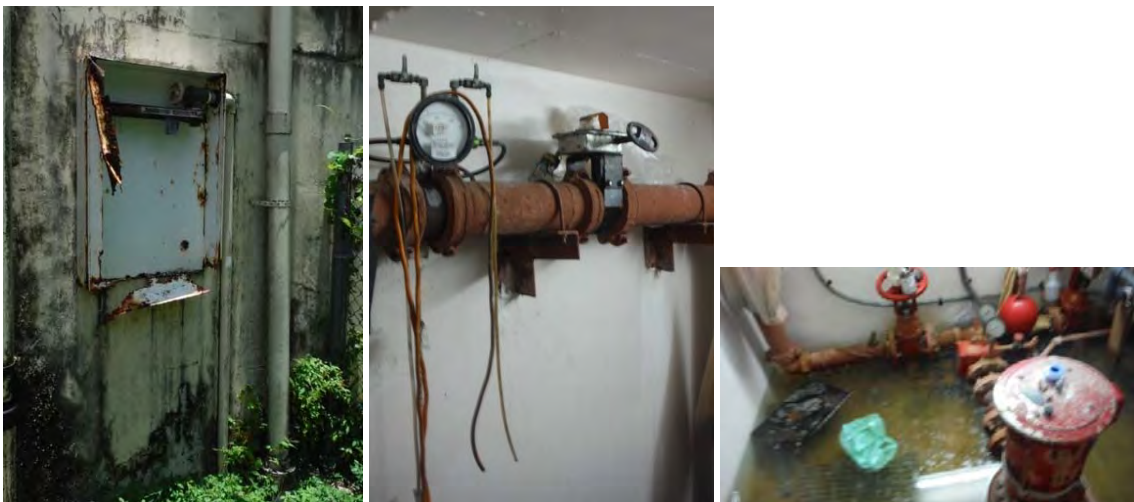
## 2. Building 19 - Gymnasium

OIA Phase II survey found the fire pump, fire controller and fire hose system were inoperable. Fire pump was installed in a below grade pit that flooded. OIA Phase III survey found these fire safety systems remained inoperable. The pump pit is subject to flooding, and the inoperable fire pump and fire hose are safety hazard to the occupants. Fire protection system should be properly and regularly serviced and maintained.

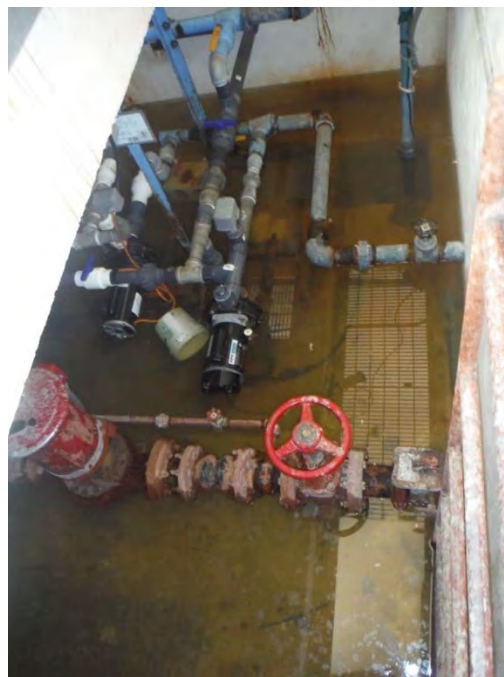
OIA Phase II survey found the duplex domestic water booster pumps were installed in a below grade pit where was flooded. OIA phase III survey found only one booster pump was operable. The pump pit was flooded. The failure of booster pump was because of lack of low suction water pressure protection and the flooded pit. The water entering into the pit came from the adjacent cistern through the pipe penetrations. It was a safety and health hazard to the occupants. The leak at pipe penetration should be repaired. The booster pumps should have proper low suction water pressure protection and controls. Pumps, motors and control components should be away from flooding not unless they were made and installed for submersed environments. Booster pumps should have provision to hook up to emergency shelter standby electrical power generator provided by CNMI EMO if the school would be used as emergency shelter.

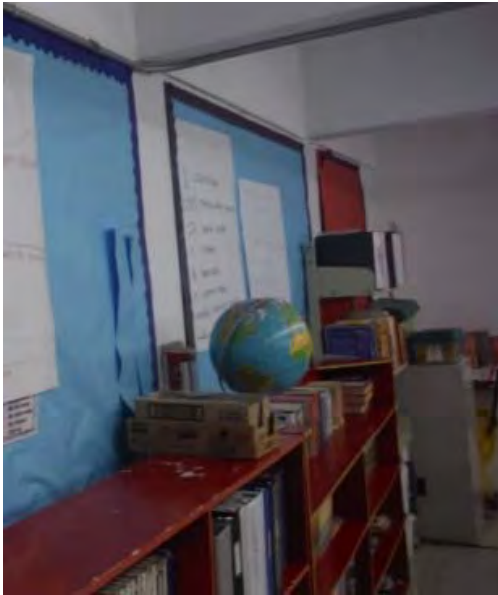
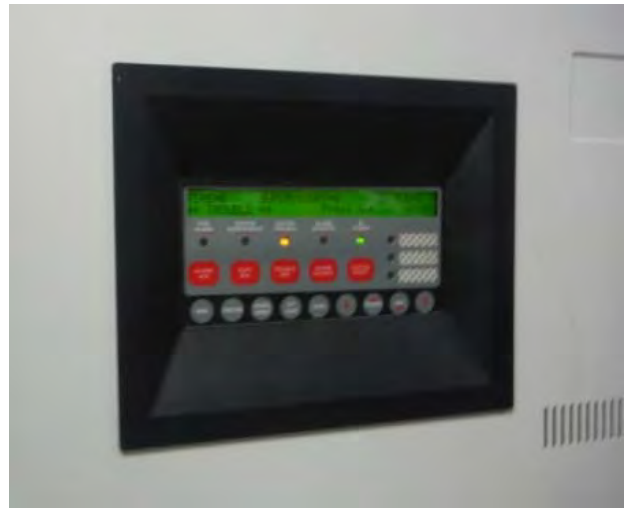
OIA Phase III survey found the fire alarm panel had trouble signals. The fire alarm system required services and repairs to ensure its functions and performance meeting the fire safety requirements.

OIA Phase III survey found some manual pull stations were obstructed. The manual pull stations should be conspicuous, unobstructed and accessible.

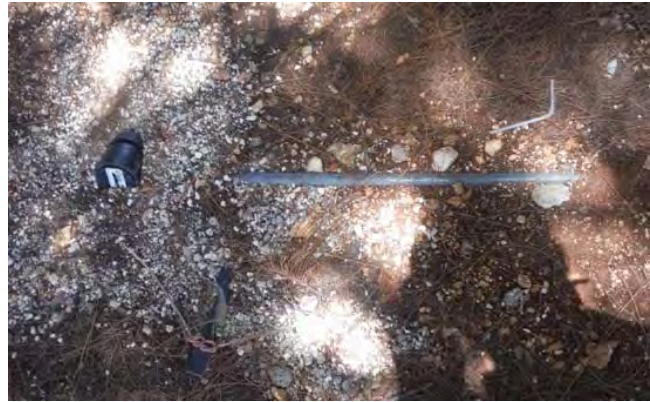
OIA Phase III survey found the newly installed buried plumbing piping to the outdoor hand sinks were too shallow and partially exposed. The exposed buried piping would be damage without proper coverage and pose a tripping hazard to the occupants.

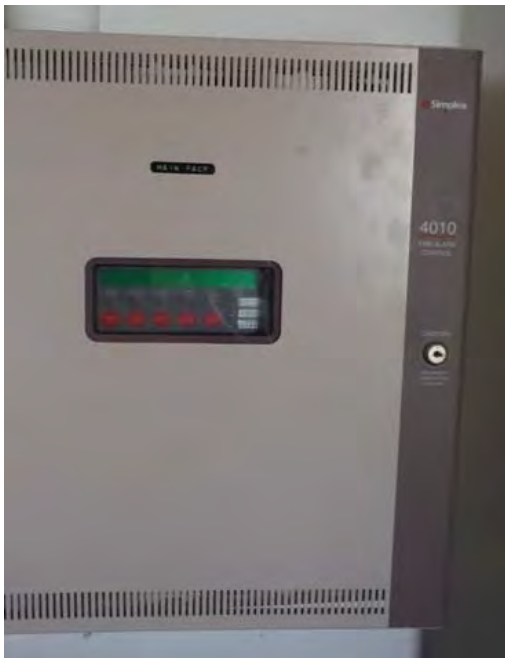
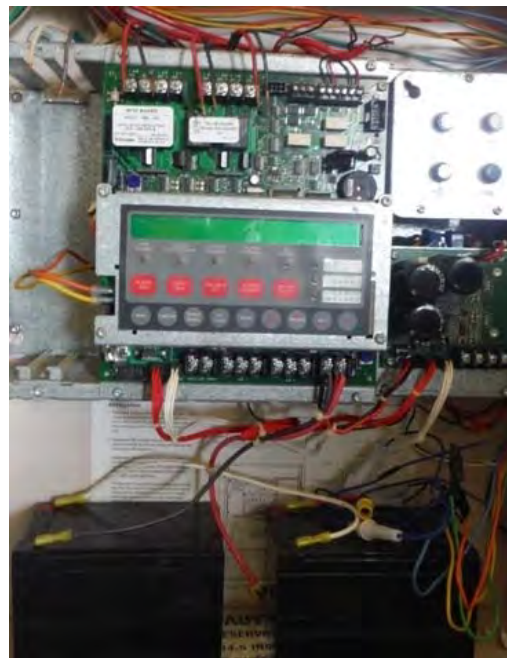
OIA Phase III survey found the fire alarm panel was power-off. It was a safety hazard to the occupants. The fire alarm system required services and repairs to ensure its functions and performance meeting the fire safety requirements.

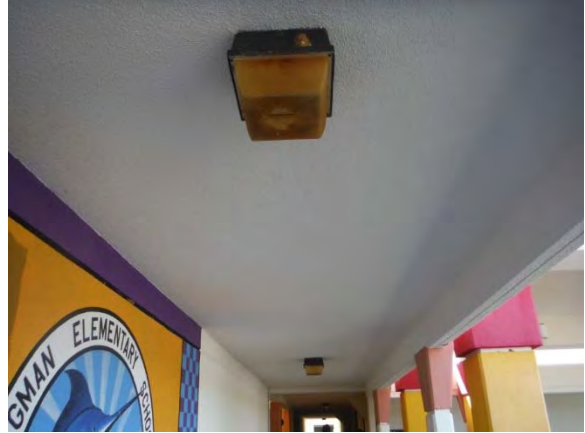
OIA Phase III survey found that walkway lights were inoperable.

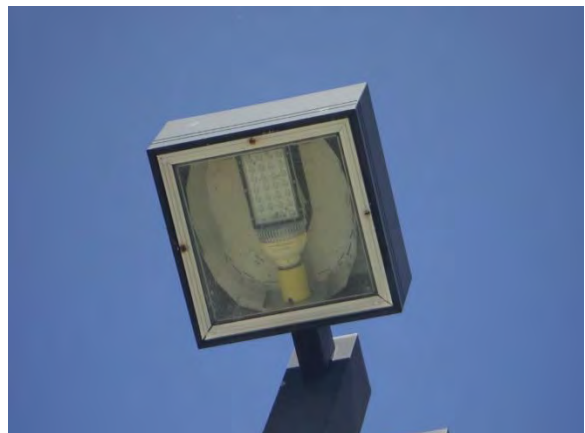
#### Parking

OIA Phase III survey found that parking lights were inoperable.

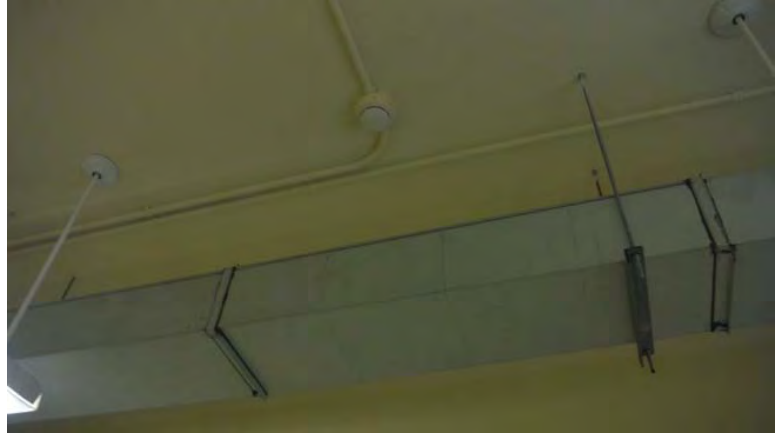
2. Building 7, Classroom  
OIA Phase III survey found smoke detector installed at unconditioned space which would likely result in false alarms or other system trouble. Fire alarm system should be serviced and maintained by qualified contractors to avoid and correct the false alarms and system troubles.

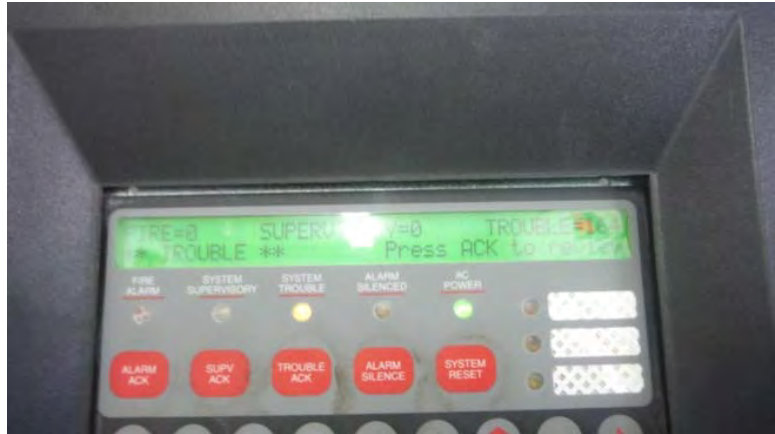
1. Fire alarm system  
OIA Phase III survey found the fire alarm panel had trouble signals. The fire alarm system required services and repairs to ensure its functions and performance meeting the fire safety requirements.

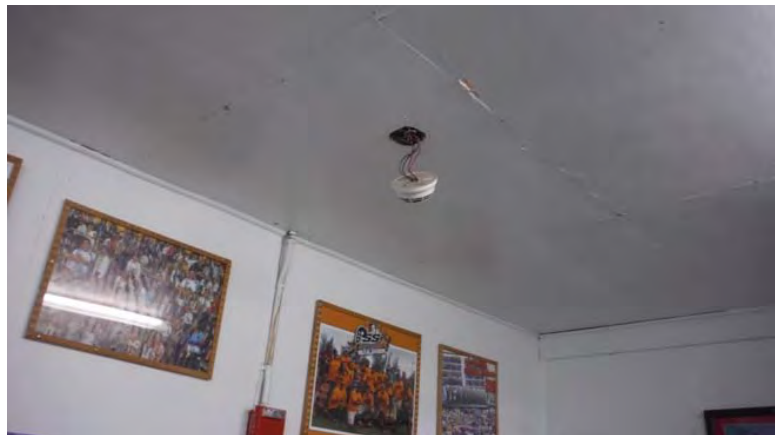
2. Building 3, Office  
OIA Phase III survey found smoke detector did not secured. Fire alarm system should be serviced and maintained by qualified contractors to avoid and correct the false alarms and system troubles.

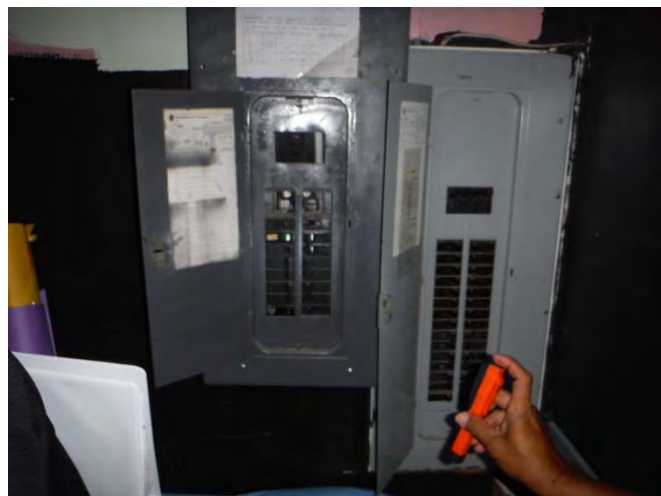
OIA Phase III survey found that panel board should be replaced.

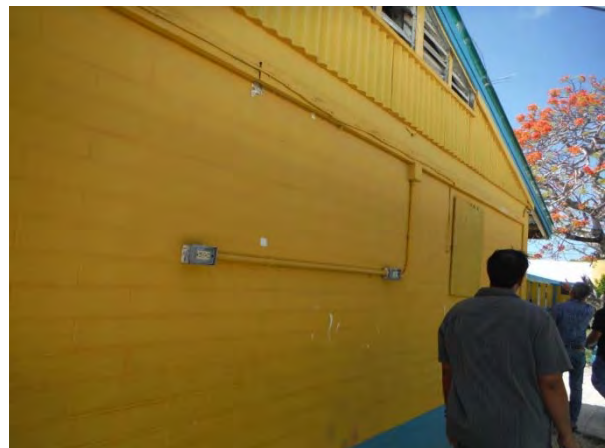
Building 6-C

OIA Phase III survey found that two receptacles on the exterior side of the building should be removed.

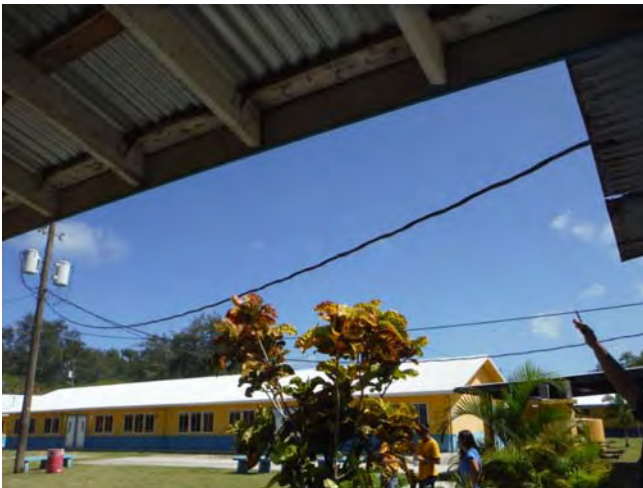
OIA Phase III survey found CUC service line is too low.

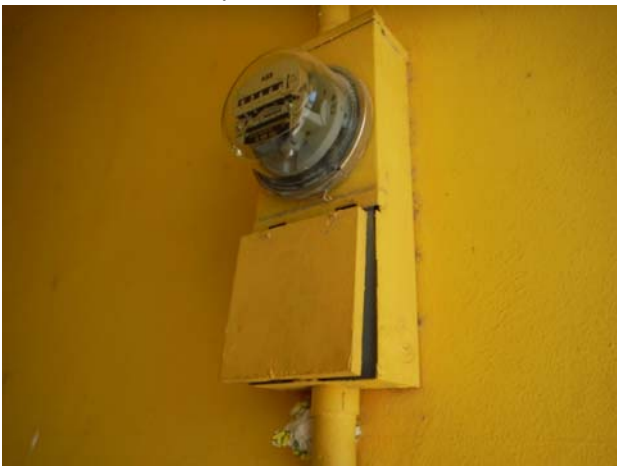
Building 20- PE

OIA Phase III survey found that meter service disconnect box cover needs replacement.

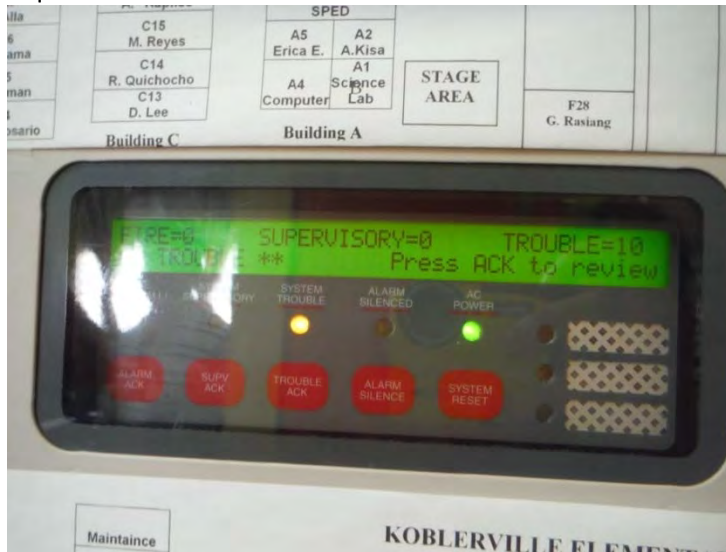
OIA Phase III survey found the fire alarm panel had trouble signals. The fire alarm system required services and repairs to ensure its functions and performance meeting the fire safety requirements.

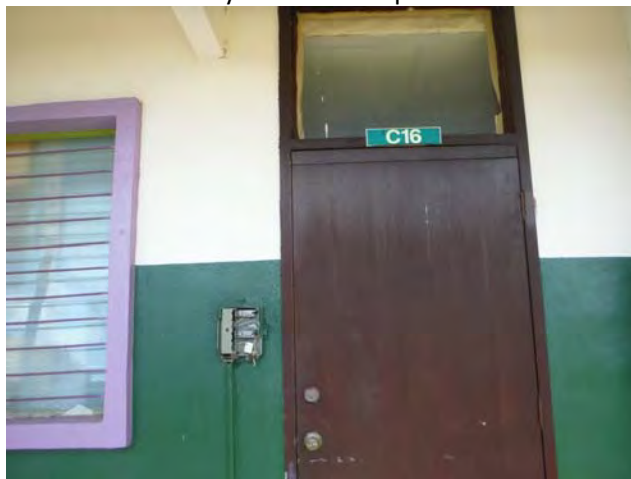
OIA Phase III survey found an inoperable telecommunication box outside room C-16.

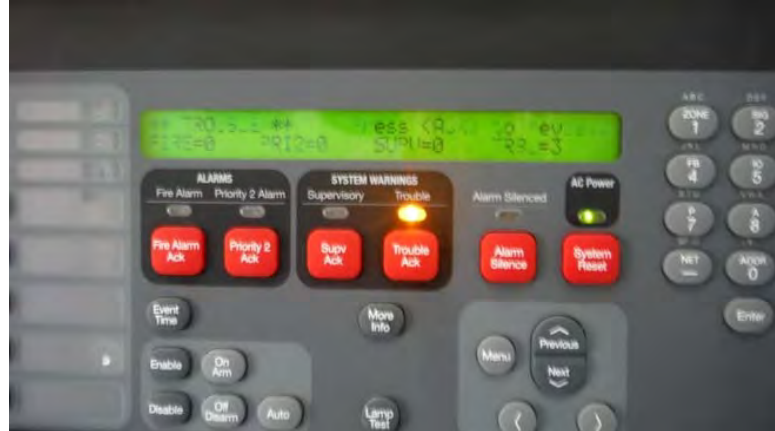
OIA Phase III survey found the fire alarm panel had trouble signals. The fire alarm system required services and repairs to ensure its functions and performance meeting the fire safety requirements.

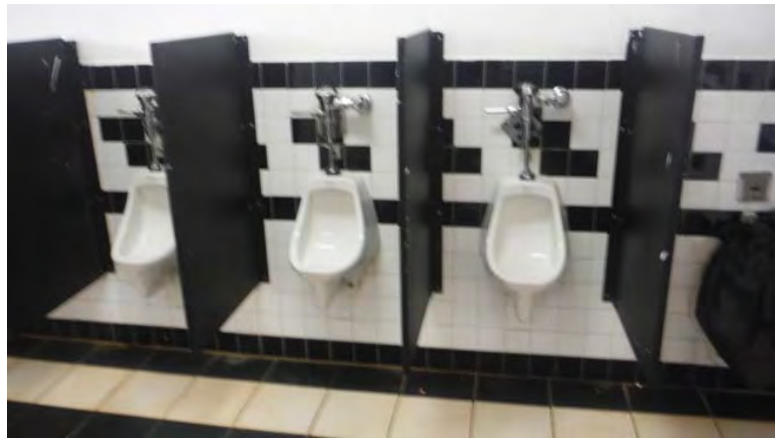
2. Building 8, Classroom

OIA Phase III survey found the new flush valve did not operate properly. They needed adjustment or replacement.

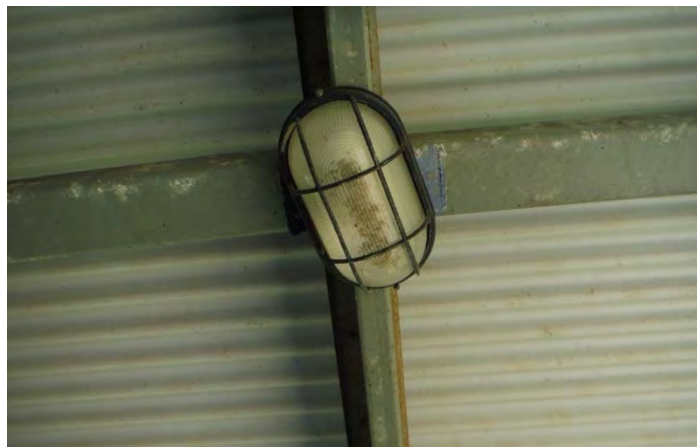
OIA Phase III survey found that walkway lighting is inoperable between buildings.

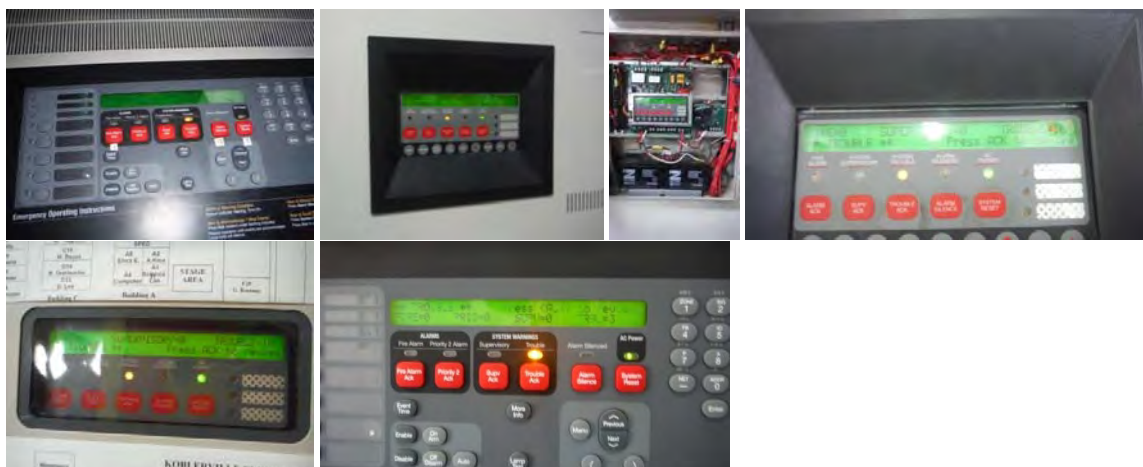
Fire alarm panels at Marianas HS, Garapan ES, Kagman HS, Hopwood JHS, Koblerville ES, and Saipan Southern HS have trouble indications and silenced alarms.

Obstructed pull station at Garapan ES.	Defected pull station and smoke detector at Hopwood JHS.
