# **INSULAR ABC'S INITIATIVE**

## **Phase III Task 1 Findings and Recommendations**

### **Guam**

October 2015

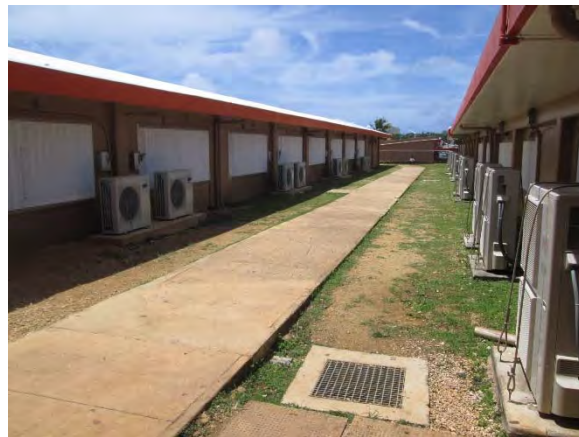
After renovation, many buildings now have windows on only one side, and the temporary buildings have no windows; this could pose a problem if the A/C fails and there is lack of natural ventilation, making rooms uncomfortable. At nearly every window, the storm shutters are kept closed to help prevent vandalism. As a result, limited natural light is available.

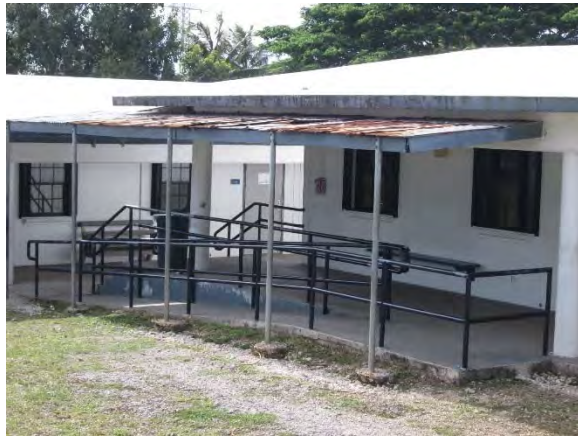
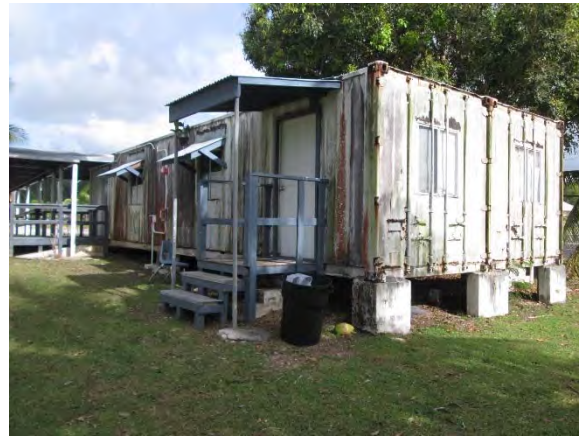
New gutters and roofing are needed at the covered walkways. A new covered walkway is needed between buildings 8 and 10, as students often get rained on when walking to these classrooms. Building 1 (built from metal containers) is still in poor condition.

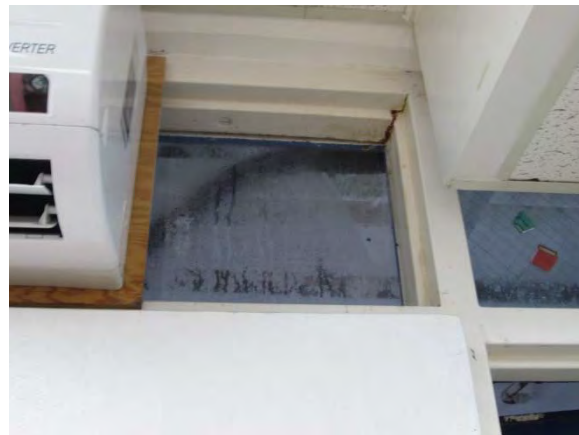
Concrete repairs has been done as well as roofing work at the Cafeteria, which has for now stopped water leaks. At several locations, but predominantly at Building 14, condensation is forming on the outside of the building due to low room temperature inside and no insulation; moisture is damaging steel door and window frames, light fixtures, paint, and causing mold to form.

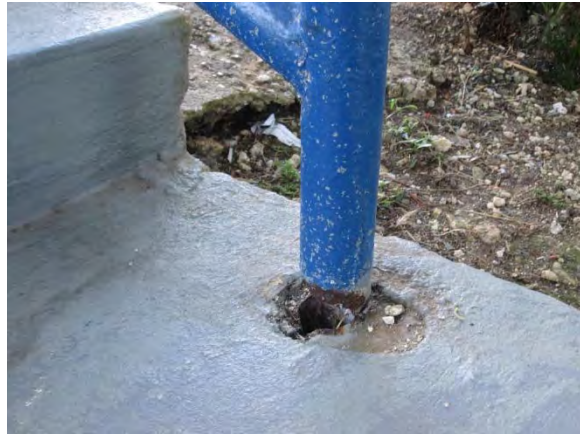
Buildings 9 and 12 have moisture/water issues inside due to earth outside of wall. Installation of a moisture barrier is needed at the walls and floor. Most concrete roofs have received new roofing except at buildings 6 and 7. Some metal railing repairs are needed.

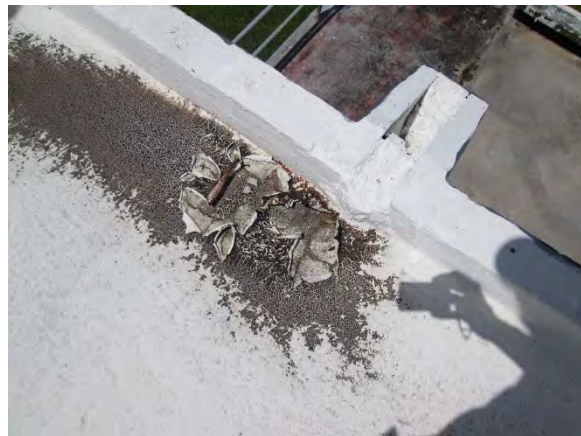
The roofing is generally in good condition, except in some areas where ponding occurs, and the roofing is starting to peel up. At the Cafeteria and adjacent offices it leaks when it rains; this appears to be from needed waterproofing at the joint between the building roof and the exterior walkway roof.

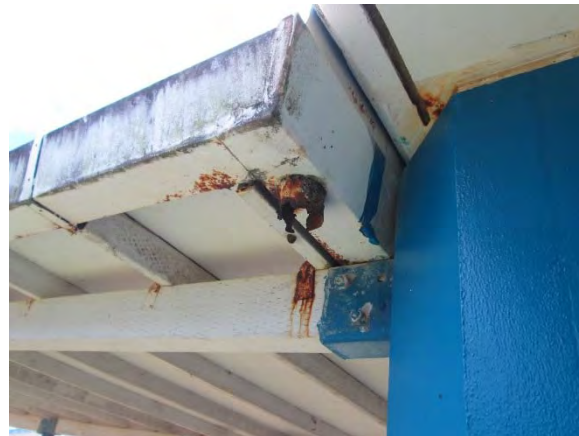
Some ponding areas were noted at the roof, but roofing at the concrete roofs is in good condition. New metal roofing is needed at the Stage (Building 17). The covered walkways on the southeast side of the campus are dilapidated and need new gutters.

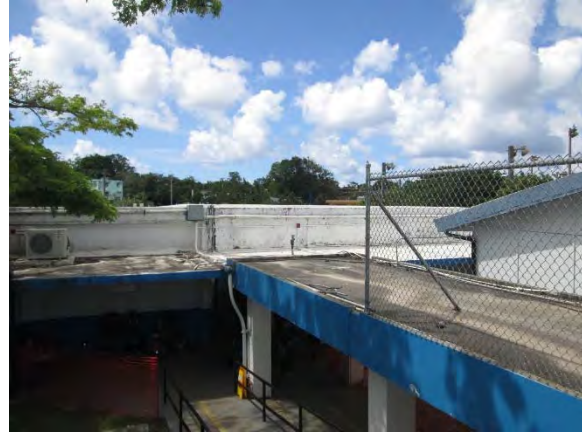
Buildings 2, 12 and 5 are not in use and are planned for demolition. Some new gutters and downspouts were installed at Building 1. Tree debris is causing clogging of gutters, and debris on roof will hold moisture and cause damage to the roofing. The covered walkways with concrete roofs need new roofing.

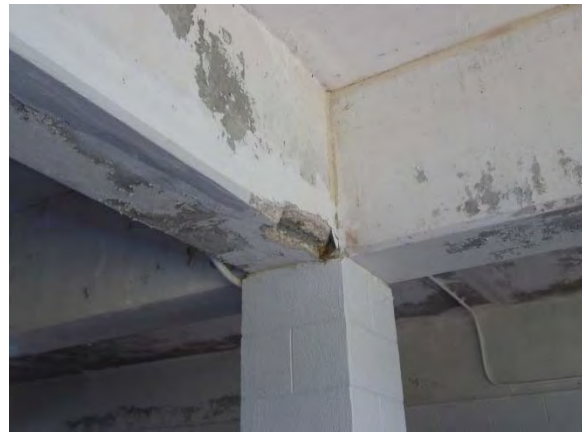
The spalling concrete was repaired at several locations, but there are other locations of spalling concrete, including the exterior stair at Buildings 1, 4 and 6, and at a beam at Building 5.

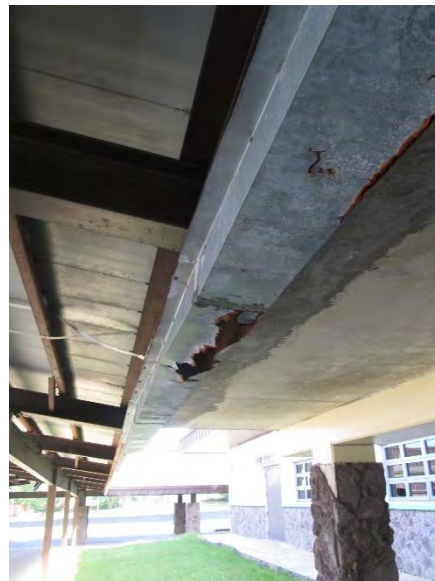
The Auditorium (Building 12) and Gym (Building 11) have been renovated. The roofs are leaking at the Gym, Nurse's Office, and Building 6 (5000); mold is forming in the wet ceiling of the restroom at the Nurse's office. In several locations the gutters are rusting; it appears that they are not properly sloped and so water sits in the gutter for an extended time.

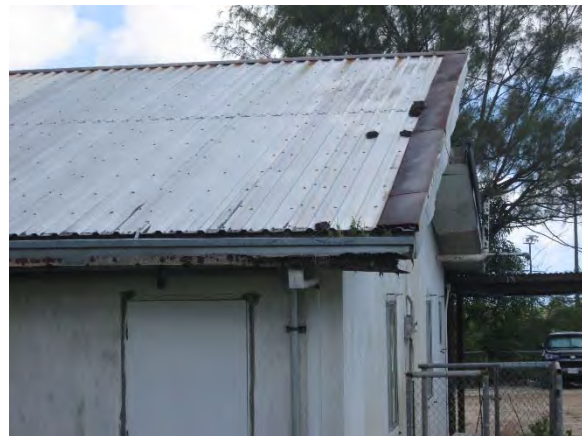
The roof is leaking at library; also it appears the bottom of the wall at the addition is not properly flashed/sealed and is leaking inside during rains. New gutters are needed in several locations. Some trees were removed, but several of the remaining trees put debris on roofs and clog up the gutters and downspouts. The trees should at least be trimmed to reduce debris on the buildings.

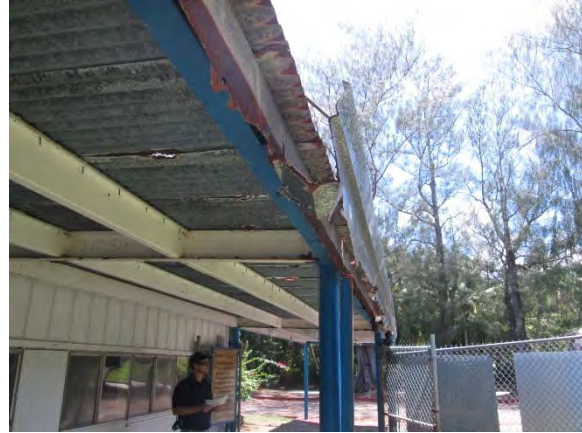
Most buildings have received new fluid-applied or metal roofing. The covered walkways need new gutters and roofing, and Building 3 needs new metal roofing, gutters and flashing.

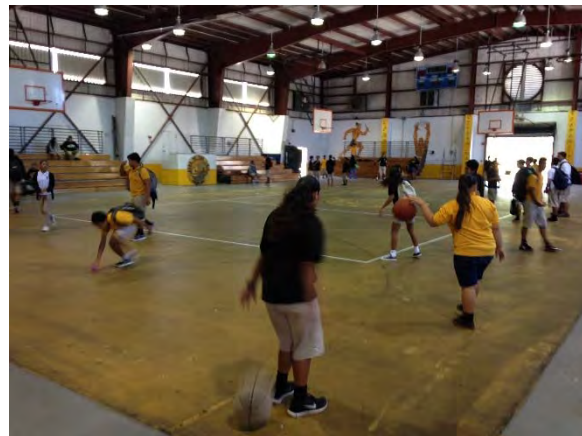
At the joint between Buildings 1 and 5, the steel beam is rusted and the concrete is spalling. The Gym has rusted girders, broken bleachers, and the gym needs a new floor.

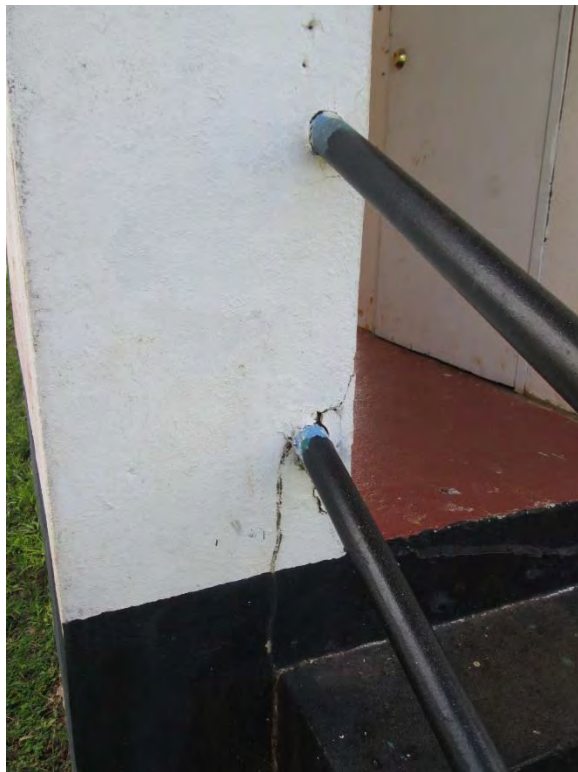
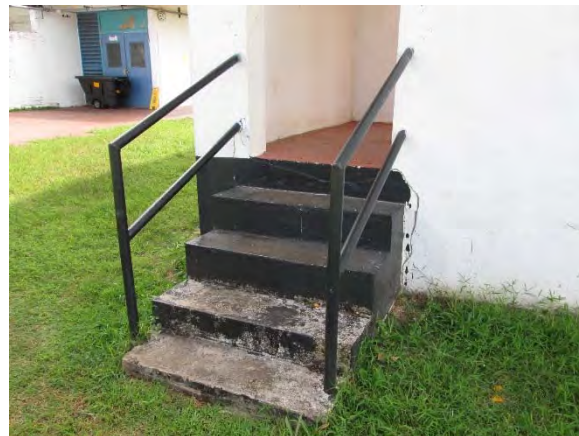
### 1. Damaged concrete at railing attachment

The concrete wall is cracking and spalling at several locations where the railing connects to the wall. It is likely some of the damage is due to students pulling or pushing against the railing from either side, but if the railing ends had been adequately imbedded in the concrete wall it would not likely be damaged.

In addition, the connection of the rail to the concrete step on one side is also spalled and has lost integrity to support the railing. This should also be repaired to ensure overall strength of the railing.

- Cut railing off at each rail end and remove railing
- Cut out the metal end bases in concrete at both wall and steps and remove all loose concrete
- Install new metal railing end bases in concrete wall, deeper than previous end base. Patch with hydraulic concrete.

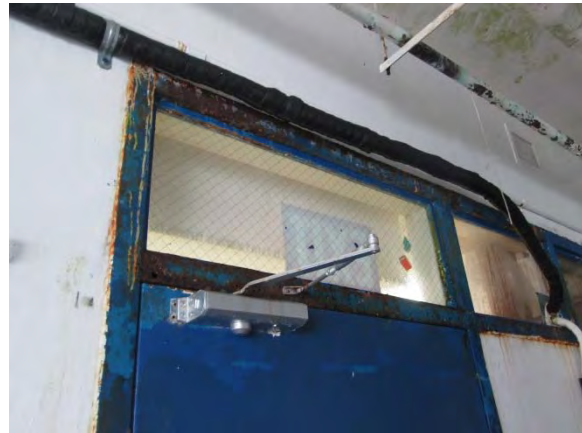
**4. Rusted metal door and window frames**

The extreme temperature difference between the outside air and the heavily cooled classrooms in this building causing moisture to condense on the outside of the walls, doors and windows. The moisture is causing the metal doors and metal frames to rust.

- Remove paint from frames and doors
- Remove as much rust as possible
- Treat with a rust inhibitor

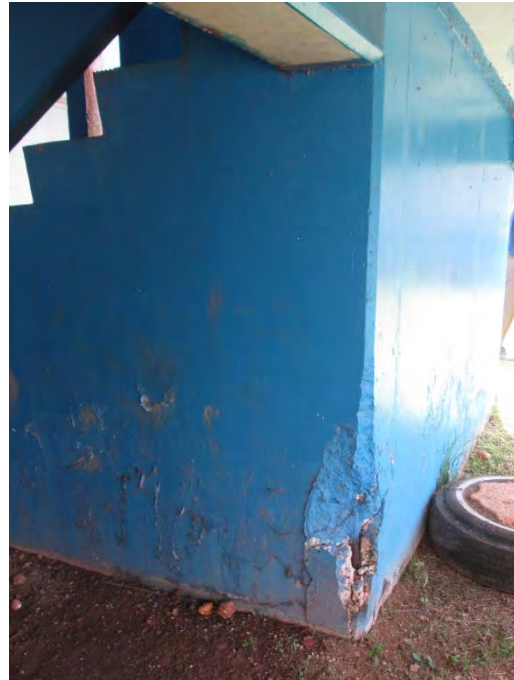
6. Spalling concrete (non structural)

The concrete is spalling at several locations on this campus, including at several stairs. The spalling should be repaired before it becomes worse and further compromises the integrity of the concrete element.

- Remove all loose concrete
- Remove as much rust as possible from steel reinforcing elements
- Replace reinforcing as necessary. Consider using fiberglass reinforcing bars
- Treat steel with a rust inhibitor compound
- Fill all cracks and patch spalls with new concrete

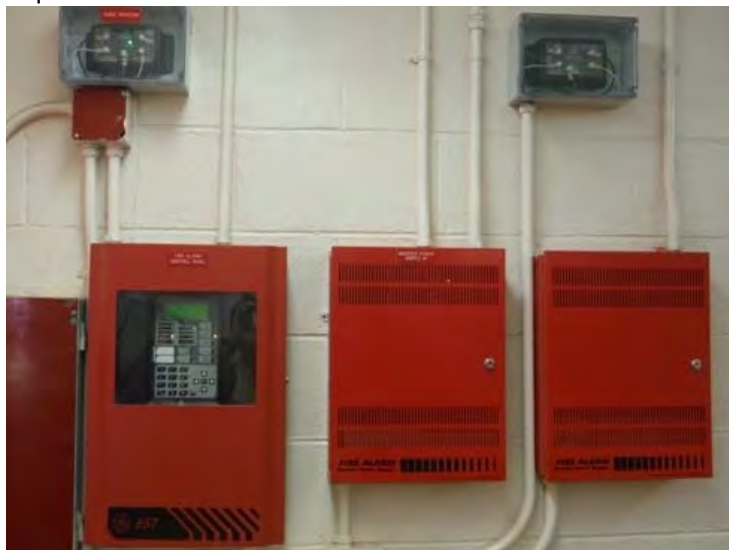
OIA Phase III survey found the fire alarm panel had trouble signals. The fire alarm system requires services and repairs to ensure its functions and performance meet the fire safety requirements.

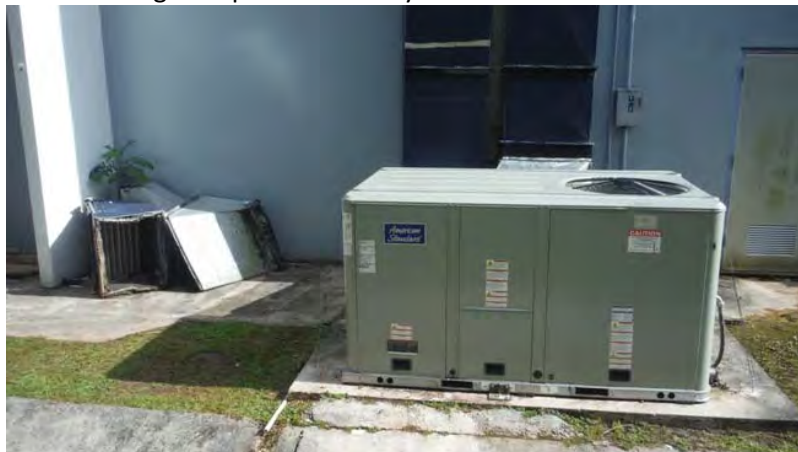
OIA Phase II survey found the air conditioning system at Building 15, Gymnasium required repair and balancing. OIA phase III survey found new air conditioner had been installed.

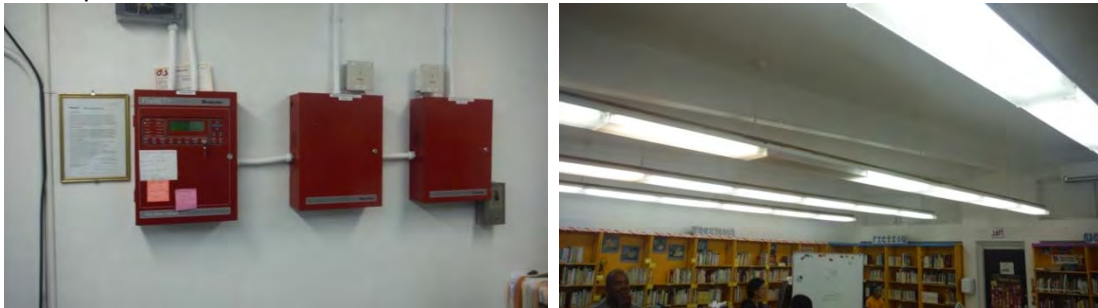
OIA Phase III survey found the fire alarm panel was at normal operation. Building 12, Library, had no pull stations or automatic fire detectors.

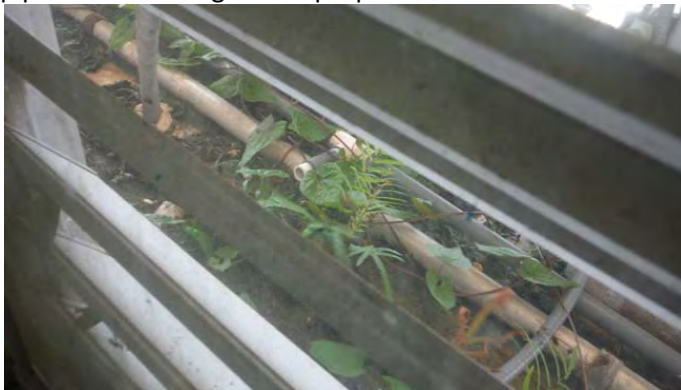
Condensate drain pipes at Building 10 discharged at the overhang. Condensate drain should be piped and discharged to a proper location.

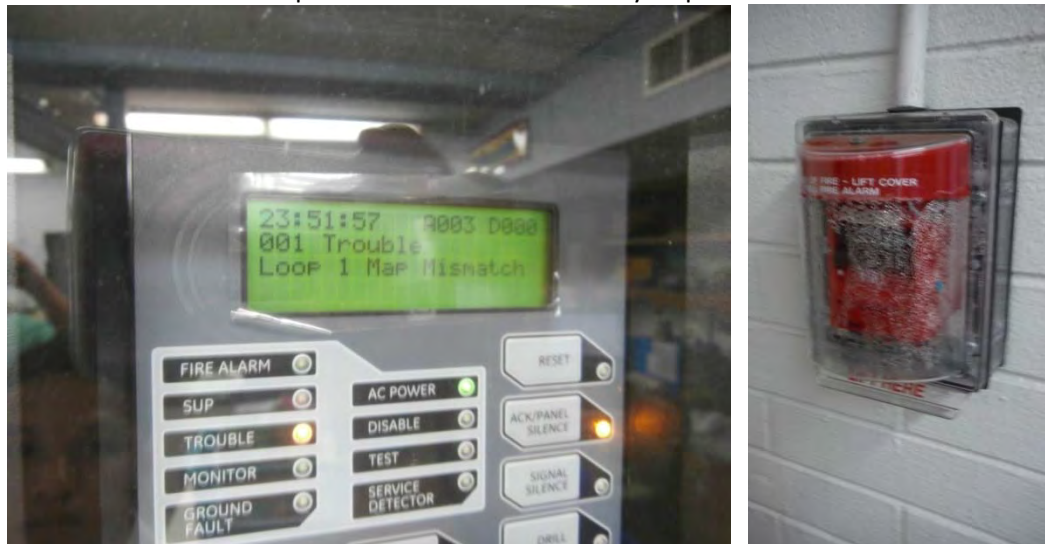
OIA Phase III survey found the fire alarm panel had trouble signals. Some protective cover for manual pull stations had condensation. The fire alarm system requires services and repairs to ensure its functions and performance meet fire safety requirements.

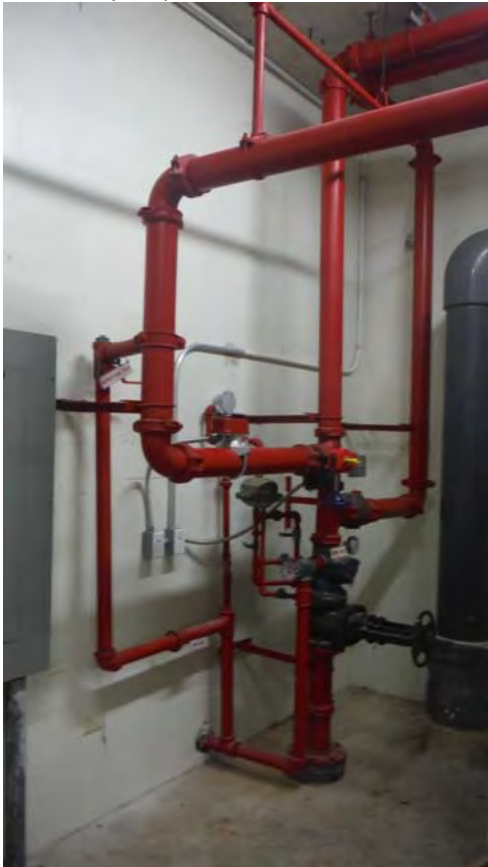
Sprinkler riser at Building 11, Gymnasium

OIA Phase III survey found the fire sprinkler systems were not serviced per NFPA 25. Control valve at Building 11, Gymnasium, was not supervised per NFPA 13 and Internal Fire Code (IFC). Fire department connection at Building 12, Auditorium, had no cover protection. The fire sprinkler systems require regular servicing and tests to ensure functions and performance meet fire safety requirements.

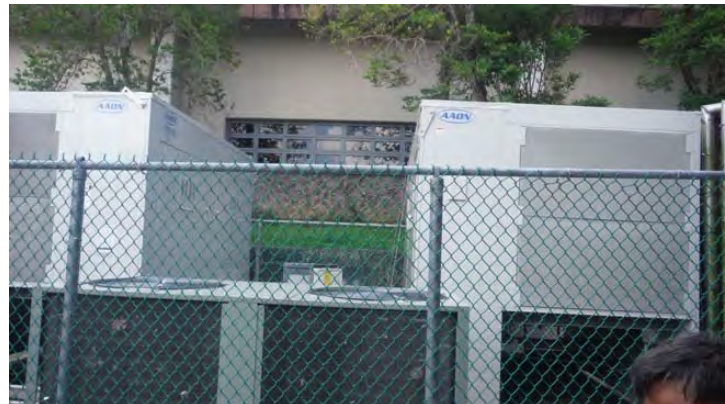
OIA Phase III survey found the air conditioning system at Building 7, Cafeteria, was down and required repairs. This system was installed after OIA phase II survey.

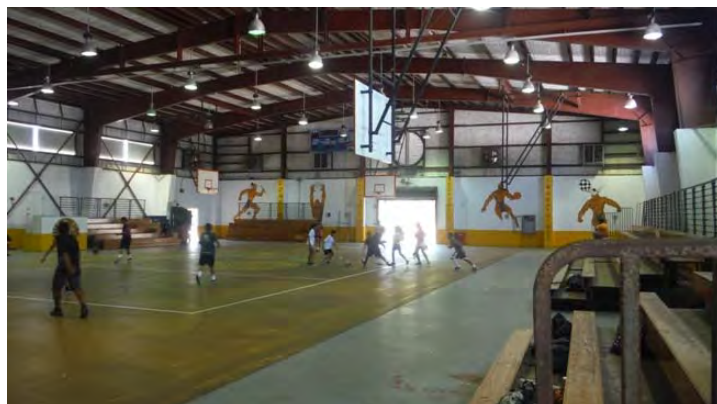
OIA Phase III survey found some new installed air conditioning units dripped at the walkway. Ventilation fans at Building 2, Gymnasium were not operational and needed repair.
