INSULAR ABC'S INITIATIVE

Phase III Task 1 Findings and Recommendations

United States Virgin Islands

October 2015

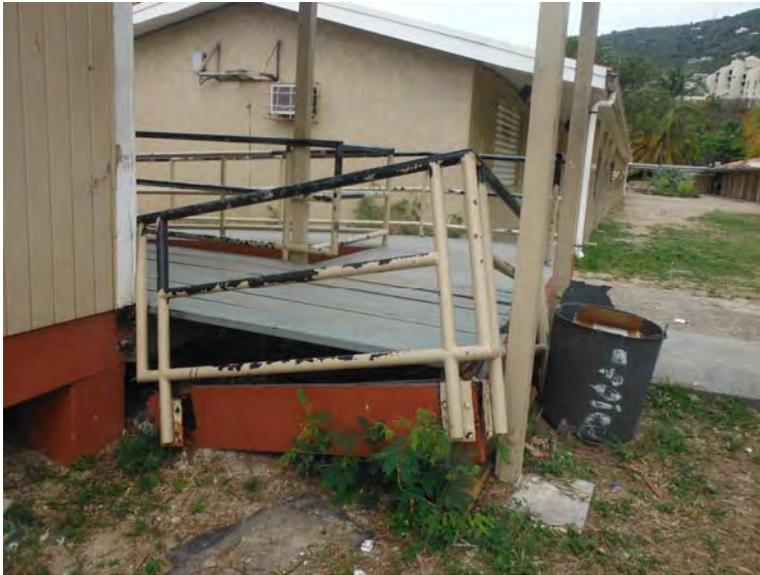
Building 5 is a wood-framed building on a post and pier foundation, and has a covered walkway on the entry side with a wood floor structure. The wood joists supporting the base of the railings is damaged (rotted or termite damaged) at one end, and the metal railing has completely fallen off.

Recommended Scope of Work:

The damaged joists should be replaced in order to fully support the metal railing. If the joists are in good condition except at the ends, the joists could be sistered onto so that there is a solid bearing area at each end. Install at least 3 feet of new sistered joist at each damaged existing joist, and bolt through both joists in several locations. Attach the metal railing to the new wood members.

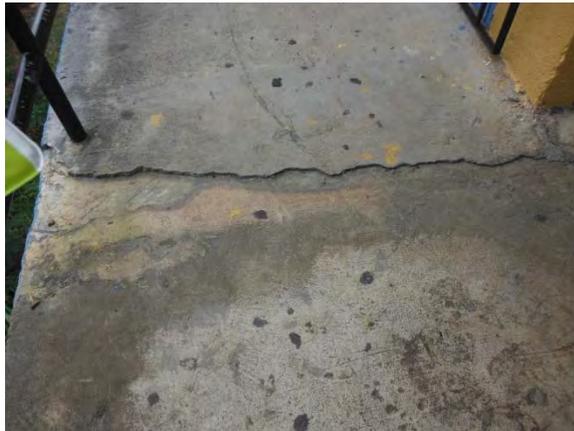
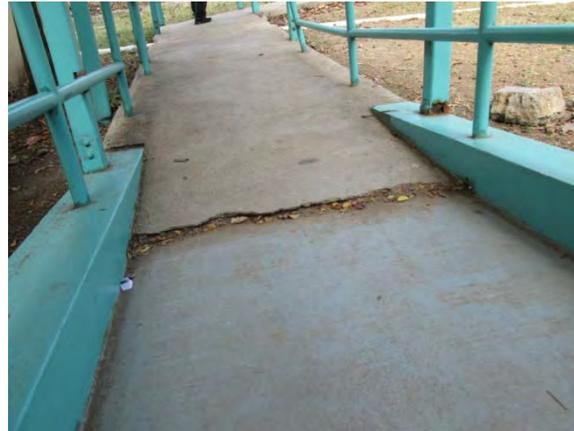
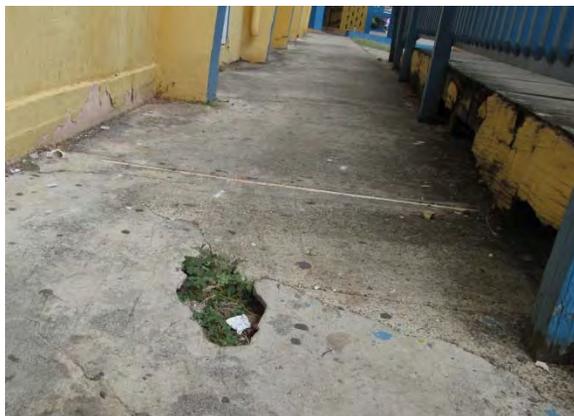
The concrete surface at several ramp and walkway surfaces are in poor condition and are a hazard for tripping. There are holes, spalled areas, rough edge transitions, and unsafe edge conditions.

Recommended Scope of Work:

Where holes or spalled areas have formed, remove all loose concrete and clean area/hole. Patch area with new concrete, ensuring that edges are smooth.

Where uneven edges at transitions are large enough to cause tripping hazards, simply adding a patch along the edge will typically eventually delaminate, and a new transition must be created.

- Sawcut at least 1" deep of concrete across slab at joint, more if doweling is needed. Cut strip wide enough to create smooth transition, at least 2 feet wide if doweling.
- Remove concrete
- Patch to two existing sides, inserting dowels if needed, and creating smooth transition at each edge.

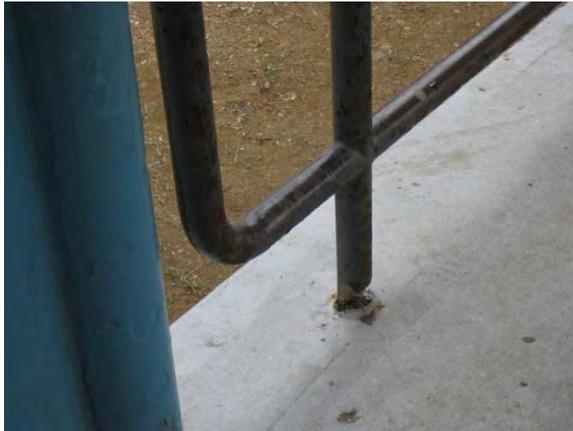
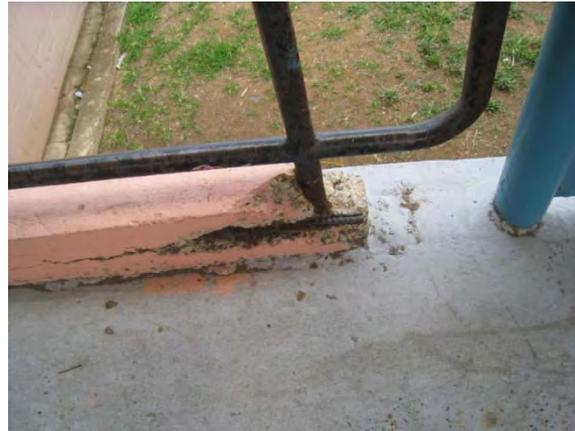
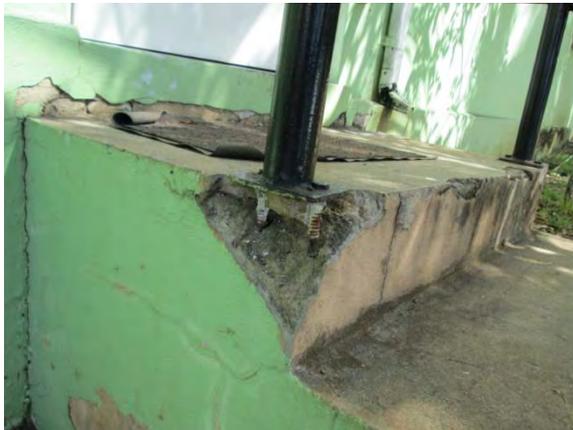
3. Rusted metal railings, spalling connections at concrete stairs/walkways/ramps
Location: Juanita Gardine ES Building 2,

In several locations, metal railings are heavily rusted at the base, and are a potential hazard due to the possibility of becoming disconnected at the base, and also by creating a sharp, rusted edge that could cut someone.

Recommended Scope of Work:

Where railings are rusted at the base, the railing must be removed and a new metal railing base installed in the concrete.

- Cut railing off at each base and remove railing
- Cut out the metal bases in concrete and remove all loose concrete
- Install new metal railing bases in concrete with hydraulic concrete. Weld bases to railing such that railing is required height.

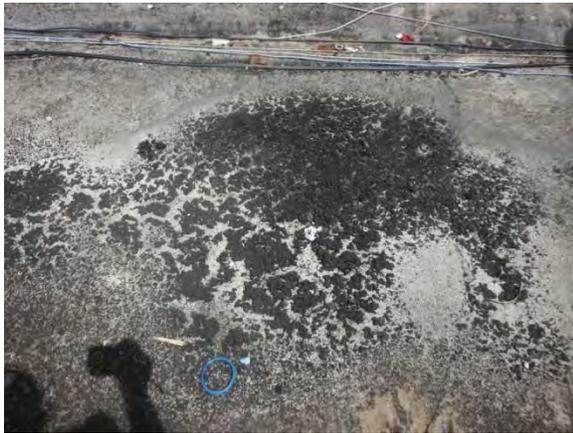
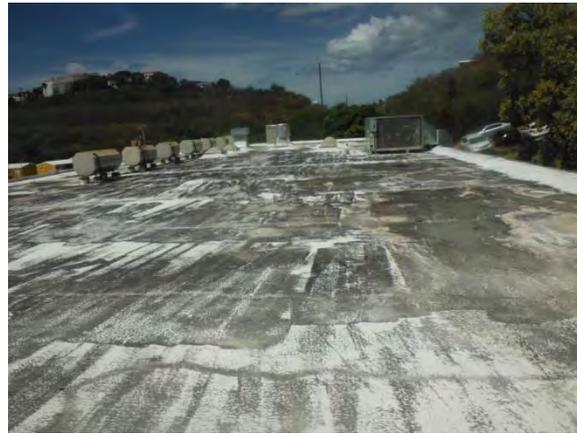
In some locations, often due to roof slope creating areas of ponding, the fluid-applied roofing has isolated problems but does not yet warrant total replacement. In addition to promoting leaks, the deteriorated areas will allow water to get under the roofing layers, which may cause expanded areas of roofing failure.

Recommended Scope of Work:

If roofing is damaged due impact, it can be quickly patched and will likely last as long as if the roofing was undamaged. But if roofing has deteriorated, it can be patched but will likely last only a few years at the maximum before the entire roof should be re-roofed.

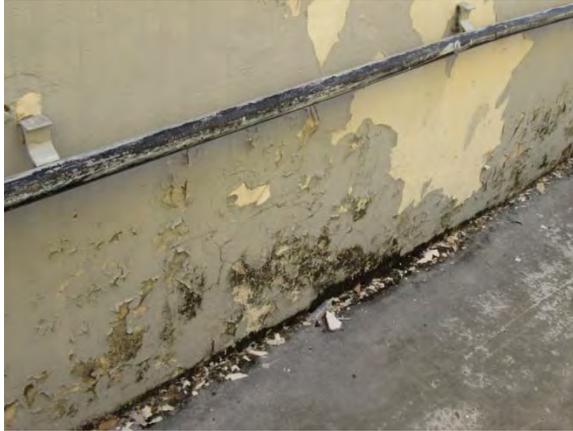
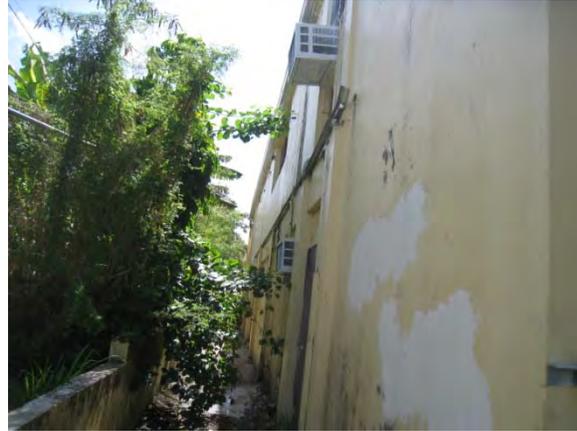
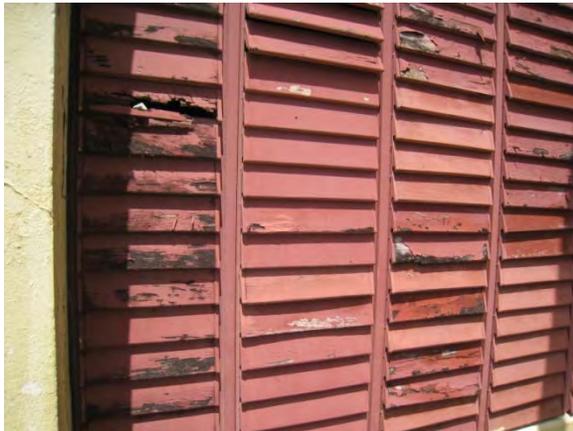
Paint failure can be due to one or more of several causes, including improper application, water leaks, condensation, plant growth, etc. Paint helps to protect materials from damage due to water, sun, and other environmental components. The loss of an intact paint surface exposes the building to damage; the building should be repainted as soon as possible.

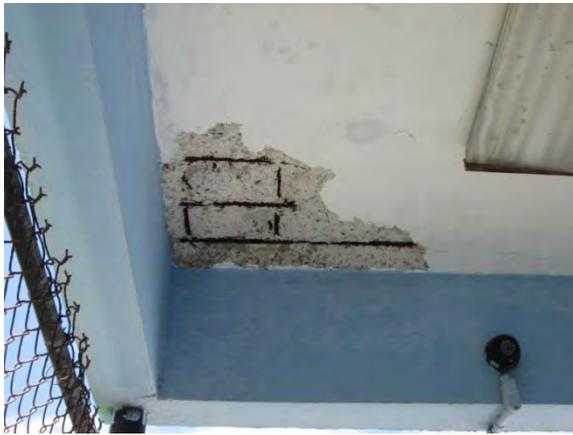
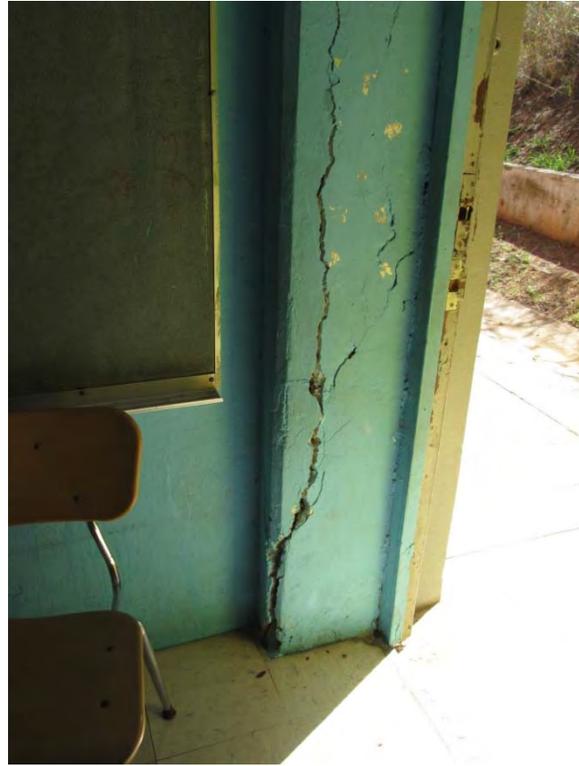
Several buildings have spalled concrete areas in both structural and non-structural elements. The spalling is typically caused by moisture getting into the concrete and rusting the steel reinforcing, which expands as it rusts and causes the concrete to crack and eventually break off. Where cracked and spalling concrete is on ceilings or is on columns or walls above, it is a safety concern as they create a falling hazard to the building occupants.

Recommended Scope of Work:

To repair non-structural concrete spalling, the following steps should be taken:

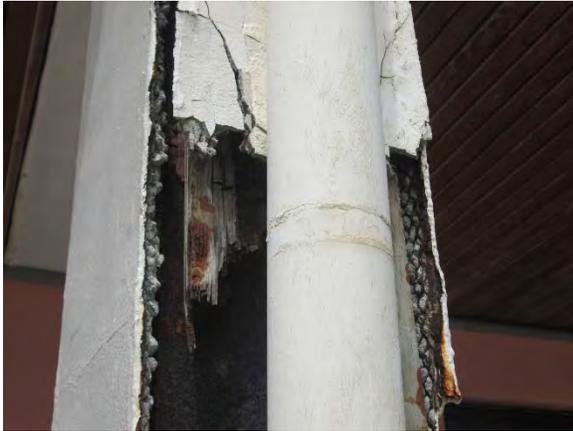
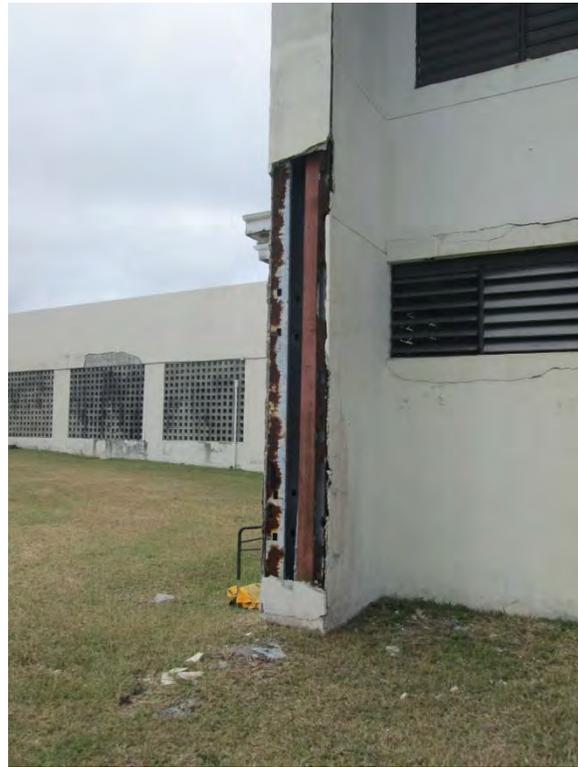
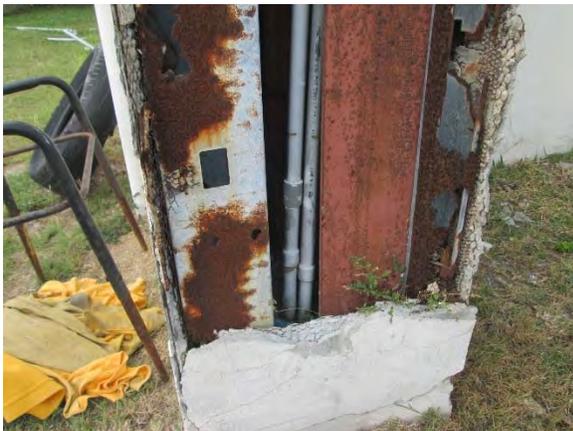
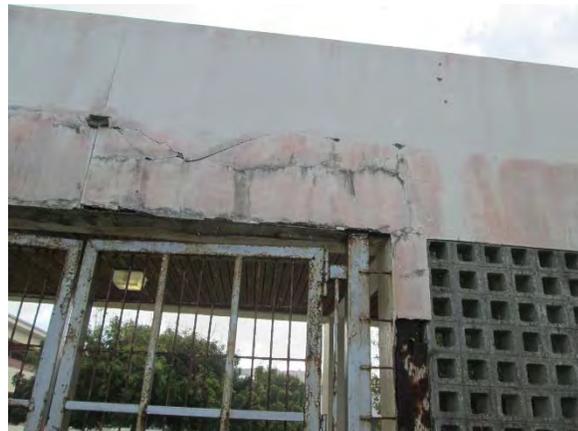
During the Phase 2 survey, it was noted that the EFIS exterior finish of most of the buildings on the campus was beginning to fail in several areas, and pieces had fallen off in a few locations. The Phase 3 assessment confirmed the condition has continued to worsen and more of the exterior finish is failing. The failure appears to be due to moisture and salt penetrating the finish material, either through cracks, joints, or due to a lack of a waterproofing membrane. The moisture then rusts the steel mesh and other steel components, causing the surface material to crack and fall off. In some areas entire panels have fallen due to the rusting of the metal connectors and furring components.

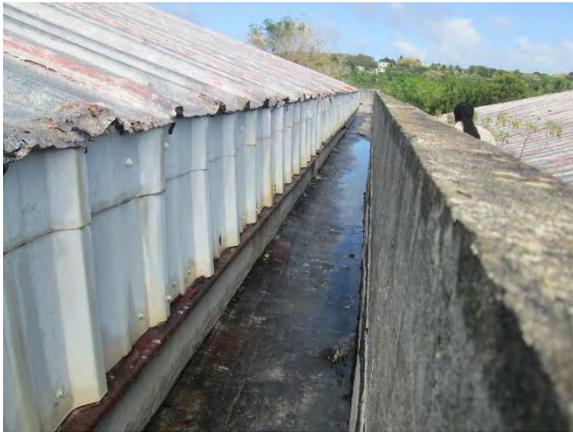
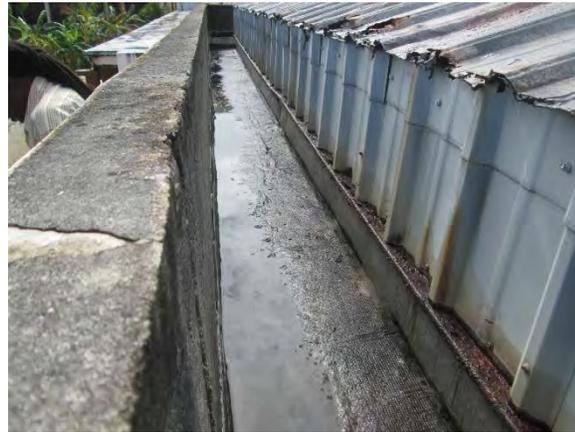
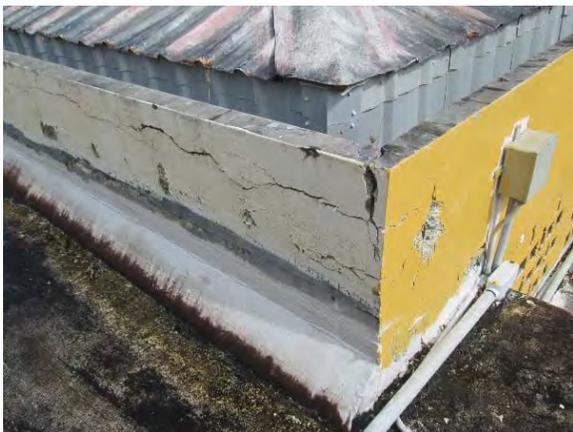
In addition, in several locations the metal roofing is rusting at the edges, in some areas it has rusted beyond the wall finish below, allowing water to easily enter the building. Some of the concrete gutters have clogged drains, and are often full of standing water, possibly also causing interior building leaks. Some of the concrete gutter walls are beginning to crack and spall.

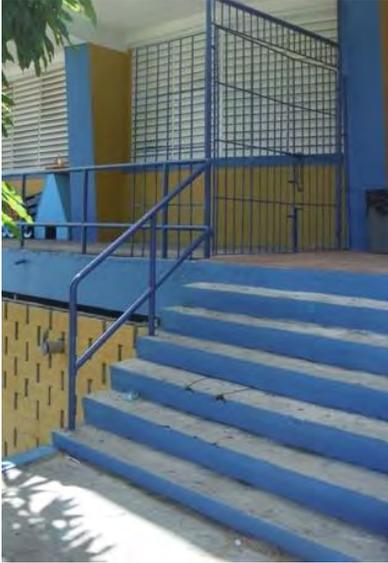
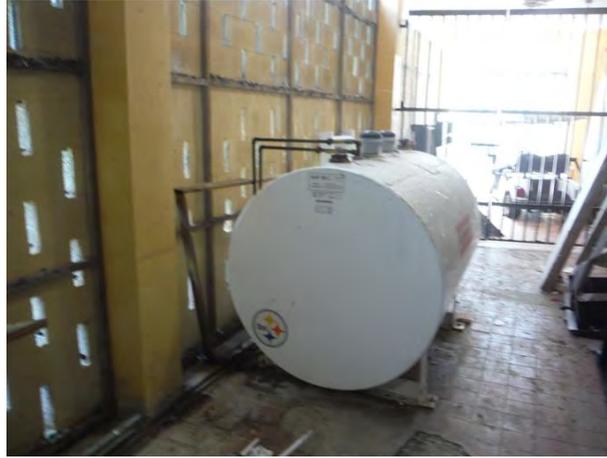
FEMA emergency power generator engine exhausts were discharged adjacent to stair and walkway which posed health hazard to public. Fuel tank was not vented to outside the generator room. It was a fire safety due the accumulation of fuel vapor at the generator room.

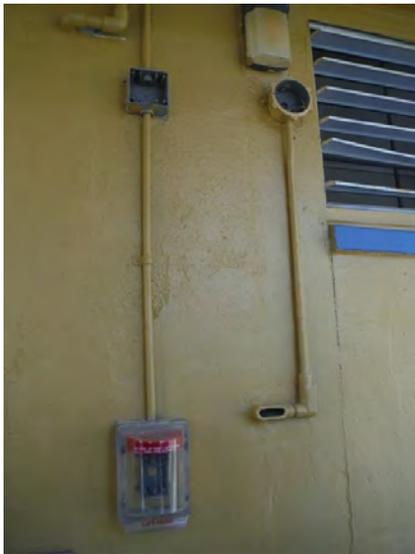
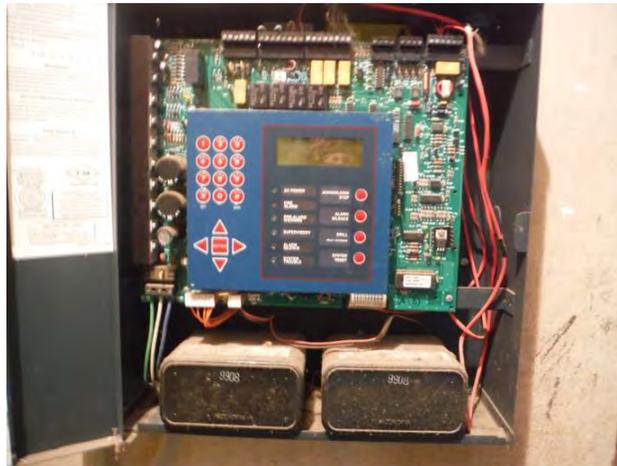
3. Fire alarm system

OIA Phase II survey found the fire alarm system was inoperable and incomplete. The fire alarm system remained inoperable and incomplete throughout the campus in OIA Phase III survey. This poses a safety hazard to the occupants. New fire alarm system should be provided throughout the campus and be upgradable for future voice communication.

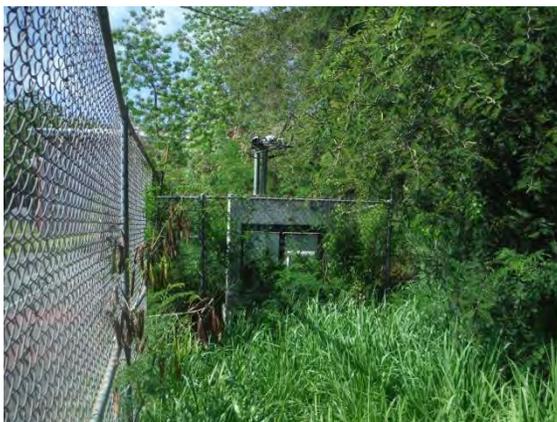
Two electrical services with pole mounted transformers and low lying weather heads. WAPA recommended to have these services relocated to provide ground pad mounted services.

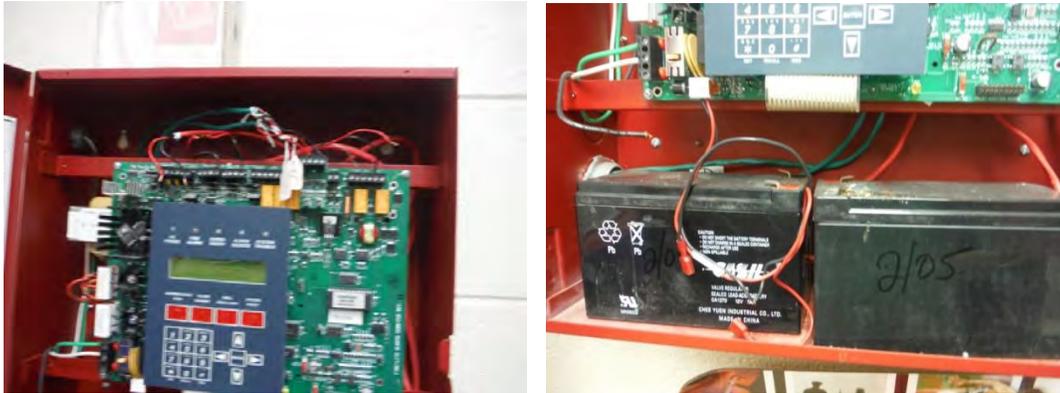
OIA Phase II survey found the fire alarm system was inoperable. During the OIA Phase III survey, the fire alarm panel power was off and batteries at the fire alarm panel were disconnected, posing a safety hazard to the occupants. The fire alarm system should be serviced and repaired to provide fire detection and notification throughout the campus and be upgradable for future voice communication.

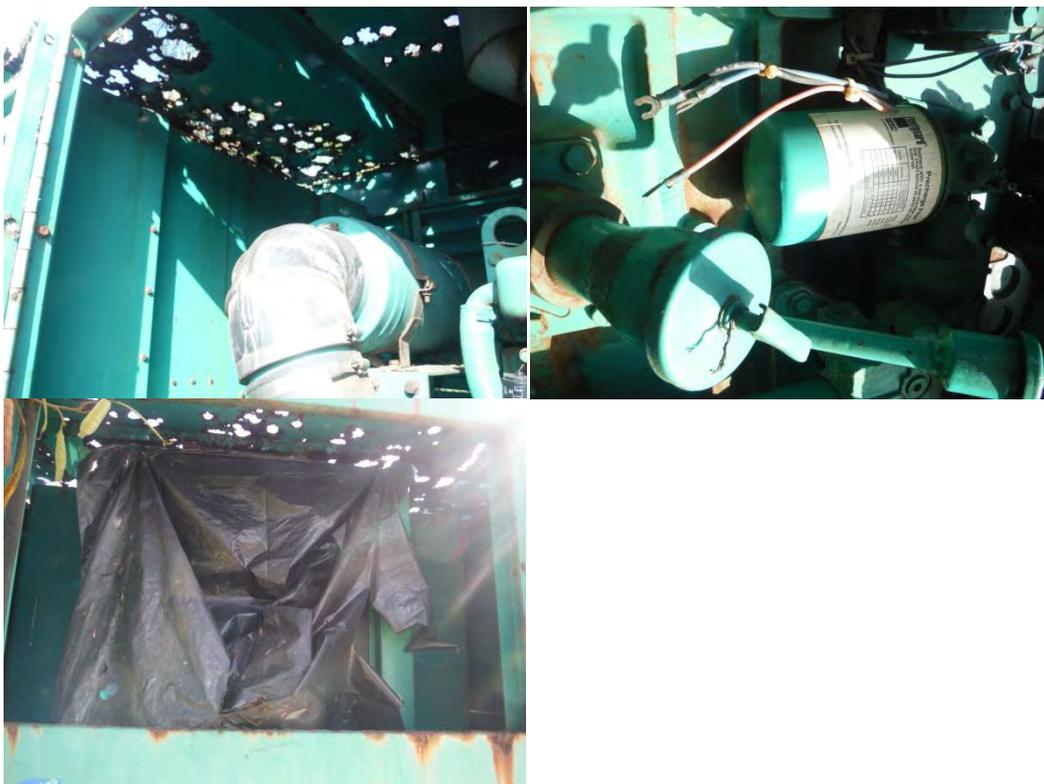
250kW standby generator housing (not FEMA generator) is badly corroded. Sensor wires are removed. Control panel covered by plastic. Generator needs repair and service or replacement.

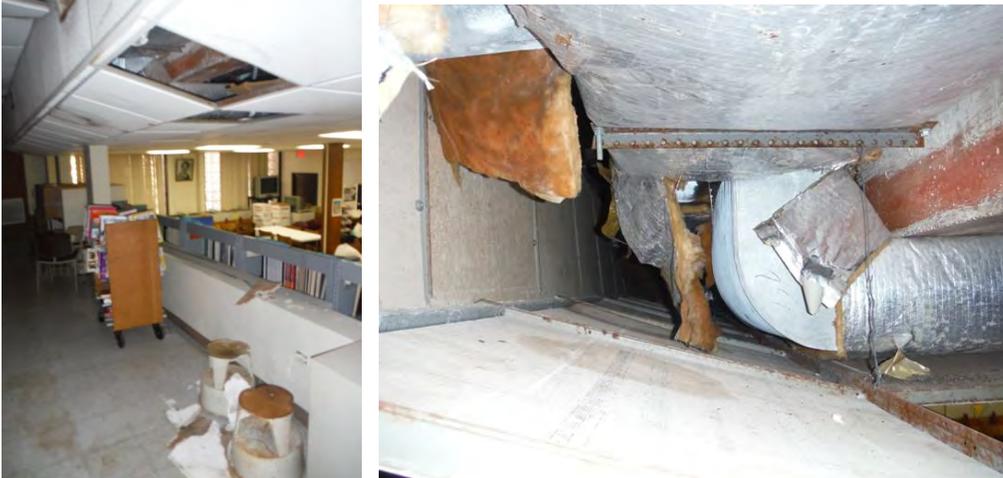
Roof leaks and damage to the air conditioning ducting insulation caused condensation, moisture and mildew issues at the library. These issues posed health hazards to the occupants.

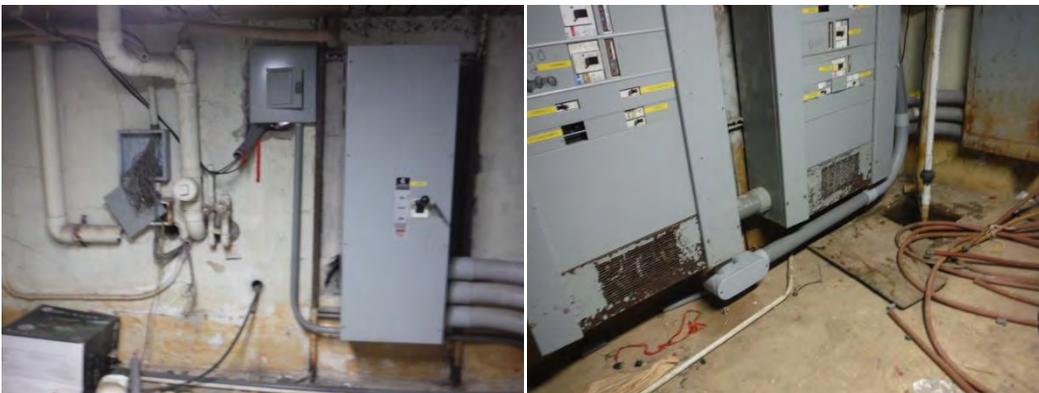
Main distribution panels are located at the main building (08 – Admin) basement. The electrical room in this building has an opening on perimeter wall causing flooding during heavy rain. Electrical panels have corroded covers and are vulnerable to flood damage. Main distribution panels and other electrical equipment are recommended to be relocated out of the basement.

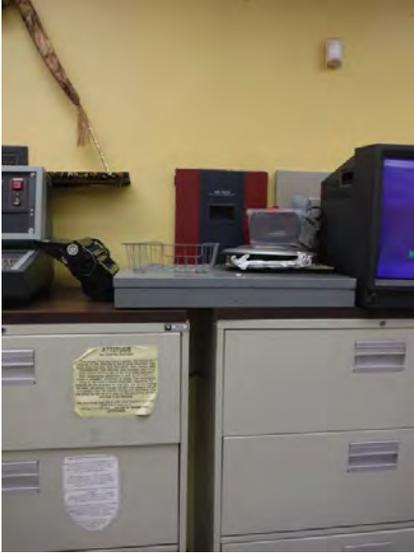
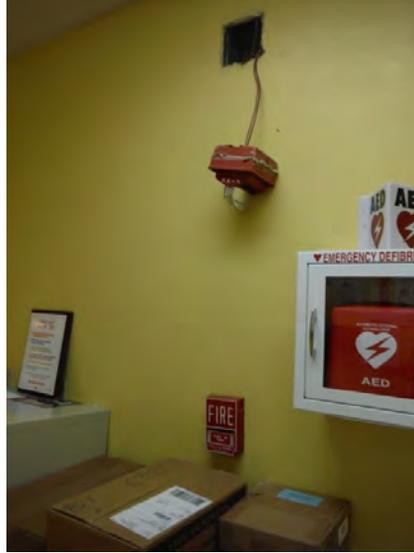
OIA Phase II survey found the fire alarm system required service and repair. During OIA Phase III, the fire alarm panel power was off. Fire alarm devices were not attached on the boxes. Both fire panel and manual pull station were obstructed. These are safety hazards. The fire alarm system should be serviced and repaired to provide fire detection and notification throughout the campus and be upgradable for future voice communication.

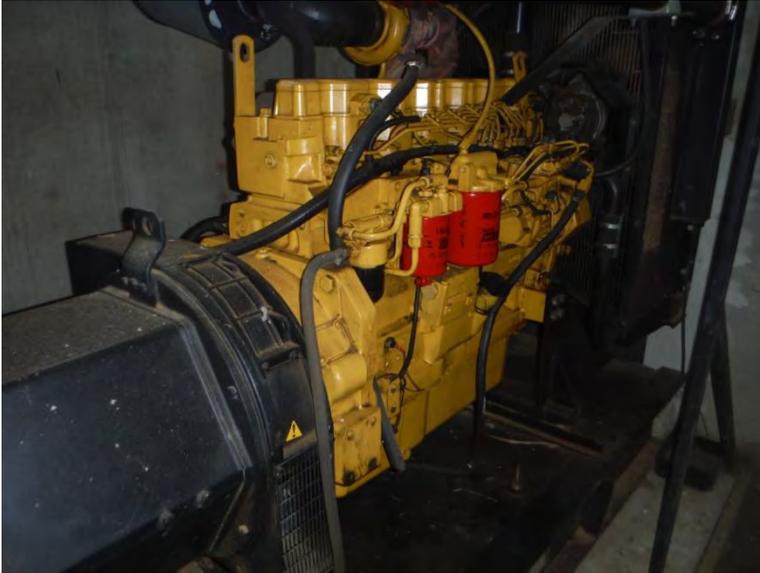
Standby generator (not FEMA generator) is located indoors in a room adjacent to the kitchen. Generator is in fair condition.

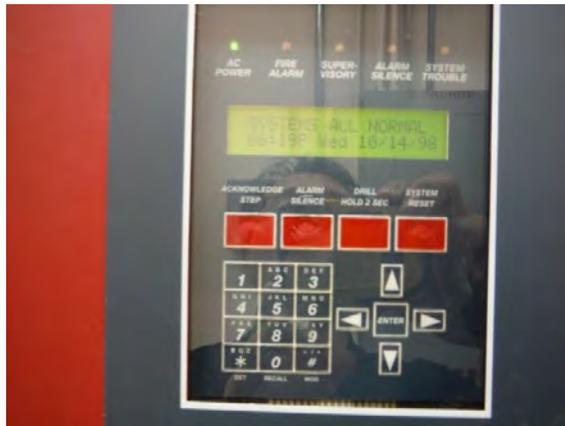
OIA Phase II survey found the fire alarm devices were inadequate. Since the Phase II assessments, the fire alarm was upgraded and now is in good operable condition.. The time and date of the fire alarm panel was inaccurate and should be corrected and be upgradable for future voice communication.

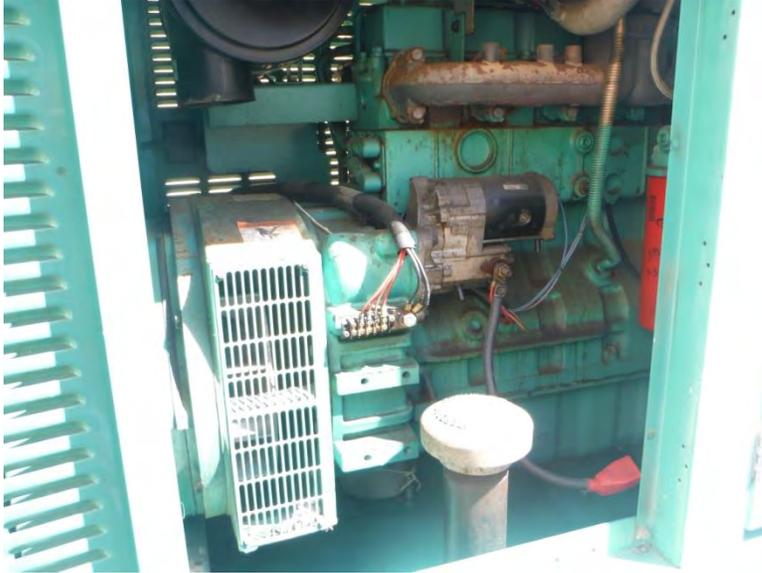
Standby Generator (not FEMA generator) is in fair condition, but battery is missing

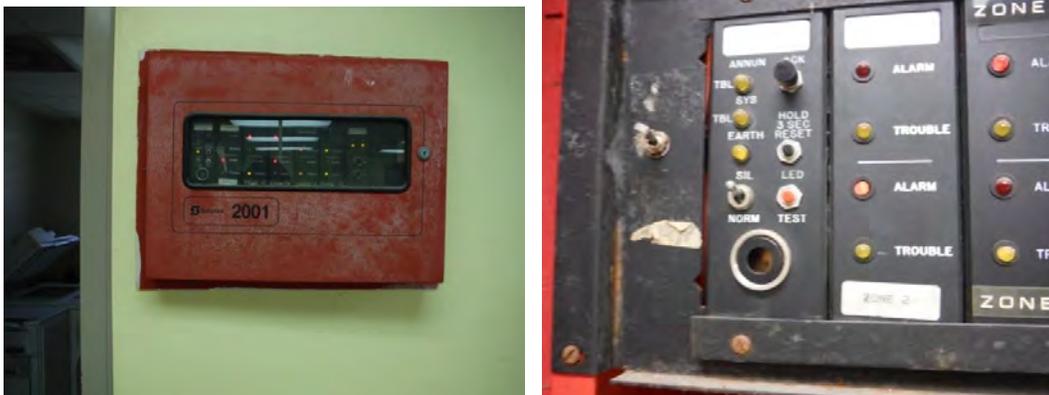
OIA Phase II survey found the fire alarm system was inoperable. The fire alarm was still inoperable at the start of Phase III. Fire alarm panel was silenced and had numerous trouble and alarm signals. Defected manual pull stations and fire alarm devices need to be repaired or replaced. These pose safety hazards to occupants. Fire alarm system should be serviced and repaired and be upgradable for future voice communication.

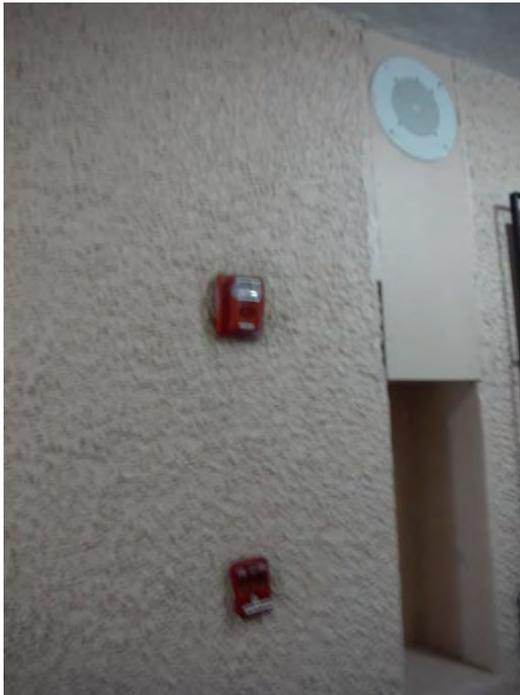
OIA Phase II found the fire alarm system was inoperable. At the start of Phase III, the fire alarm system remained inoperable. Fire alarm panel power was off, wires were removed from the fire alarm panel terminals, and batteries were disconnected. Defected manual pull stations were not repaired or replaced. These are safety hazards to the occupants. Fire alarm system should be serviced and repaired and be upgradable for future voice communication.

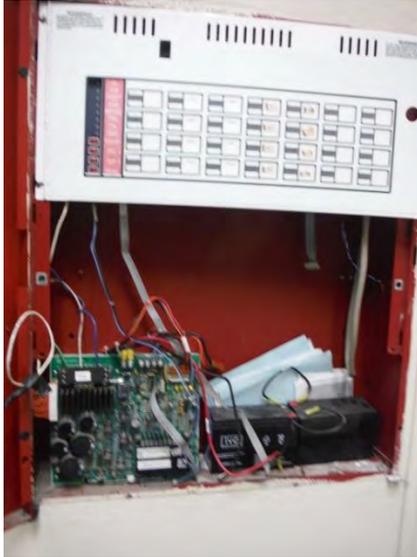
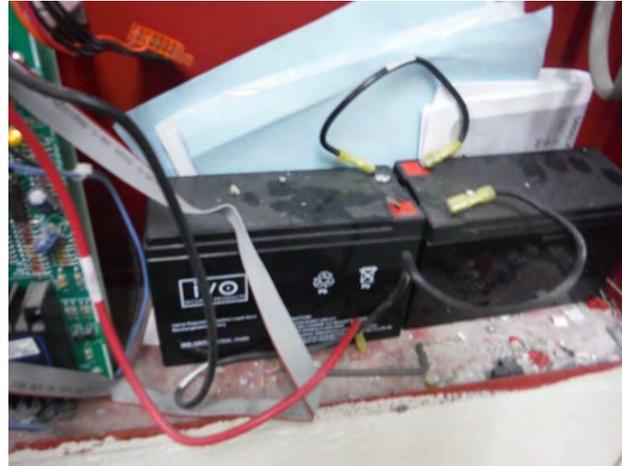
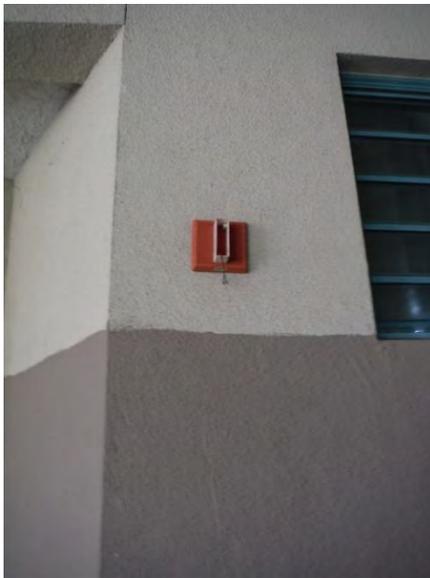
OIA Phase II found the fire alarm systems were inoperable. At the start of Phase III, fire alarm systems were still inoperable. Power to the fire alarm panels were off, batteries were disconnected, and defected fire alarm devices were not repaired. These are safety hazards to the occupants. The fire alarm system should be serviced and repaired and be upgradable for future voice communication.

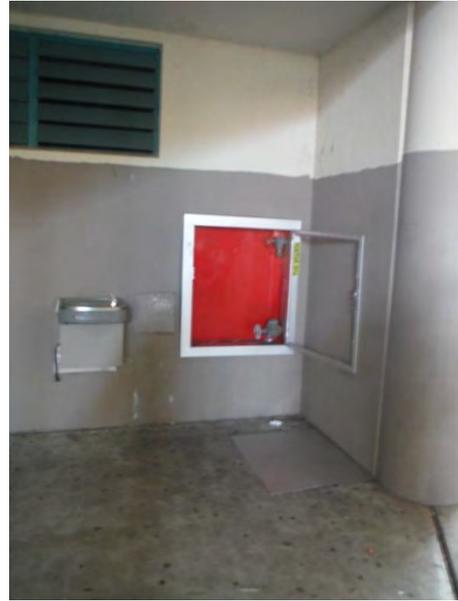
OIA Phase II found the fire pump, fire sprinkler and standpipe systems required service and repair. At the start of Phase III, no service and repair work had been completed for fire sprinkler and standpipe systems. These pose safety hazards to the occupants. Fire pump, fire sprinkler and standpipe systems should be serviced and repaired.

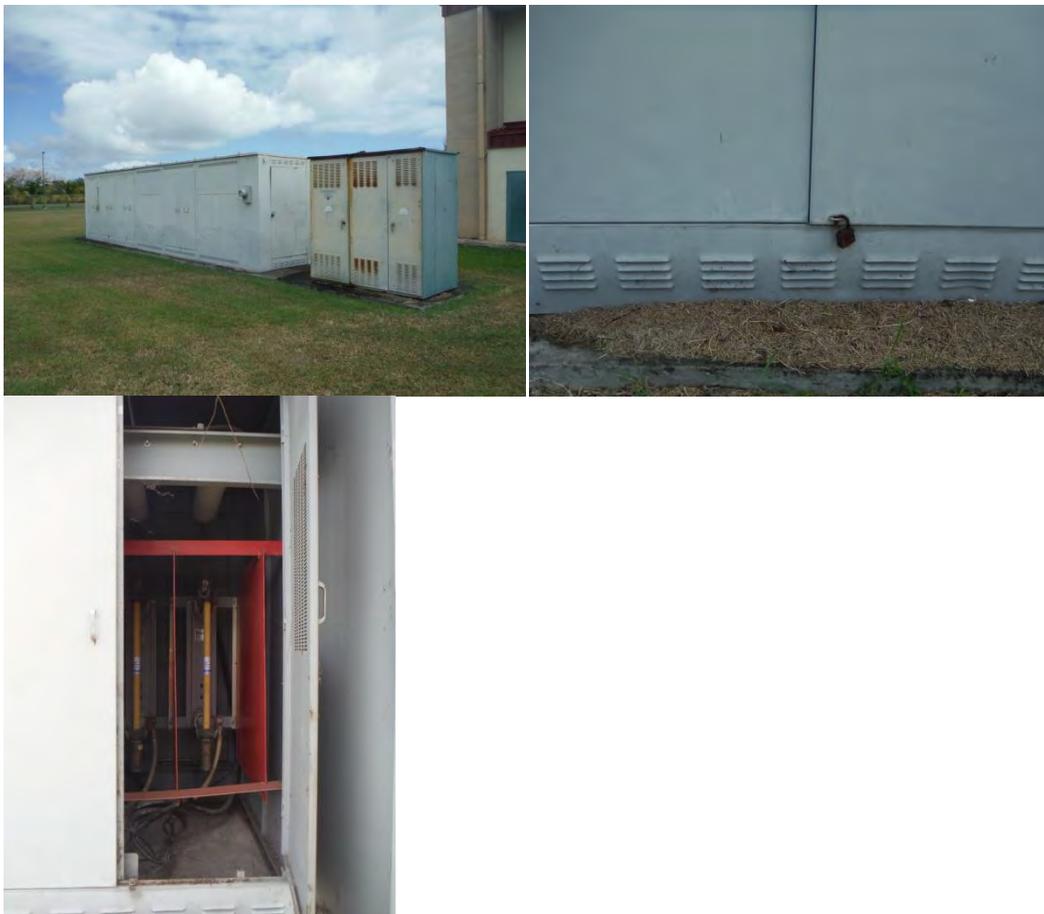
Main distribution equipment located outdoors in outdoor enclosures are in satisfactory condition. However, equipment enclosures were not locked exposing live electrical parts if opened.

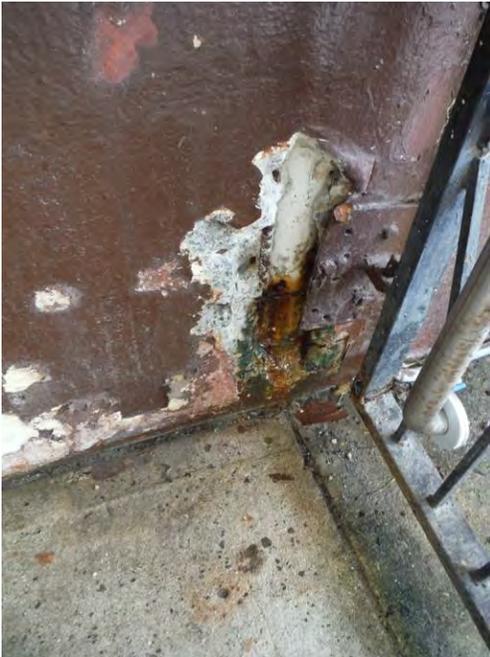
At the time of the initial Phase III site visit, the encased down spout was leaking and needed repair.

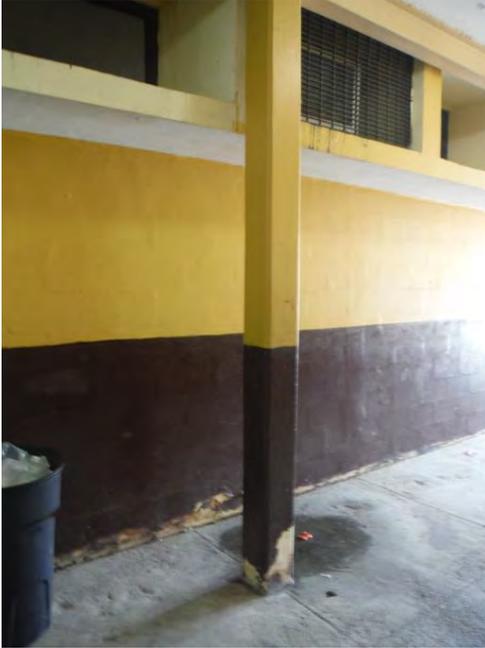
Air conditioners' condensate drains discharged or dripped to the walkway. These are creating slipping hazards as well as damaging the walkway surface. Condensate drain should be piped and discharged to proper location, such as waste line or dry well.

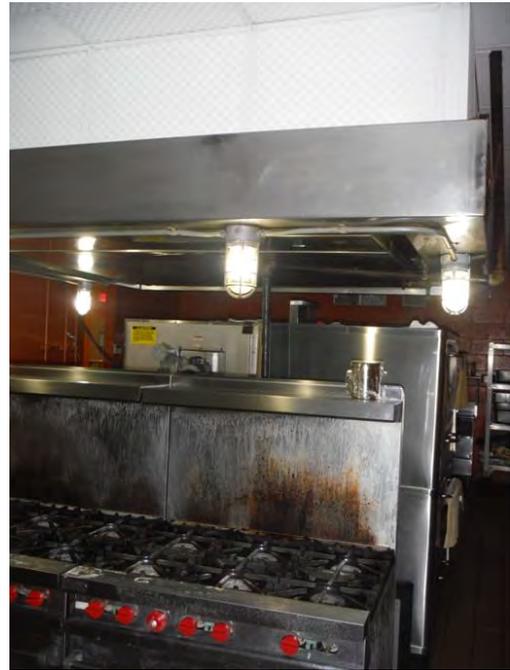
OIA Phase II found that the kitchen hood lacks a fire suppression system. At the start of Phase III, kitchen was being upgraded with new appliances under VIEO's Energy Saving Performance Contract (ESPC). Kitchen hood fire suppression system was not included in the ESPC scope. Lack of fire suppression to the kitchen hood is a fire safety hazard. We recommend including the kitchen hood fire suppression system in the upcoming ESPC.

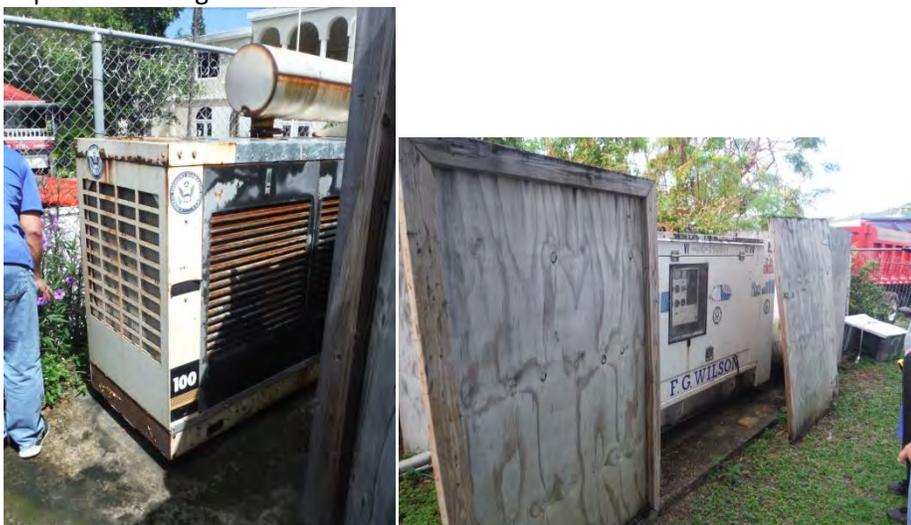
A 100kW FEMA generator is located at main campus. A 72kW FEMA generator is located at the annex building. Both generators are in fair condition but the 72kW generator doesn't start and requires servicing.

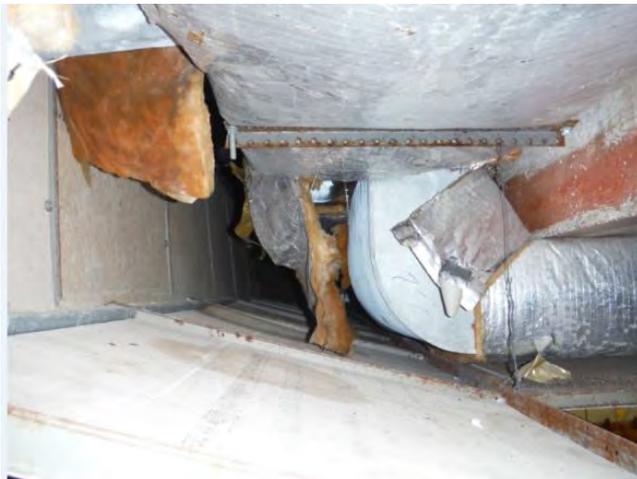
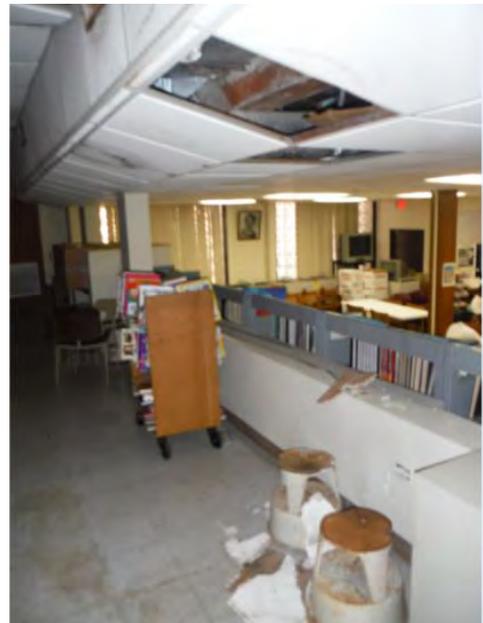
Roof leaks damaged insulation of air ducts. Subsequently, condensation occurred on air ducts and aggravated ceiling damage and high indoor humidity issues.

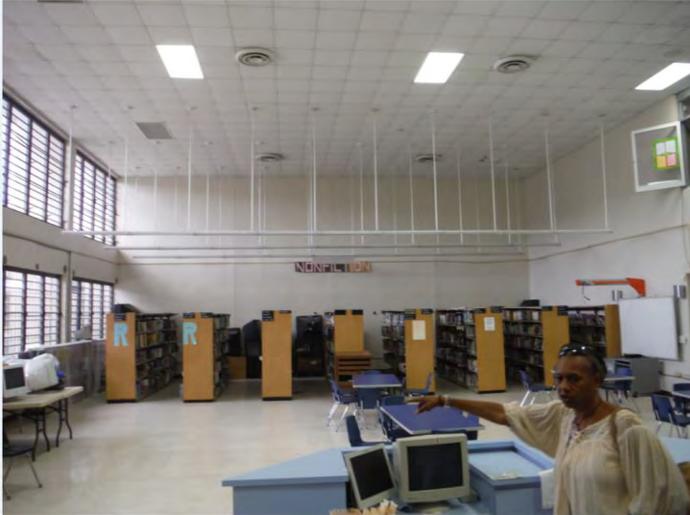
Location: E. Christian JH Building 02, Classrooms & Library

Air conditioners were broken at Library. Library was closed due to high room temperature and humidity.

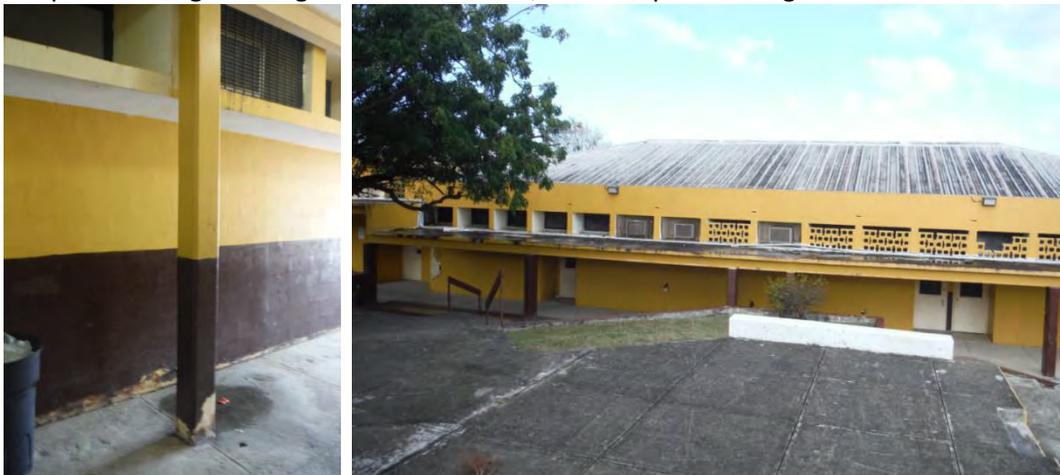
Condensate drains discharged to sidewalks and overhung eaves. They caused slipping hazards and promote vegetation growth at the eaves, which impact roofing.

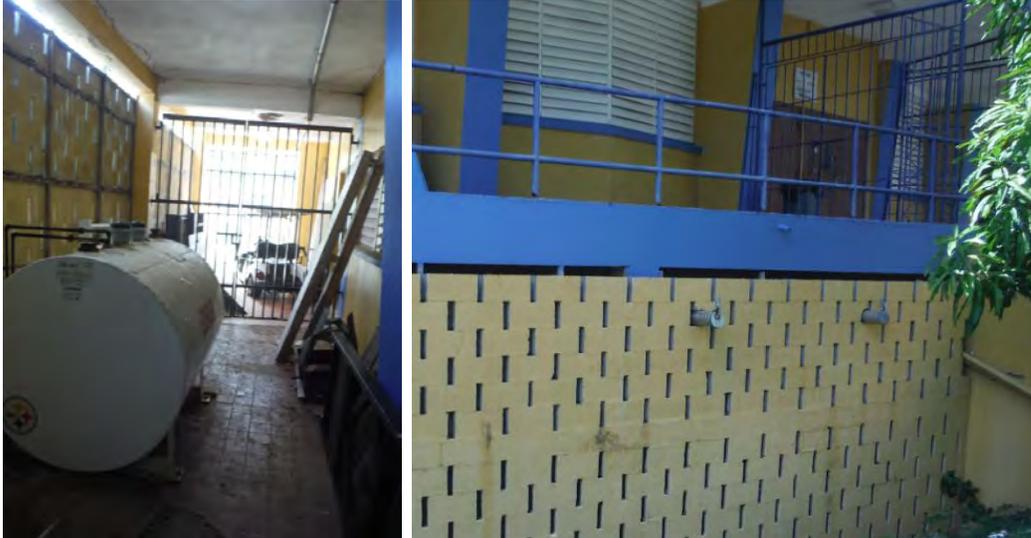
Normal vent and emergency vents of aboveground fuel tank were not piped to outside per IFC requirements. Generator engine exhausts terminated by the sidewalk did not comply with IMC and IFC, and posted safety and health hazard to occupants.

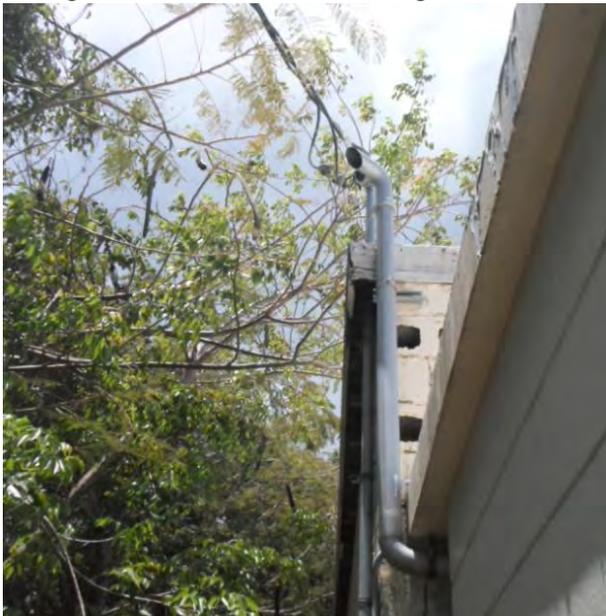
Location: Claude O. Markoe ES Building 2, Storage

Engine exhaust discharged underneath of the utilities cables. Hot engine exhaust fume could damage the cable insulation causing hazards.

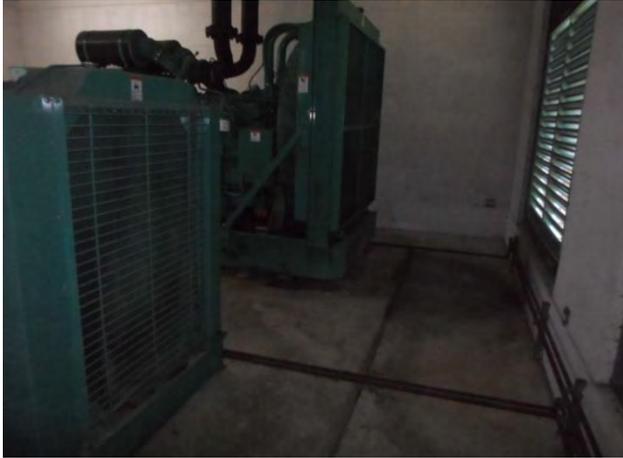
Location: St. Croix Education Complex Building 4, Agriculture / Green House.
Radiator exhausts were not connected to exhaust louvers. Hot air could not leave the room and recirculate to radiator causing generator overheat and operation problem.

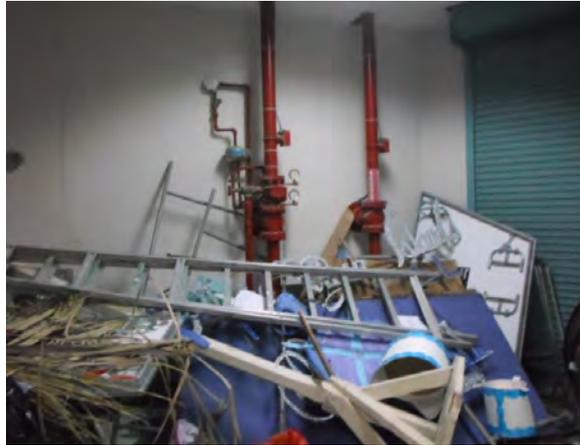
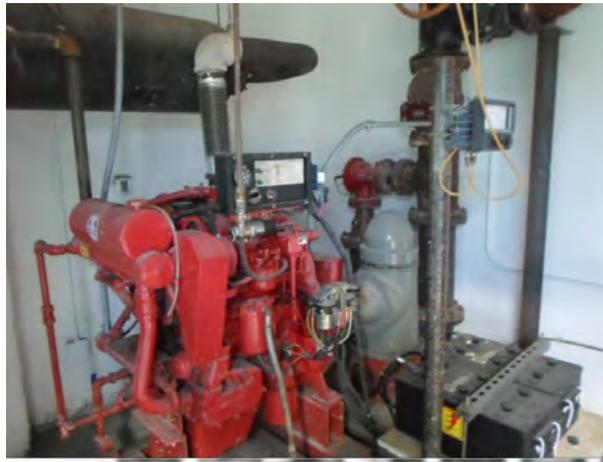
Wet based fire protection systems including fire sprinkler, standpipe and fire pump were not maintained and tested in accordance with NFPA standards. Fire hoses were missing at fire hose cabinets. Sprinkler risers were obstructed by combustibles materials. Flow test header and fire pump were not maintained and tested. Fire protection systems are fire and life safety systems to protect the occupants and the properties. They should be maintained and serviced regularly to ensure their functions and performance. They should be repaired as soon as impairment is required.

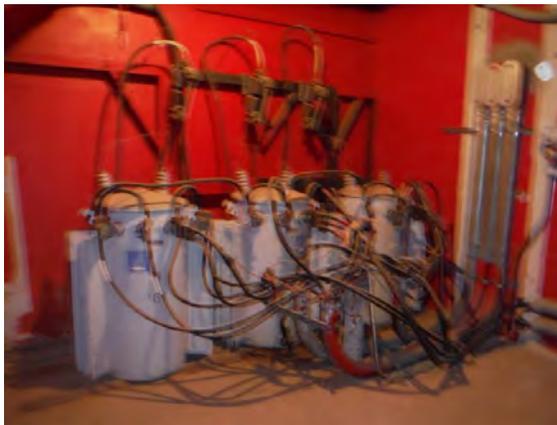
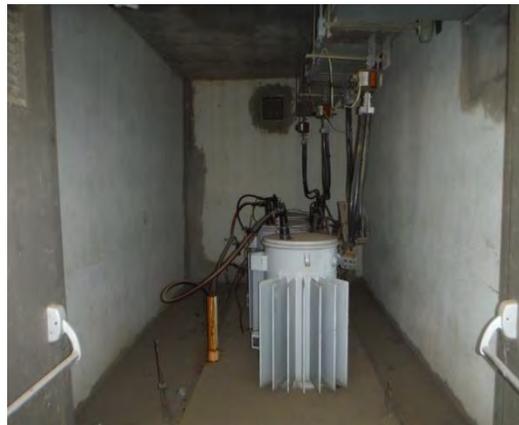
Location: Charlotte Amalie High School and E. Benjamin Oliver Elementary School

Existing transformers are located in a room that is not rated for use as a transformer vault.
