REPAIR & MAINTENANCE

UPDATE

ABCs Implementation Progress

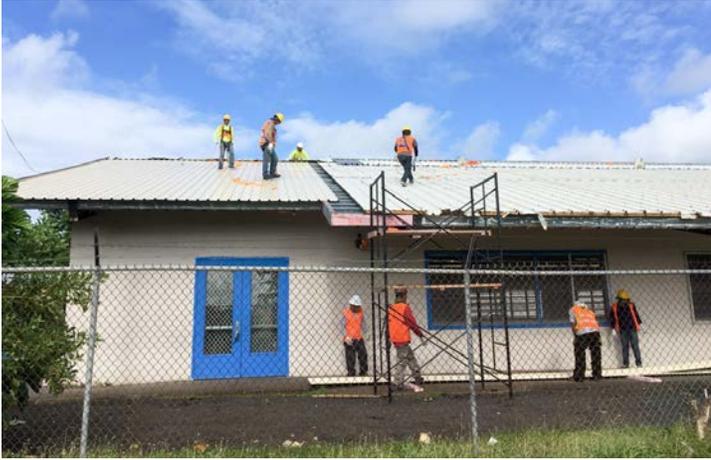
A new preformed metal roof is installed at Tafuna Elementary

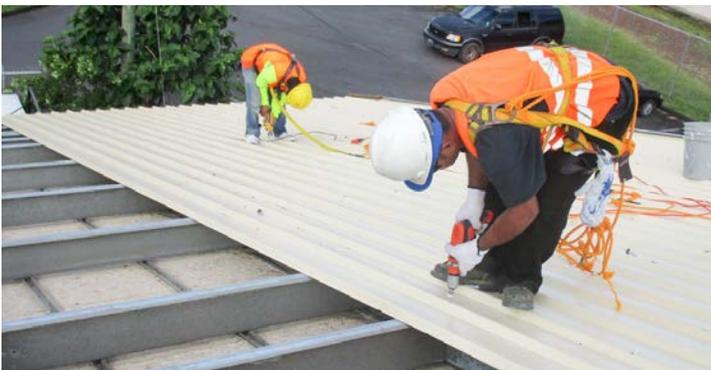
Workers from local contractor Global Tech Limited install new roofing on the cafeteria of Tafuna Elementary School

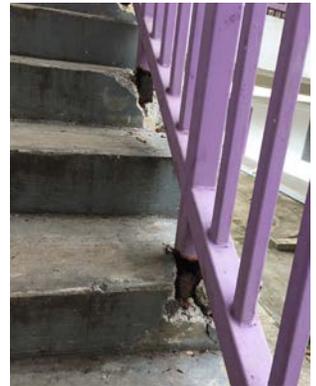
Railing repairs are underway at Aua & Tafuna Elementary

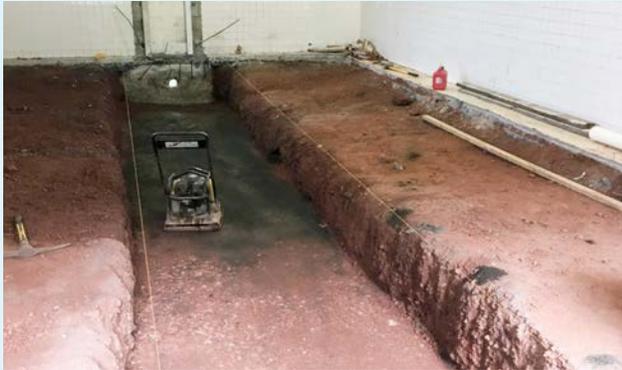
A new foundation and flooring is prepped at Matafao Elementary

Projects have been completed at nine different schools to renovate restrooms with new fixtures, plumbing and flooring. Work at Matatula Elementary is in progress with work at more schools planned for the future.

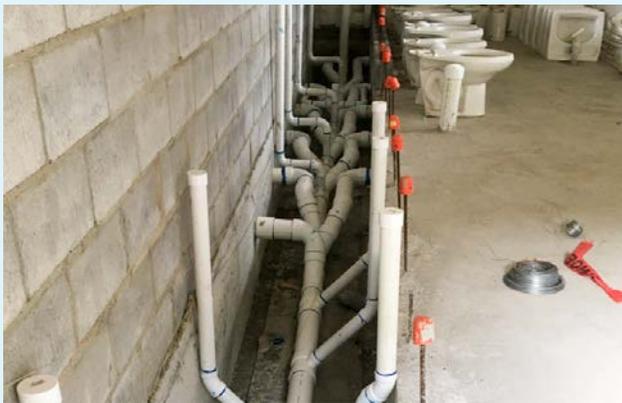
New concrete wall, plumbing and fixtures are being installed at Matafao Elementary

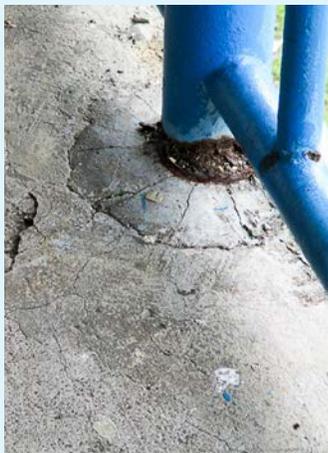
Second story verandah railings are being replaced at Tafuna Elementary School to improve student safety (photos below). The steel anchors in the concrete were rusted beyond repair and needed to be replaced. Work also included replacing the entire walkway with reinforced concrete. The underlying rebar will make the concrete more durable and crack resistant.

Above, left: Rusted railings are being replaced. Second from left: Existing concrete has cracks and spalling. Third from left: New rebar is laid to support new concrete flooring. Top, right: A crew from E&W Construction pours new concrete.
