REPAIR & MAINTENANCE

UPDATE

ABCs Implementation Progress

The Assessment of Buildings and Classrooms (ABCs) initiative is a partnership between the US Department of Interior's Office of Insular Affairs (OIA) and CNMI. The US Army Corps of Engineers manages the ABCs program through its Contractor, HHF Planners.

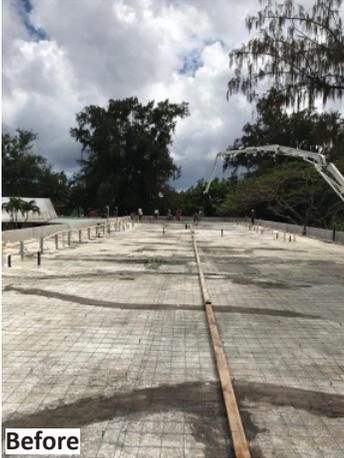
Before

BEFORE: Francisco Mendiola Sablan Middle School's (formerly San Antonio MS) roof lacked adequate slope and retained pockets of ponding water. Wire mesh and a thin concrete topping were added to create positive drainage. Contractors worked into the evening to cover the entire roof in a single pour.

To repair delaminating roofing, adhesion tests are used to help select the proper materials. Proper bonding to the roof substrate extends the durability of repairs and reduces the chance of future delamination. When concrete roofs are not properly sloped, the ABCs program corrects this deficiency before applying a new roof coating (see photos, above).

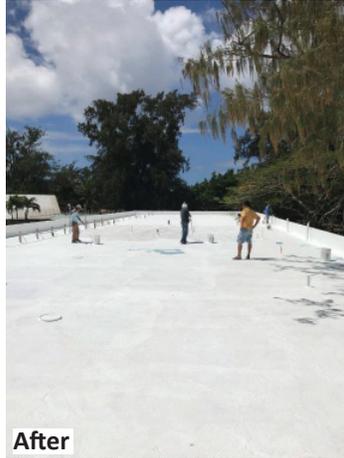
After

AFTER: The new sloped surface was primed and coated with a new fluid-applied roofing. Roof drain inlets were cleaned and new drains added at the perimeter.

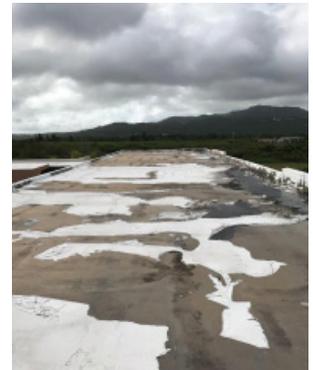
Roofing failure due to membrane delamination.

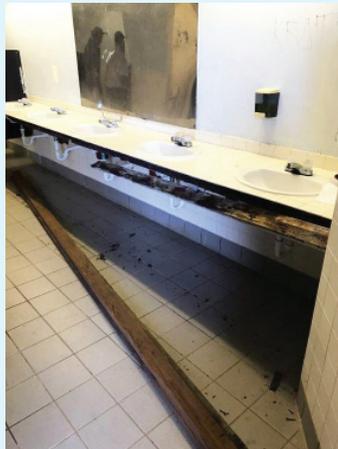
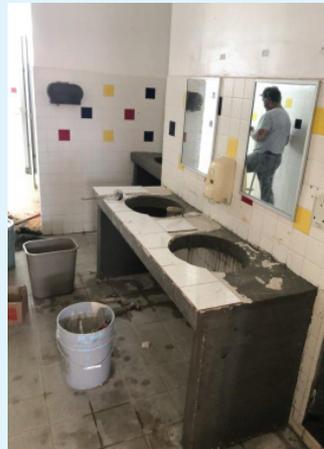
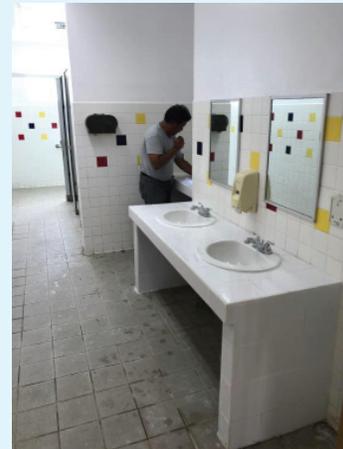
To improve durability and reduce student damage, wood lavatory countertops are being recast in concrete (photos below). The counters are built using formed concrete with steel reinforcing. The work is finished with tile to provide a clean, non-absorbent finish that matches adjacent surfaces. The result should be more resistant to damage and hopefully student-proof. These countertops will last longer and require less maintenance than wood.

Above, left: Wood countertops are being replaced with more durable materials (steel-reinforced, cast-in-place concrete). Above, right: Concrete lavatories with tile finish.

Repairs focused on refurbishment using durable assets. Wall hung fixtures (that had been separating from walls) are being replaced with ground-mounted fixtures. Wood countertops (subject to wood rot and termites) are being replaced with tiled, reinforced concrete countertops -- see "Durable Construction Details."
