Indoor Environmental Quality (IEQ) Handbook

December 2015

Accordingly, the focus of the Indoor Environmental Quality (IEQ) Insular ABCs' 2012-2013 assessment of school buildings, was to evaluate the condition of classroom learning facilities that have the biggest impact on student performance. Primary areas evaluated included:

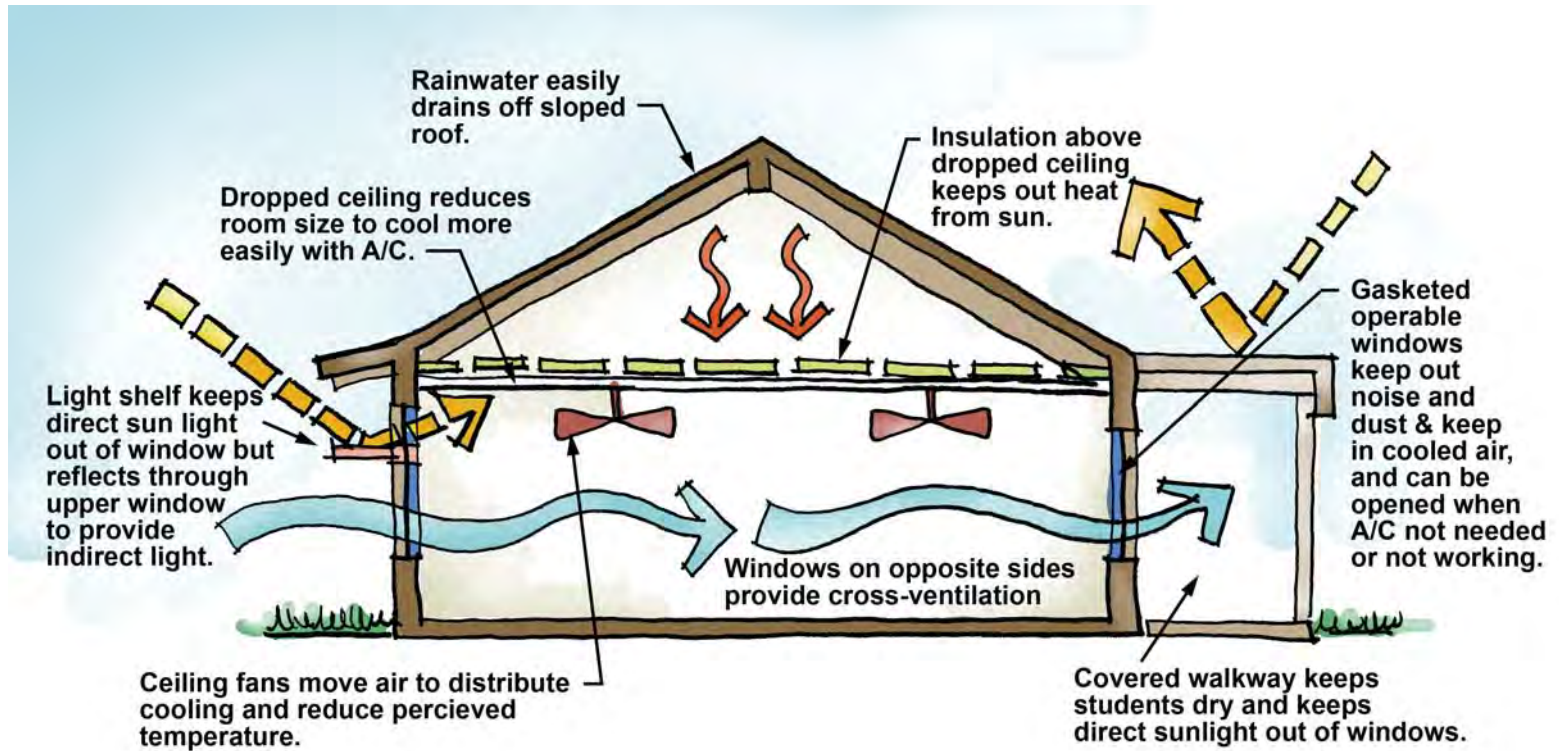
Figure 1: Design Considerations for Future Schools

The following bullet points summarize recommendations for creating optimal classroom spaces in new buildings:

- Buildings should have classroom spaces that are effective for air conditioning but would also be comfortable using natural ventilation.
- Designs should maximize indirect natural light (using fenestration and shading), while protecting the interior from direct sun.

- Buildings should be insulated to keep out heat and reduce noise transfer from outside and inside.
- Moisture from rain, drainage, plumbing and air conditioning should be properly controlled and directed away from the building.
- Buildings should be designed to withstand high winds and potential storms.
- Material choices should promote the extended life of building elements as well as ease of maintenance.
- Design and construction techniques that are appropriate for a tropical (hot-humid, coastal) environment may have higher initial costs, but will have a lower lifecycle facility cost by reducing ongoing operating and maintenance costs.

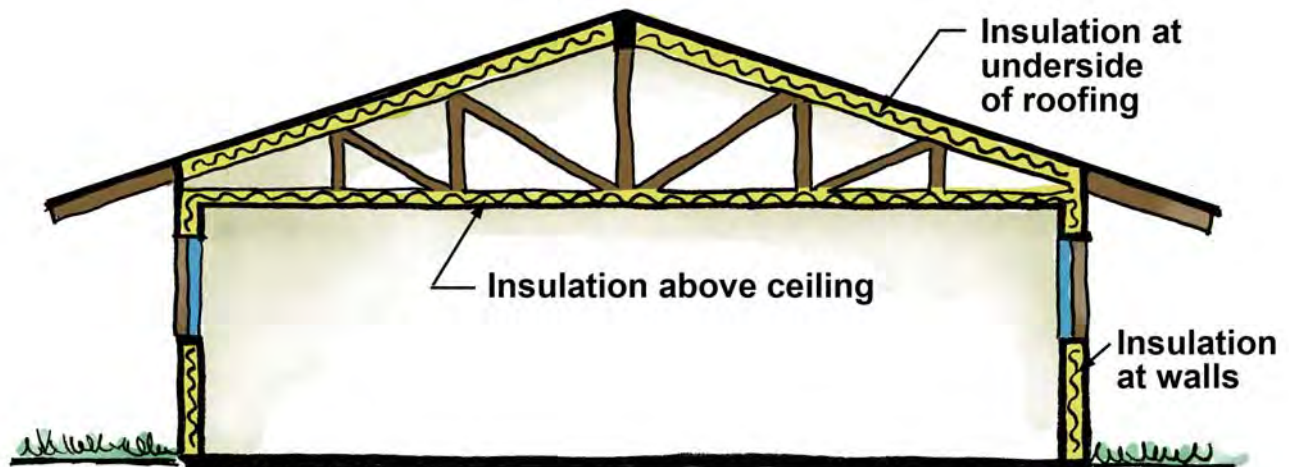
Figure 2: Building Insulation within the Exterior Envelope

Pros and Cons of 3 types of insulation

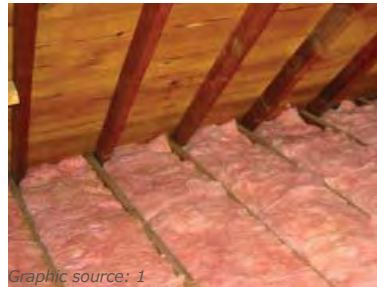
Graphic source: 1

Batt insulation in attic

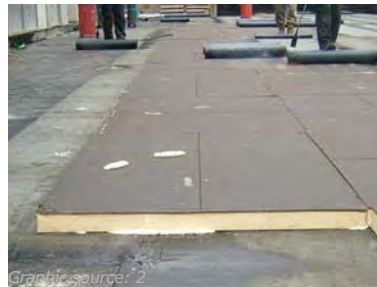
Graphic source: 2

Foam board insulation on roof

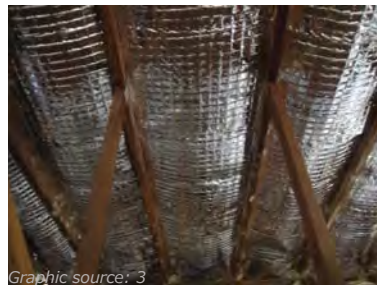
Graphic source: 3

Radiant barrier insulation draped between trusses

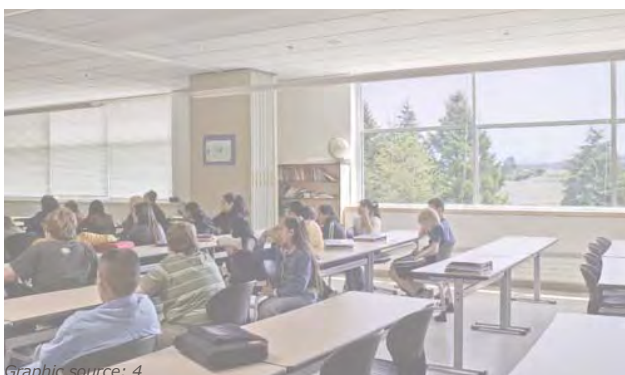
Graphic source: 4

Direct sun rays through wall openings can substantially increase the interior temperature (as well as create glare).

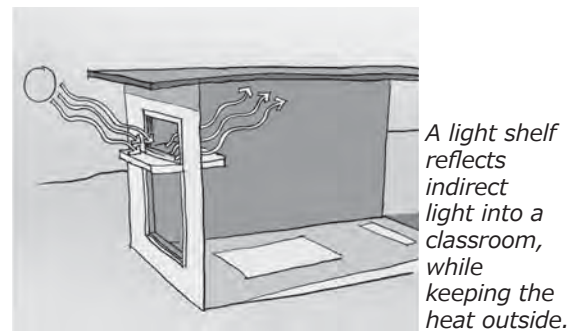
Figure 3: South-facing Window Shading

Variations of a standard horizontal overhang that provide shade and indirect daylight.

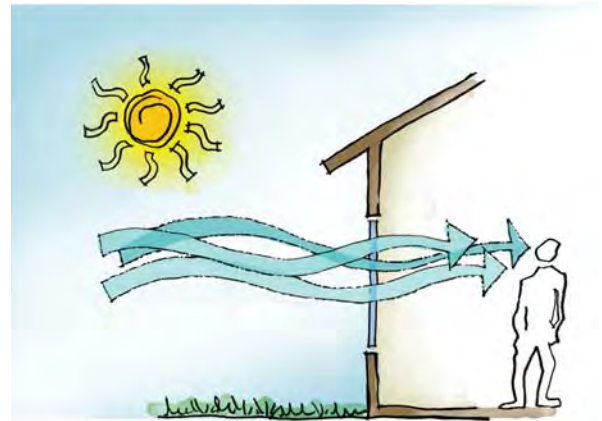
Figure 5: Unobstructed Window

Unobstructed window enhances air flow through the classroom.

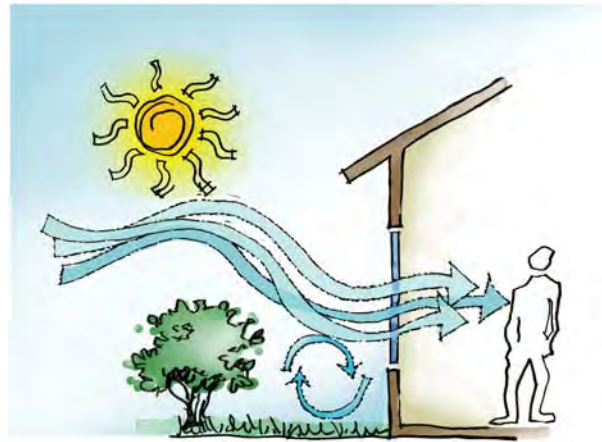
Figure 6: Low-Shrubs and Air Flow

Low shrubs planted outside (up to 20 feet away from the building) can also enhance air flow by creating downward deflections of air movement.

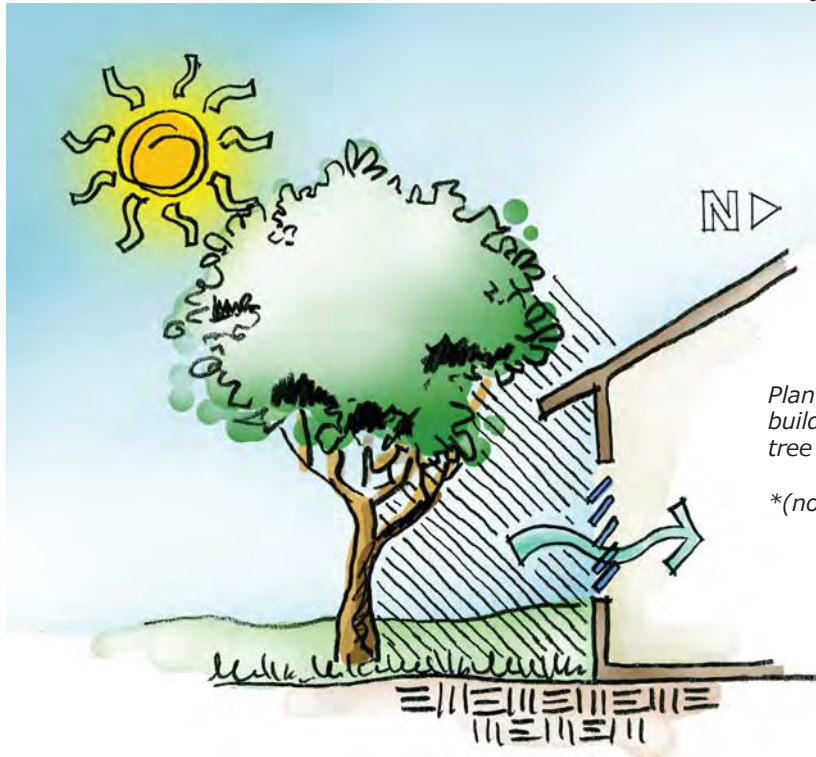
Figure 7: Canopy Trees and Air Flow

Plant tall canopy trees on the south* side of buildings to shade roofs and walls. Keeping the tree understory clear, promotes ventilation.

*(north side for American Samoa)

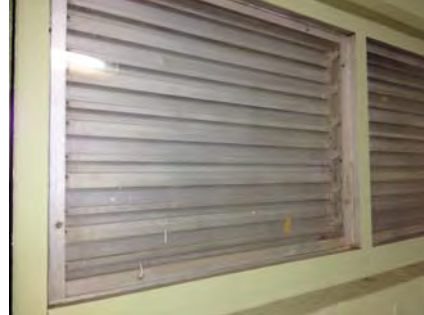
Plexiglass covering windows help retain cooled air but also eliminate the possibility of natural ventilation.

Some naturally ventilated buildings have already been converted into air-conditioned spaces. As a temporary solution, some classrooms installed plexiglass over louvered windows to prevent leakage of air-conditioned air.

However, if the air-conditioning breaks down or is turned off, students will not have access to fresh air or natural ventilation. Ideally, windows in air-conditioned classroom should be gasketed to reduce air leaks, but also be openable.

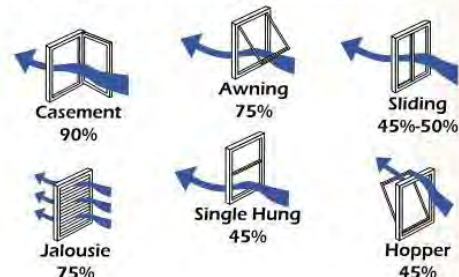
Graphic source: 6

Openable area as a percentage of window area

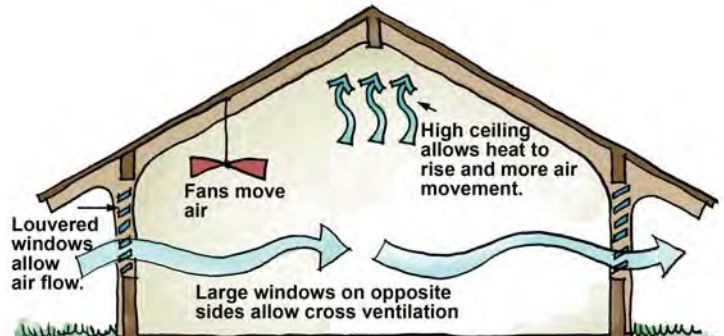
Figure 9: Naturally Ventilated Rooms

Classrooms designed for natural ventilation have high ceilings and many large window openings.

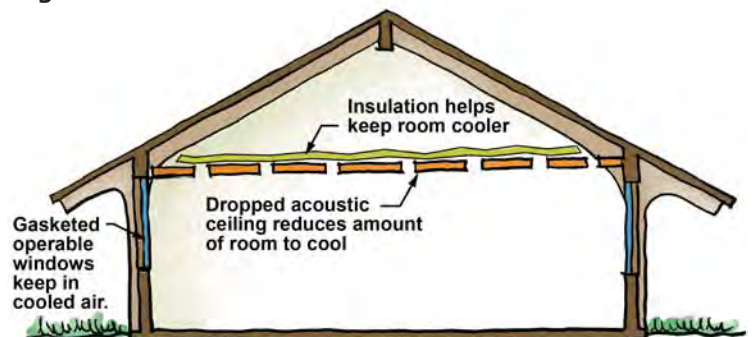
Figure 10: Air-Conditioned Rooms

Classrooms designed for air conditioning have suspended ceilings and gasketed windows.

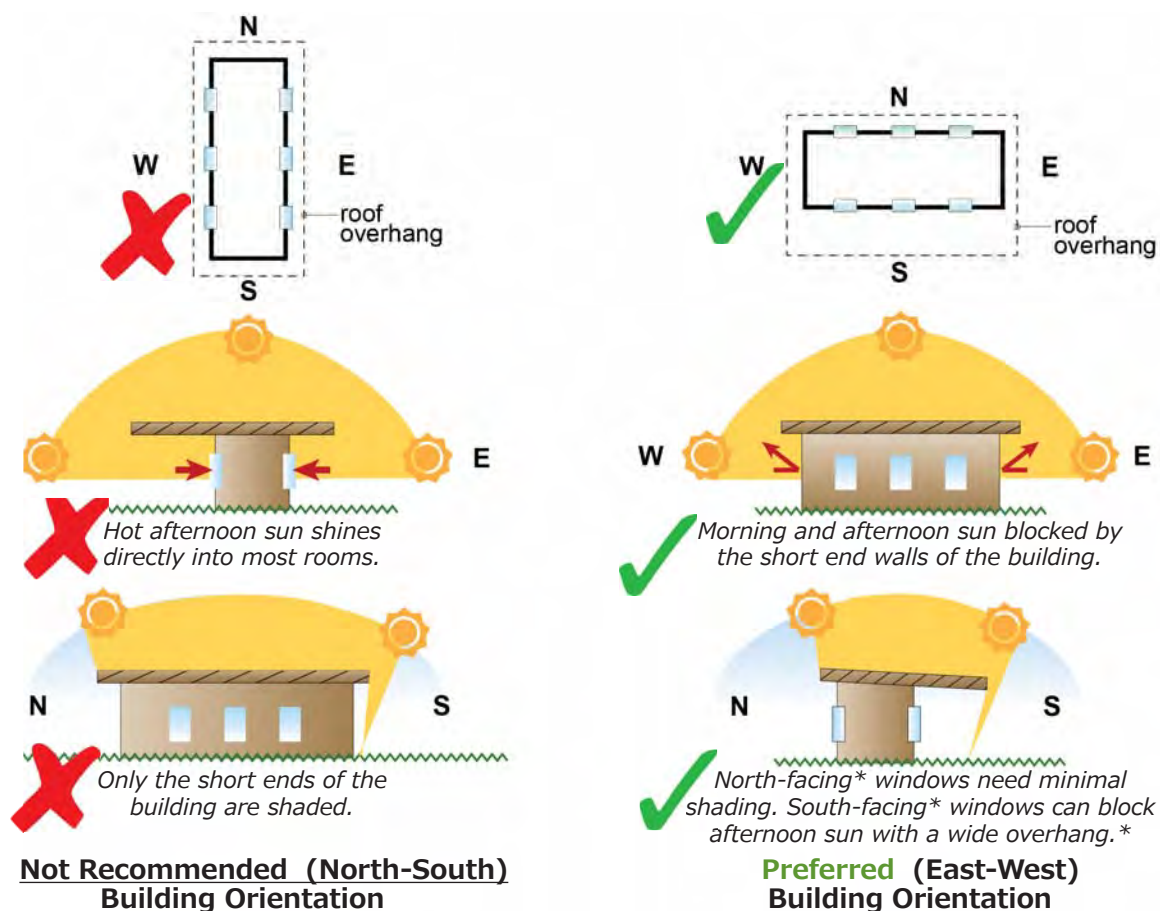
Figure 11: Building Orientation and Solar Exposure

**For American Samoa, it's reversed: north-facing windows need a wide overhang; the south side does not.*

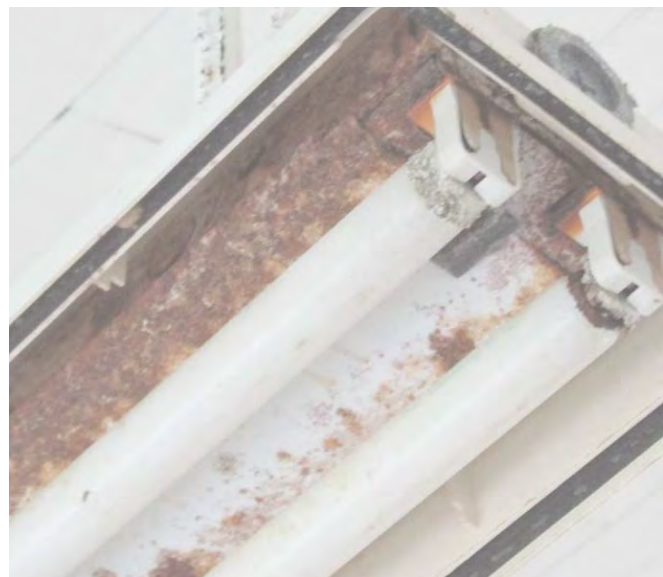
Corroded light fixture; missing light cover.

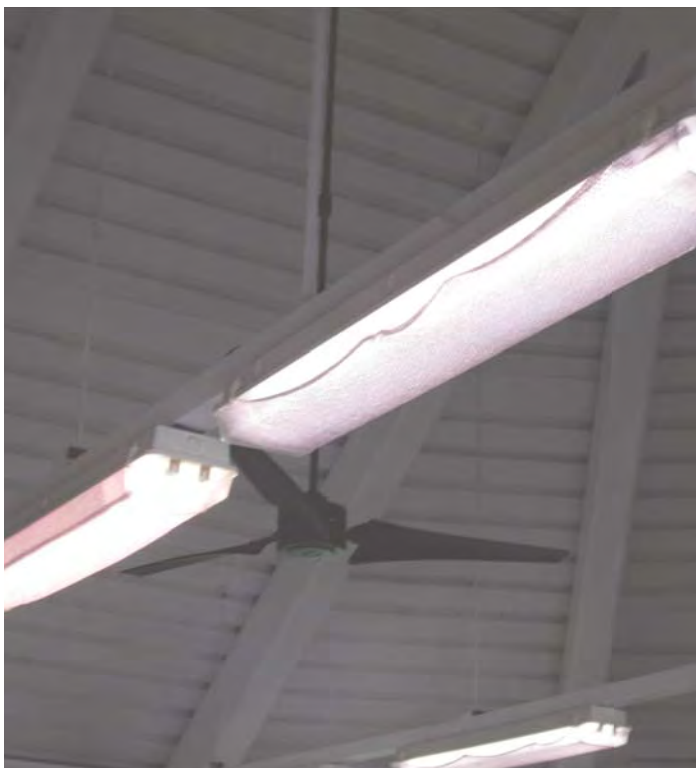
Above: Users wrap fabric around lighting because the room feels too bright and hot. Instead, differential light controls would allow users to turn off or dim a portion of the lights.

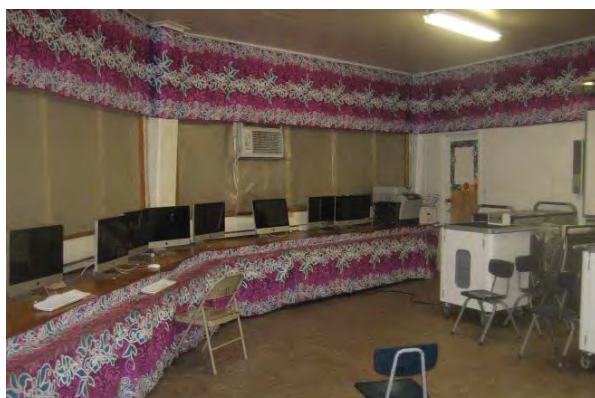
Photos: Classrooms have different reasons for blocking windows. **Left:** Windows blocked to reduce glare and reduce air-conditioned air leakage. **Right:** Windows blocked to reduce glare but also blocks natural ventilation. **Far Right:** As a temporary solution, clear plastic is used to reduce air-conditioned air leakage while allowing flexibility for natural daylighting.

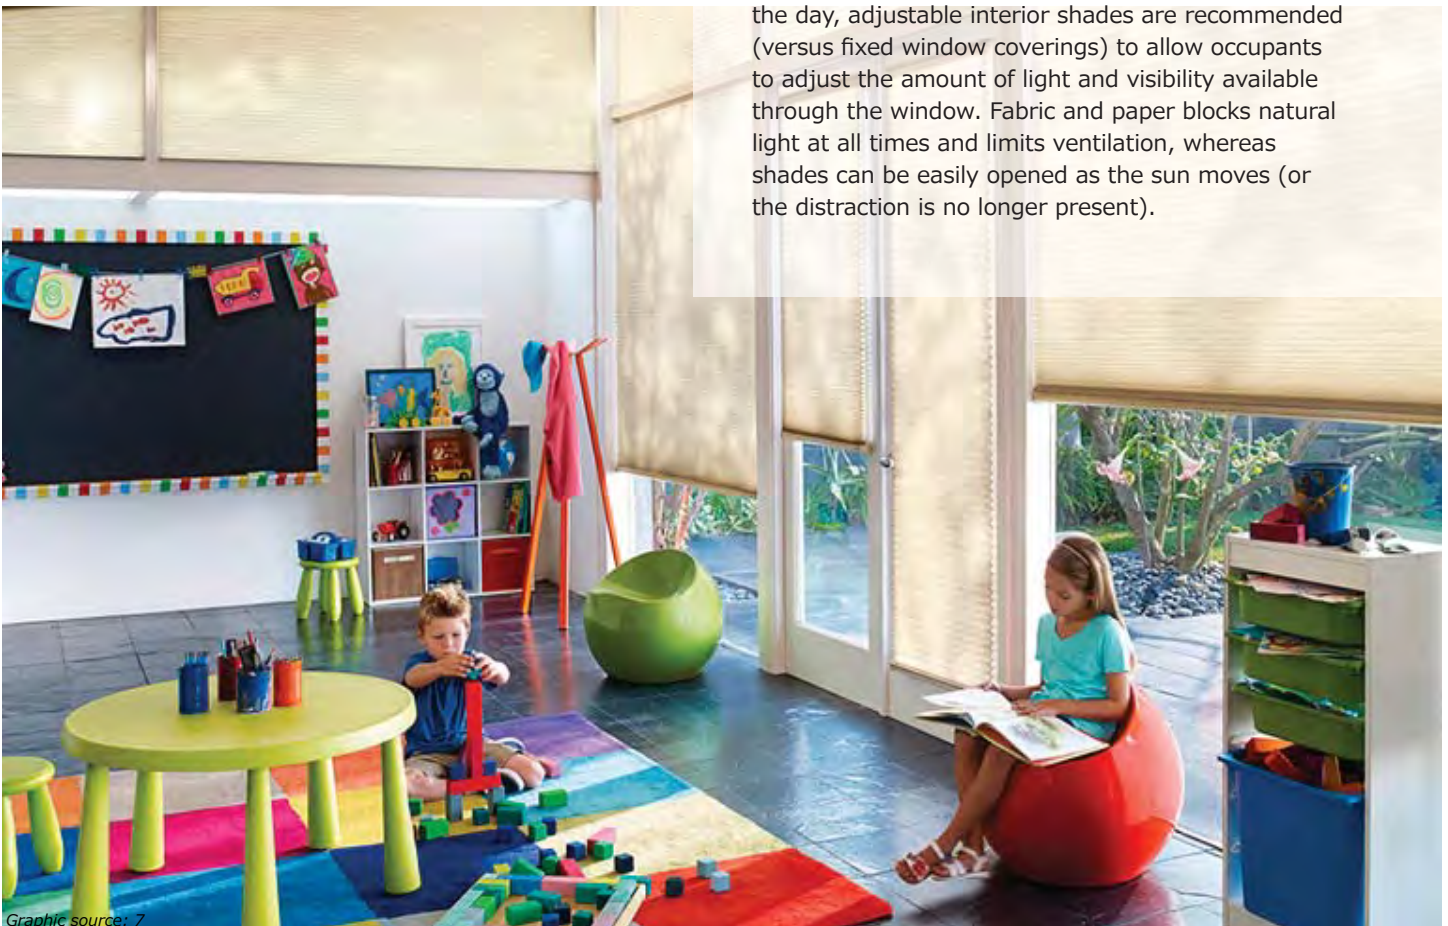
Graphic source: 7

If sunlight is directly entering the room during part of the day, adjustable interior shades are recommended (versus fixed window coverings) to allow occupants to adjust the amount of light and visibility available through the window. Fabric and paper blocks natural light at all times and limits ventilation, whereas shades can be easily opened as the sun moves (or the distraction is no longer present).

Window shades allow users greater control over the amount of daylight in the learning environment.

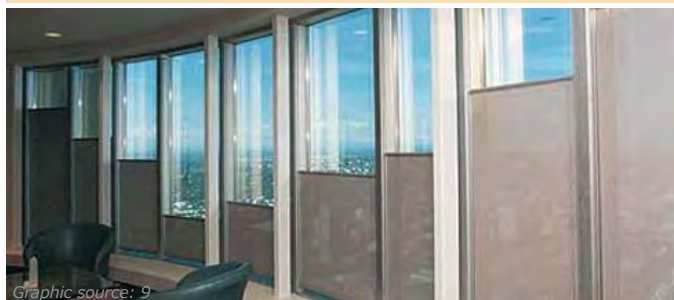
Graphic source: 9

Bottom-up shades allow natural light while blocking undesirable views at the bottom.

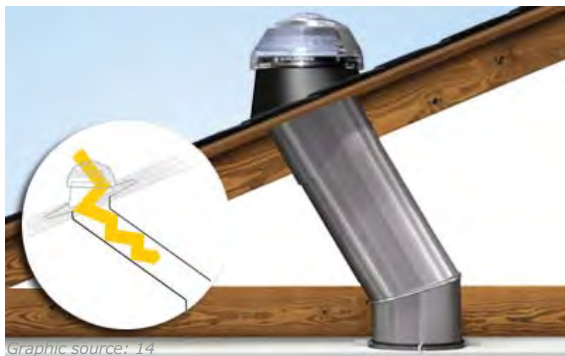
Graphic source: 14

For interior spaces that do not have adequate access to natural light or ventilation, adding skylights or clerestory windows can provide supplemental natural light and possibly ventilation. Solar access tubes in particular, include a reflective tube that can illuminate hard-to-reach spaces.

Solar light tubes are able to draw-in sunlight into hard to reach places

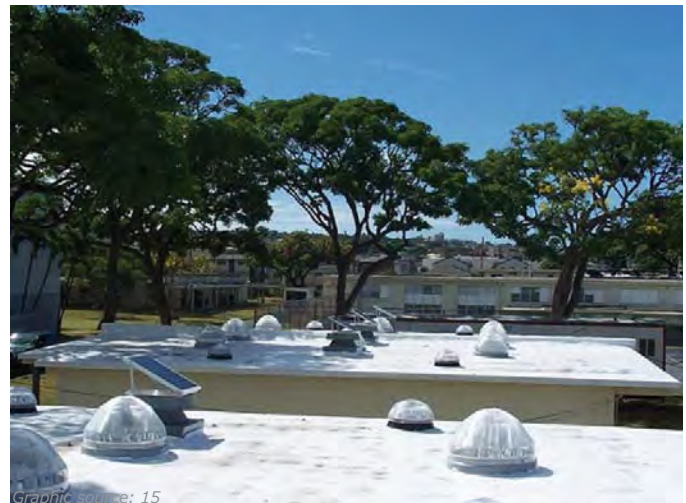
Graphic source: 15

As part of its strategy to reduce air-conditioning, the Hawaii state Dept. of Education is installing light tubes, solar vent fans, and white membrane roofs on classroom roofs. Tall canopy trees also help shade classroom buildings.

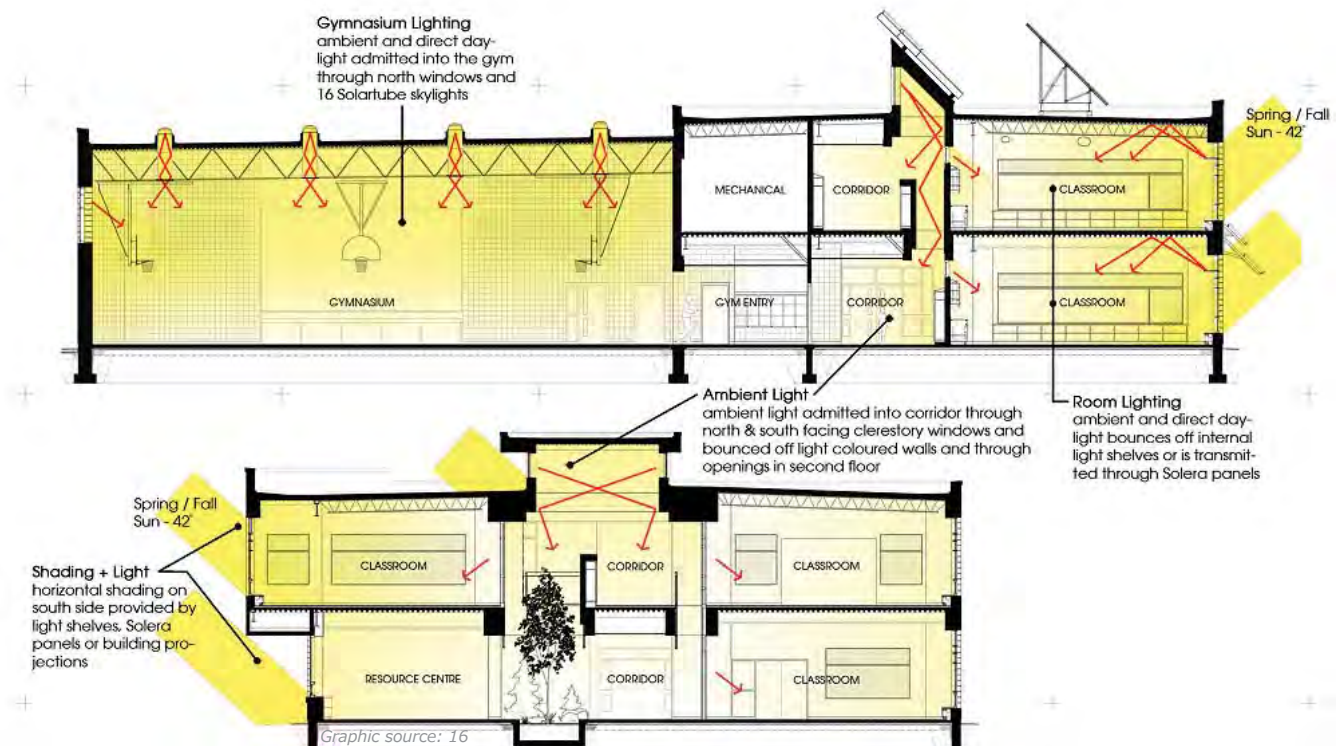
Building sections illustrate a variety of ways to extend (mostly indirect) daylight into interior spaces.

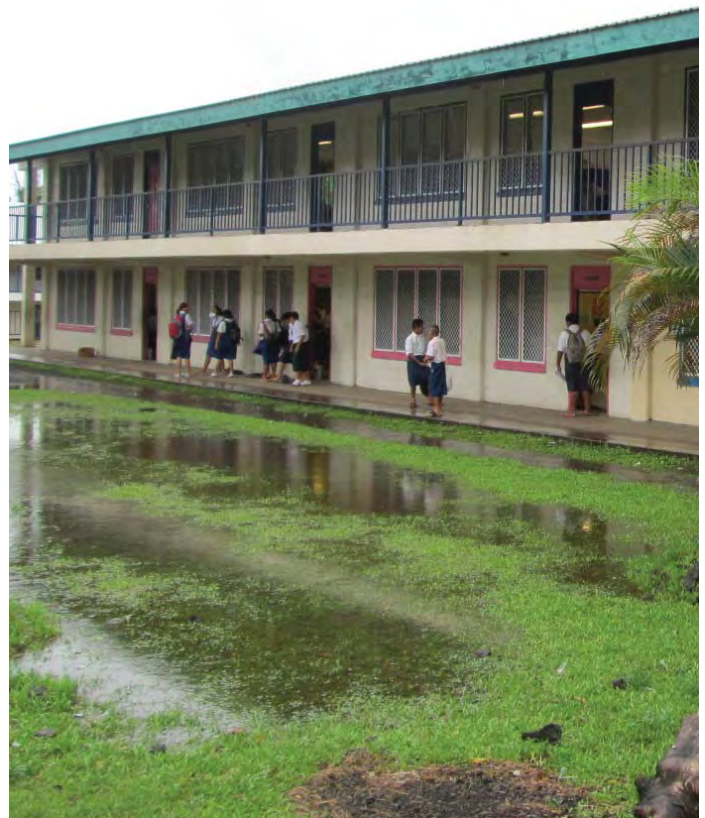
Poor site drainage stimulates mold growth within classrooms

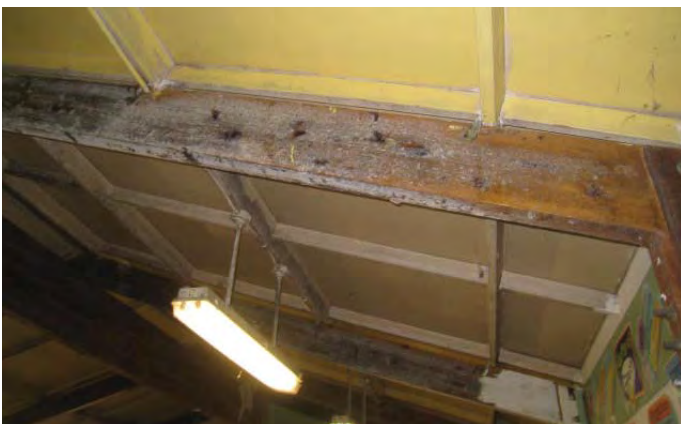
Mold on exposed roof framing

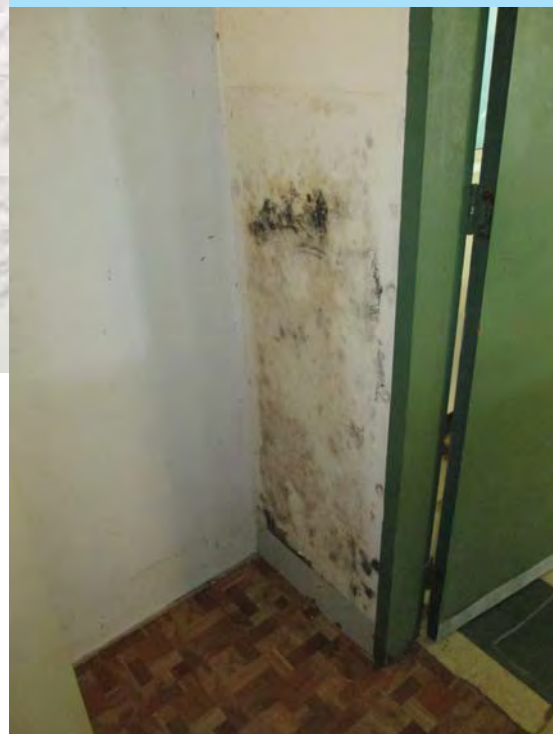
Left: Replace rusted AC grill. ***Middle:*** Clean dusty ceiling fans. ***Right:*** Replace ceiling panels that have mold ***Above:*** Remove mold on wall or replace wall board

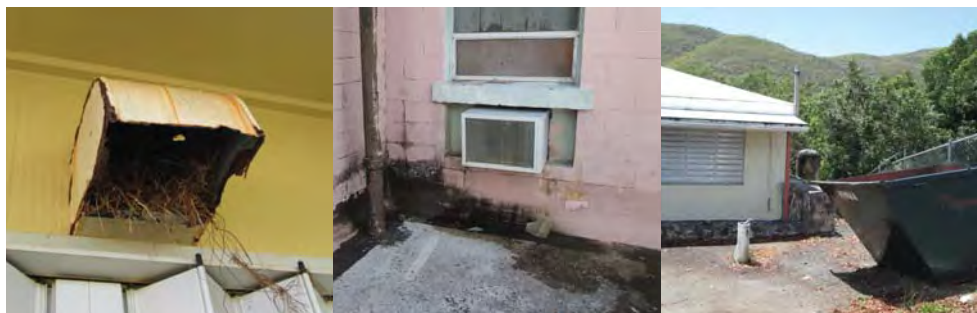
Left: Bird nest and debris in air vent. **Middle:** Mold growing near window AC. **Right:** Trash area next to a classroom window

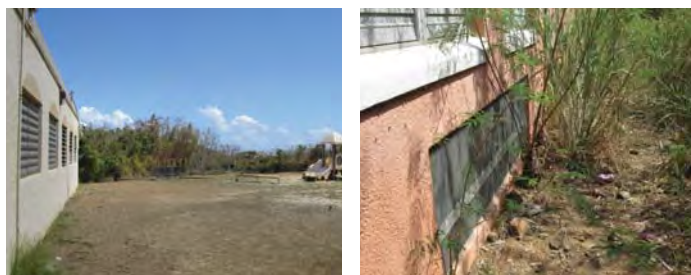
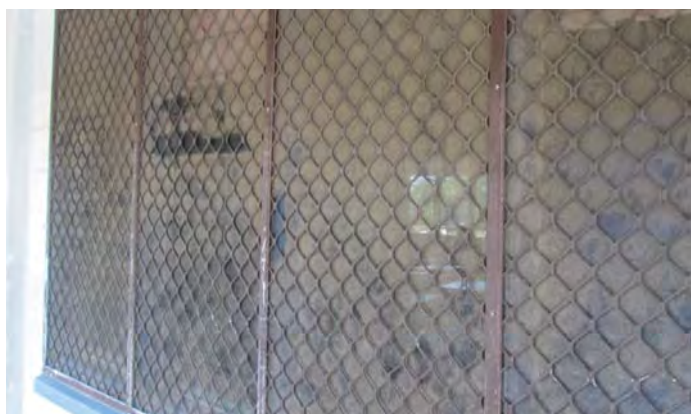
Clockwise from Left: No landscaping creates dusty yard outside classroom windows. **Right:** Plants and dust near air vent. **Bottom:** Window screen collects dirt and mold; needs routine cleaning

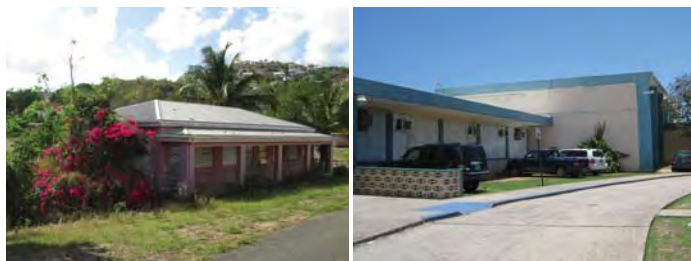
Left: Overgrown landscaping can damage structure, trap moisture, and allow pests to enter. **Right:** Parking too close to classroom windows and AC.

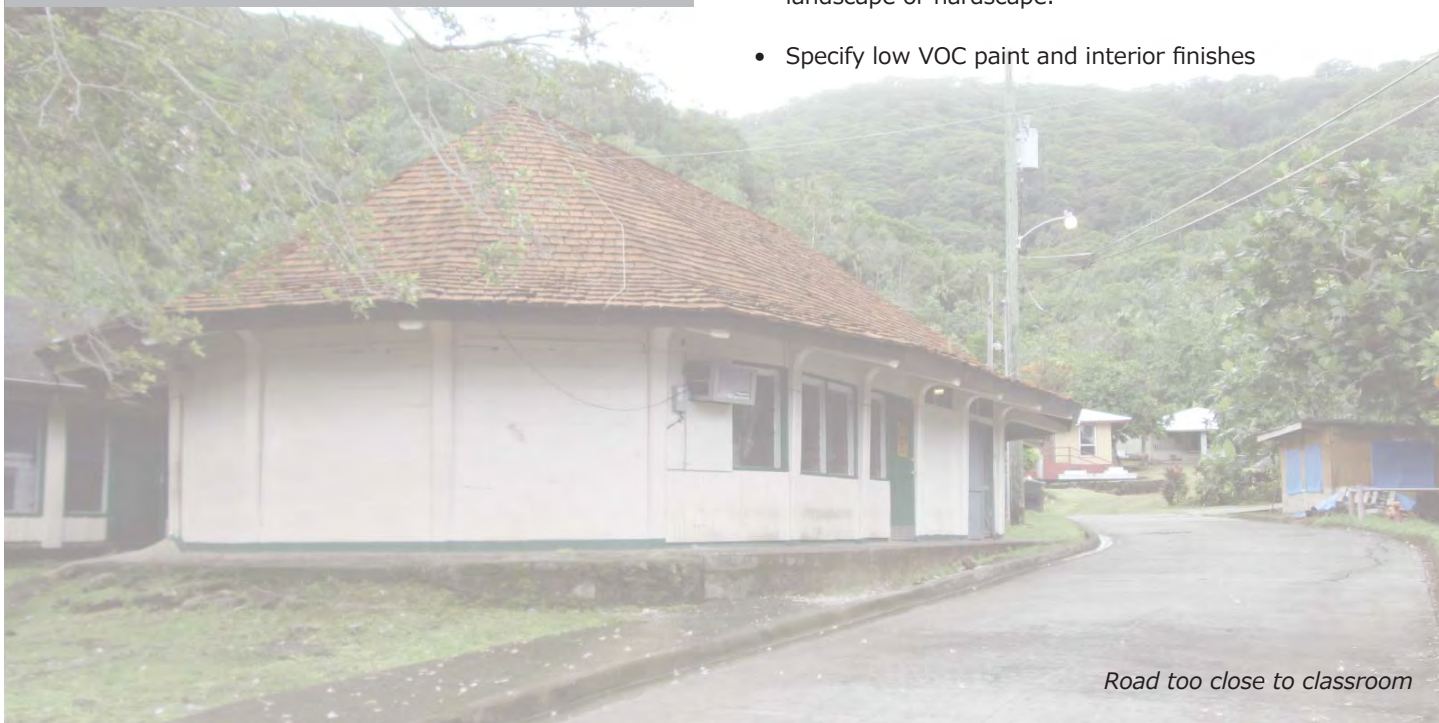
Road too close to classroom

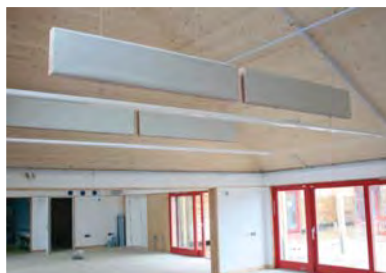
Graphic source: 17

Above: Acoustic tile ceilings help to reduce noise in the classroom.

Right: Ceiling baffles help reduce sound transmission in high ceiling, open plan rooms.

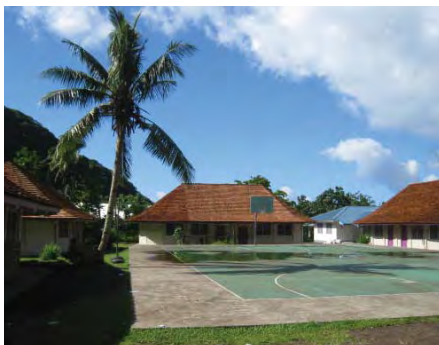
Sport courts should be sited away from classrooms, or schedule use times around class time.

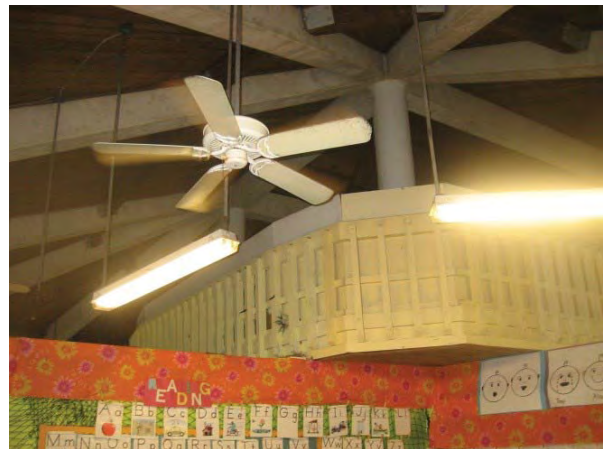
Noise travels between classrooms because the building does not have full-height partition walls.

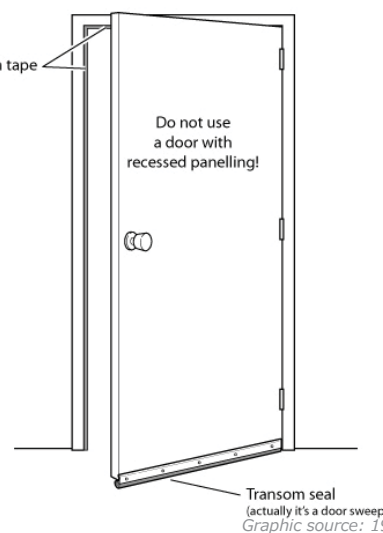
Top: Insulating interior walls helps to reduce noise transfer between rooms. **Center and bottom:** Gasketed solid core doors reduce noise transfer.

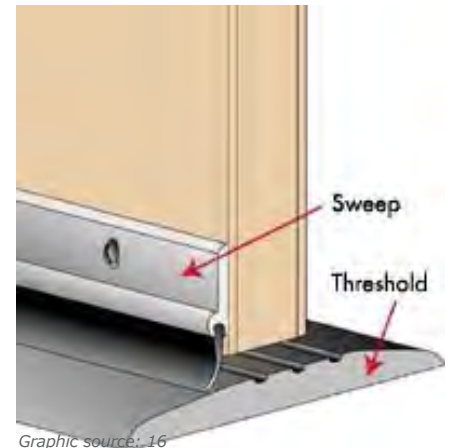
Graphic source: 16

Right: Door sweeps can help prevent pests from entering classrooms by sealing the space below exterior doors.
Bottom: Once pests are in the attic they can enter classrooms through the ceiling.

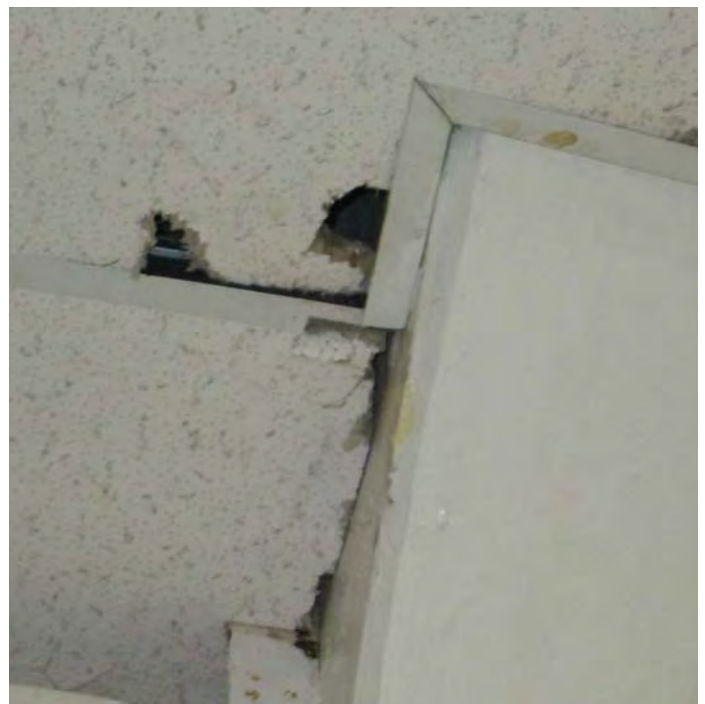
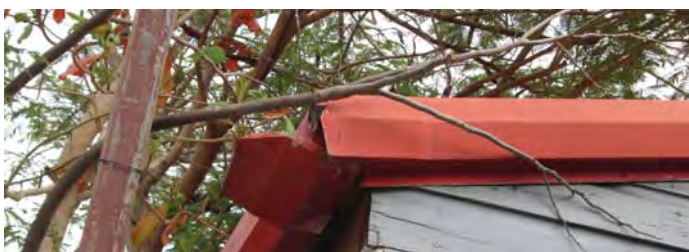
Iguanas and other pests enter classroom attics through holes created by damaged flashing.

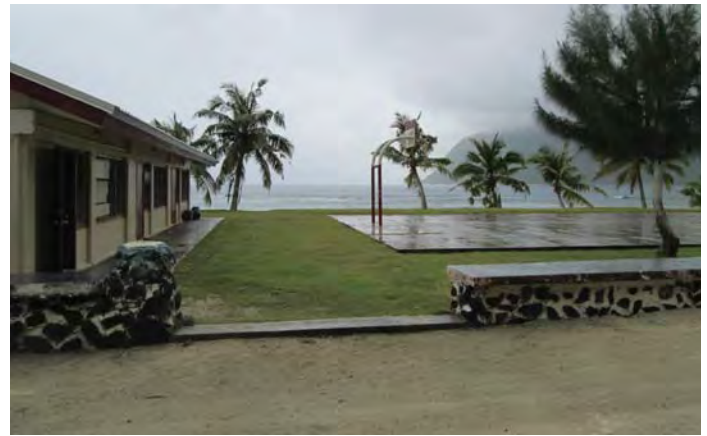
Harsh environmental conditions typical at school

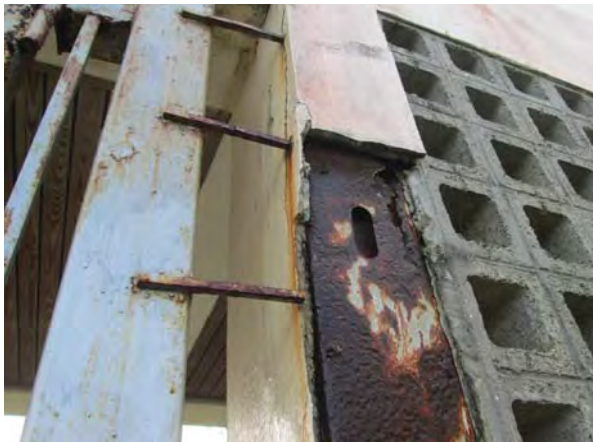
Corrosion of steel column by marine environment.

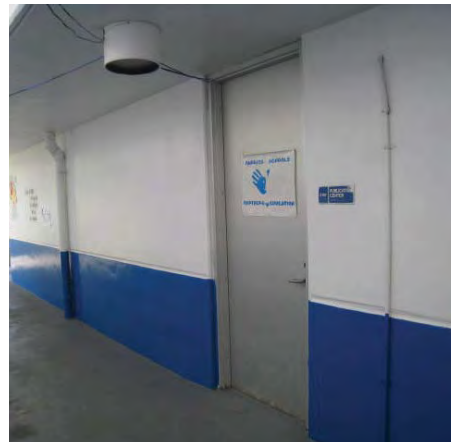
Unpainted aluminum door resists corrosion well.

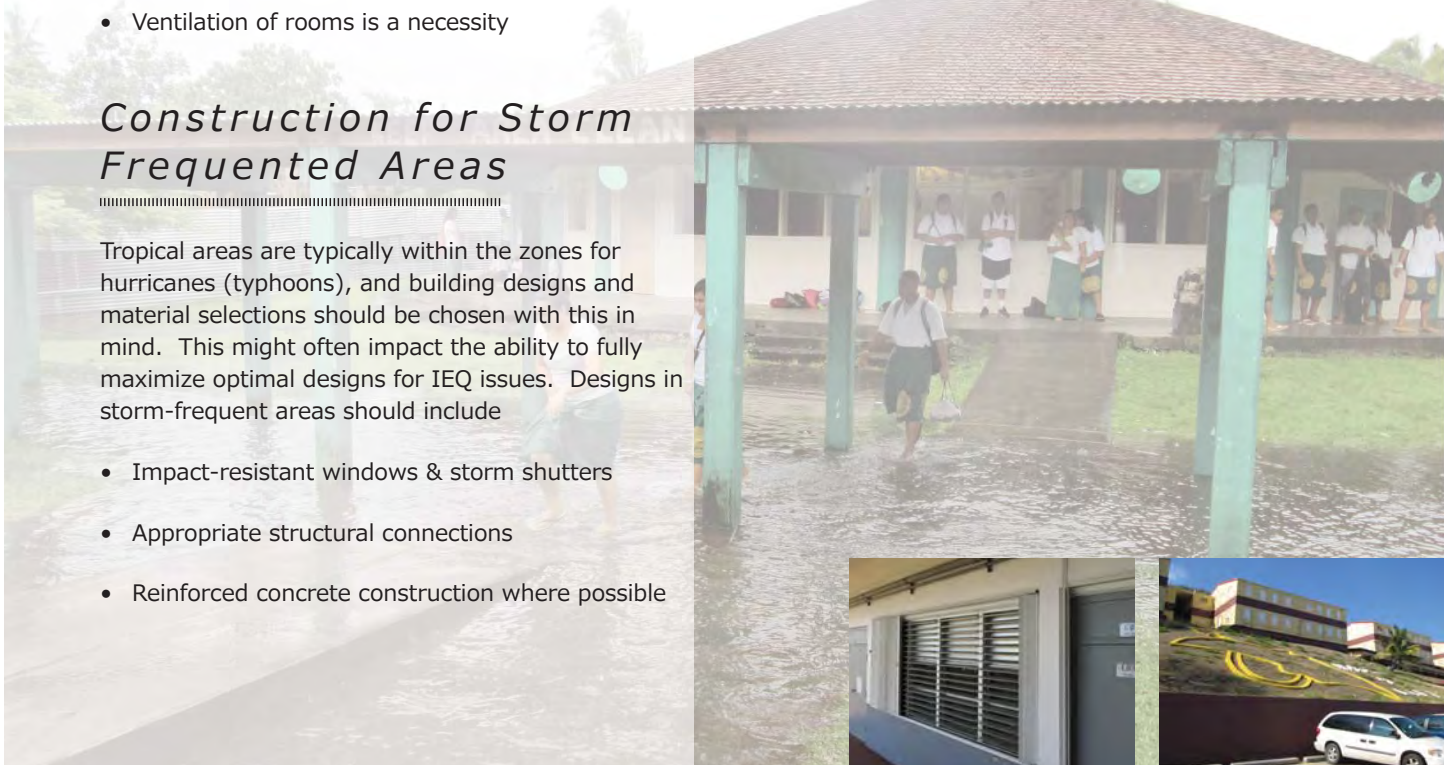
Background: Site drainage is a challenge for many schools. **Center:** Storm shutters can reduce damage to windows. **Right:** Steep slopes present unique challenges for schools.

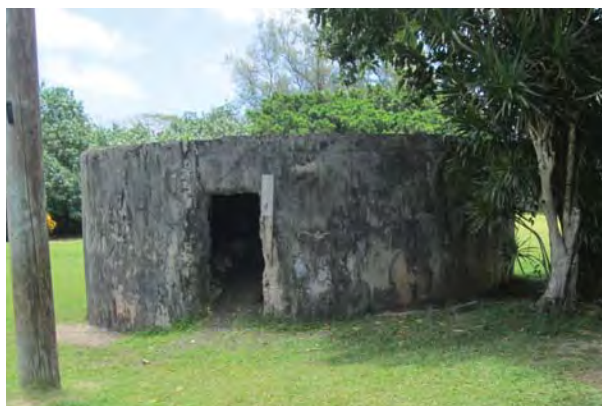
World War II water tank is considered a historic structure.

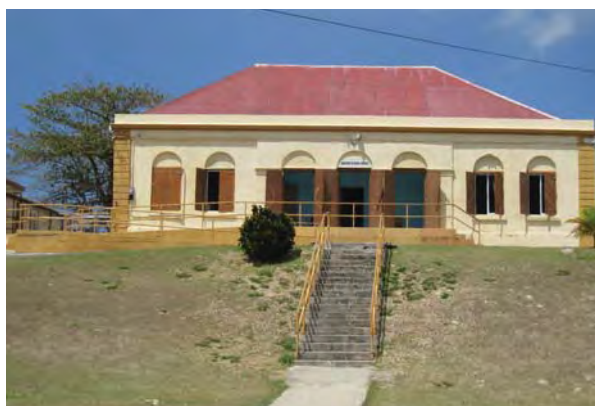
This historic building is considered significant, which may require special considerations for repair work or alterations.

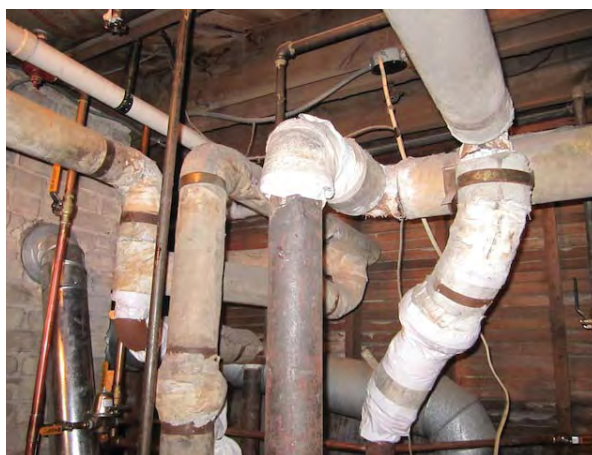
Asbestos is found in many building products, including pipe insulation.
