# **INSULAR ABC'S INITIATIVE**

## **Phase III Task 1 Findings and Recommendations**

### **American Samoa**

October 2015

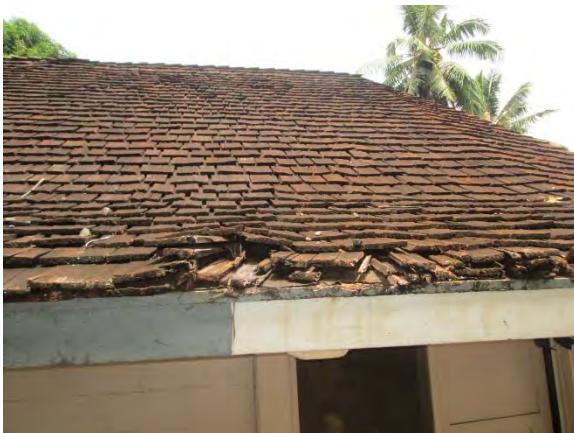
The wood roof shakes on buildings 2-6 are deteriorating, and should be replaced in the near future. If asphalt shingles are used instead of wood shakes, roof insulation should also be installed, as the asphalt shingles do not provide as much thermal protection.

Deteriorated wood shakes

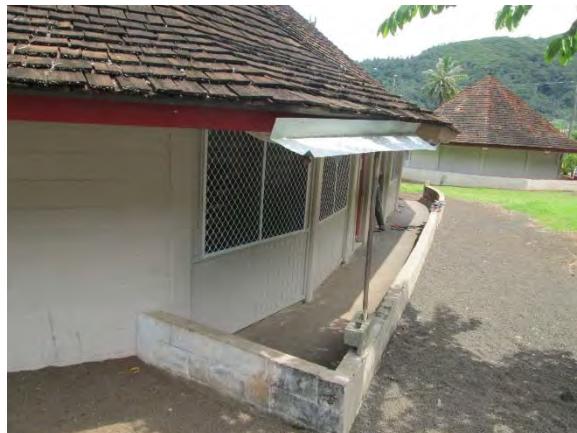
At Building 4, there is a make-shift gutter installed that appears unsafe.

Gutter at Building 4

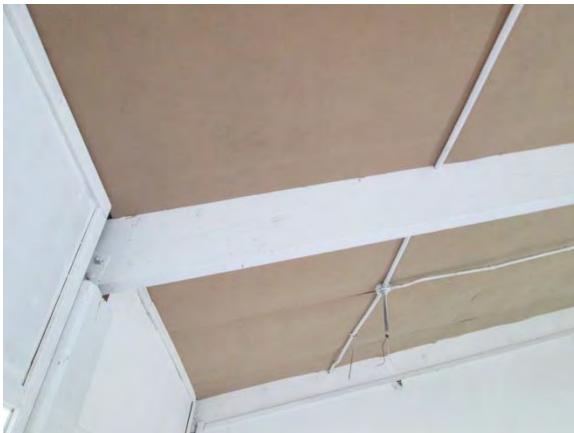
Building 1 is closed and is currently not in use, as the termite damage there has worsened. Damage is apparent in structural members as well as in roof sheathing, purlins, and other non-structural elements.

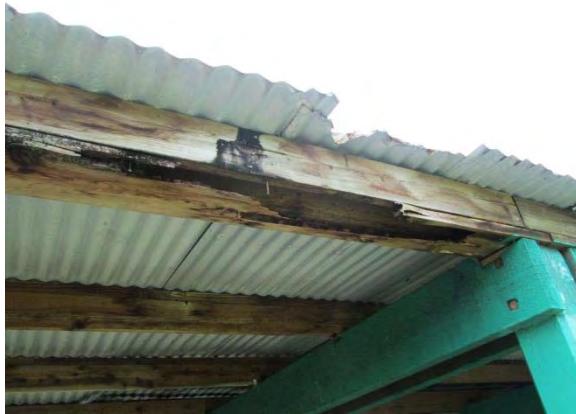
The covered walkways have received some repairs, but there are still some damaged wood members and deteriorated metal roofing that require replacement.

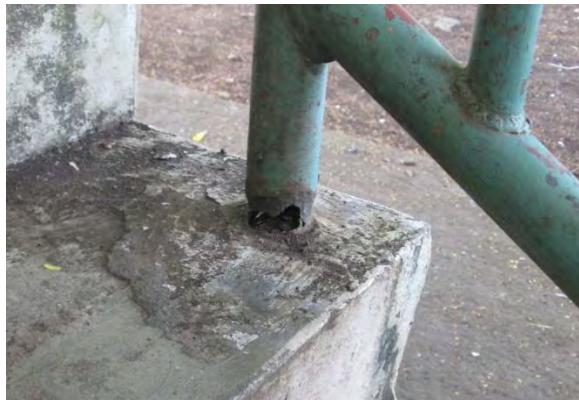
Some of the corrugated metal roofing panels at Building 4 are heavily rusted and should be replaced.

The metal railing at building 5 has rusted holes, which could cut someone and will eventually cause the loss of integrity of the railing, and should be repaired.

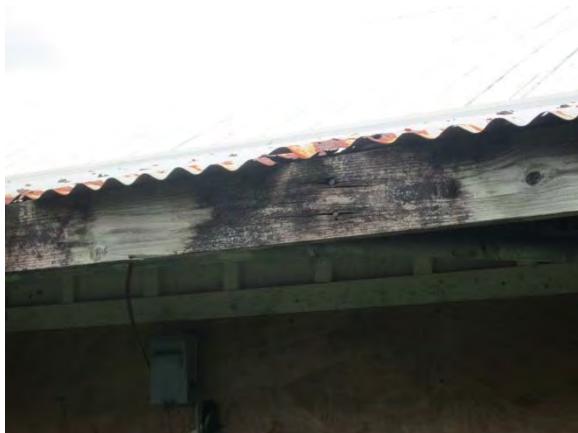
Building 1 received numerous repairs, including new ceilings, windows, siding and lights. Some roofing was replaced, but the corrugated metal roofing on the back side of the building is still in bad shape and needs to be replaced. Some of the metal railings at the front entries have missing pieces and there are jagged rusted portions, which are a safety hazard.

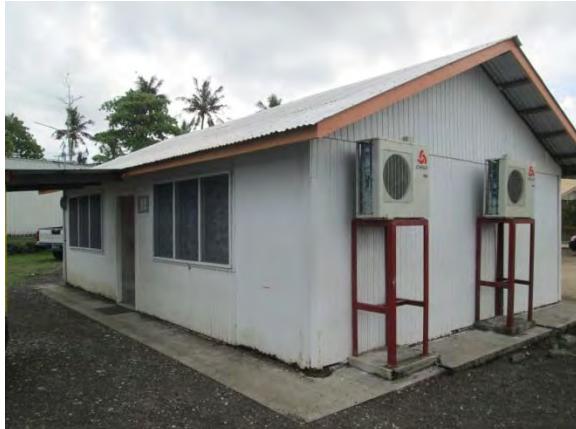
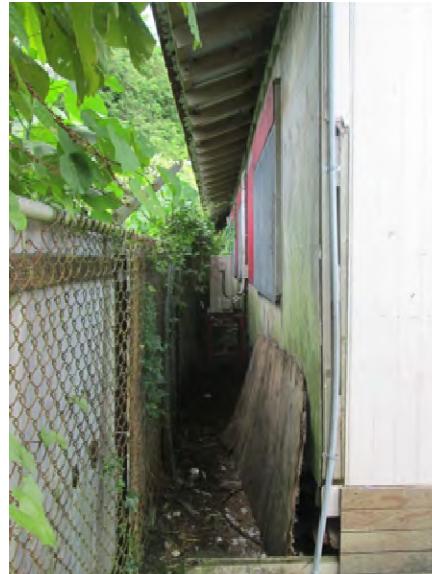
Buildings 3, 6, 7 and 10 have received extensive repairs. At Building 6, only the concrete walls were retained and the rest of the building was completely rebuilt. Some of this work was done by an Adopt-a-School summer program in which DOE and ASPA repaired these buildings. The old siding still remains at the back of Building 7, and should be replaced.

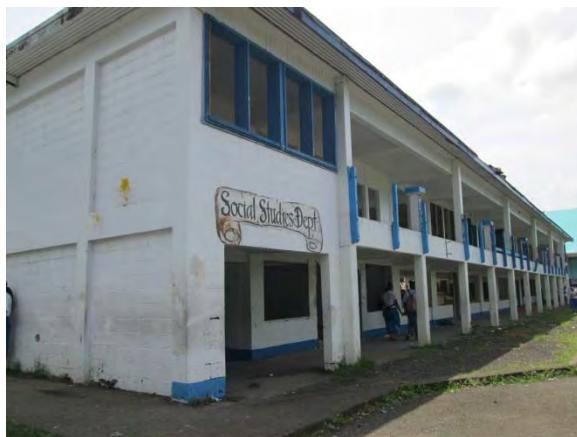
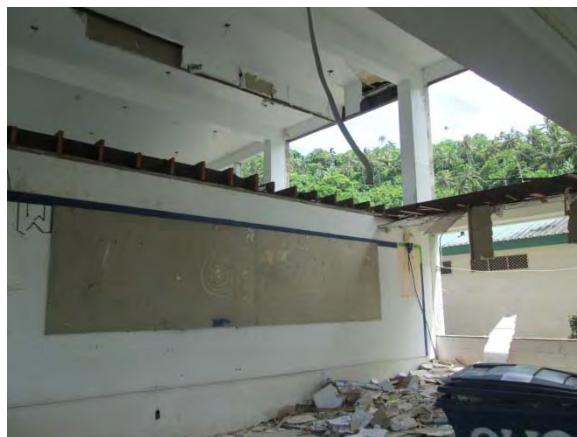
Buildings 3 and 6, reportedly built by the Navy in the 1950s, are planned for demolition. Building 3 has already been partially gutted, but work was halted until the school year is completed. The building has been left wide open, and students are hanging out in the building, and even doing some cleanup. This is a serious safety hazard, with broken and jagged wood and metal elements, rusty elements, nails, glass, and many other dangerous elements that could injure someone. Loose members dangle precariously above and could easily fall. The building should be cordoned off and students and staff should not be allowed in or near it. At the time of this survey, the DPW staff was made aware of the situation and intended to inform the school Principal.

The concrete structures of these two buildings do not appear to be in bad condition and could easily be reused, but school staff stated that a new building was slated for construction in another location of the campus, and that demolition of these two buildings would allow more space for the track and for more natural ventilation.

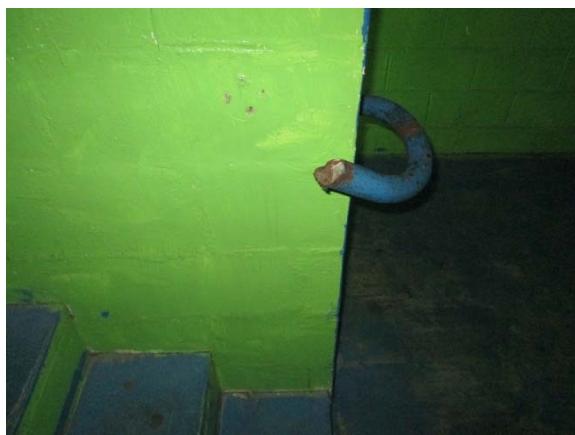
The metal handrail at the stair in Building 1 is broken and rusted, and is a safety hazard. The top of the stair has no landing, which is also dangerous.

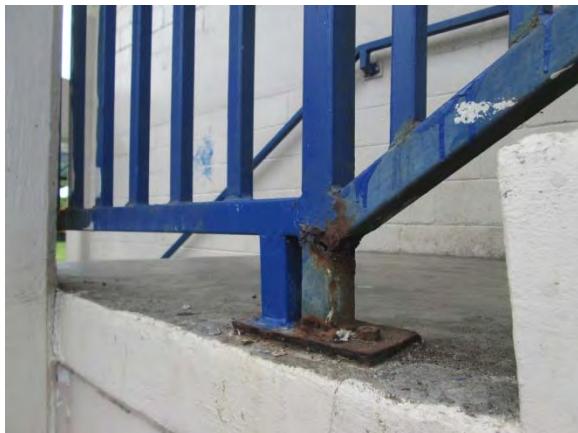
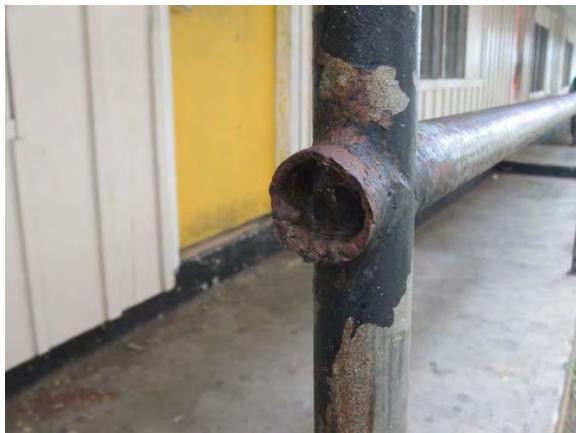
The metal railings at the stairs and walkways are heavily rusted at the base; in some locations the connection to the concrete is completely gone.

Where railings are rusted at the base, the railing must be removed and a new metal railing base installed in the concrete.

- Cut railing off at each base and remove railing
- Cut out the metal bases in concrete and remove all loose concrete
- Install new metal railing bases in concrete with hydraulic concrete. Weld bases to railing such that railing is required height.

Where railings are rusted at horizontal portions or at pickets:

- Remove rusted metal and clean rail surface
- Weld railing as required to repair and ensure required strength

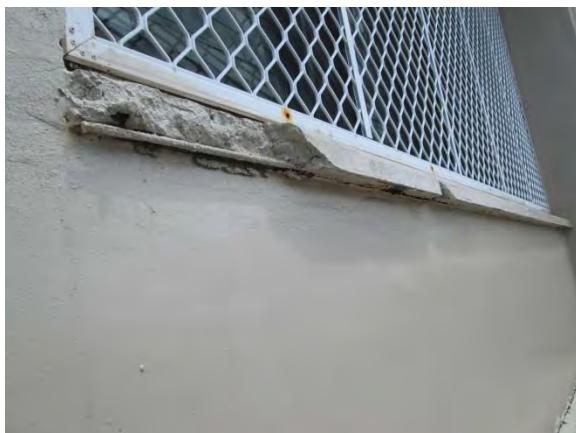
The concrete sills below the windows on the northeast side are spalling. This appears to be due to a lack of adequate concrete cover over the steel reinforcing bars; moisture has gotten to the steel bars, causing them to rust and expand, which then causes the concrete to spall. As this is occurring on the second floor windows as well as the first floor, it is a safety hazard due to the concrete falling from above.

- Remove entire concrete sill and steel reinforcing bar
- Clean concrete surface
- Install stainless steel nails into wall perpendicular to sill at 24" O.C.
- Attach fiberglass reinforcing bar to nails at center of sill (equal distance to bottom and top, equal distance to wall and outer edge)
- Pour new concrete sill

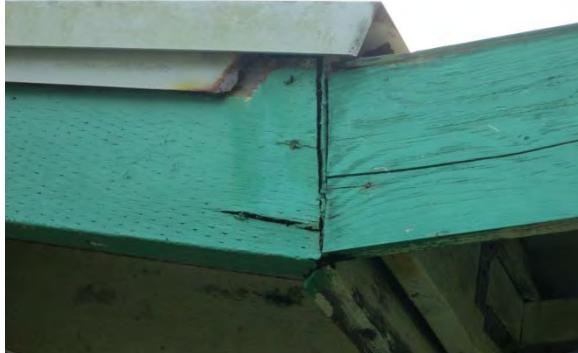
This school is about 20 years old; the roof covering over the exterior walkways was added about 5 years ago. At the joint between the end of the building rafters and the top of the walkway roof rafters, no flashing was installed, and the building roofing extends only a few inches past the end of the building rafters. Water often gets into this joint, pouring down on the walkway below

- Flashing needs to be installed at the joint between the original roof and the new exterior walkway roof. Insert metal flashing at least 6" under the existing building roofing
- Bend metal flashing so that it curved down and then extends 6" over the walkway roofing.
- When buildings are reroofed, extend roofing further past the end of the rafters over the walkway roofing.

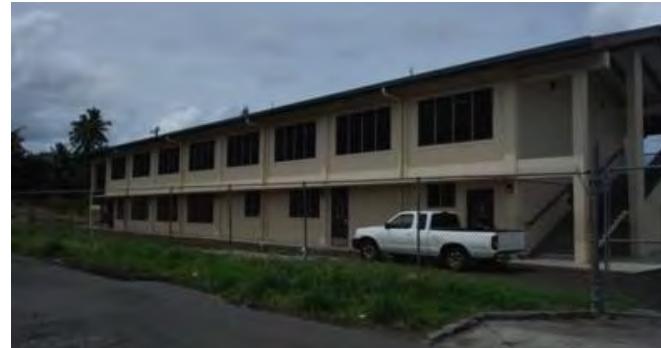
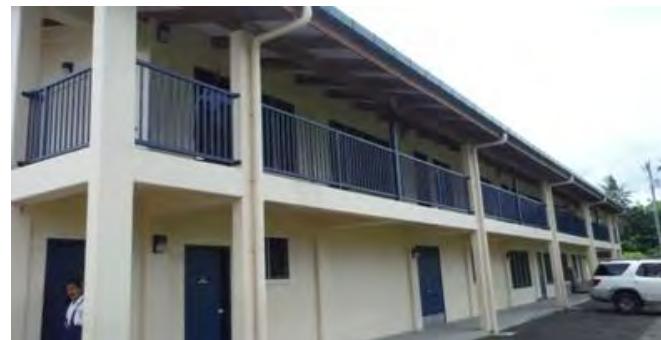
OIA Phase II survey found no fire alarm system in the campus, and no fire alarm system was installed in OIA Phase III survey. Neither the new 2 story building constructed in 2014, which has kitchen and cafeteria on the first floor and 4 classrooms on the second floor, has fire alarm system. This poses a safety hazard to the occupants. New fire alarm system should be provided throughout the campus.

New 2 story building constructed in 2014 did not have fire alarm system. This building was constructed after OIA Phase II survey.

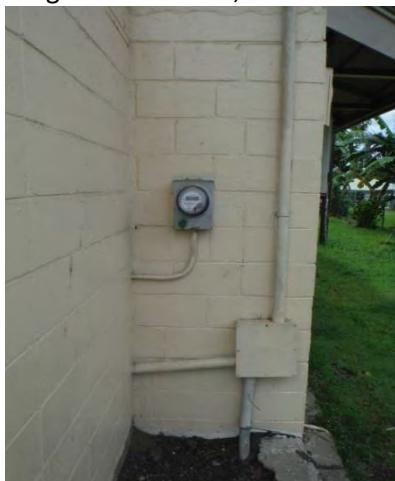
Building 03 – Per ASPA, New meter enclosure is required.

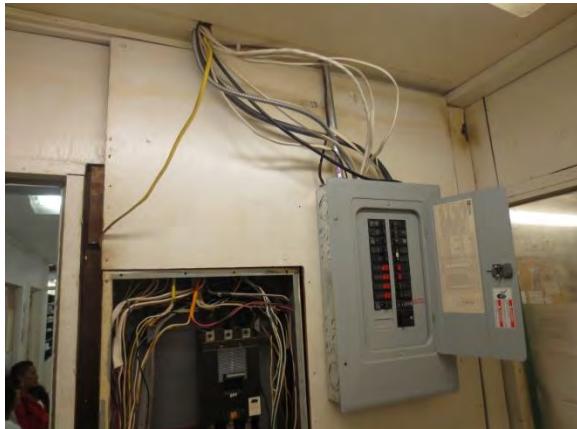
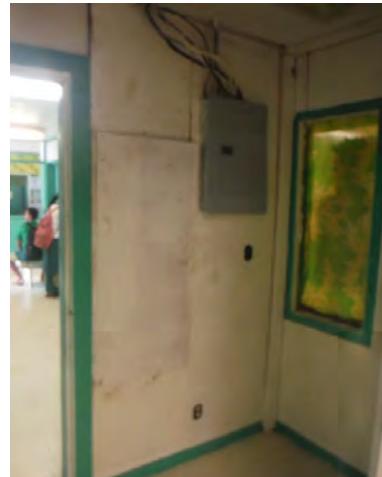
Building 16 – Panelboard improperly covered

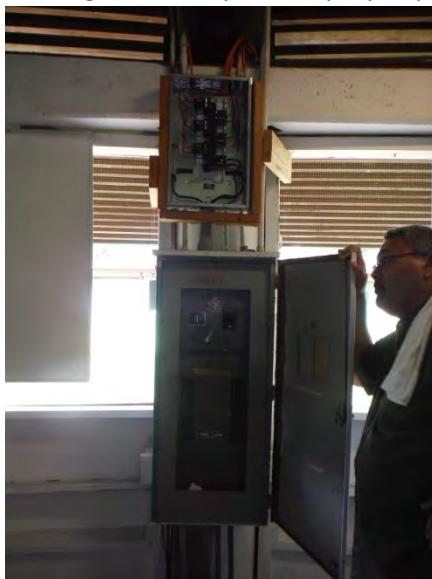
Building 10 – New panel improperly installed, height exceeds Code acceptable mounting height

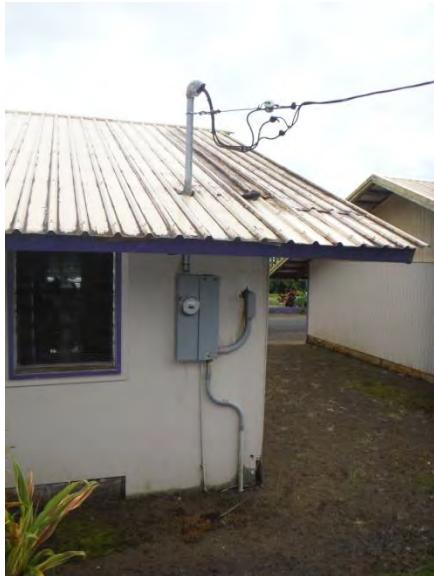
Building 02 – New ASPA Service

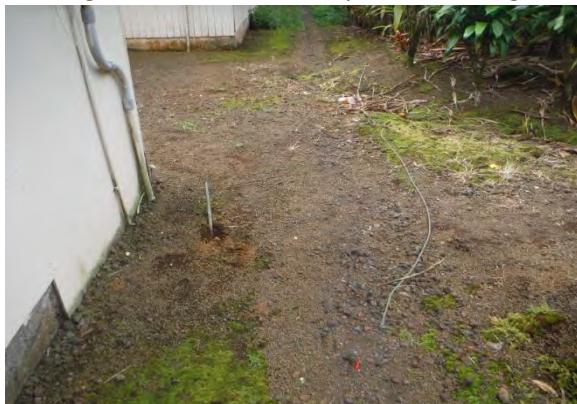
Building 02 – Ground wire exposed creating a tripping hazard

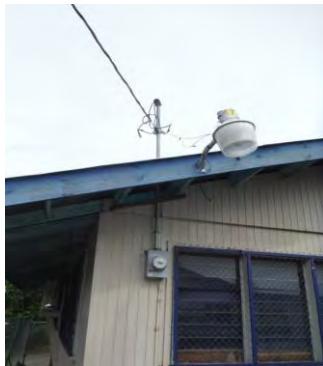
Building 10 – New ASPA Service Meter

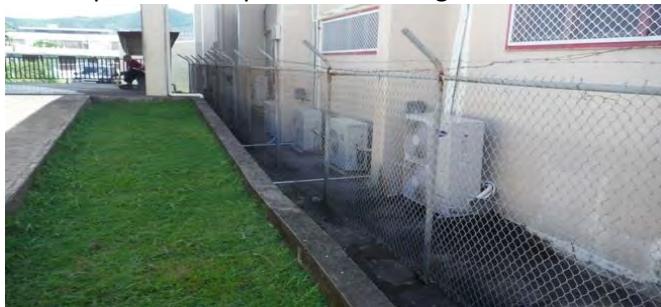
### 1. Building 03

OIA Phase II survey found some split type air conditioners were inoperable. Air conditioners were repaired and operational during OIA Phase III survey.

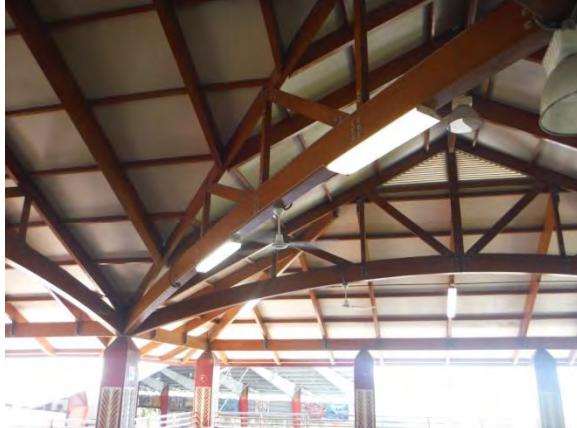
### Building 01 – New Lighting Completed

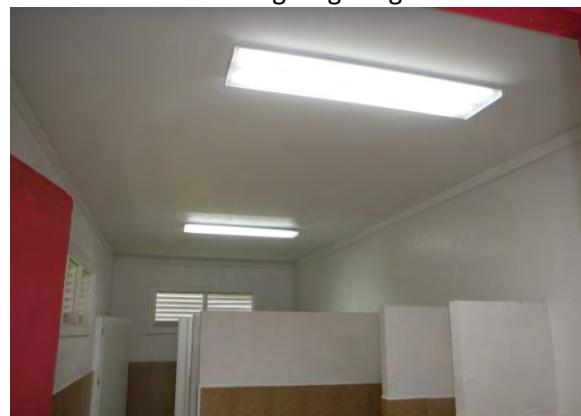
New Restroom Building - Lighting

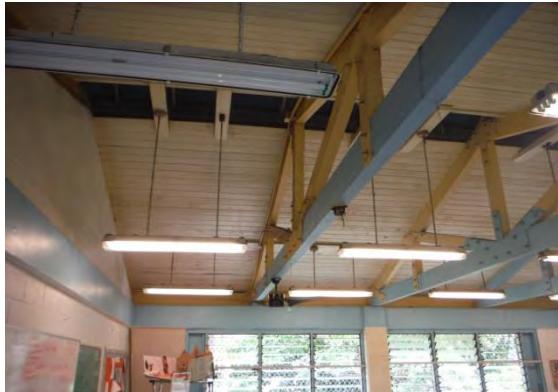
Building 07 – Lighting fixtures unchanged; replacement needed

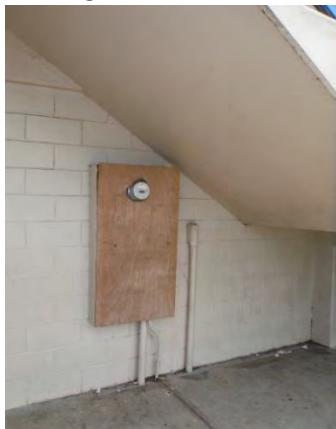
Building 08 – New ASPA meter; panel cover needs to be replaced to code

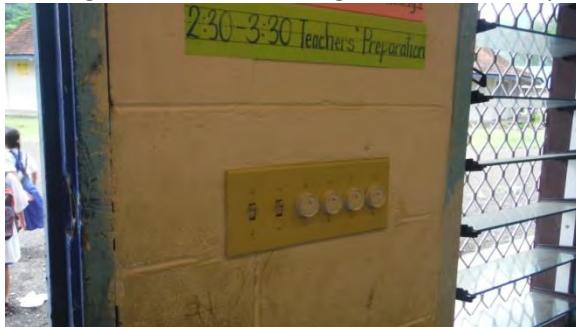
Building 04 – Broken/missing device covers replaced

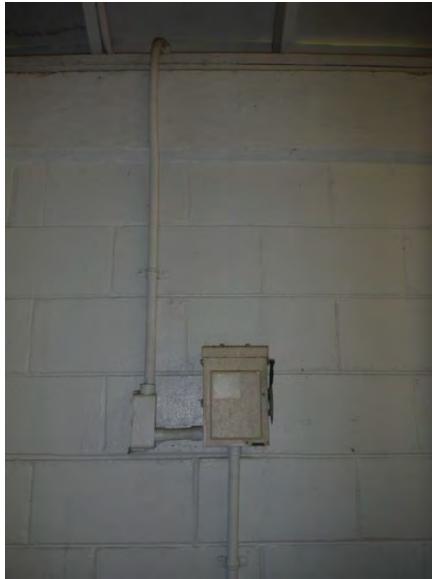
Building 06 – Disconnect is original; replacement is needed

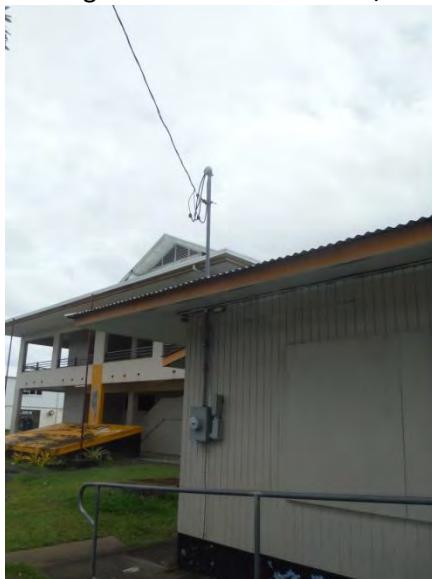
Building 01 – New ASPA service/meter

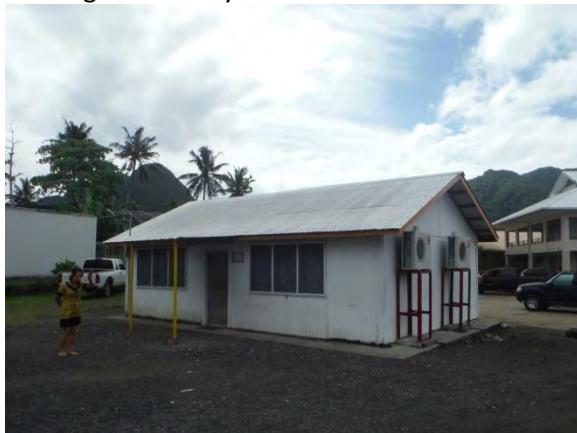
Building 03 – Newly enclosed classroom with new electrical

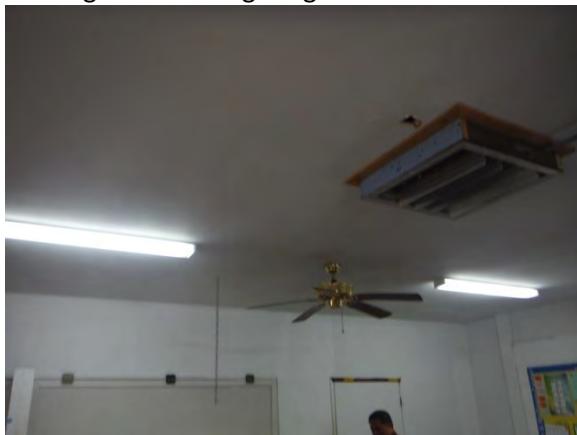
Building 06 – New Lighting

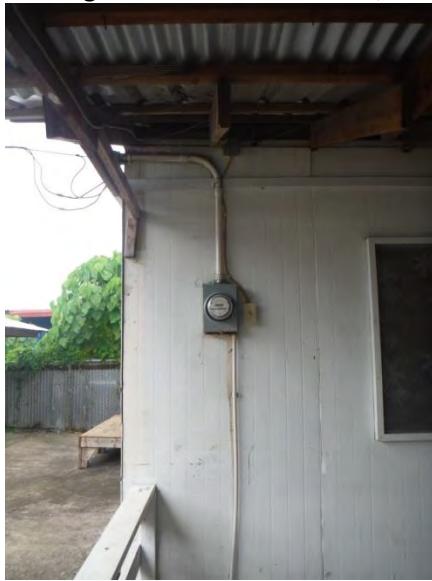
Building 07 – New ASPA Service, building has been newly renovated

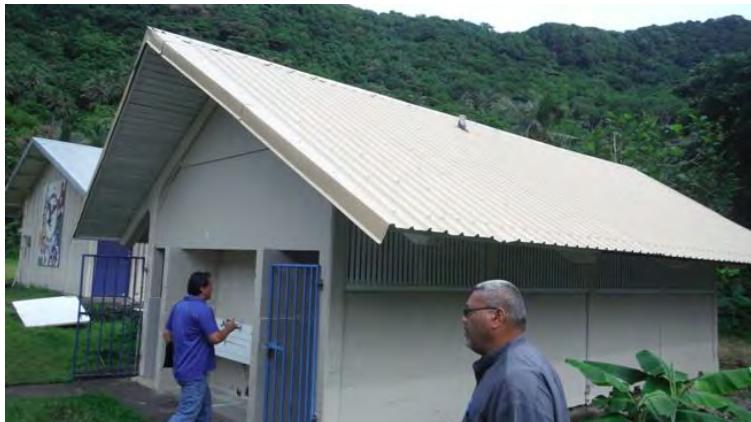
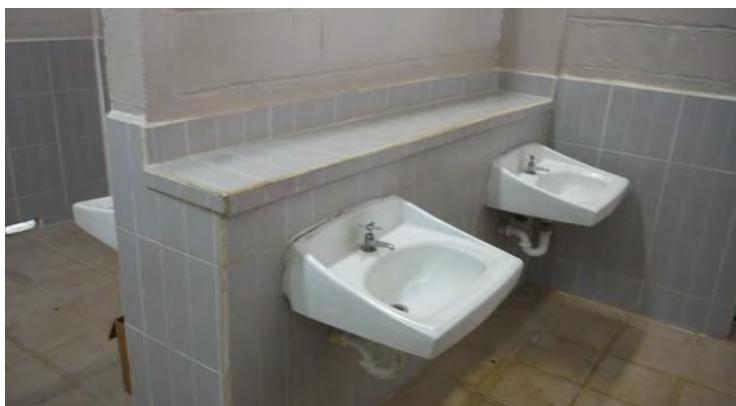
1. Building 02

OIA Phase II survey found the restrooms were closed for repair. The restrooms were rehabilitated and reopened to students in OIA Phase III survey.

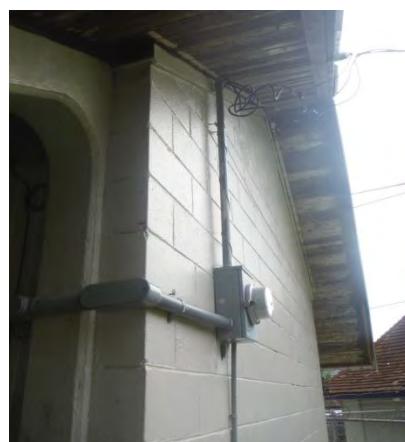
Building 16 – New ASPA Service/Meter

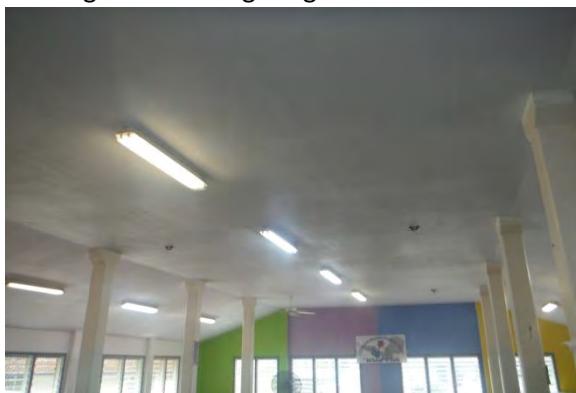
### Building 22 – New Lighting

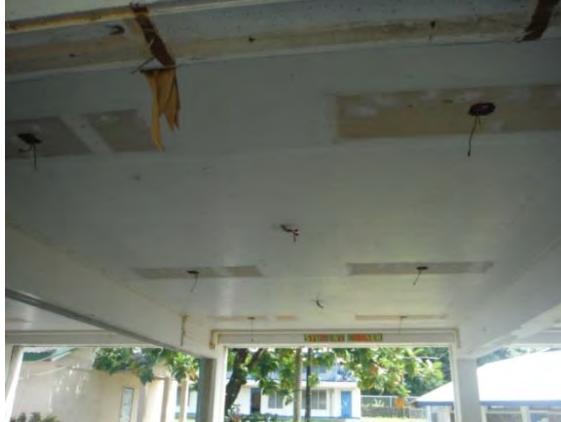
##### Building 03 – Currently being demolished

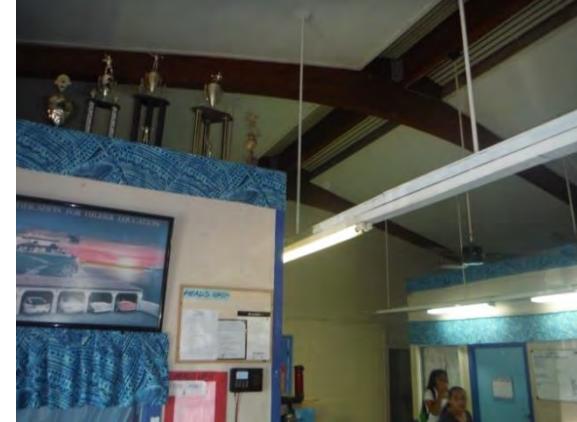
##### Building 09 – Lighting upgrade completed

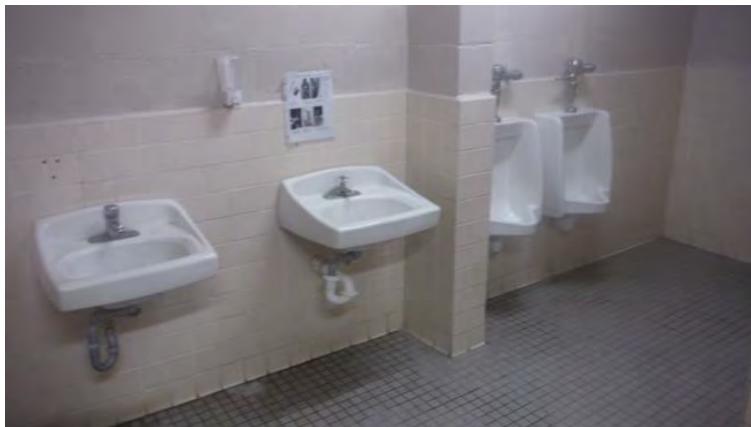
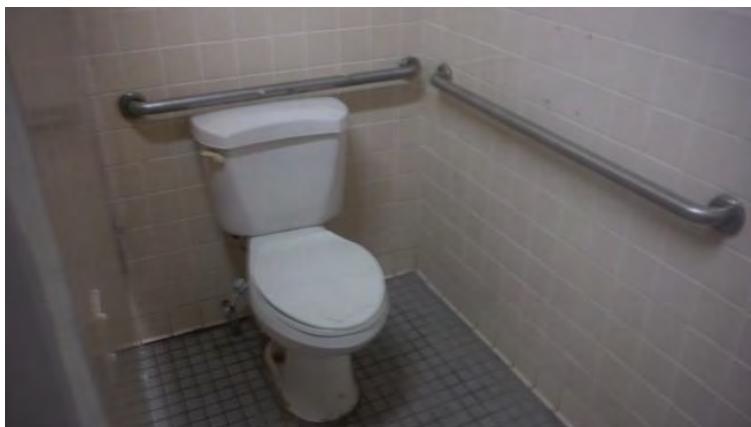
1. Building 06

OIA Phase II survey found incomplete and leaky plumbing fixtures in the restrooms. Restrooms were repaired and fully operational in OIA Phase III survey.

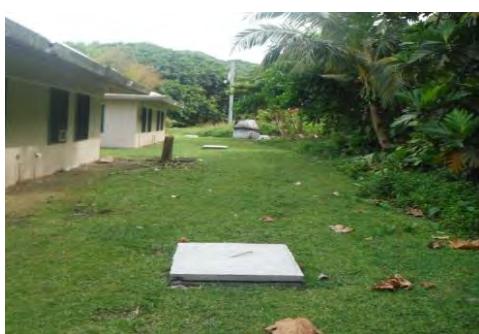
Site – New electrical handhole covers

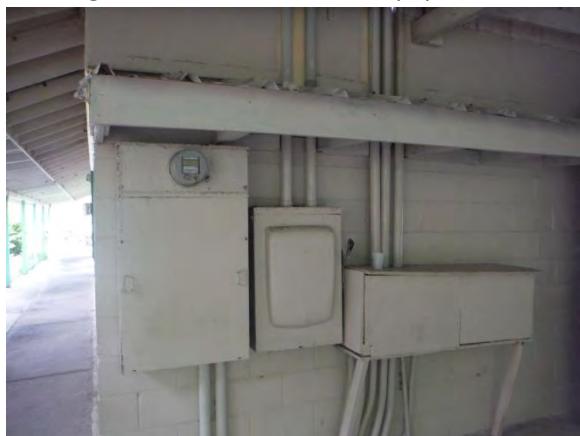
**Building 06 – Electrical Service Equipment is unchanged**

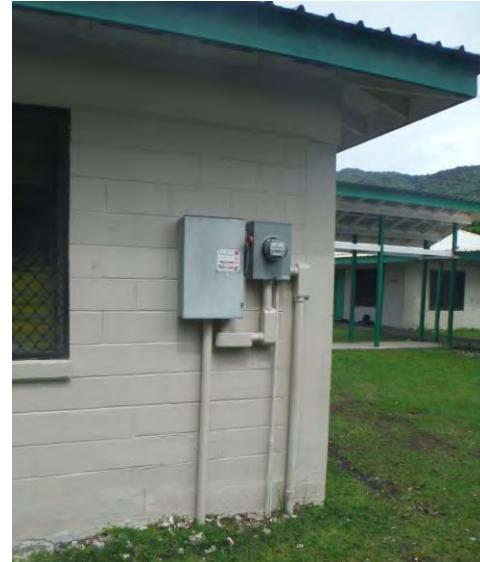
**Building 03 – New ASPA Electrical Service/Meter**

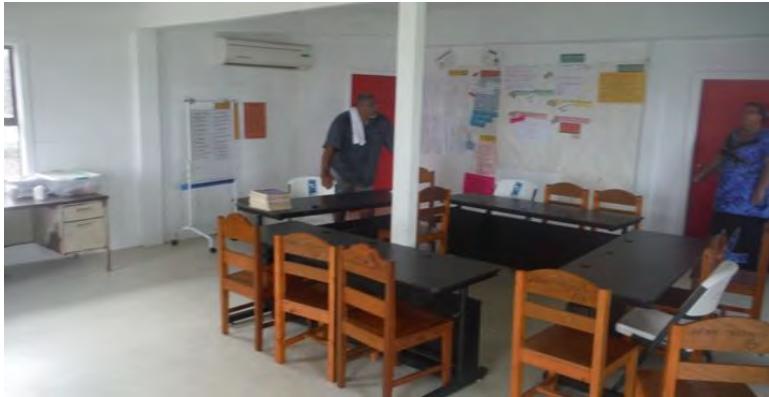
2. Building 17

OIA Phase II survey found the air conditioners were inoperable causing poor indoor air quality.  
Air conditioners were repaired in OIA Phase III survey.

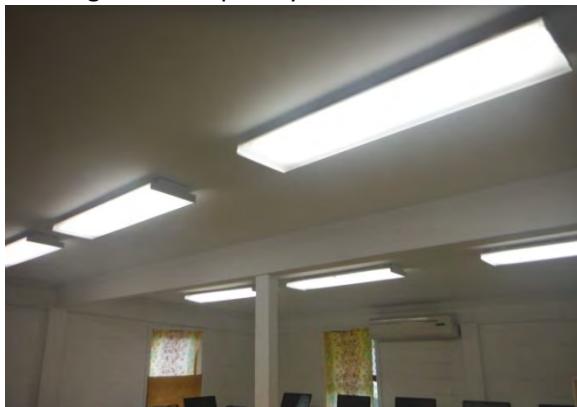
Building 17 – Completely Renovated

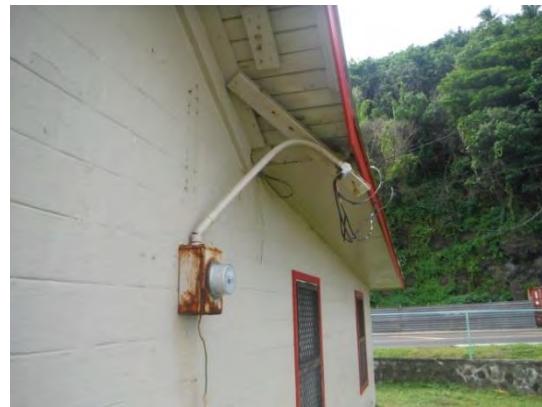
Building 15 – Existing Overhead ASPA service needs repair

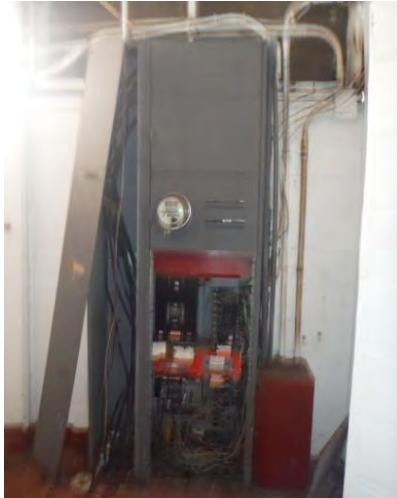
Building 14 – Location of Main Electrical Service. Needs to be relocated prior to demolition

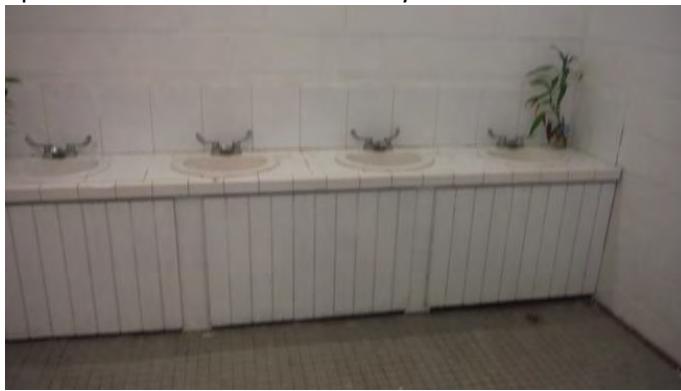
1. Building 10

OIA Phase II survey found incomplete and leaky plumbing fixtures in the restrooms. Restrooms were repaired and fully operational in OIA Phase III survey.

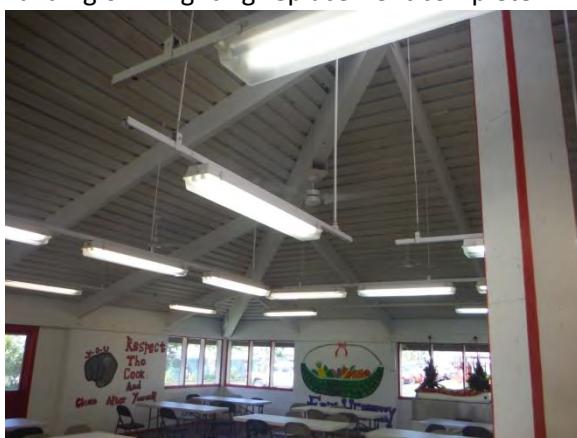
Building 07 – Lighting replacement complete

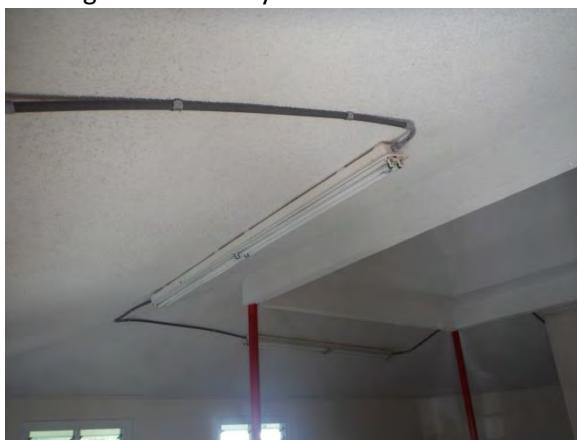
Building 08 – Currently under renovation

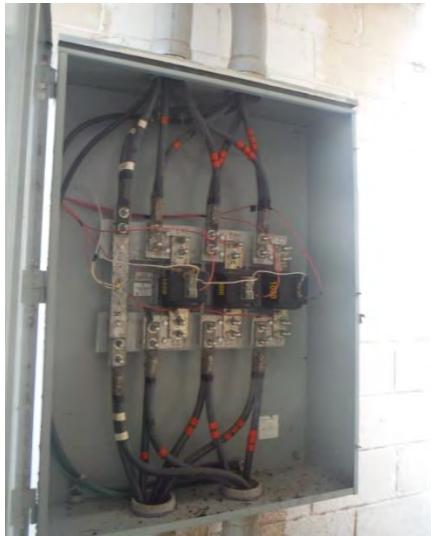
Building 09 – Electrical equipment cabinet is not secured exposing live electrical bussing

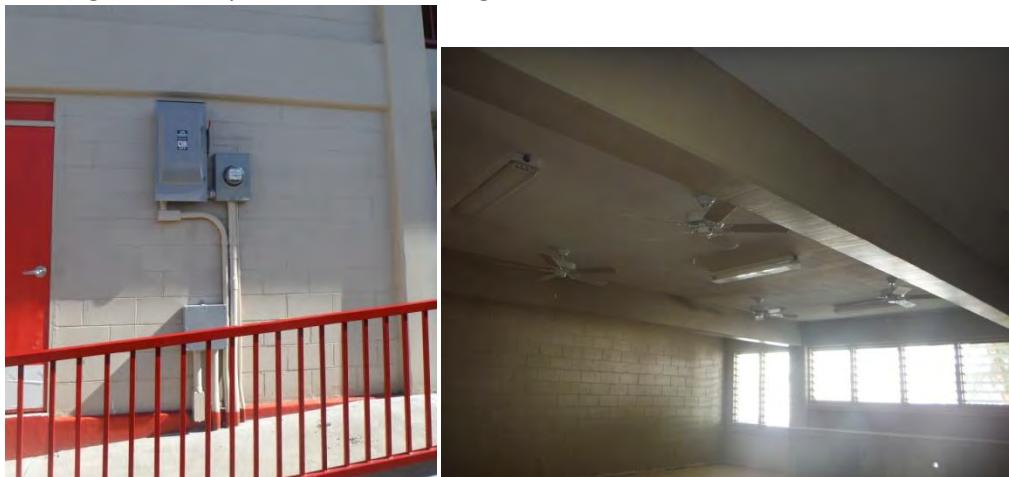
Building 06 – Newly constructed building with new ASPA Electrical Service

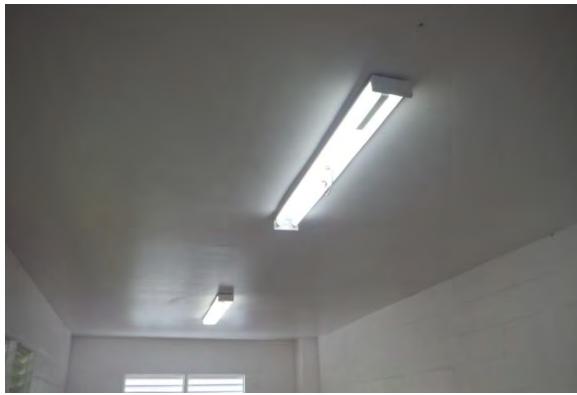
New Restroom Building - Lighting

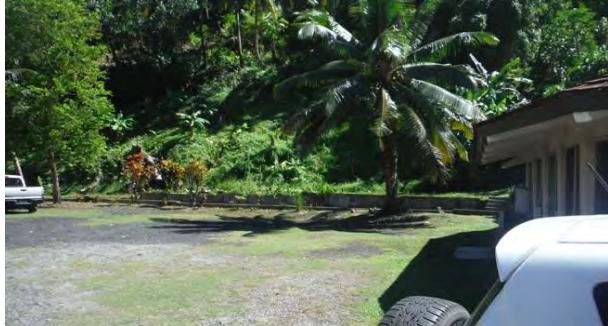
### 1. Building 02

OIA Phase II survey found the restroom building was deteriorated. It was demolished in OIA Phase III survey.

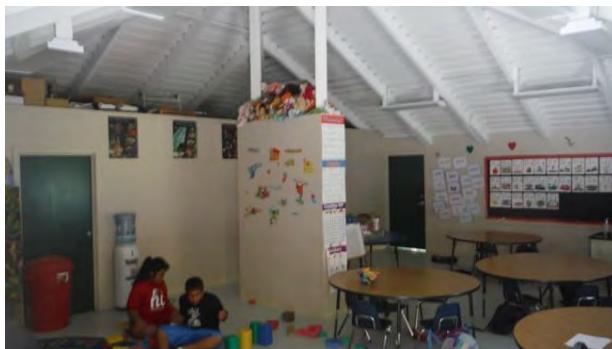
### 2. Building 04

OIA Phase II survey found the building was deteriorated and needed repair. The building was rehabilitated and used as a classroom in OIA Phase III survey.

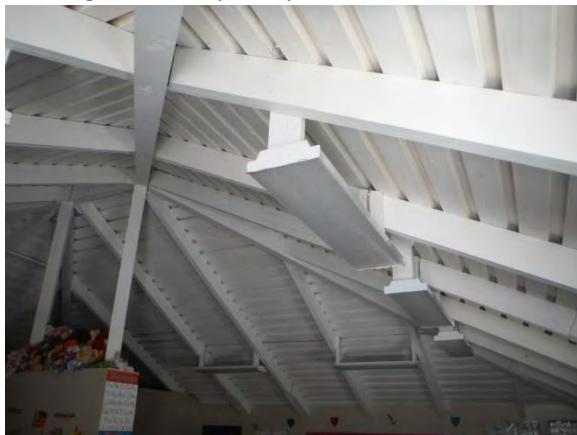
Building 04 – Completely renovated

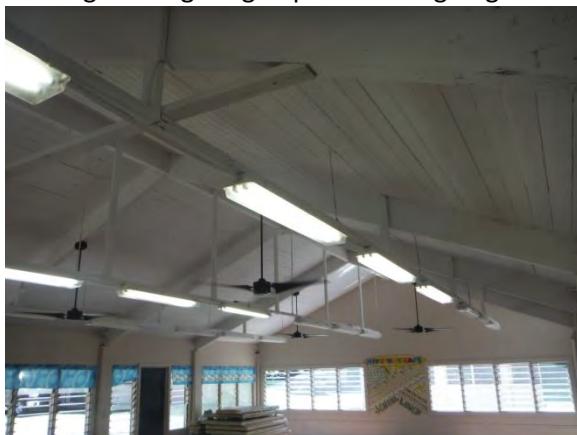
Building 03 – Lighting Repairs are ongoing

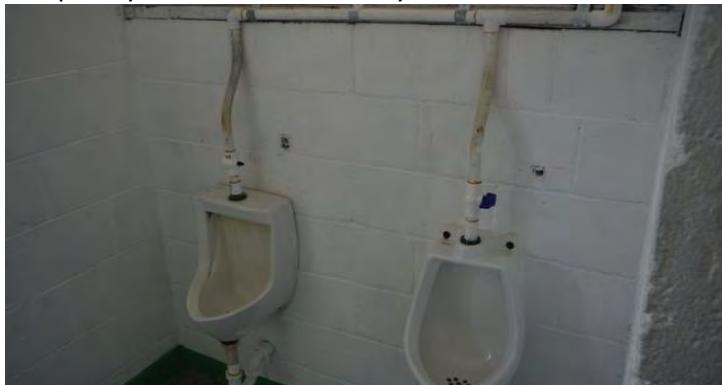
2. Building 04

OIA Phase II survey found defective plumbing fixtures. Plumbing fixtures were repaired adequately in OIA Phase III survey.

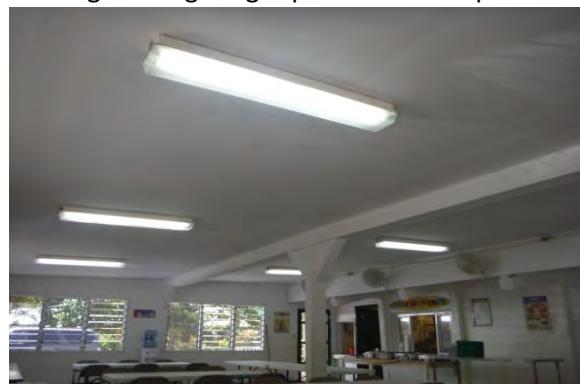
Building 09 – Lighting replacement completed

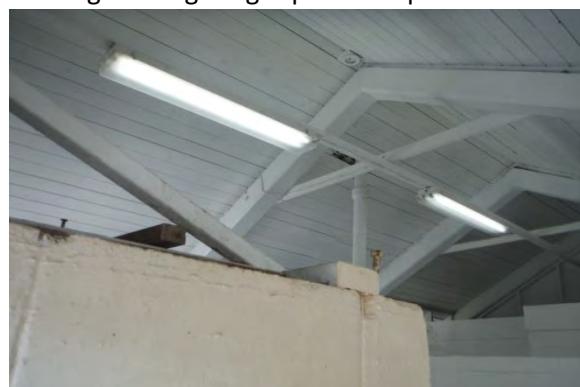
Building 04 – Lighting repairs complete

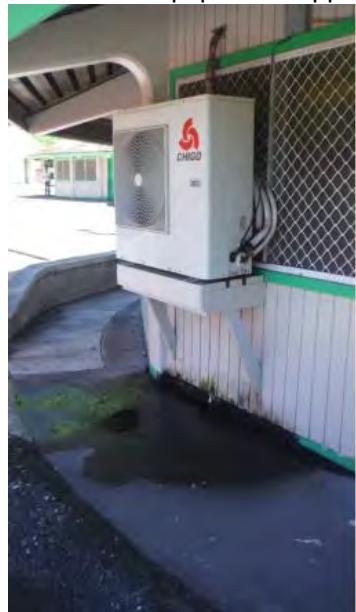
Location: Lauli'i ES building 6, kitchen and Nu'uuli Polytechnic building 1, classroom – wooden AC equipment supports.

- EPA approved refrigerant, high efficiency system and corrosion protective coating air conditioning equipment should be used.
- Implement energy conservation programs such as temperature set back or turn off air conditioning based on school activity schedules. Programmable thermostats or centralized controls should be used.
- Placement of condensing units should consider maintenance accessibility, required operation clearance, acoustical impact to classrooms; minimize penetrations to building envelopes and typhoon protection.
- Metal supports with corrosion protective coating for AC equipment should be used.

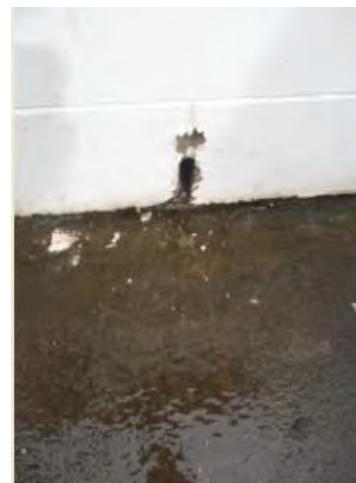
Location: Pavaia'i ES, building 21, restroom – water leak inside the pipe chase was not repaired. A hole was drilled on wall to relief the water leak inside the pipe chase.

- Repair water leak and plumbing fixture as soon as possible.
- Keep inventory of parts and fixture. Use common model and local available products.
- Provide ADA fixtures to comply ADA requirement.

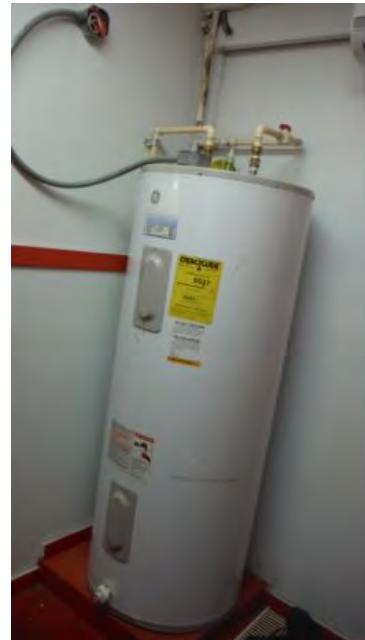
Location: Faga'itua HS building 7 , Cafeteria – electric hot water heater was not secured. Temperature pressure relief valve was not pipe to above floor.

- Install hot water heater in accordance with applicable codes and standards. Provide seismic restraints, relief valve piping and service clearance.

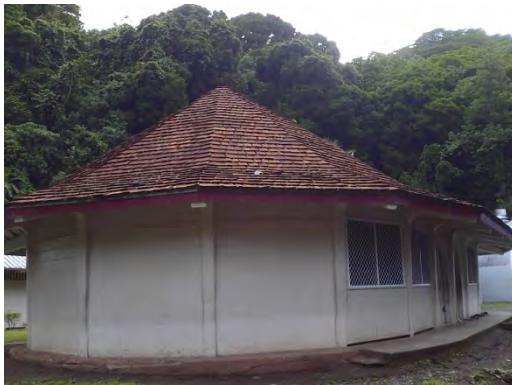
Phase II Site Visit (April 2013)

Building 6 (Classroom Building) is a typical oval-shaped reinforced concrete and wood framed fale structure. During the 2013 Phase II site visit, the exterior slab-on-grade was observed to have cracks and spalls with exposed reinforcing at the edges. It does not appear to be any change in the condition between the 2013 Phase II and the 2015 Phase III site visits.

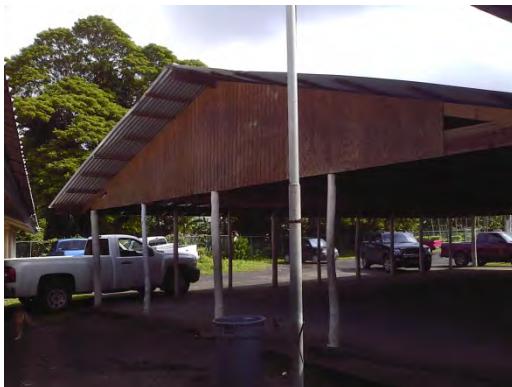
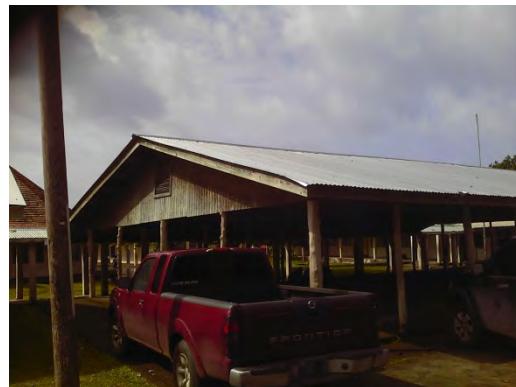
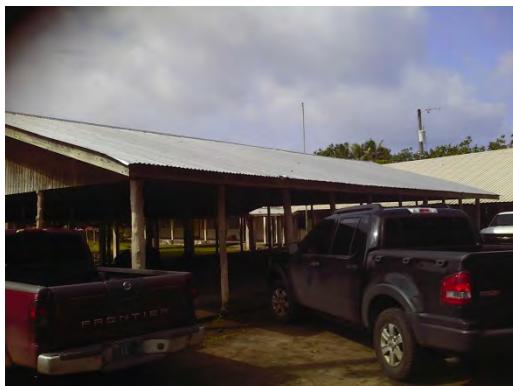
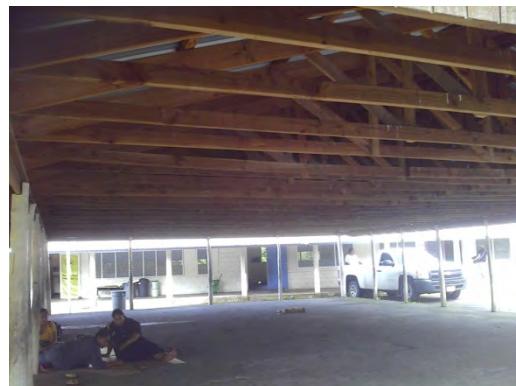
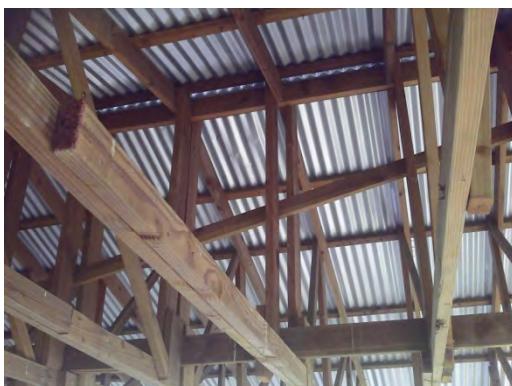
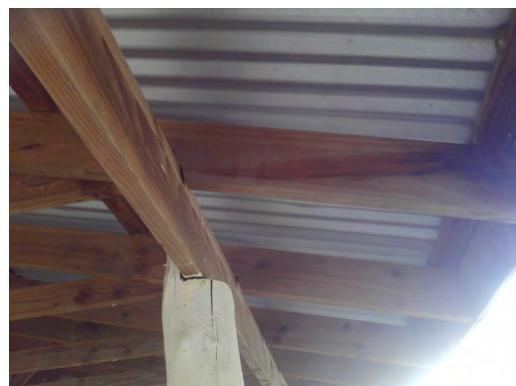
Phase II Site Visit (March 2013)

At the time of the 2013 Phase II site visit, Building 2 was an open fale structure made up of long-span wood trusses on wood beams on log columns. During the 2015 Phase III site visit, the fale structure had been demolished and a new building constructed in its place (see Building 20).

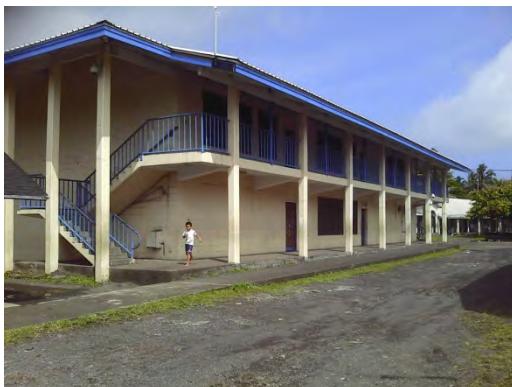
Phase II Site Visit (March 2013)

Building 3 (Classroom Building) is a two-story building with a reinforced concrete (footings, columns, beams, and second floor slab) concrete masonry unit (exterior and interior walls), and wood (wood roof decking, purlins, and beams) superstructure. On one side of the building, structural steel pipe columns are used in between concrete columns to support the wood roof. It was observed during the 2015 Phase III site visit that one of the steel columns has experienced corrosion at the bottom near the base plate. The corrosion disintegrated the weld between the column and the base plate leaving approximately half of the column cross section exposed. In addition, the corrosion has resulted in a spall at the edge of the second floor slab.

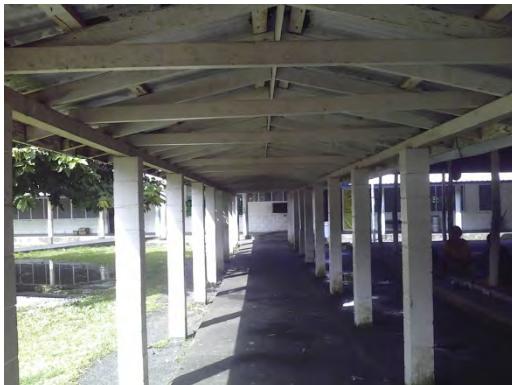
Phase II Site Visit (March 2013)

The walkways connecting Buildings 1, 2 and 6 consist of a wood gable roof supported on square concrete masonry unit (CMU) columns. The roof is made up of metal roofing on wood battens on wood purlins. Every other purlin has a horizontal wood strut for lateral bracing. The CMU columns appear to be unreinforced and not grouted. During the 2013 Phase II site visit, one of the CMU columns was observed to be bent out of plane approximately at the joint between the fourth and fifth block course from the bottom. The kink made the CMU column unstable and was, therefore, noted as a life safety concern.

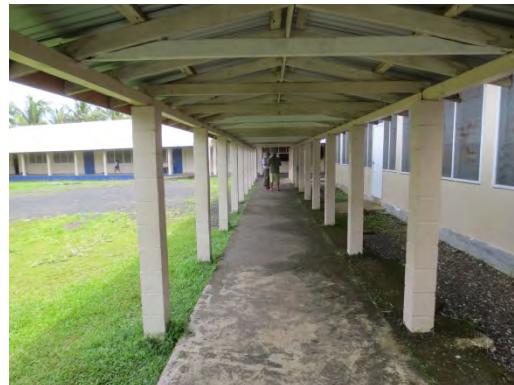
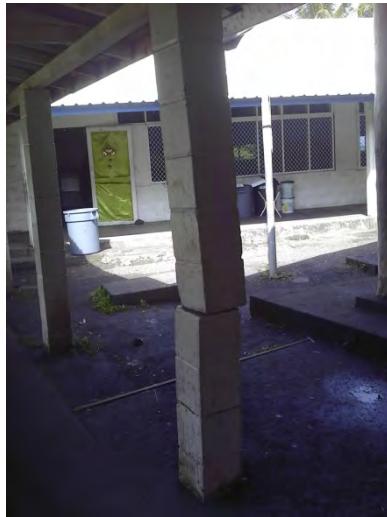
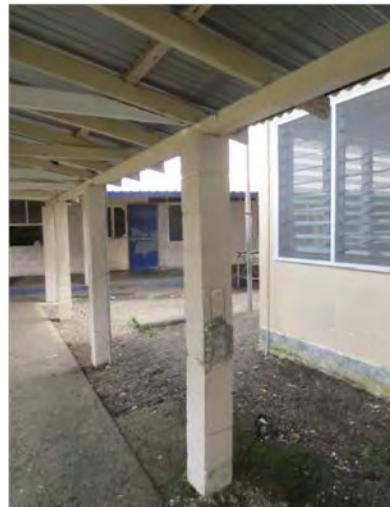
Phase III Site Visit (March 2015)

At the time of the 2015 Phase III site visit, the CMU column had been repaired by straightening all courses back into plumb. The column appeared to remain unreinforced and not grouted. The life safety flag has been removed for this item.
