# **INSULAR ABC'S INITIATIVE**

## **Phase III Task 1 Findings and Recommendations**

### **American Samoa**

October 2015

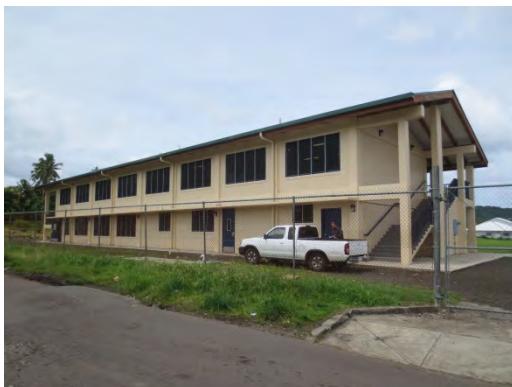
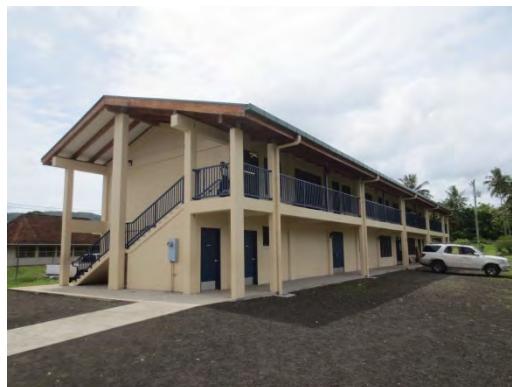
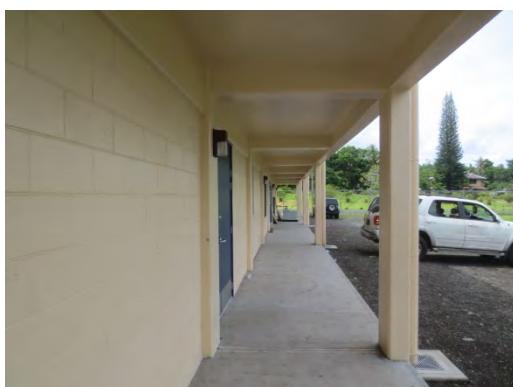
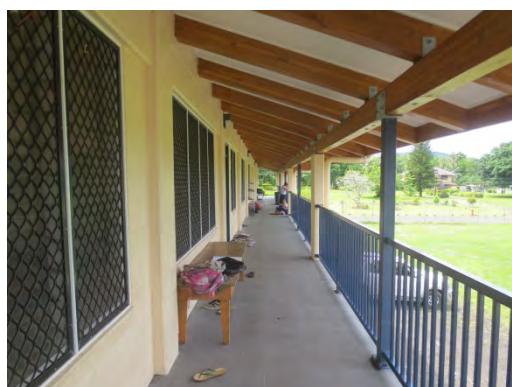
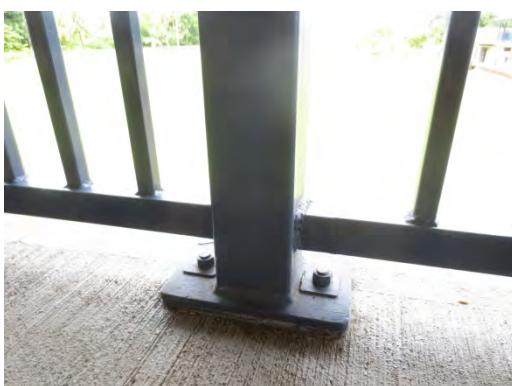
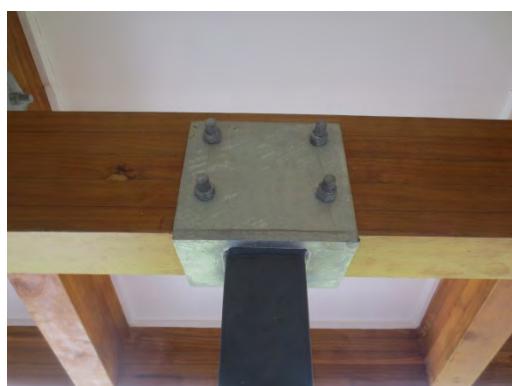
Phase III Site Visit (March 2015)

Building 19 (Classroom Building) is a new two-story building with a reinforced concrete (footings, columns, beams, and second floor slab), concrete masonry unit (exterior and interior walls), and wood (glulam roof beams) superstructure. All structural elements appeared to be in excellent condition. The building was reported to have been recently completed by New Zealand based Fletcher Pacific Construction. At the time of the visit, the building was occupied.

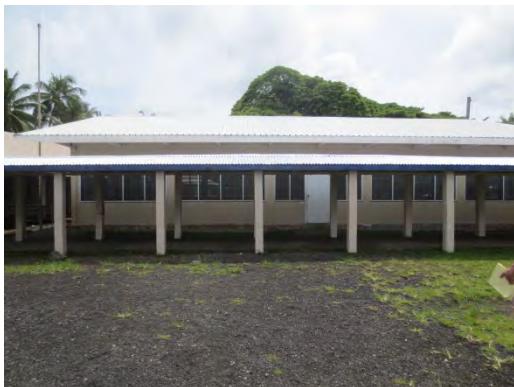
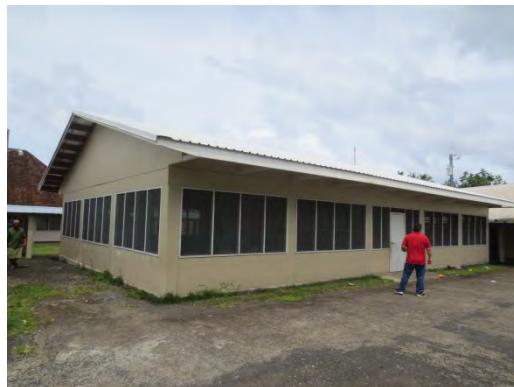
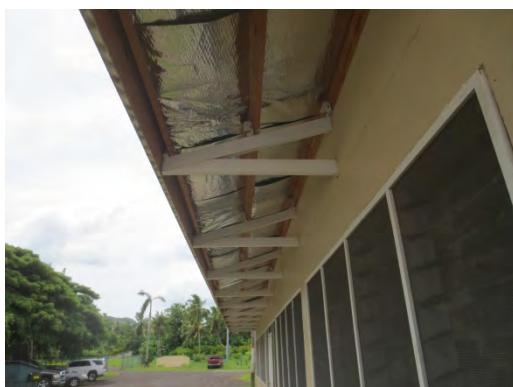
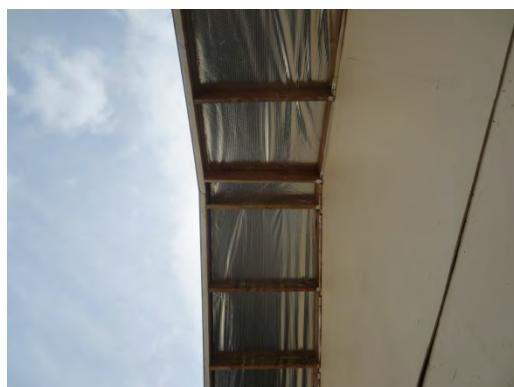
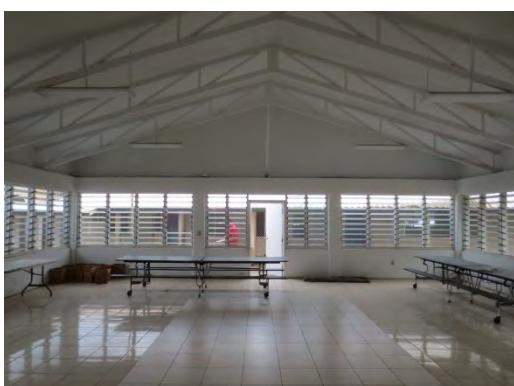
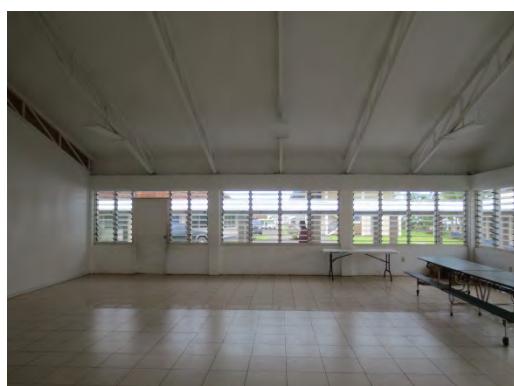
Phase III Site Visit (March 2015)

Building 20 is a new single-story classroom building constructed on the former site of Building 2. The building is rectangular in plan and has a gable roof framed with wood purlins over structural steel long span trusses (purlins are only exposed at the roof overhangs). Reinforced concrete frames at the perimeter of the building support the steel trusses. The concrete frames are infilled with a windows resting on a concrete masonry unit (CMU) sill. All structural elements were observed to be in excellent condition.

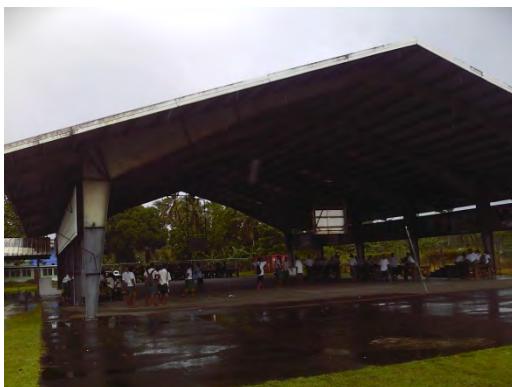
Phase II Site Visit (March 2013)

Building 1 (Gymnasium) is a single-story structural steel and cold-formed steel framed structure with reinforced concrete foundations and slab-on-grade. The superstructure consists of cold-formed steel purlins over long-span structural steel rigid frames. In 2013, the structural elements were observed to be in overall good condition with only minor corrosion of the structural steel rigid frames and minor to moderate cracks in the slab-on-grade.

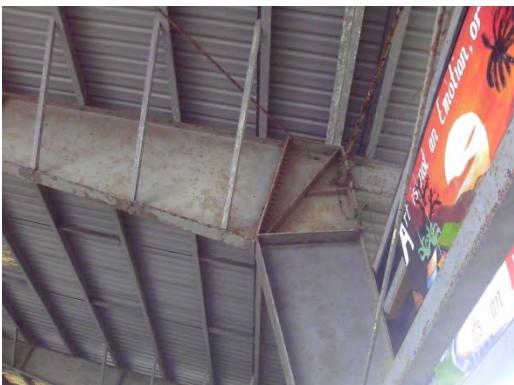
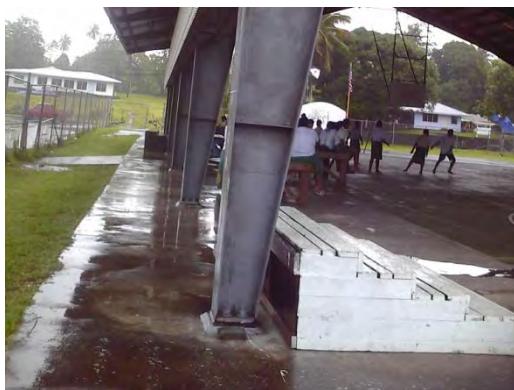
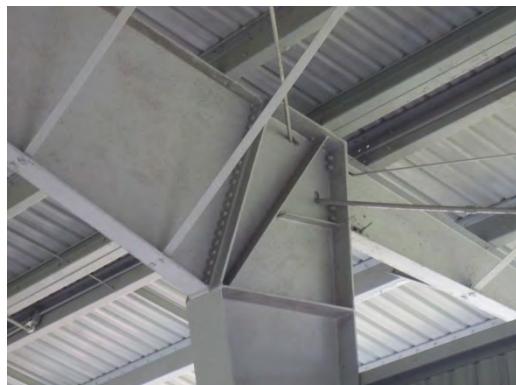
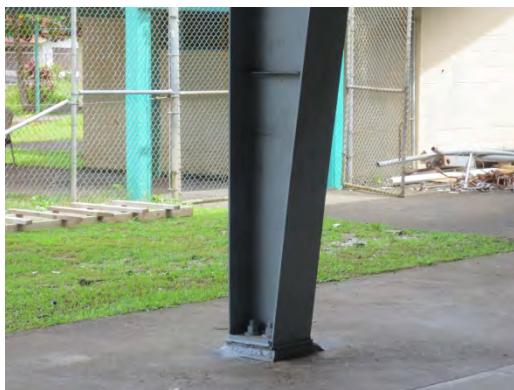
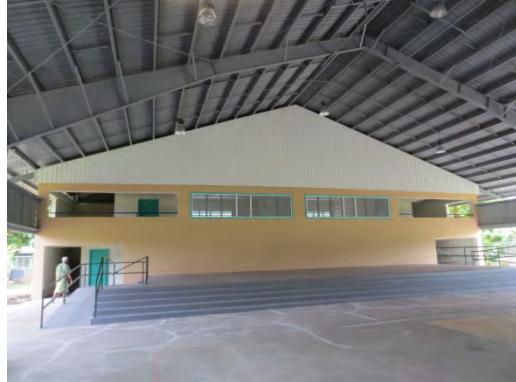
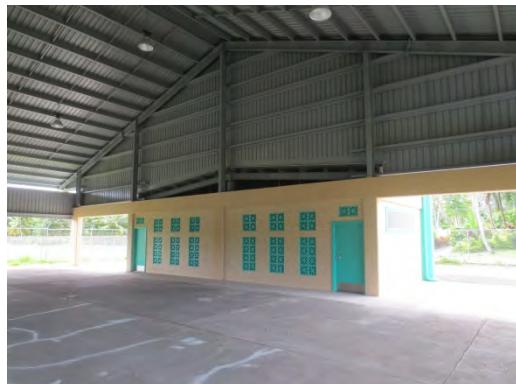
At the time of the 2015-site visit, the structure had just undergone a complete renovation. During the renovation, the structural steel members appeared to have been cleaned of corrosion and repainted. Repairs to the cracks in the slab-on-grade were also done. Lastly, two reinforced concrete and concrete masonry unit (CMU) structures were added to the east and west gable ends of the original building. The new addition on the east side of the building is one story only and houses a small weight room. On the west side of the building, in contrast, the addition is two stories and includes bathrooms and offices/work-out rooms. All structural elements were observed to be in excellent condition following the renovation.

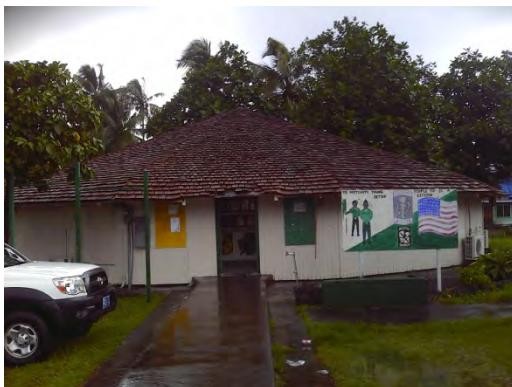
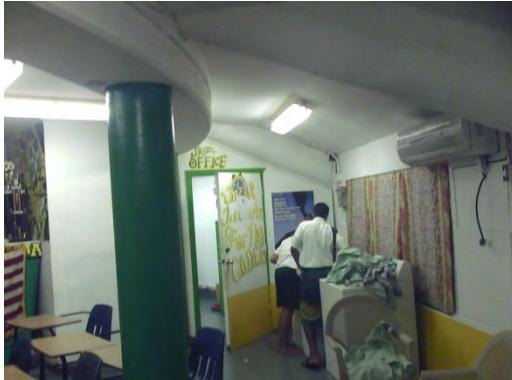
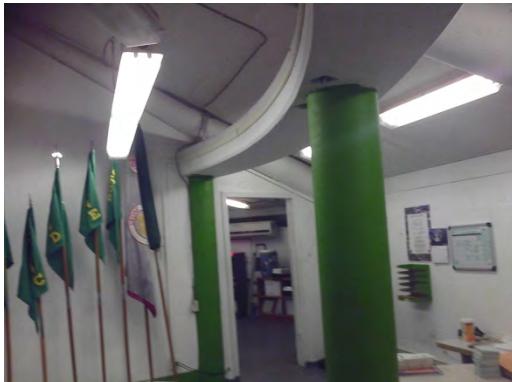
Phase II Site Visit (March 2013)

Building 3 (JROTC Building) is a circular-shaped reinforced concrete (columns and ring beams) and wood (stud walls and circular roof beams) framed false structure. In 2013, the building was occupied and used as classrooms. The building was found to be in overall fair condition mainly because of moderate termite and rot damage to the wood walls and beams. The slab-on-grade was also noted as uneven and settled.

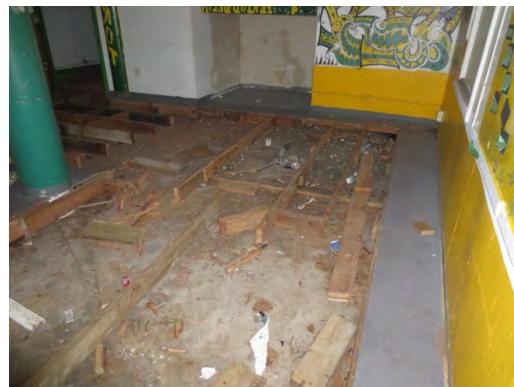
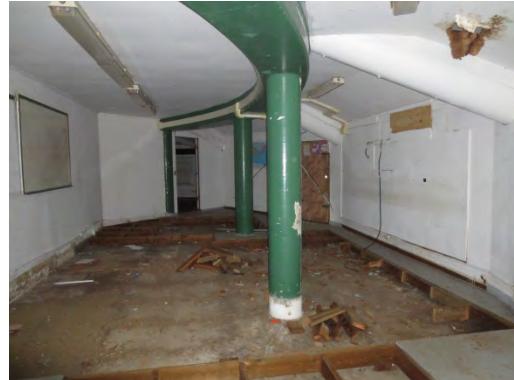
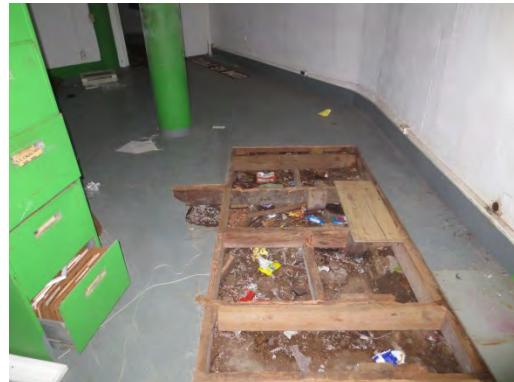
Phase III Site Visit (March 2015)

During the 2015 site visit, the building had been abandoned. A wood framed raised floor exists over the slab-on-grade. This raised floor was found to be in detrimental condition with large portions either collapsed or intentionally removed. Hence, a health and safety flag has been issued for the damaged raised floor.

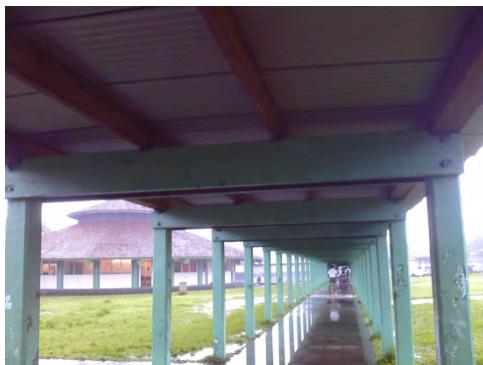
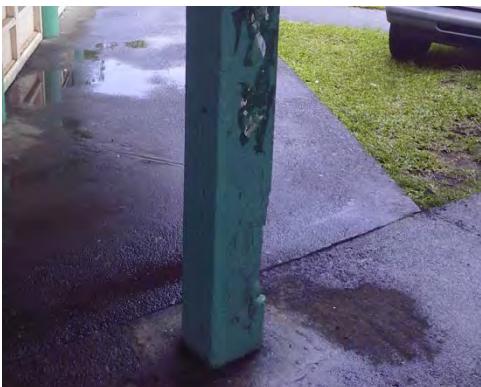
During the 2013 Phase II site visit, the walkway was found to be in overall fair condition. Some of the wood purlins were observed to have minor to moderate termite damage and/or wet rot. A concrete column was also found to have large cracks and spalls near the base. The metal roofing was missing along portions of the walkway.

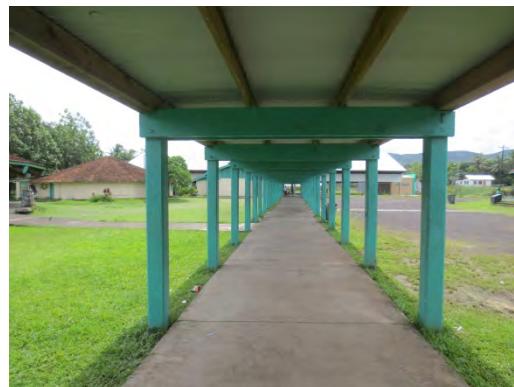
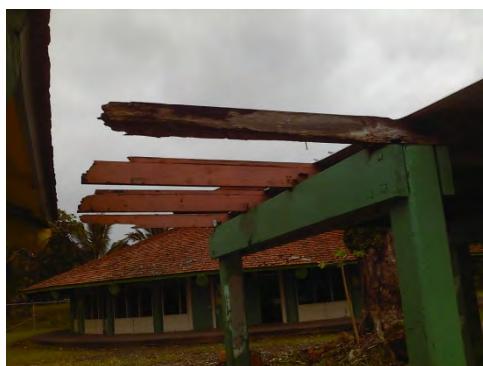
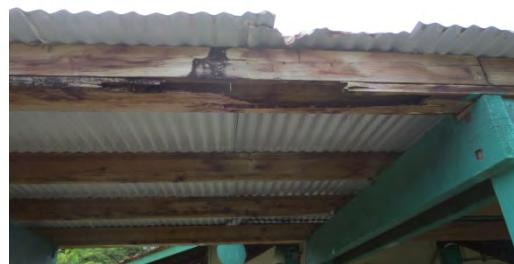
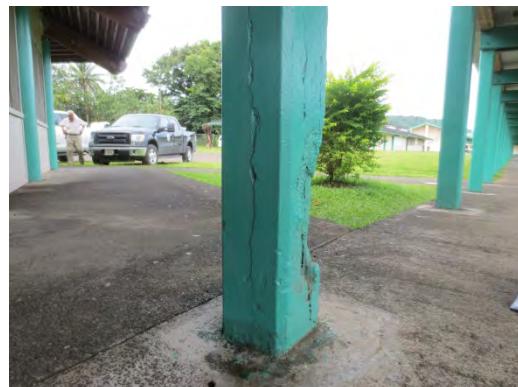
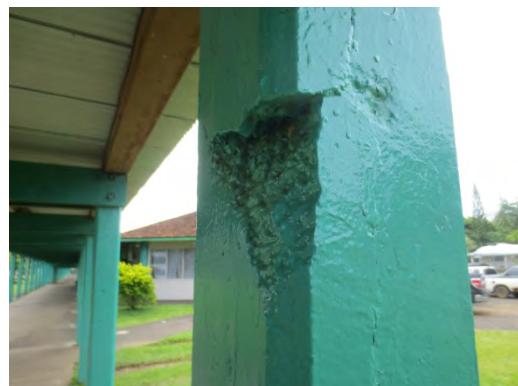
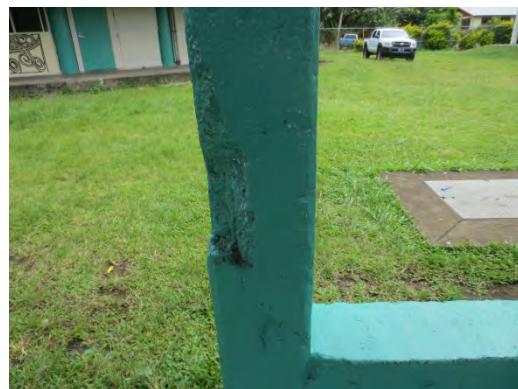
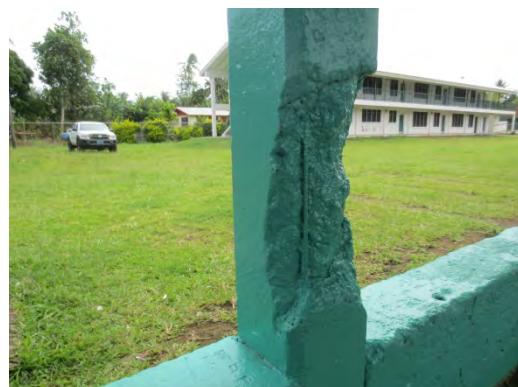
In 2015, during the Phase III site visit, extensive repairs to the walkway were observed. The repairs included replacement of damaged or missing wood purlins and metal roofing. Albeit localized in terms of location and extent, some termite-damaged purlins were still observed. The damaged column observed in 2013 has not been repaired. This time around, three other concrete columns were observed to have moderate to severe cracks and spalls. In one case, the column has severe loss of cross section. This item has, therefore, been identified as a health and safety concern. The damage to these last three columns was inadvertently overseen during the 2013 assessment.

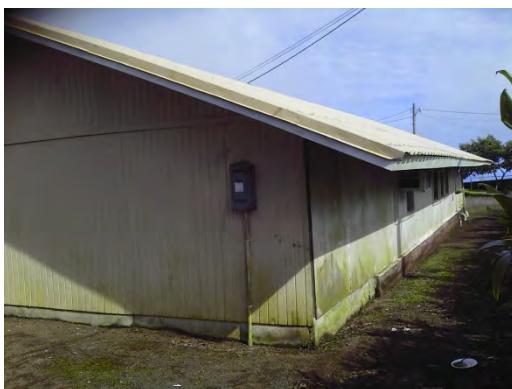
Phase II Site Visit (March 2013)

Building 1 (Classroom) is a single-story wood framed building with a gable roof. During the 2013 Phase II site visit, moderate to severe water damage was observed at the exterior wood siding. Water damage to the interior finish of the exterior walls was also observed. Due to the breach in the exterior envelope, damage to the perimeter structural wood bearing walls was determined to be very likely. At the time of the 2015 Phase III site visit, the building had undergone extensive renovation. The exterior siding had been repaired and/or replaced. It is unknown whether repairs to the wood bearing walls, if any were required, were performed. The perimeter walls appeared to be in excellent condition both from the exterior and from the interior.

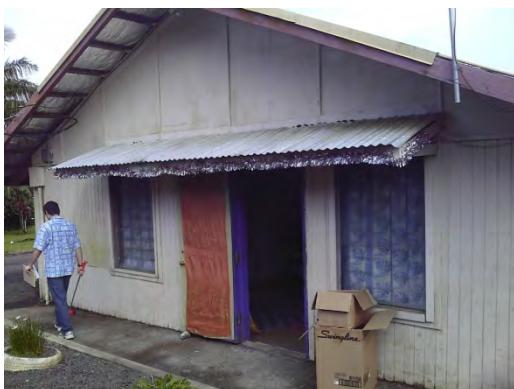
Phase II Site Visit (March 2013)

Building 2 (Classroom) is a single-story wood framed building with a gable roof. During the 2013 Phase II site visit, moderate to severe water damage was observed at the exterior wood siding. Water damage to the interior finish of the exterior walls was also observed. Due to the breach in the exterior envelope, damage to the perimeter structural wood bearing walls was determined to be very likely. At the time of the 2015 Phase III site visit, the building had undergone extensive renovation. The exterior siding had been repaired and/or replaced. It is unknown whether repairs to the wood bearing walls, if any were required, were performed. The perimeter walls appeared to be in excellent condition both from the exterior and from the interior.

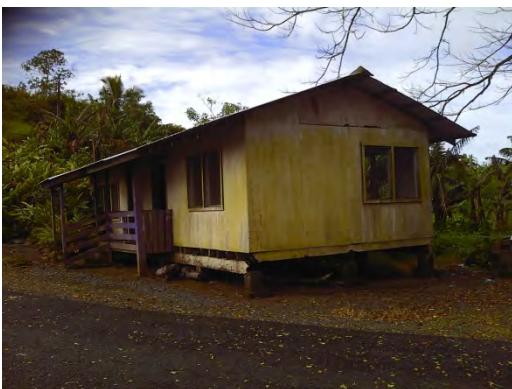
Phase II Site Visit (March 2013)

Building 7 is a single-story wood framed building. During the 2013 site visit, the building was identified as abandoned. Due to the overall decrepit condition of the structure (the floor joists and beams in particular), a life safety tag was assigned to the building. It was recommended that the building be demolished because of its detrimental condition its relatively low monetary value.

Two year later, the building is still abandoned and its condition has not changed. The recommendation that the building be demolished remains.

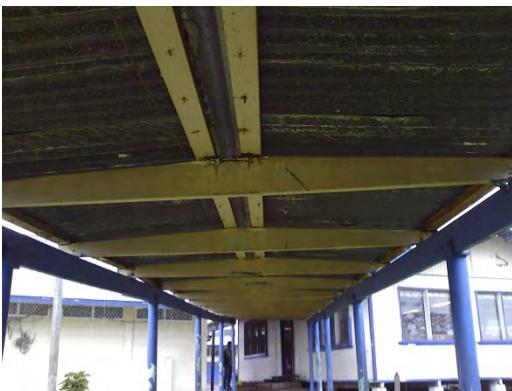
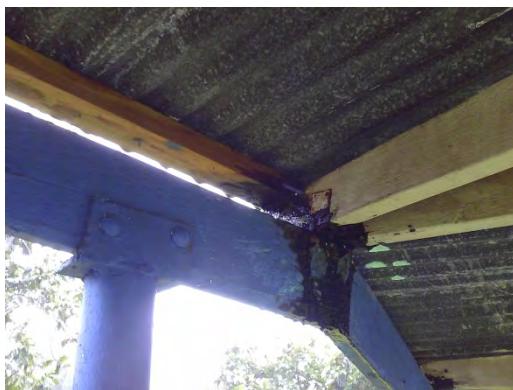
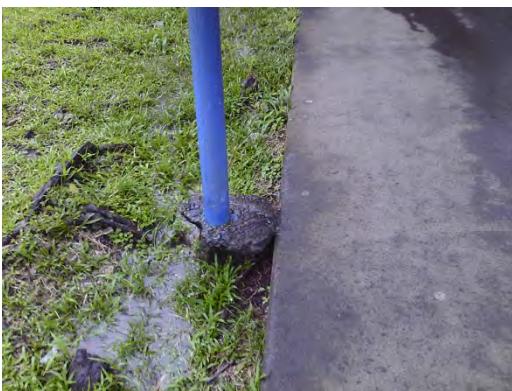
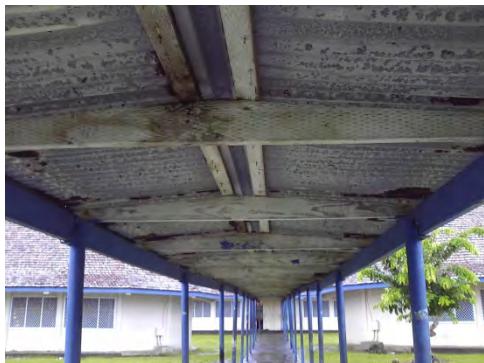
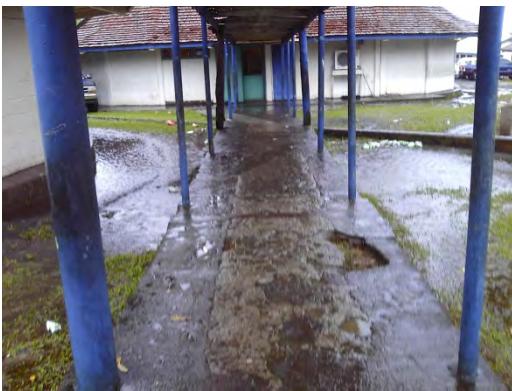
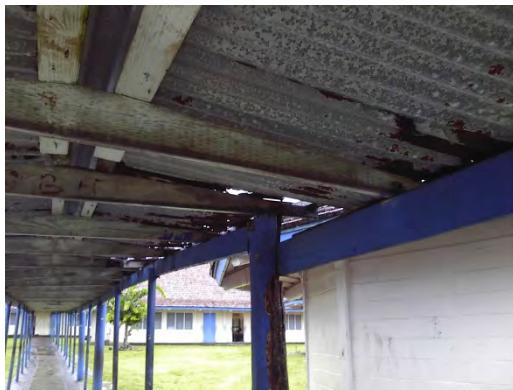
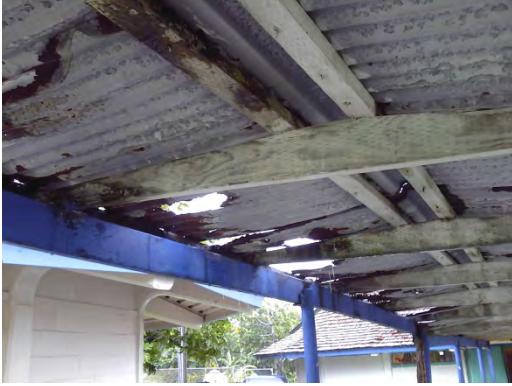
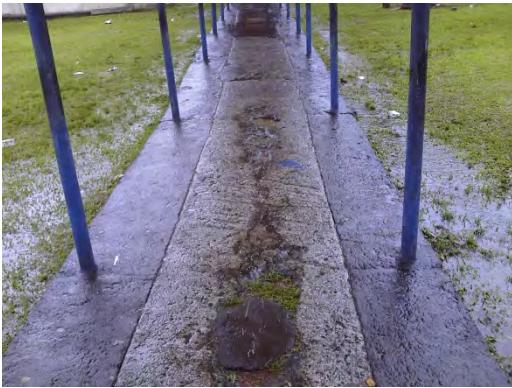
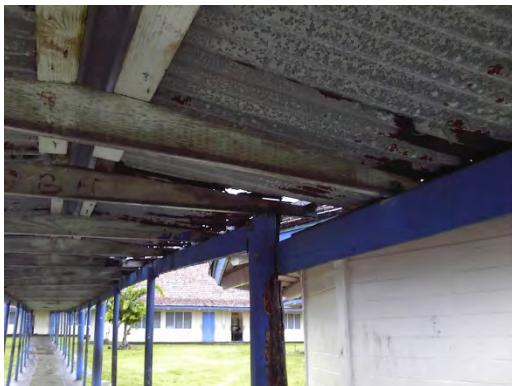
In 2013, the roofs at both walkways were observed to be in fair to poor condition. The wood beams, rafters, and battens exhibited extensive termite and wet rot damage. The columns were also found to be in detrimental condition, especially cases where the columns were made out of wood (this condition was typical of the walkway connecting Buildings 13 through 20). One wood column in particular was found near the point of collapse and was given a life safety tag. In the case of steel columns, the foundation was exposed and appeared to be just a blob of concrete completely above grade (this condition was more prominent on the walkway connecting Buildings 13 through 20).

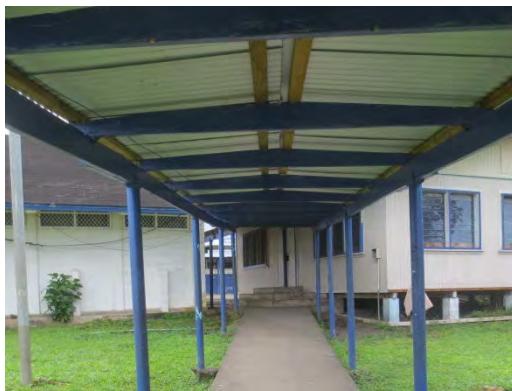
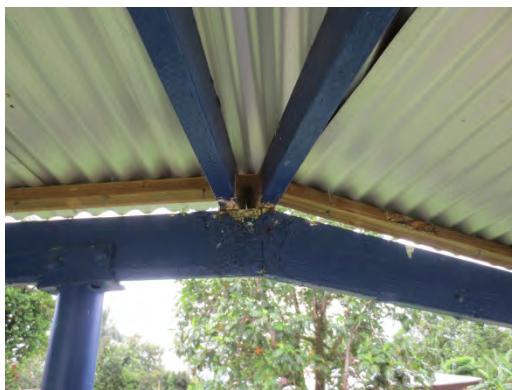
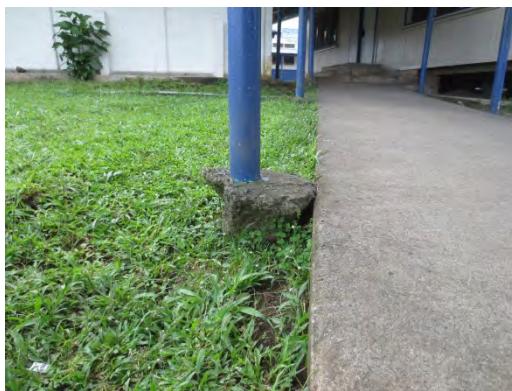
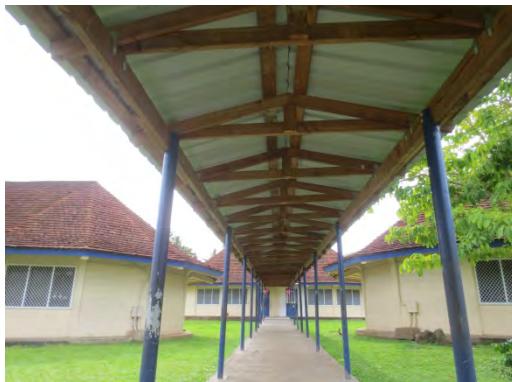
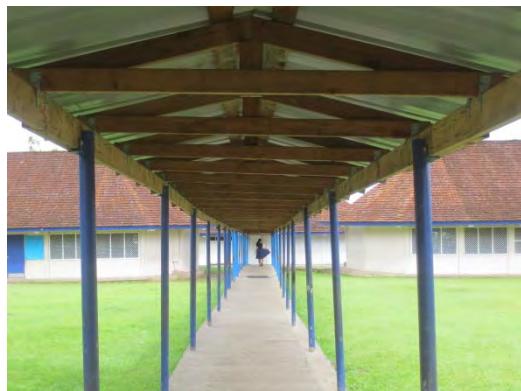
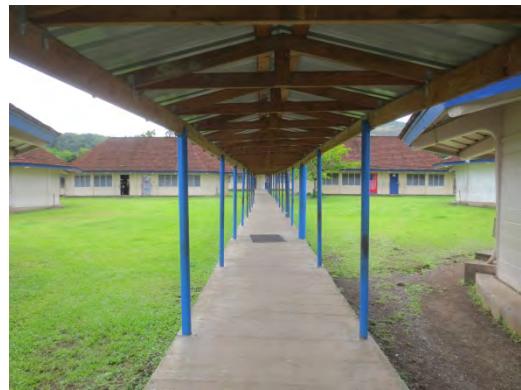
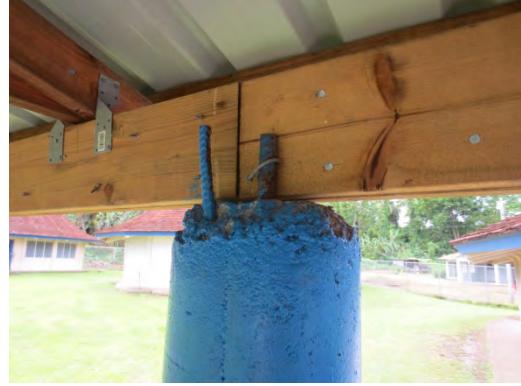
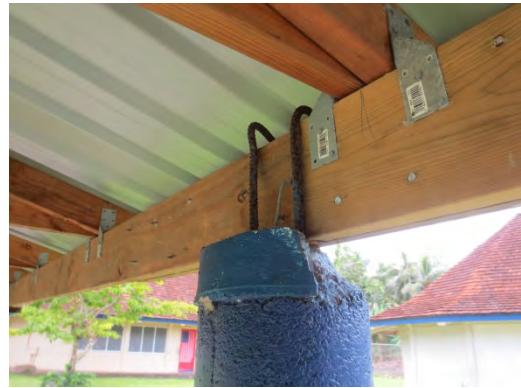
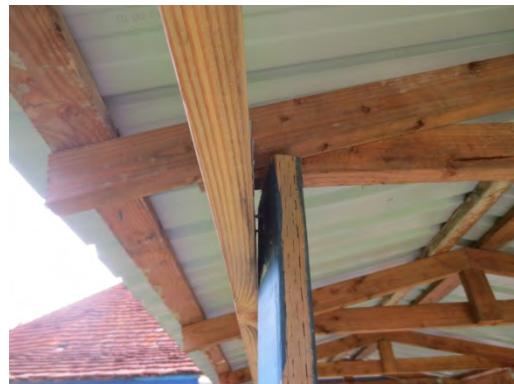
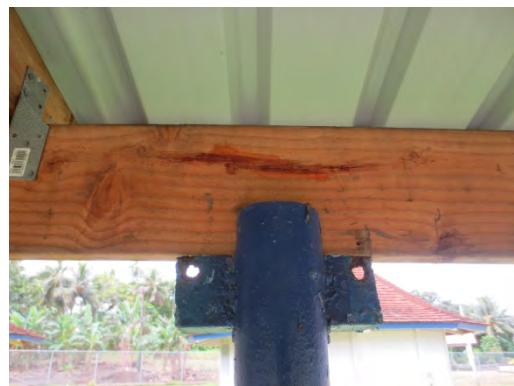
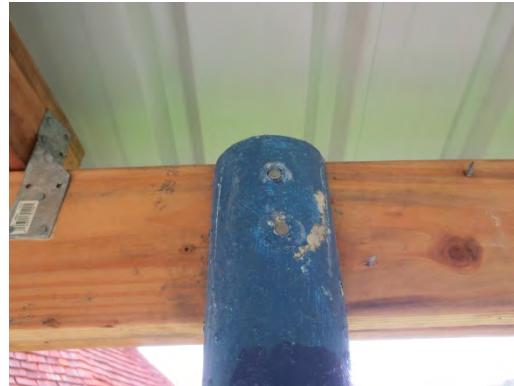
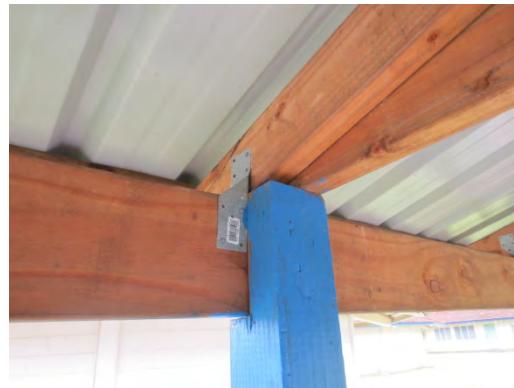
Two years later, during the Phase III site visit, it was observed that the walkway connecting Buildings 13 through 20 had been renovated. The roof had been completely replaced with wood trusses supported on wood beams. The metal roofing appeared to be new as well. The original steel and concrete columns were retained and the wood columns, including the one that had triggered the health and safety tag, were replaced with new wood columns. A new concrete slab-on-grade was poured over the existing slab-on-grade effectively encapsulating some of the exposed foundation at the base of the steel columns. The connections between the new roof beams and the existing/new columns remain of many different types. In some cases, the connections appear incomplete, with missing fasteners, metal connectors, or other fittings.

The walkway connecting Buildings 3 and 4, in contrast, was only given a cosmetic makeover consisting of new metal roofing, paint, and the random replacement of few termite damaged wood members at the roof. The foundation at the base of the steel columns remains exposed at this walkway.

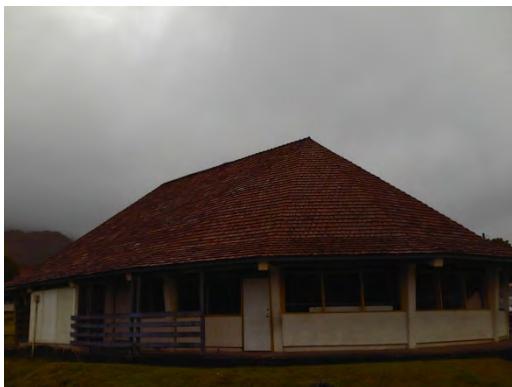
Phase II Site Visit (March 2013)

Building 9 (Administration/Library) is an oval-shaped reinforced concrete and wood framed fale structure. During the 2013 site visit, this two-story building (there is a partial mezzanine) was undergoing renovation. Minor to moderate termite damage was observed at the roof framing. Severe damage was found at the exterior wood walls.

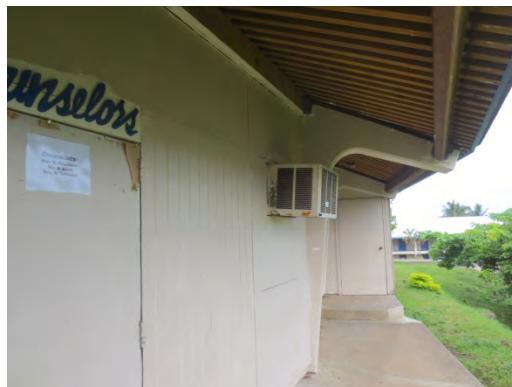
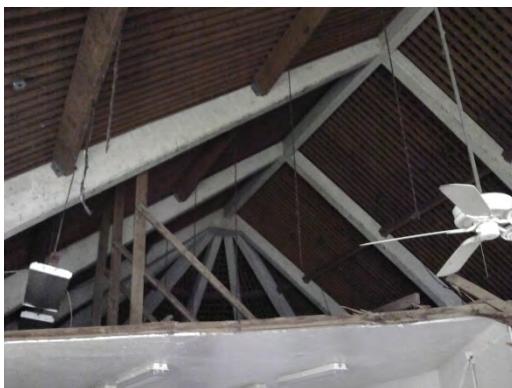
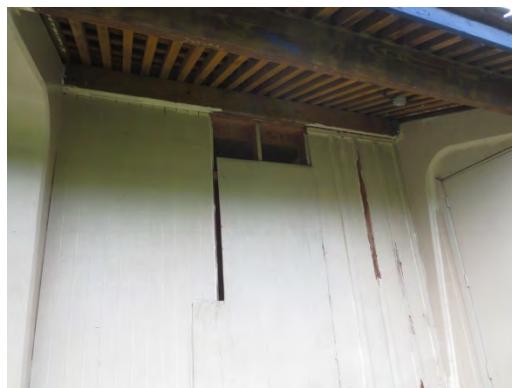
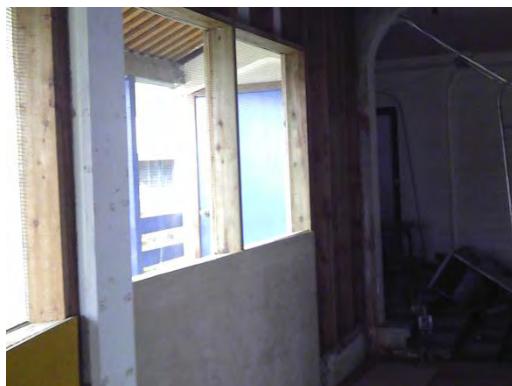
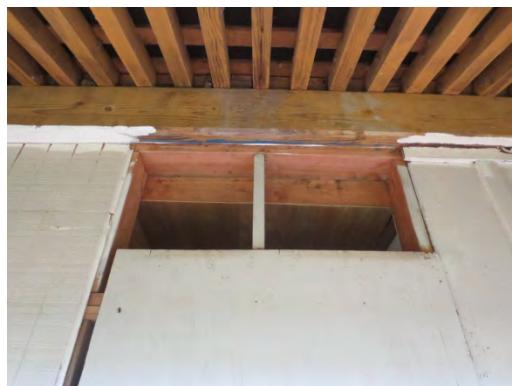
Phase III Site Visit (March 2015)

The renovation of the building had been completed by 2015. The building currently houses a library, classrooms, storage rooms, and a server room. The structure was overall found to be in good conditions. Roof wood framing appeared to have been replaced where the damage was extensive. The exterior wood walls also appeared to be in good condition with only one bay exhibiting some termite damage.

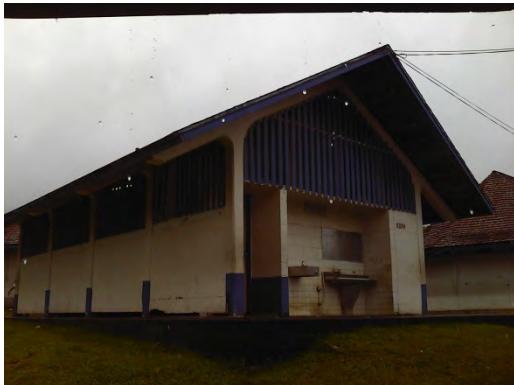
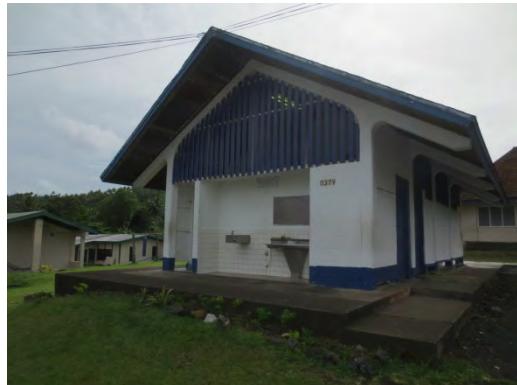
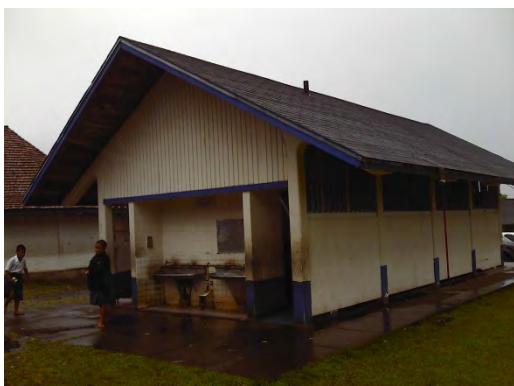
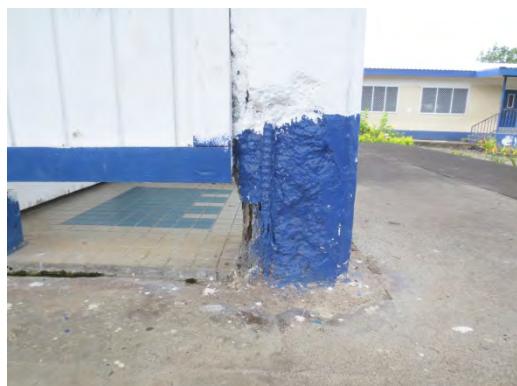
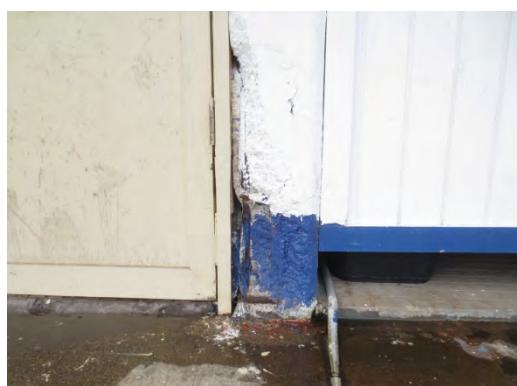
Building 12 (Restroom) is a typical rectangular-shaped reinforced concrete and wood framed fale structure. During both the 2013 and 2015 site visits, two columns were observed to have spalls near the base. Reinforcing bars are exposed at both columns.

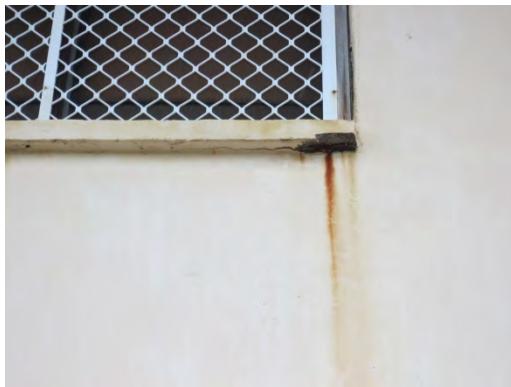
Phase II Site Visit (March 2013)

Building 8 (Classroom) is a two-story building with a reinforced concrete (columns, walls, beams, and second floor slab) and steel (purlins and beams) superstructure. During the 2013 Phase II site visit, a small spall was observed at the top of the sill at one of the second floor windows. This spall was not identified as a health and safety concern due to its small size. In a similar fashion as the second floor, a complete portion of the sill at one first floor windows was found to have completely detached.

During the 2015 Phase III site visit, staff from the Department of Public Works indicated that spalls at the top of the window sills is a common occurrence on the east façade of the building. Upon observing the entire east façade of the building, it was found that spalls indeed exist consistently on top of the first and second floor window sills. In some instances where the spalls had progressed more extensively, the horizontal reinforcing bar in the sill is exposed. Observation of the spalls revealed that the horizontal reinforcing bar has absolutely no cover at the bottom and hence the spalls initiate easily and progress rapidly.

In the case of the second floor, the spalls at the sill constitute a health and safety hazard since loose fragments can detach and fall onto the building occupants below. The spalls with exposed reinforcing at the first floor also pose a health and safety concern since the bars can hurt a building occupant that leans or falls against the sill.

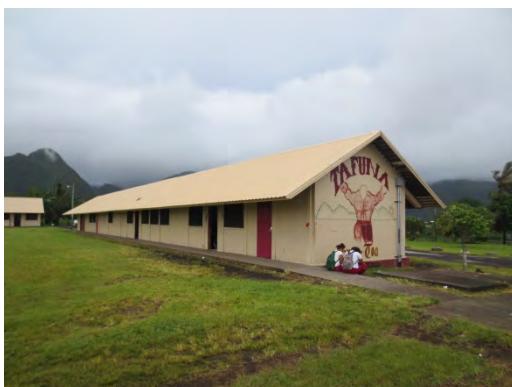
Phase II Site Visit (March 2013)

Building 11 (Classroom Building) is a typical rectangular-shaped reinforced concrete and wood framed fale structure. It was mentioned by school officials and by Department of Public Works staff that the building was originally built by the US Navy and used as barracks. During the 2013 Phase II site visit, several concrete columns (8-inch square) were observed to have moderate to extensive cracking and spalling on their exterior face near the base. The spalls are more frequent and prominent on the south and east facing sides of the building. In some instances, the spalls had led to minor to moderate loss of column cross section.

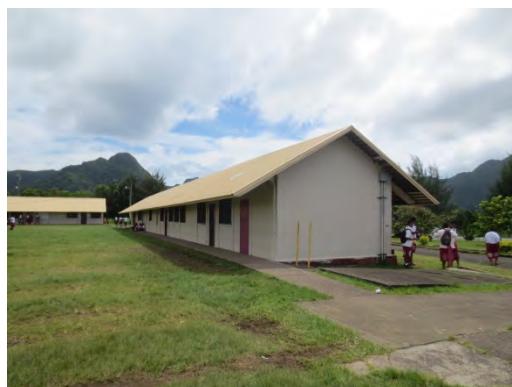
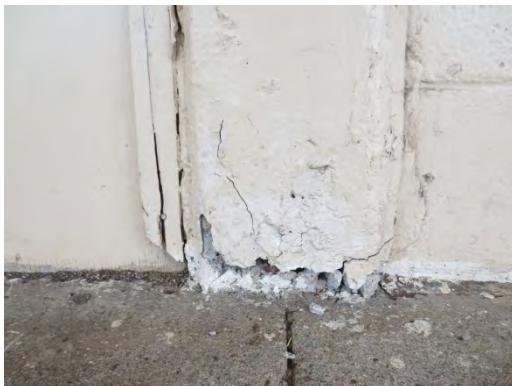
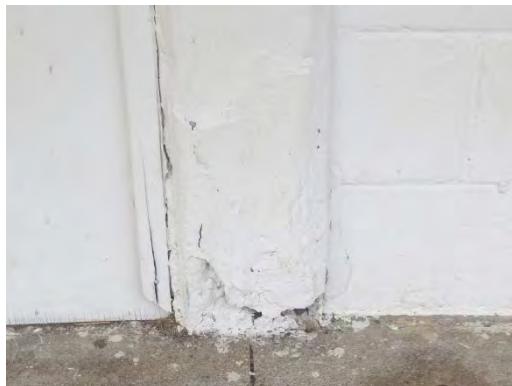
Phase III Site Visit (March 2015)

During the 2015 Phase III site visit, it was observed that none of the columns had been repaired. The spalls have progressed and, in some cases, loose chunks of concrete have blown off leaving the reinforcing bars exposed. Loss of column cross section has also increased further and is now moderate in a few cases.

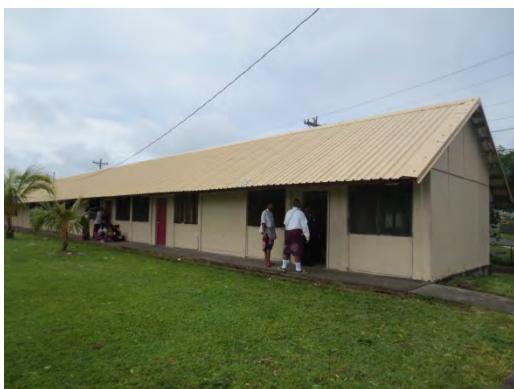
Phase II Site Visit (March 2013)

Building 13 (Classroom Building) is a typical rectangular-shaped reinforced concrete and wood framed fale structure. It was mentioned by school officials and by Department of Public Works staff that the building was originally built by the US Navy and used as barracks. During the 2013 Phase II site visit, almost every concrete column (8-inch square) on the south facing side of the building was observed to have moderate to extensive cracking and spalling on their exterior face near the base. In some instances, the spalls had led to severe loss of column cross section. A life safety flag was, therefore, assigned to the damaged concrete columns.

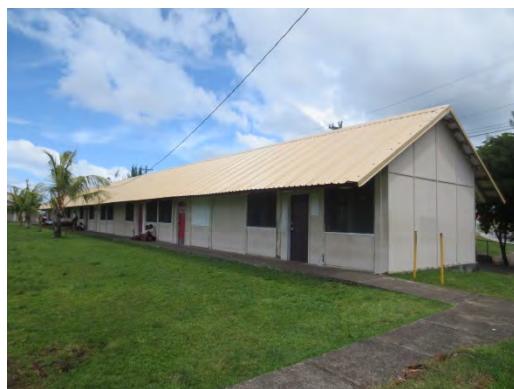
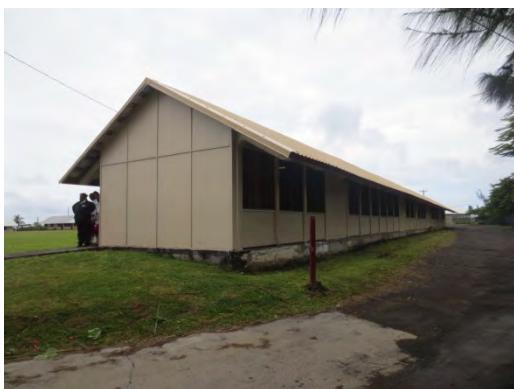
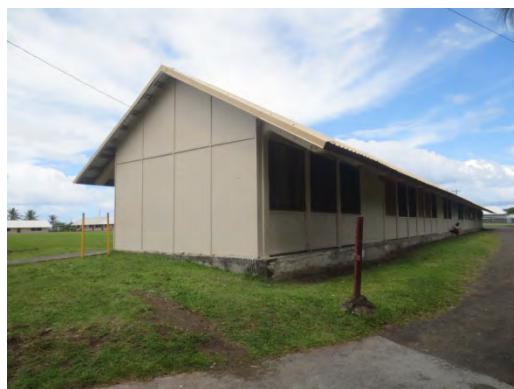
Phase III Site Visit (March 2015)

During the 2015 Phase III site visit, it was observed that none of the columns had been repaired. The spalls have progressed and, in some cases, loose chunks of concrete have blown off leaving the reinforcing bars exposed. Loss of column cross section has also increased further to the point where more than 40% of the cross section has been lost. The health and safety tag remains effective for these damaged columns.

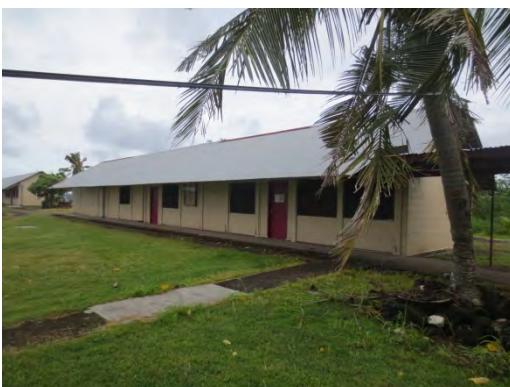
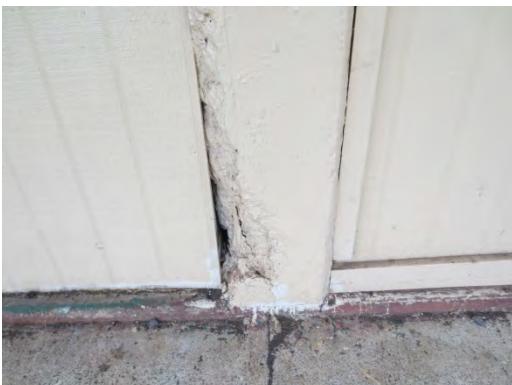
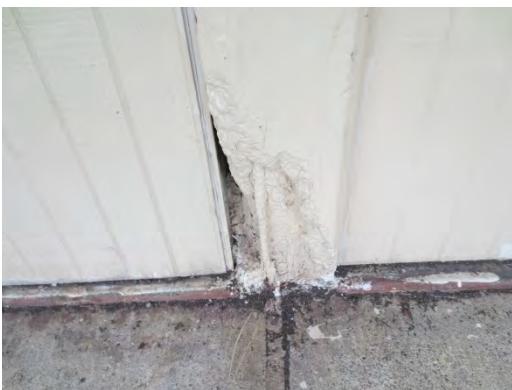
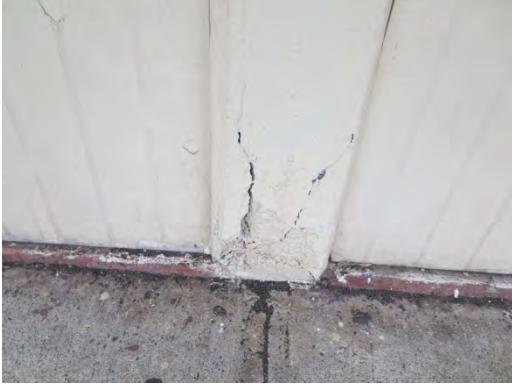
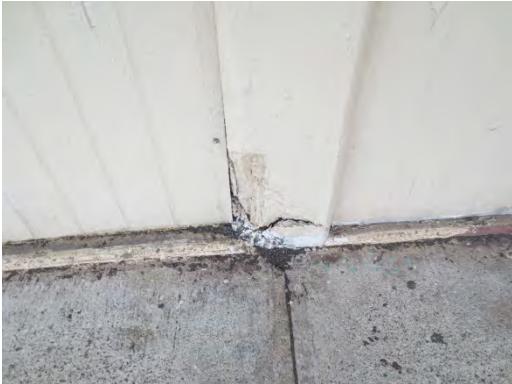
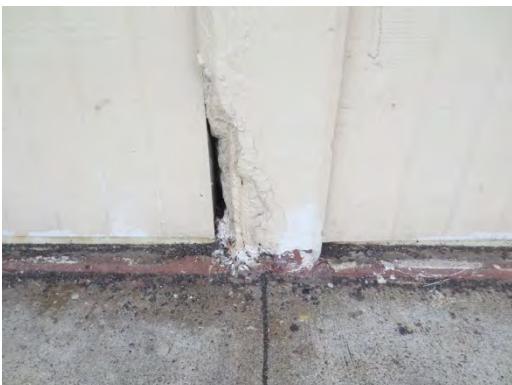
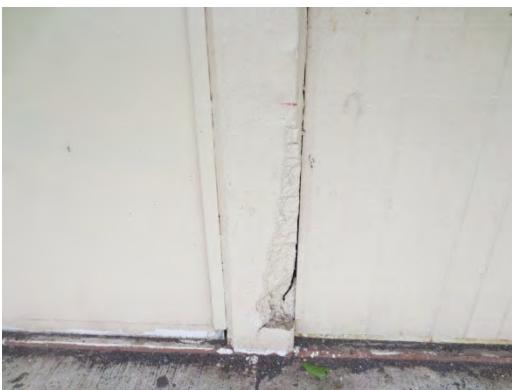
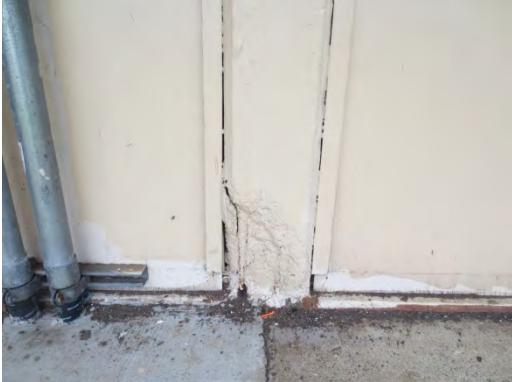
Phase II Site Visit (March 2013)

Building 15 (Classroom Building) is a typical rectangular-shaped reinforced concrete and wood framed fale structure (partial mezzanine exists in this building). It was mentioned by school officials and by Department of Public Works staff that the building was originally built by the US Navy and used as barracks. During the 2013 Phase II site visit, almost every concrete column (8-inch square) on the east facing side of the building was observed to have moderate to extensive cracking and spalling on their exterior face near the base. In some instances, the spalls had led to minor to moderate loss of column cross section.

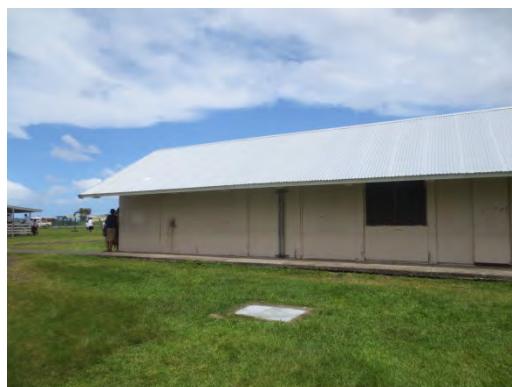
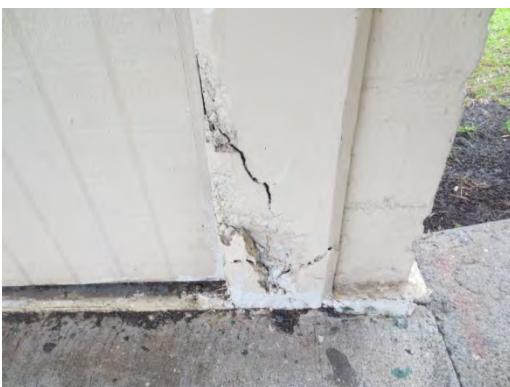
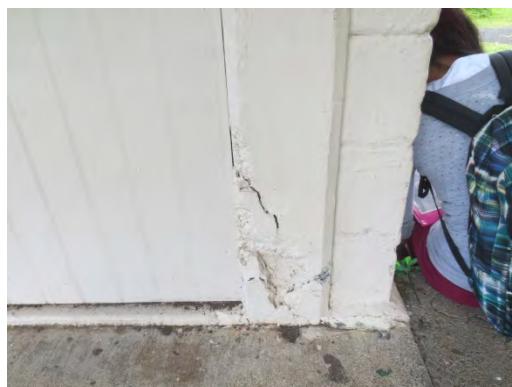
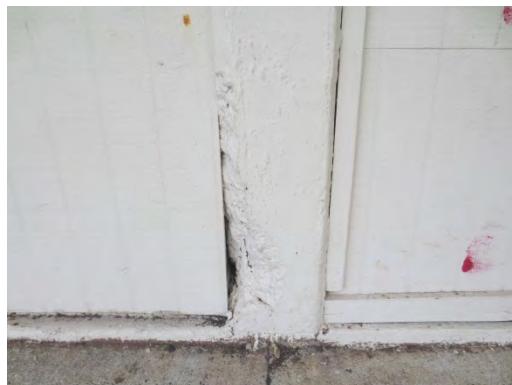
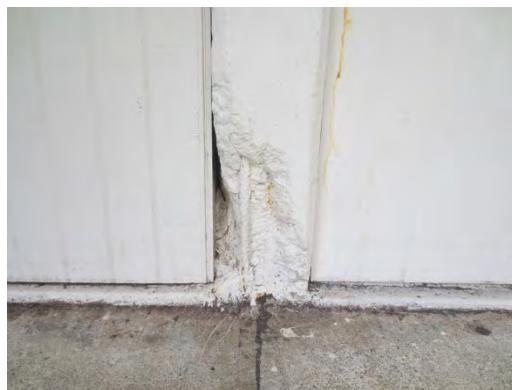
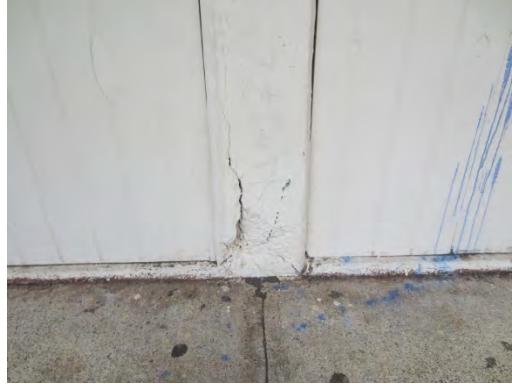
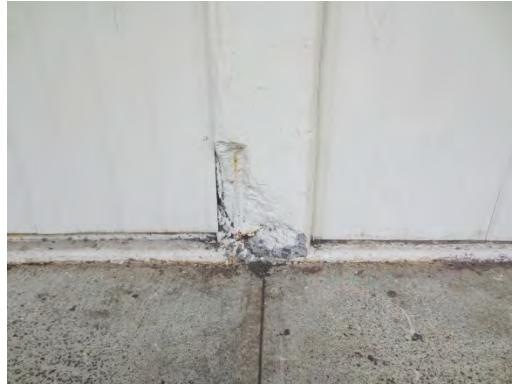
Phase III Site Visit (March 2015)

During the 2015 Phase III site visit, it was observed that none of the columns had been repaired. The spalls appear to have progressed slightly but no major loose chunks of concrete have blown off leaving more reinforcing bars exposed. Increases in loss of column cross section were not evident at any of the columns in this building
