# **INSULAR ABC'S INITIATIVE**

## **Phase III Task 1 Findings and Recommendations**

### **American Samoa**

October 2015

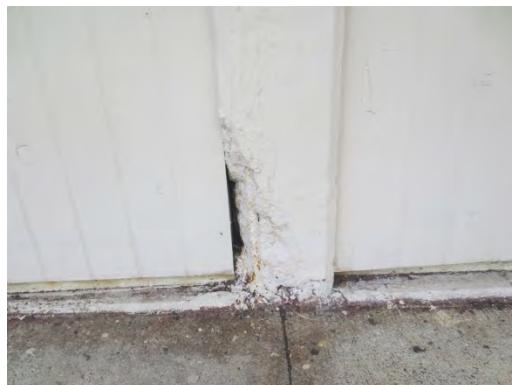
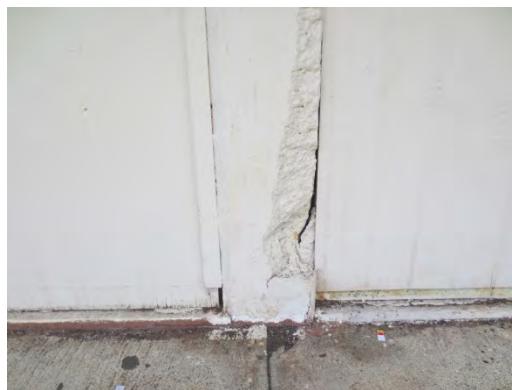
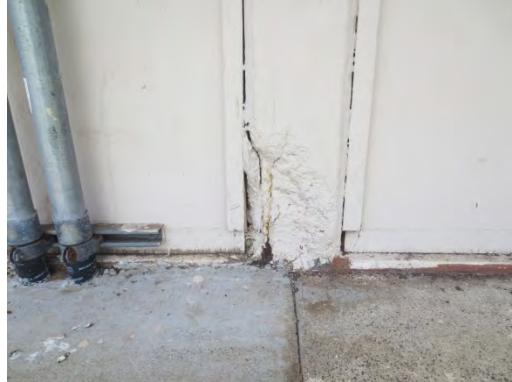
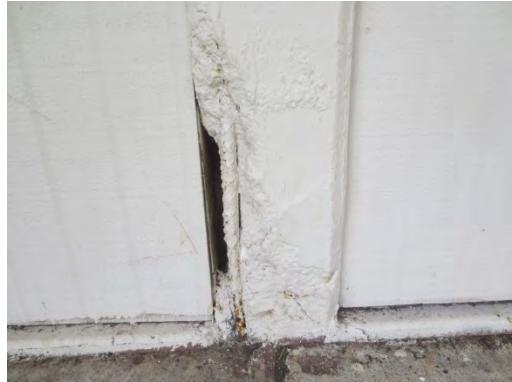
Phase III Site Visit (March 2015)

During the 2015 Phase III site visit, it was observed that none of the columns had been repaired. The spalls appear to have progressed slightly but no major loose chunks of concrete have blown off leaving more reinforcing bars exposed. Increases in loss of column cross section were not evident at any of the columns in this building

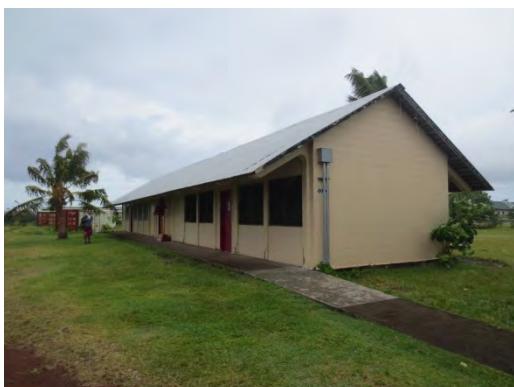
Phase II Site Visit (March 2013)

Building 16 (Classroom Building) is a typical rectangular-shaped reinforced concrete and wood framed fale structure. It was mentioned by school officials and by Department of Public Works staff that the building was originally built by the US Navy and used as barracks. During the 2013 Phase II site visit, almost every concrete column (8-inch square) on the east facing side of the building was observed to have moderate to extensive cracking and spalling on their exterior face near the base. In some instances, the spalls had led to severe loss of column cross section. A life safety flag was, therefore, assigned to the damaged concrete columns.

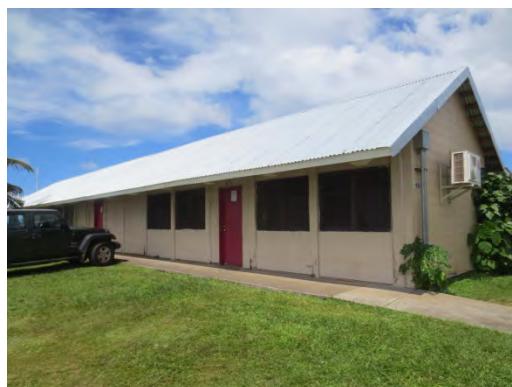
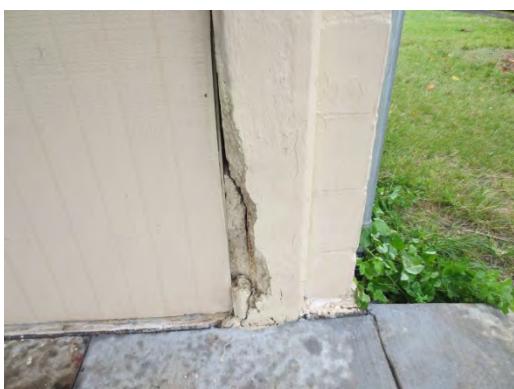
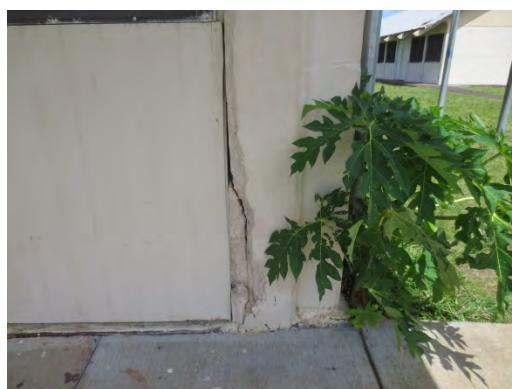
Phase III Site Visit (March 2015)

During the 2015 Phase III site visit, it was observed that none of the columns had been repaired. The spalls have progressed and, in some cases, loose chunks of concrete have blown off leaving the reinforcing bars exposed. Slight increases in loss of cross section were evident at several columns in this building. The health and safety tag remains effective for these damaged columns.

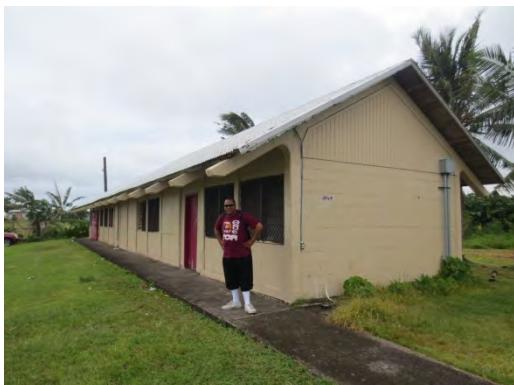
Phase II Site Visit (March 2013)

Building 17 (Classroom Building) is a typical rectangular-shaped reinforced concrete and wood framed fale structure. It was mentioned by school officials and by Department of Public Works staff that the building was originally built by the US Navy and used as barracks. During the 2013 Phase II site visit, almost every concrete column (8-inch square) on the south facing side of the building was observed to have moderate to extensive cracking and spalling on their exterior face near the base. In some instances, the spalls had led to severe loss of column cross section. A life safety flag was, therefore, assigned to the damaged concrete columns.

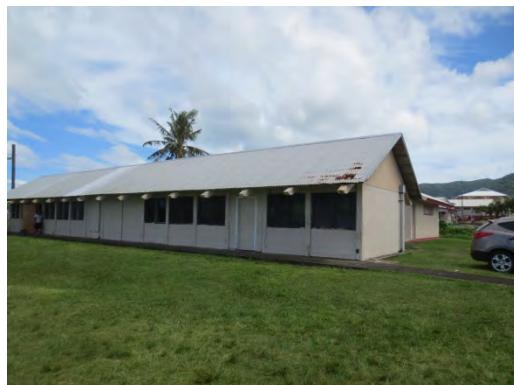
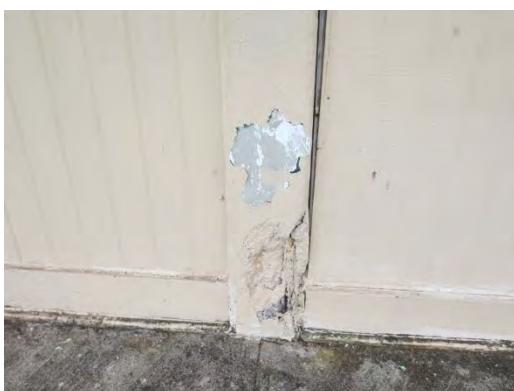
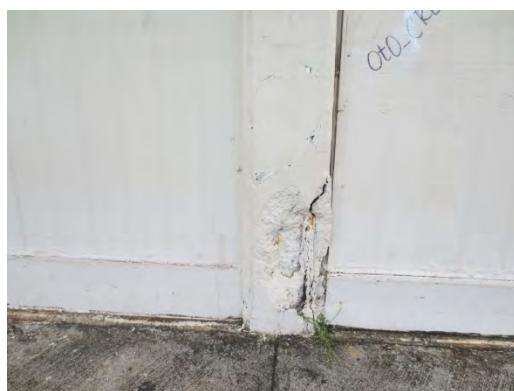
Phase III Site Visit (March 2015)

During the 2015 Phase III site visit, it was observed that none of the columns had been repaired. The spalls have progressed and, in some cases, loose chunks of concrete have blown off leaving the reinforcing bars exposed. Loss of column cross section has also increased further to the point where more than 40% of the cross section has been lost. The health and safety tag remains effective for these damaged columns.

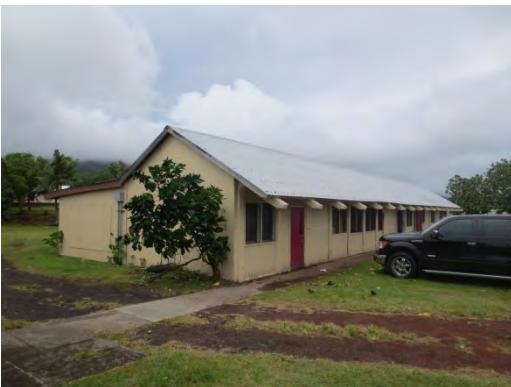
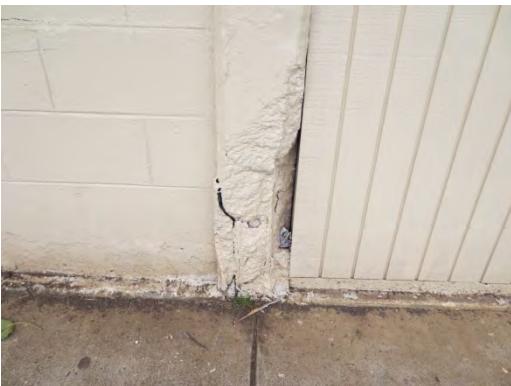
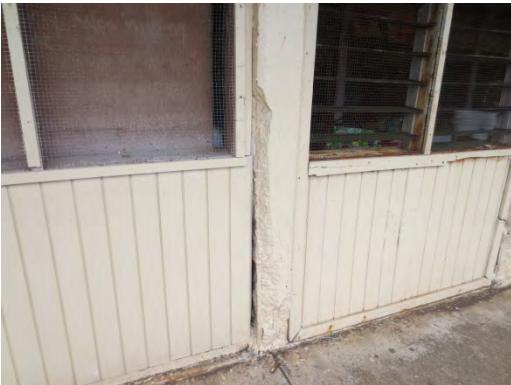
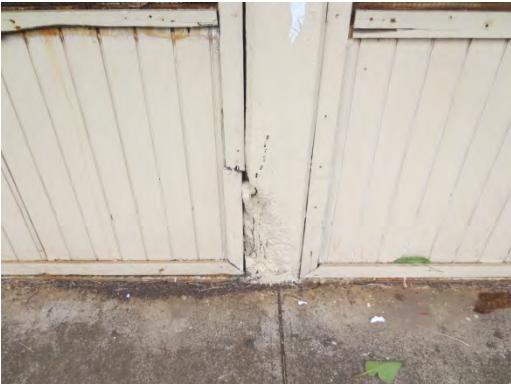
Phase II Site Visit (March 2013)

Building 18 (Classroom Building) is a typical rectangular-shaped reinforced concrete and wood framed fale structure with a rectangular addition to its north. It was mentioned by school officials and by Department of Public Works staff that the building was originally built by the US Navy and used as barracks. During the 2013 Phase II site visit, almost every concrete column (8-inch square) on the south facing side of the building was observed to have moderate to extensive cracking and spalling at the exterior face near the base. The interior columns (once exterior columns before the addition on the north side of the building) were also found to have moderate so severe spalling along their height with large concentrations near the base. In some instances, the spalls had led to severe loss of column cross section. In a few cases, more than half of the column cross section was observed to have been compromised. A life safety flag was, therefore, assigned to the damaged concrete columns.

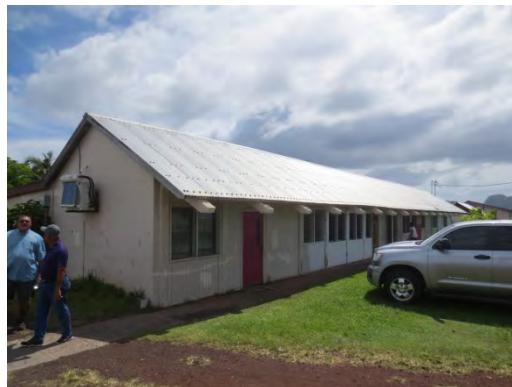
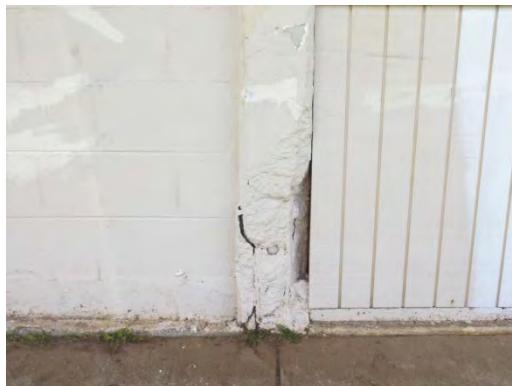
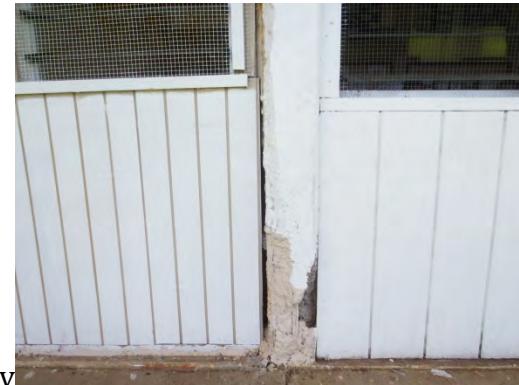
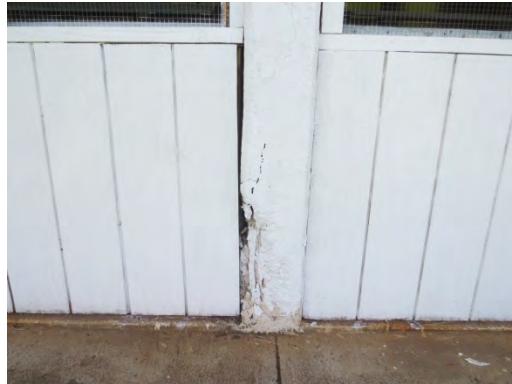
Phase III Site Visit (March 2015)

During the 2015 Phase III site visit, it was observed that none of the exterior columns had been repaired. The spalls have progressed and, in some cases, loose chunks of concrete have blown off leaving the reinforcing bars exposed. Loss of column cross section has also progressed. In the case of the interior columns (where the most severe loss of cross section was observed back in 2013), repairs appeared to have been performed. One of the teachers explained that as part of a class assignment, the students prepared a mortar and patched the damaged columns. The surface preparation carried on as well as the type of mortar used are not known. It is also unknown whether the damaged reinforcing bars were cleaned and/or replaced as required. Since the repair is evidently a non-engineered repair, the health and safety tag remains effective for these columns.

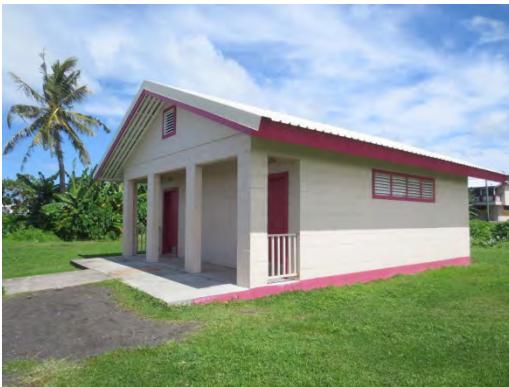
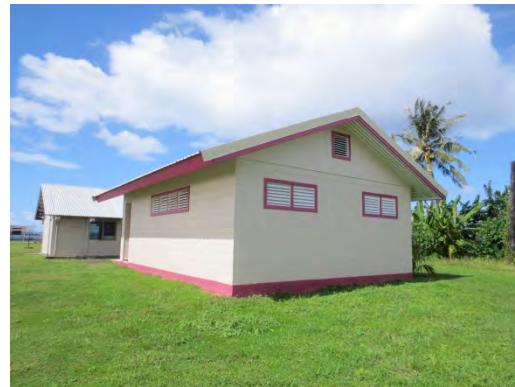
Phase III Site Visit (March 2015)

Building 24 (Restroom Building) is a building recently completed on the lower campus at Tafuna High School. The single-story building is constructed with concrete masonry unit (CMU) interior and exterior walls and with a wood framed roof. Foundations are reinforced concrete and are concealed below grade. All structural elements were observed to be in excellent condition at the time of the Phase III visit.

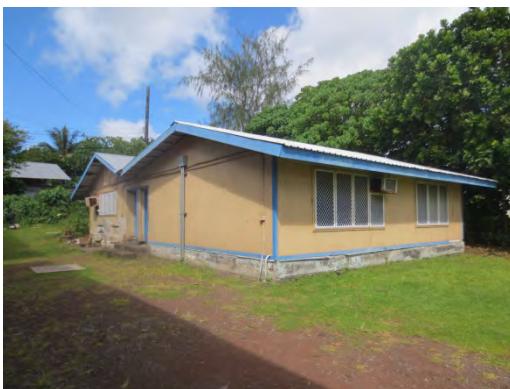
Phase II Site Visit (March 2013)

Building 2 (Computer Lab/ Storage) is a wood framed single story building. During the 2013 site visit, the structure was found to be in fair to poor condition. The suspended floor framing (wood joists with wood decking) on the west portion (storage) of the building was severely damaged and partially collapsed. This item was identified as a life-safety concern. At the time of this visit, only the east portion (computer lab) of the building was occupied.

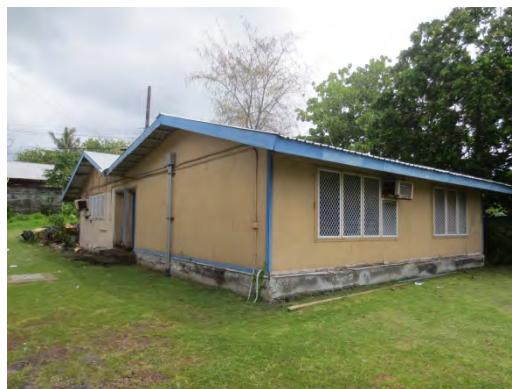
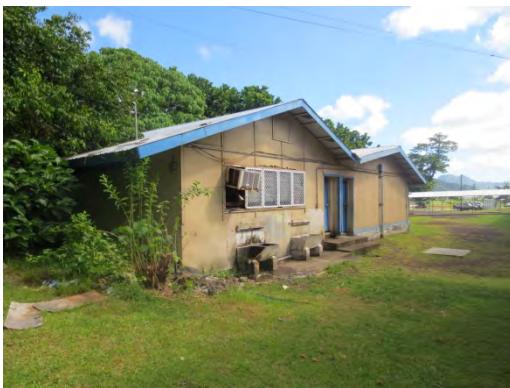
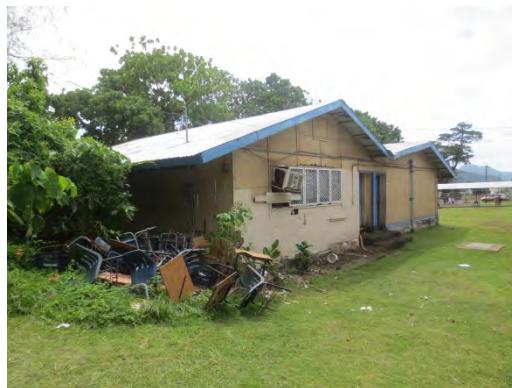
Phase III Site Visit (March 2015)

Two years later, during the Phase III site visit, this building was not occupied. Staff from the Department of Public Works (DPW) communicated that the building had been condemned and that it was scheduled for demolition in the short term. Its condition was, therefore, not assessed during this last site visit.

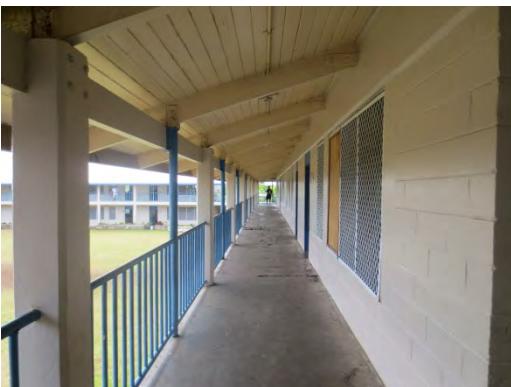
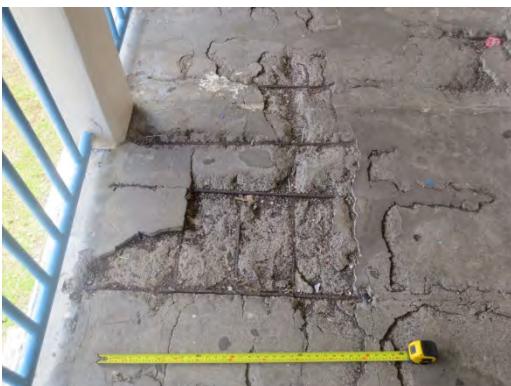
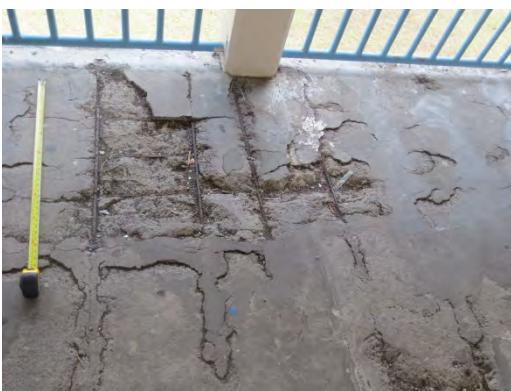
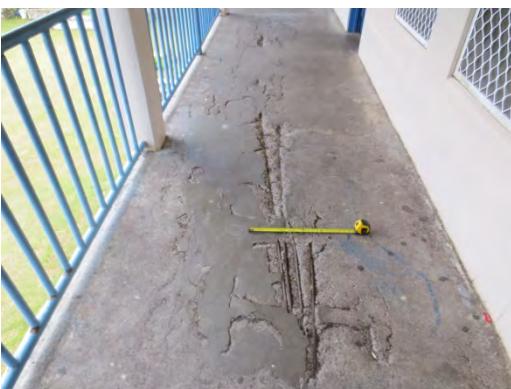
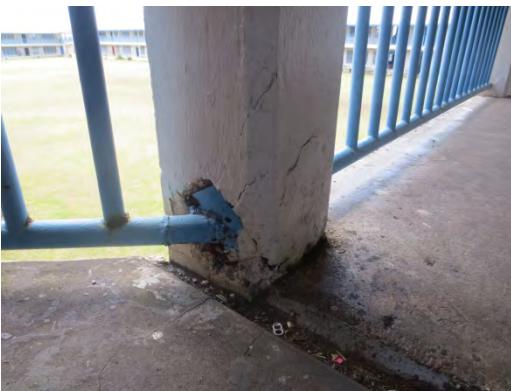
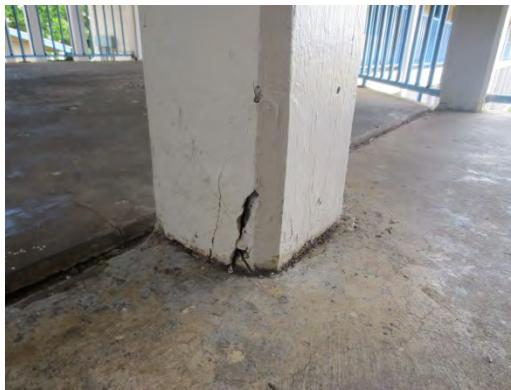
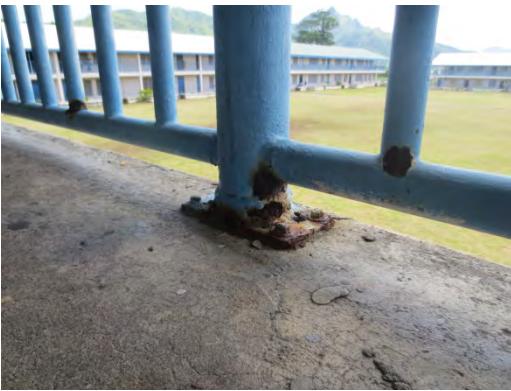
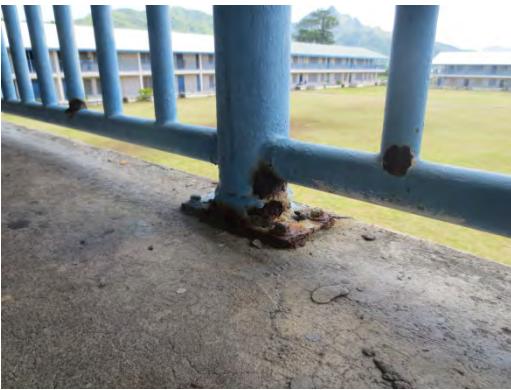
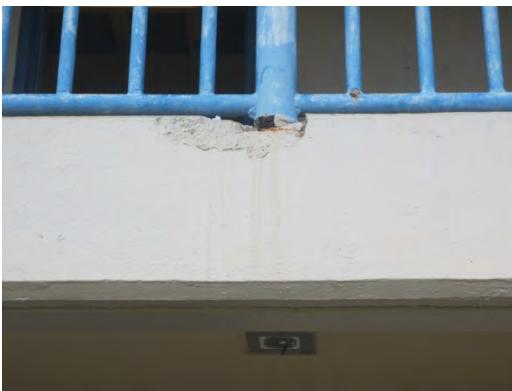
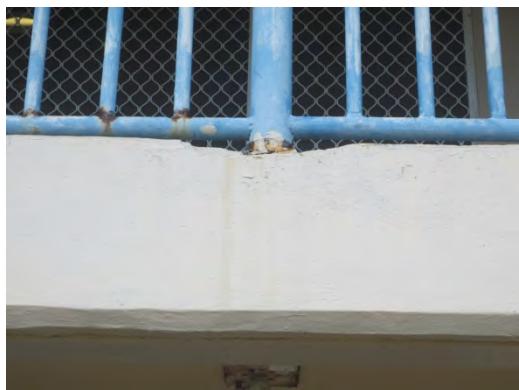
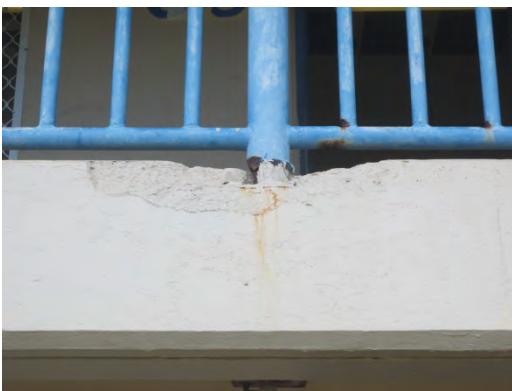
Phase II Site Visit (March 2013)

Building 7 (Classroom Building) is a two-story building with a reinforced concrete (footings, columns, beams, and second floor slab), concrete masonry unit (exterior and interior walls), and wood (timber roof trusses) superstructure. During the 2013 Phase II site visit, several elements were identified to be in poor condition. The second floor exterior slab had extensive and widespread cracks and spalls at the top. Reinforcing was exposed in the majority of the spalls. Spalls were also observed at the bottom of two of the second floor exterior concrete columns. At the second floor, the structural steel columns supporting the roof at the walkway were observed to exhibit moderate to severe corrosion near the base plate. The corrosion had resulted in spalls at the edge of the second floor slab.

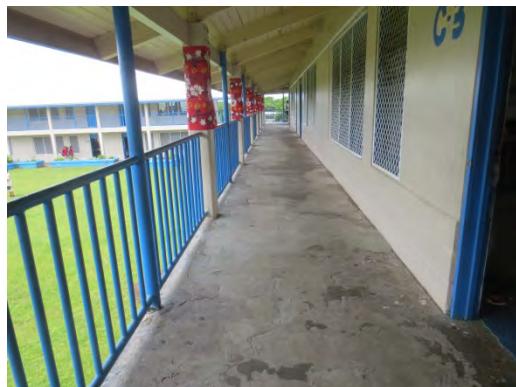
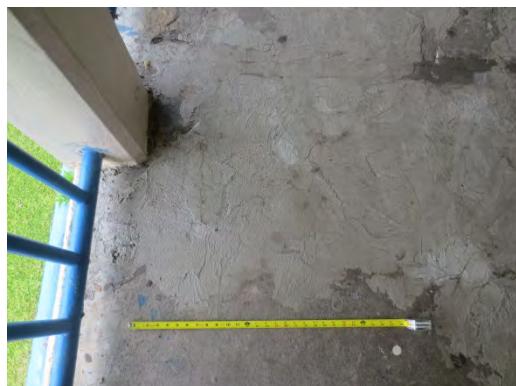
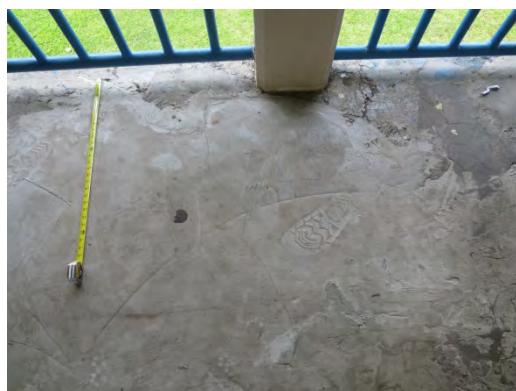
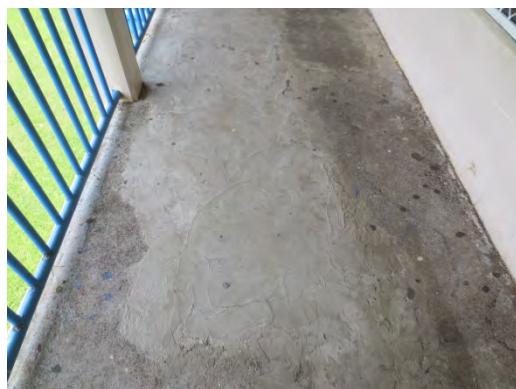
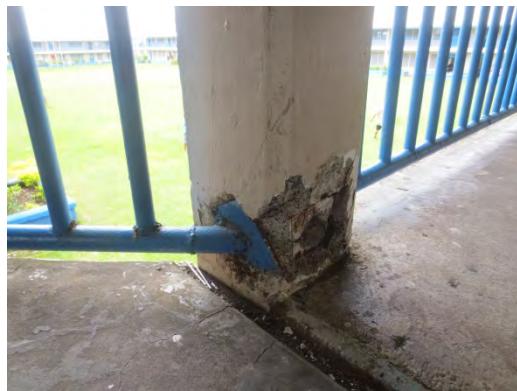
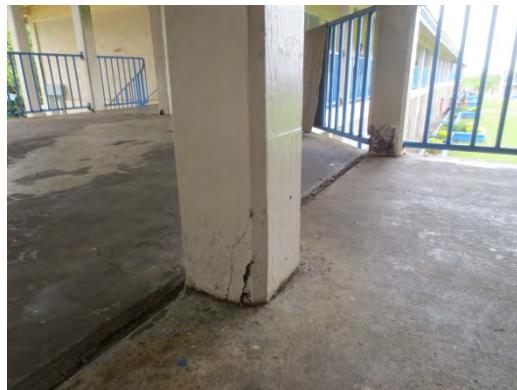
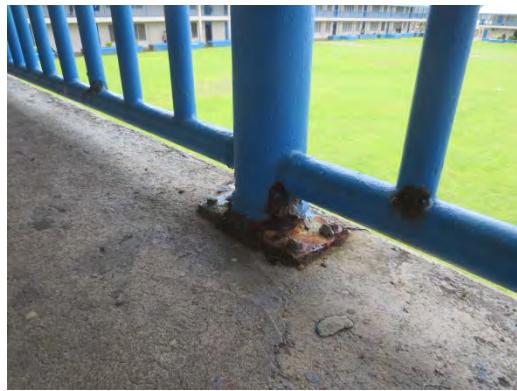
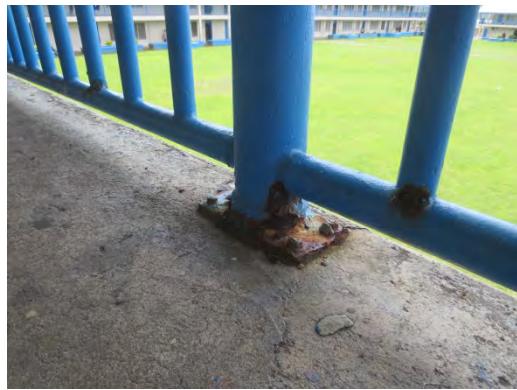
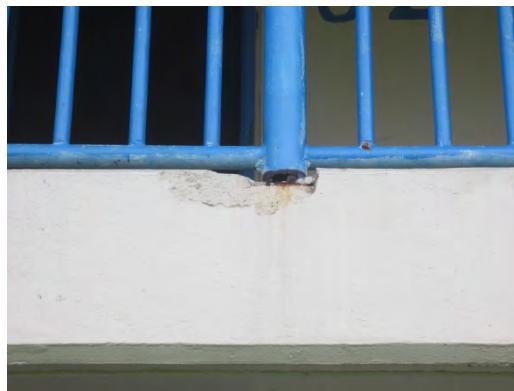
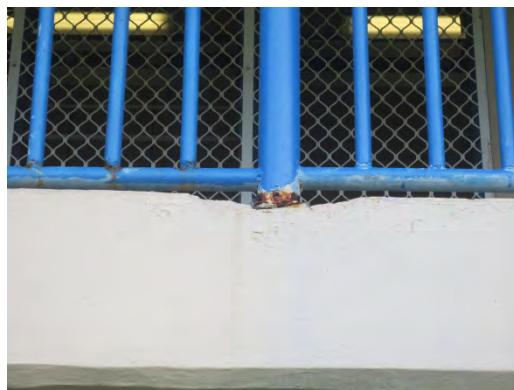
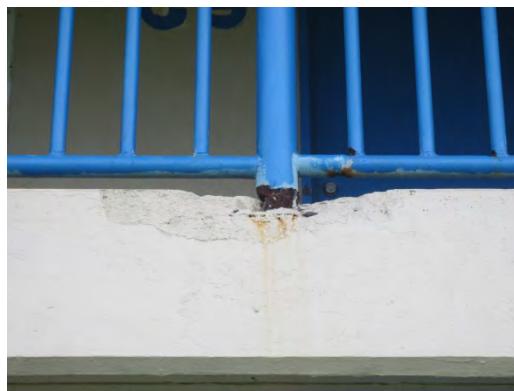
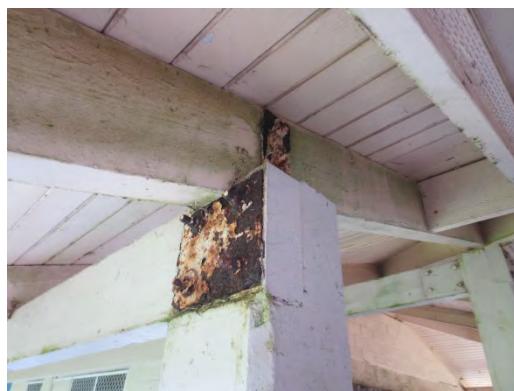
Phase III Site Visit (March 2015)

During the 2015 Phase III site visit, it was verified that the spalls at the top of the second floor exterior slab had been repaired. The patches appeared to be properly adhered to the concrete substrate and no loose fragments or delaminated pieces of the patches were found. The material used for the patch repair work is not known. It is also unknown whether the exposed reinforcing bars were cleaned and/or replaced as required before the patches were installed.

The bottom cracks and spalls at the bottom of the second floor exterior concrete columns had not been repaired by the time of the 2015 site visit. The spalls appeared to have propagated further and in one case a chunk of concrete was observed to have detached leaving the column reinforcing exposed.

The corroded base plates at the bottom of the second floor exterior steel columns had not been repaired either. The extent of corrosion appeared to have progressed and loss of bearing area at the base of the column was evident. Cracks, and thus imminent spalls, were also observed on the edge of the slab near the base plate connection. The life safety flag, thus, has been added for the steel columns.

During this last site visit, it was also observed that some of the metal plate connectors at the roof wood beams are severely corroded. At one location in particular, parts of the metal plates that make up the connection have completely corroded away effectively rendering the connection useless for wind uplift.

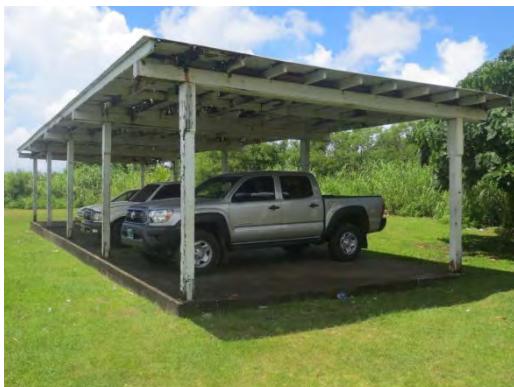
Phase II Site Visit (March 2013)

Building 12 is a wood framed carport. During the 2013 site visit, the structure was found to be in poor condition with severe termite and wet rot damage to the roof rafters and beams as well as their supporting columns. In a few cases, the columns had severe loss of cross section near the base and hence a life safety flag was raised.

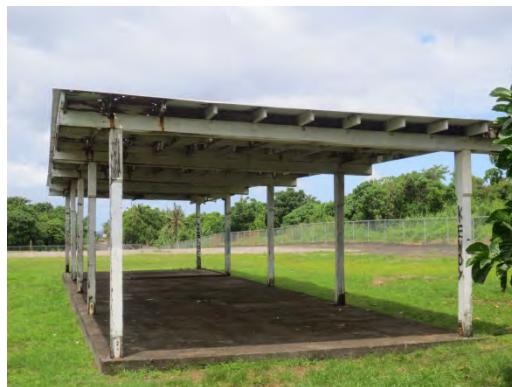
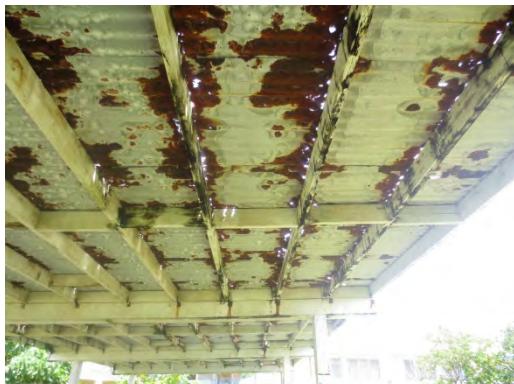
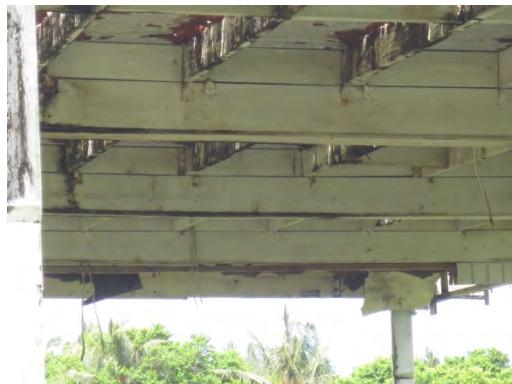
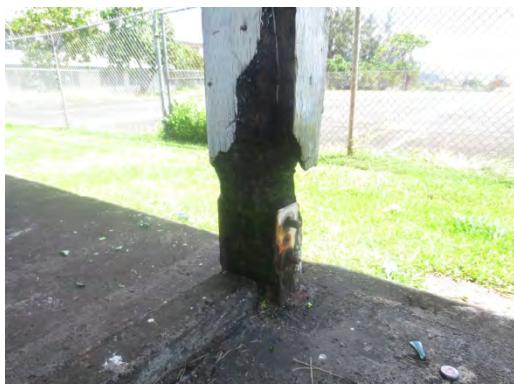
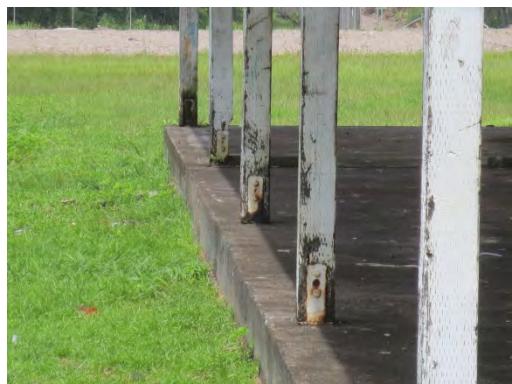
Phase III Site Visit (March 2015)

Two years later, during the Phase III site visit, the carport structure is not in use anymore. The recommendation that the structure be demolished remains. Staff from the Department of Public Works (DPW) communicated that there is confusion about whether the structure is owned and/or maintained by Department of Education or by the Department of Parks and Recreation.

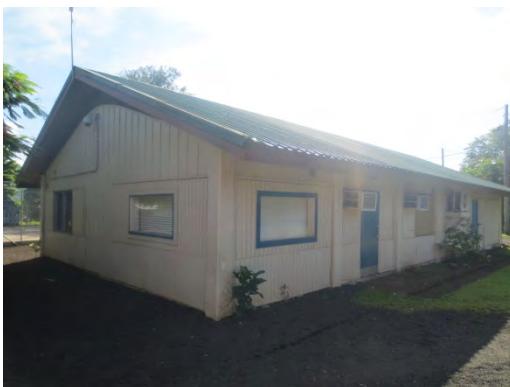
Phase II Site Visit (March 2013)

Building 3 (Administration/Library Building) is a single-story building with a hip roof. The roof is framed with plywood sheathing spanning between wood purlins in turn spanning between long-span glulam beams. The glulam beams run across the short direction of the building and are supported on square reinforced concrete columns. The building envelope between the concrete columns consists of wood framed walls with exterior wood siding. During the 2013 Phase II site visit, moderate to severe cracks and spalls were observed at the bottom of four of the concrete columns. Three of the columns had open spalls with exposed reinforcing and one had a closed spall. In the case of the one of the columns with an open spall, a large portion of the cross section was observed to be lost. This column was, therefore, identified as a life safety item.

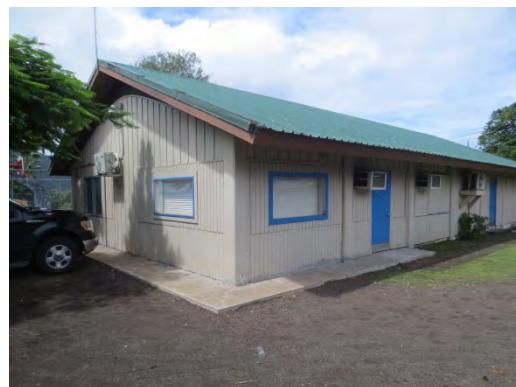
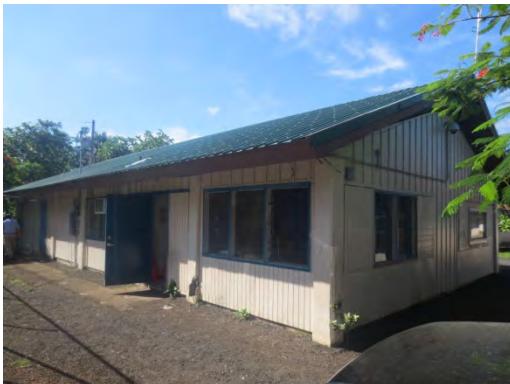
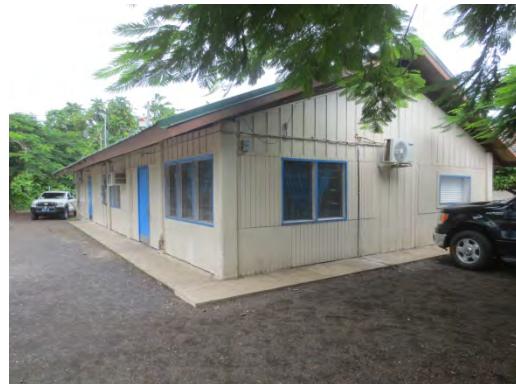
Phase III Site Visit (March 2015)

During the 2015 Phase III site visit, it was observed that a new reinforced concrete slab-on-grade apron had been poured around the building perimeter. The damaged columns had not been fixed and the spalls were in fact observed to have progressed and further exposing more of the column reinforcing bars as well as reducing the cross section of the column. The column with reduced cross section remains a life safety concern.

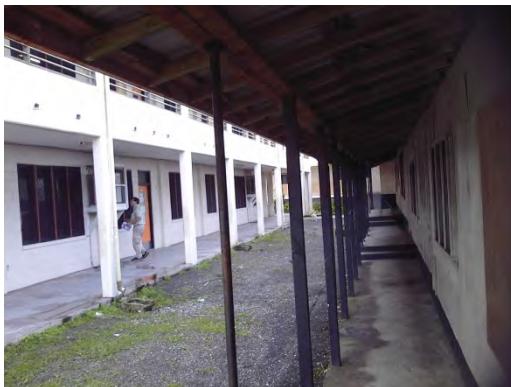
Phase II Site Visit (March 2013)

Building 1 (Administration/Classroom Building) is a single-story wood-framed building with a hip roof. The roof is framed with metal decking over wood rafters. On the south side of the building, the roof overhangs to create a covered walkway for access to the offices/classrooms. The edge of this roof overhang is supported by flat-use wood beams supported on structural steel pipe columns. During the 2013 Phase II site visit, it was observed that at the top of the pipe columns, the connection plate to the wood beams is typically misaligned and missing some or all of the fasteners. At the bottom, the columns are buried in the ground together with a bell-shaped concrete footing. In some cases, the embedment of the column into the footing and/or the embedment of the footing into the ground appeared to be insufficient. The combination of inadequate connection/restraint at the top and bottom of the columns has led to the displacement and rotation of the columns away from their plumb line.

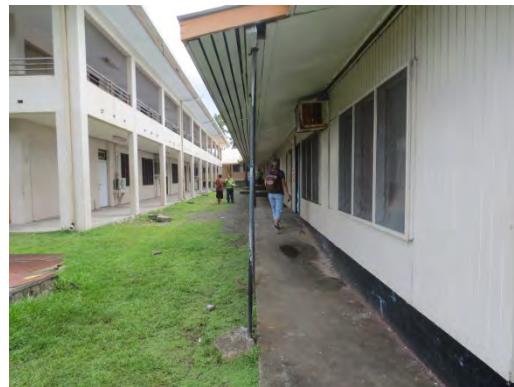
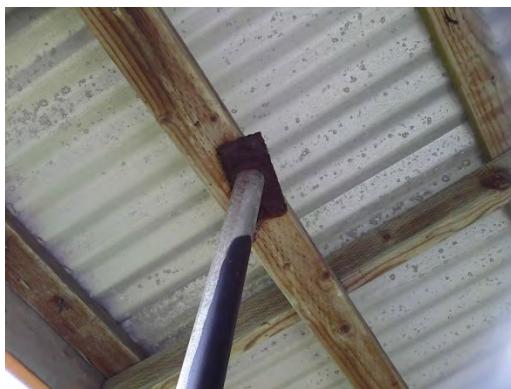
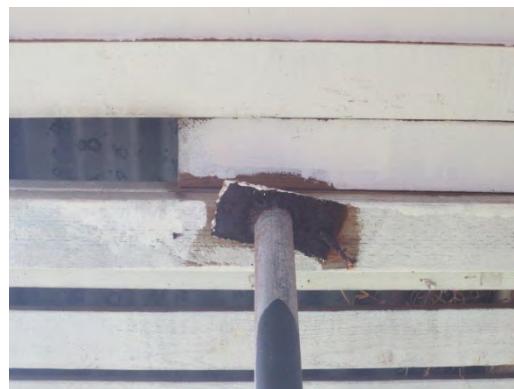
Phase III Site Visit (March 2015)

Two years later, during the Phase III site visit, the building appeared to have been repaired/remodeled (a soffit was added to the underside of the roof overhangs among other repairs). The pipe columns at the walkway, unfortunately, had not been repaired. It was also observed that one of the pipe columns has corroded away at the bottom, resulting in severe loss of cross section. A life safety tag, therefore, has been added to the pipe columns at the edge of the walkway roof.

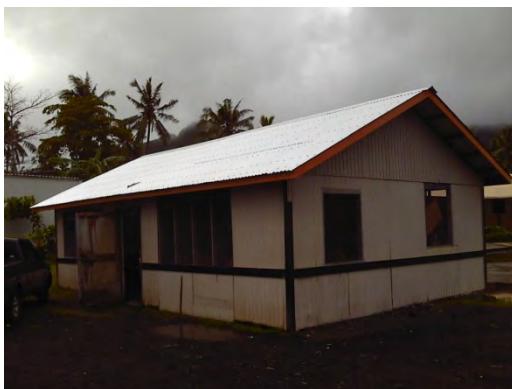
Phase II Site Visit (March 2013)

Building 10 (Classroom Building) is a single-story wood-framed building with a gable roof. The roof is framed with metal decking over wood rafters. The building envelope consists of wood-framed walls with window and door openings. During the 2013 Phase II site visit, the building was found to be in overall fair condition.

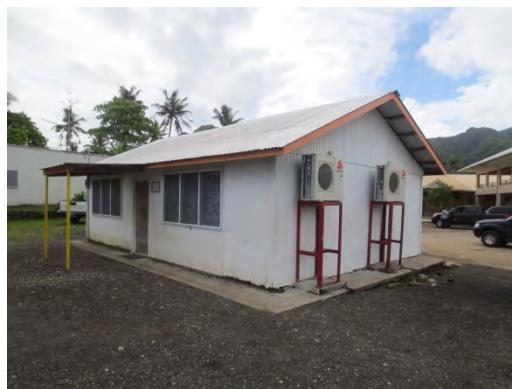
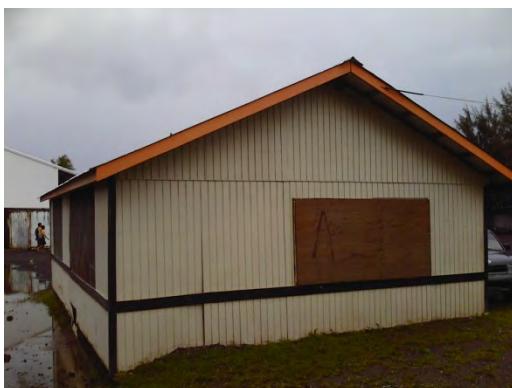
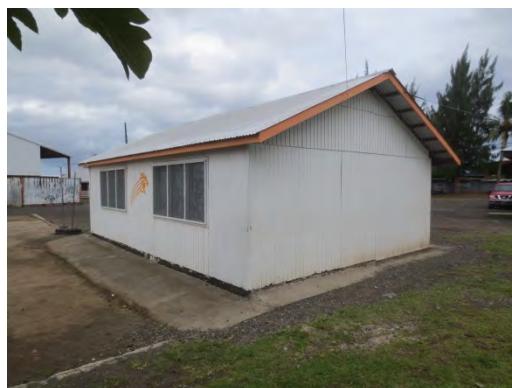
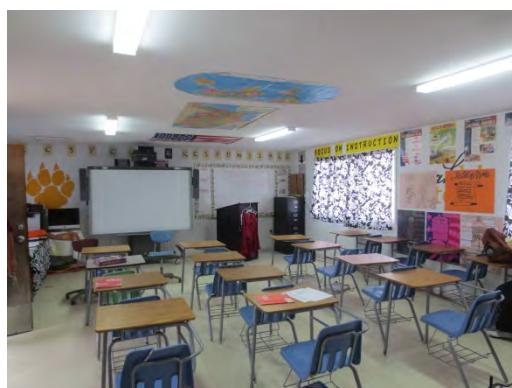
Phase III Site Visit (March 2015)

Two years later, during the Phase III site visit, the building appeared to have been completely remodeled/repaired. All structural elements were found to be in excellent condition at the time of this last visit.

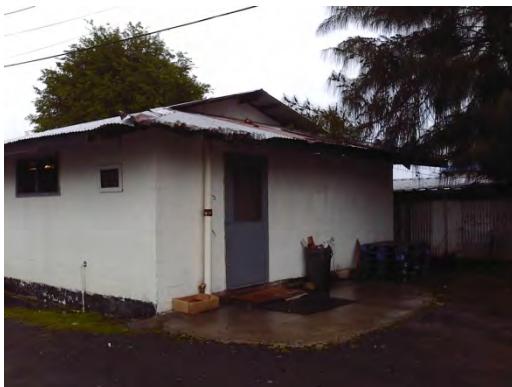
Phase II Site Visit (March 2013)

Building 6 (Kitchen/Cafeteria Building) is a single-story wood-framed building with a gable roof. The roof is framed with metal decking over wood rafters. The building envelope consists of wood-framed walls with window and door openings. During the 2013 Phase II site visit, the building was found to be in overall fair condition.

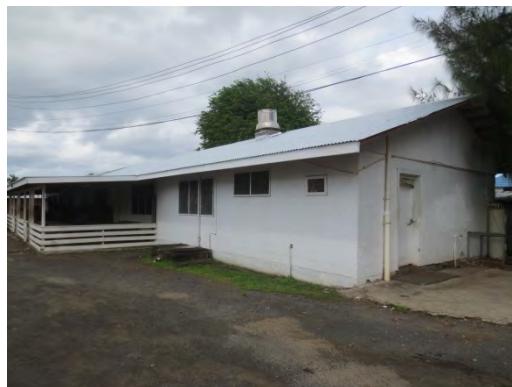
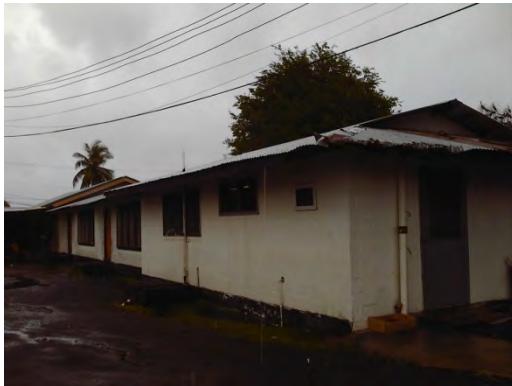
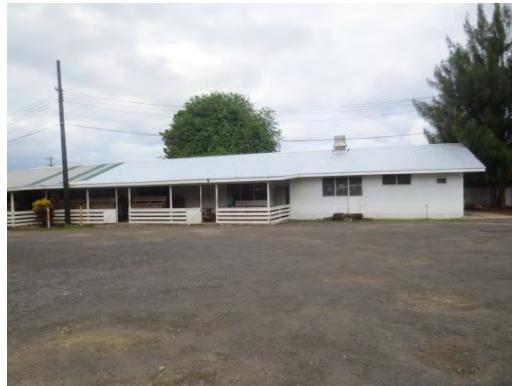
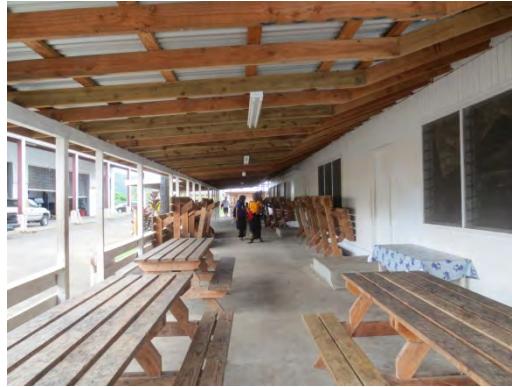
Phase III Site Visit (March 2015)

Two years later, during the Phase III site visit, the building appeared to have been remodeled/repaired. The roof was entirely replaced over the kitchen area and the roof overhang was extended over the cafeteria area to provide an exterior dining area. All structural elements were found to be in excellent condition at the time of this last visit.

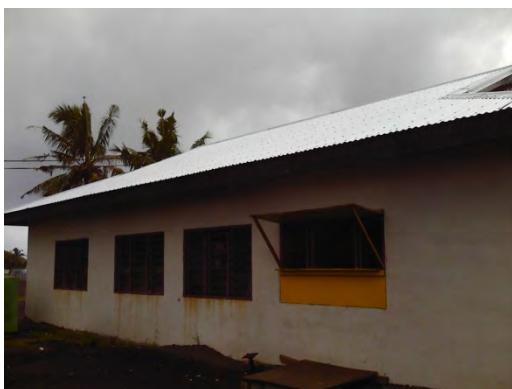
Phase II Site Visit (March 2013)

Building 10 (Classroom Building) is a single-story building with a Dutch gable roof. The roof is framed with metal decking over wood rafters. The wood rafters are supported at several locations by wood king/queen posts that are in turn supported by ceiling joists. The building envelope consists of concrete masonry unit (CMU) walls with window and door openings. During the 2013 Phase II site visit, it was observed that the roof framing was in fair condition. Over a portion of the building, the space above the ceiling was used for light to heavy storage. The heavy storage loads had resulted in a failed ceiling joist that had been propped to prevent a portion of the ceiling from collapsing. Consequently, a life safety flag was raised for the roof members.

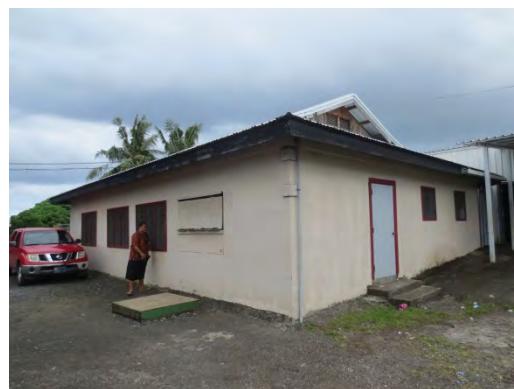
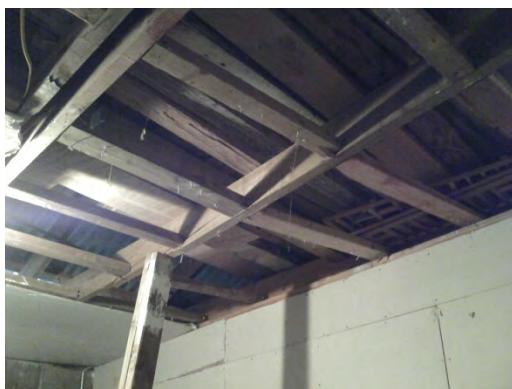
Phase III Site Visit (March 2015)

Two years later, during the Phase III site visit, the building appeared to have been remodeled/repaired. Although it was the interior of the building was inaccessible during this last site visit, the school principal confirmed that the roof members were repaired/replace as required. A quick look from through the window confirmed that a new hard ceiling now exists and thus storage above the ceiling appeared not to be possible anymore. Photographs of the interior where not taken due to the fined-mesh insect screen covering the windows. The life safety concern has therefore been addressed.

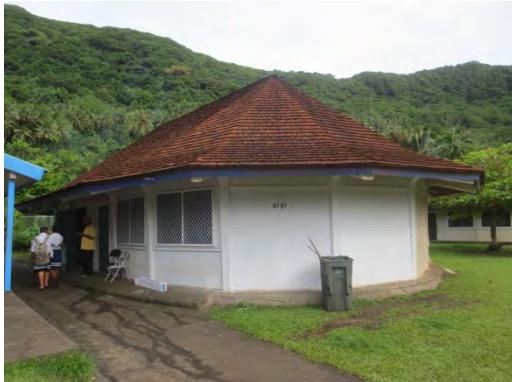
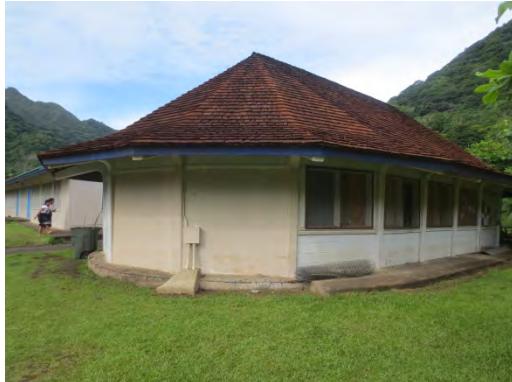
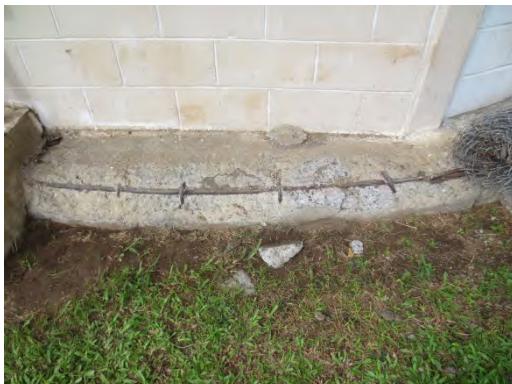
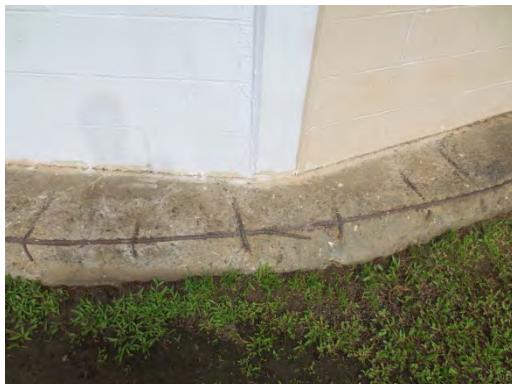
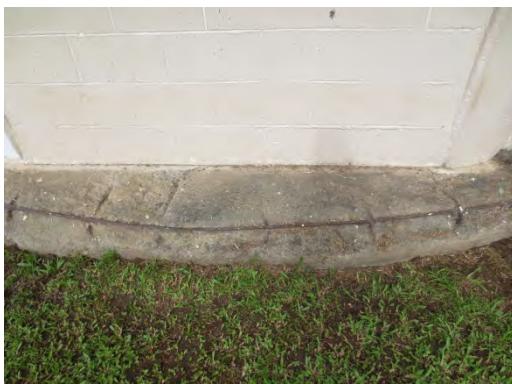
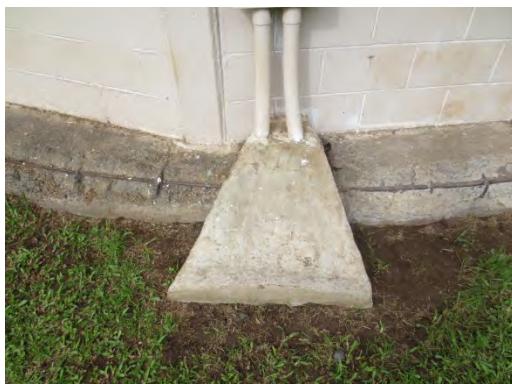
Phase III Site Visit (March 2015)

Building 16 (Classroom Building) is a typical oval-shaped reinforced concrete and wood framed fale structure. During the 2013 Phase II site visit, the exterior slab-on-grade was observed to have cracks and spalls with exposed reinforcing at the edges. It does not appear to be any change in the condition between the 2013 Phase II and the 2015 Phase III site visits.

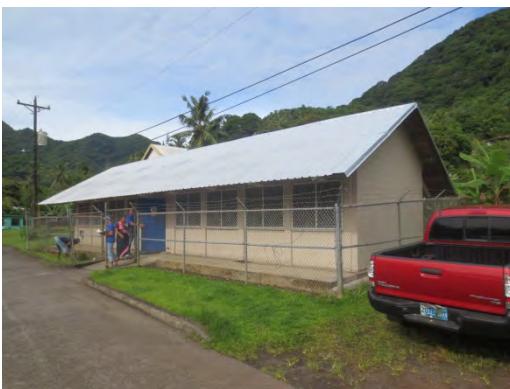
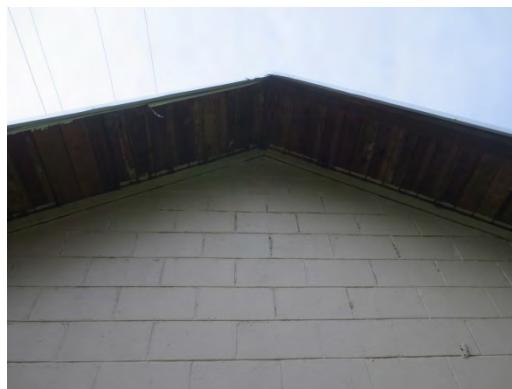
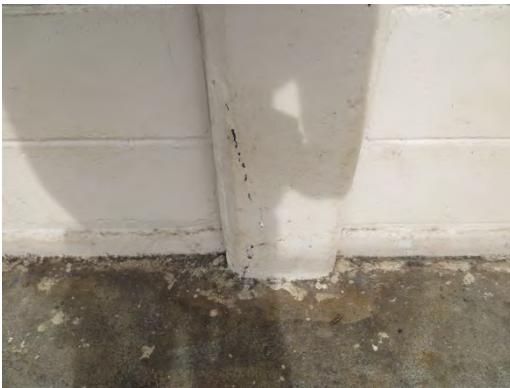
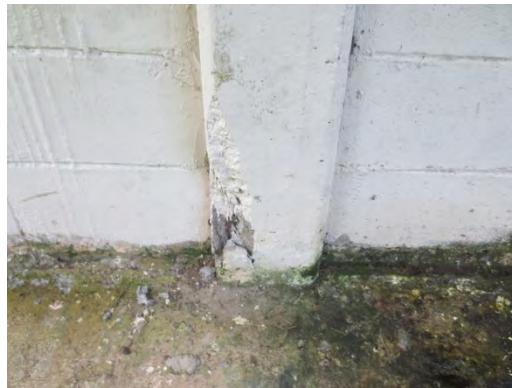
Phase III Site Visit (March 2015)

Building 16 (Administration Building) is a typical rectangular-shaped reinforced concrete and wood framed fale structure. During the 2013 Phase II site visit, this building was observed to be in overall good structural condition.

During the 2015 Phase III site visit, the school principal mentioned that this building had recently undergone renovation. All structural elements were observed to be in excellent condition except for two concrete columns which were found to have moderate spalls near the base.

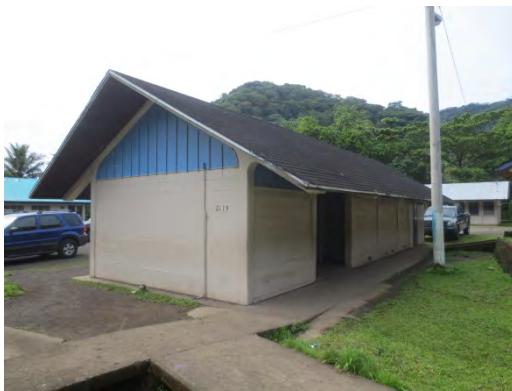
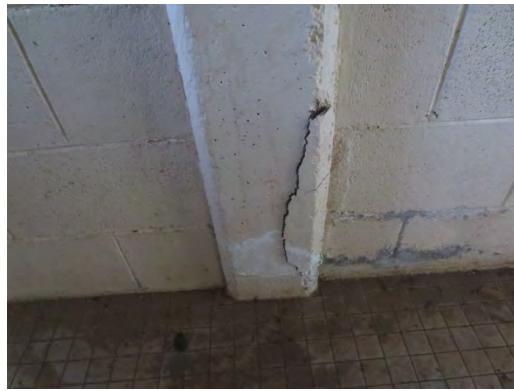
Phase III Site Visit (March 2015)

Building 19 (Restroom Building) is a typical rectangular-shaped reinforced concrete and wood framed fale structure. This building was observed to be in overall good condition.

During the 2015 Phase III site visit, only one portion of the building was in use (teachers' restrooms). School and Department of Public Works personnel reported that the unused portion of the building (boys' restroom) will be soon renovated. It was observed that minor to moderate cracks and spalls exist at one of the concrete columns near the base.
