# **INSULAR ABC'S INITIATIVE**

## **Phase III Task 1 Findings and Recommendations**

### **American Samoa**

October 2015

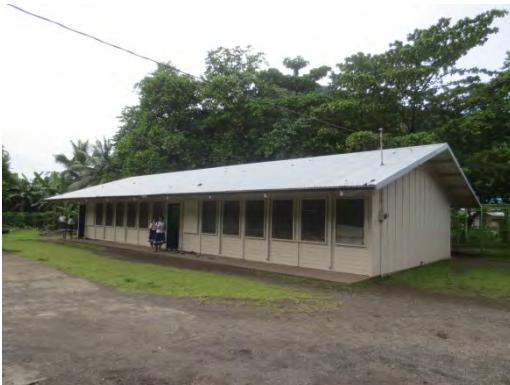
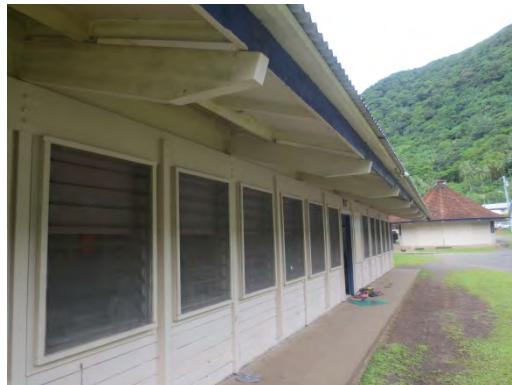
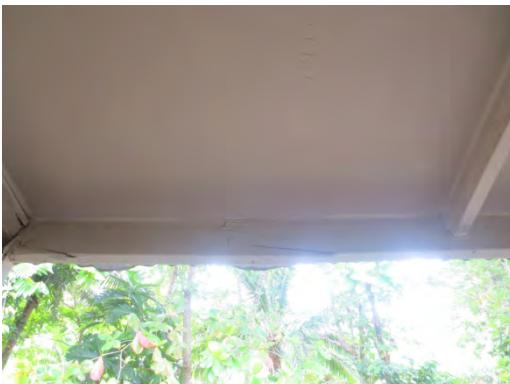
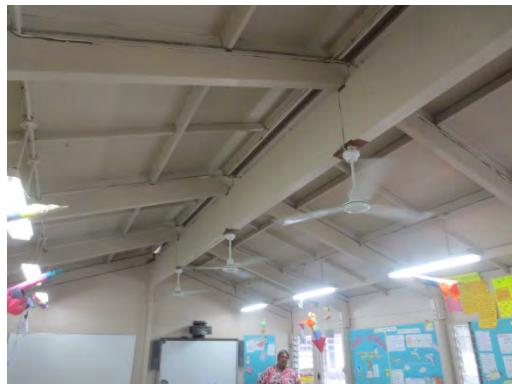
Phase III Site Visit (March 2015)

Building 20 (Classroom Building) is a single-story wood-framed building with a gable roof. The roof system consists of plywood sheathing over wood purlins (2x6 spaced at 3 ft. and braced with 2x4 battens at midspan) over wood rafters (4x spaced at 6 ft.) The rafters span between wood columns at the perimeter of the building and wood beams at the ridge of the roof. During the 2013 Phase II site visit, it was observed that some of the 2x6 purlins were split and sagging from their unusually large 3-ft spacing. At the time of the Phase II visit, it was recommended that the purlins be doubled up to increase their strength or that additional purlins be added to reduce their spacing.

Two years later during the 2015 Phase III site visit, the building appeared to have undergone remodeling and repair. Some of the sagging and split purlins had been replaced while some still remained in place.. No new purlins were added in between the existing purlins nor were the existing purlins doubled up to increase their strength.

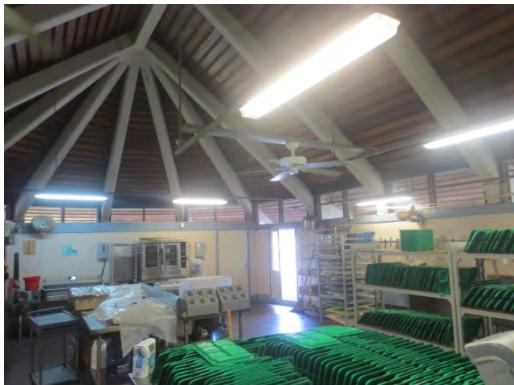
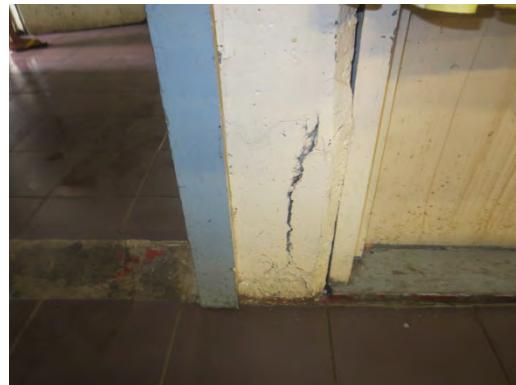
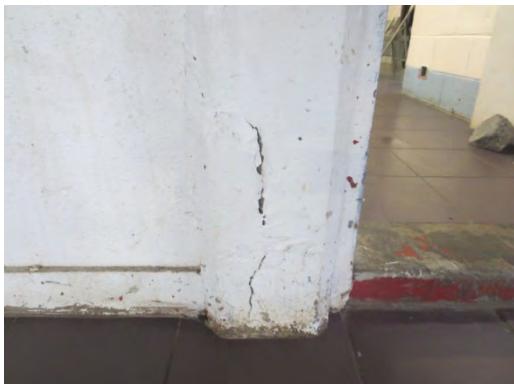
Phase III Site Visit (March 2015)

Building 21 (Kitchen Building) is a typical oval-shaped reinforced concrete and wood framed fale structure. During the 2015 Phase III site visit, the school principal reported that two concrete columns at this building were damaged. It was observed that two concrete columns indeed had cracks and spalls near the base. The damage to these two columns was inadvertently overseen during the 2013 Phase II site visit.

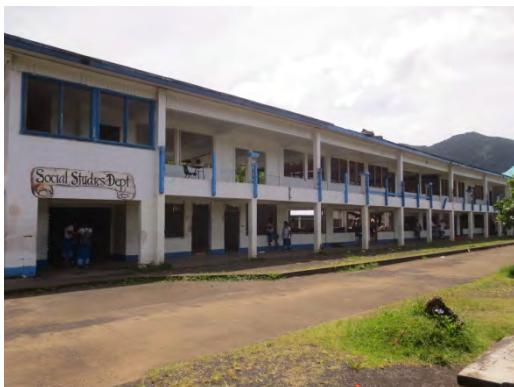
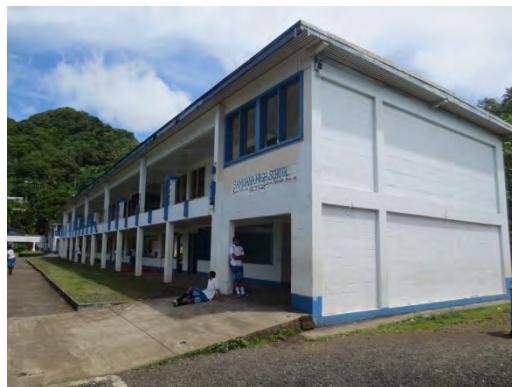
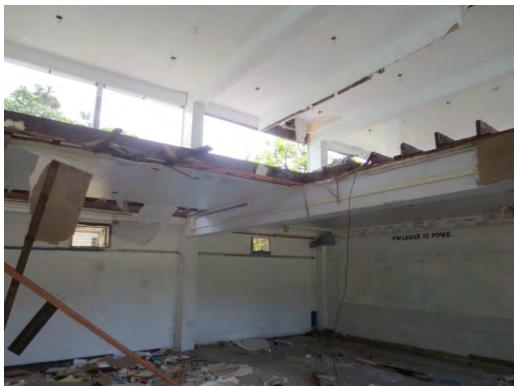
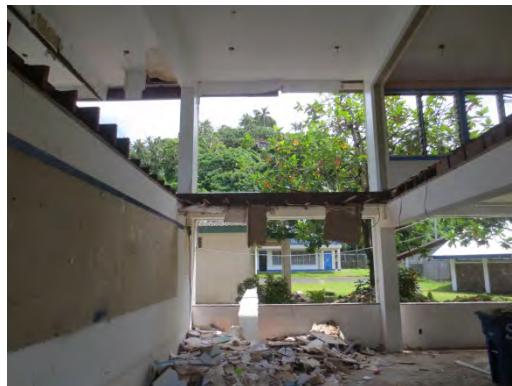
Phase III Site Visit (March 2015)

Building 20 (Classroom Building) is a two-story flat-roofed building of mixed construction. The superstructure consists of reinforced concrete frames in both the transverse and longitudinal directions of the building. Exterior and interior walls are concrete unit masonry (CMU) with openings for doors and windows. The second floor framing consists of a reinforced concrete slab at the exterior (walkway) and plywood sheathing over wood joists at the interior (classrooms). The roof framing consists of plywood sheathing over wood rafters between the concrete and wood beams. During the 2013 Phase II site visit, damage in the form of wet/dry rot was observed at the soffit of the roof overhang. The non-structural wood soffit was severely deteriorated and the rafters were exposed at several location. The rafters were also observed to be severely damaged.

During the 2015 Phase III site visit, the building was found to be partially demolished. School and Department of Public Works officials noted that demolition would re-start and be completed after the end of the school year. It was also mentioned that Buildings 3, 6 and 7 will be demolished and a new two-story building will be built on the current site of Building 7.

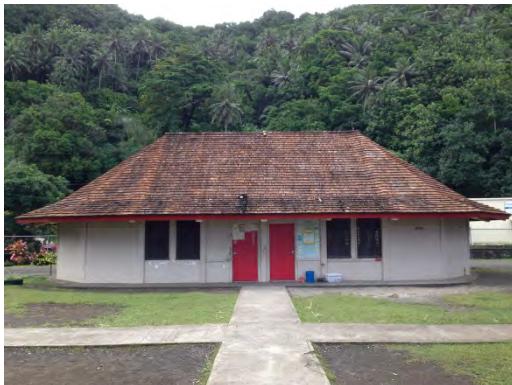
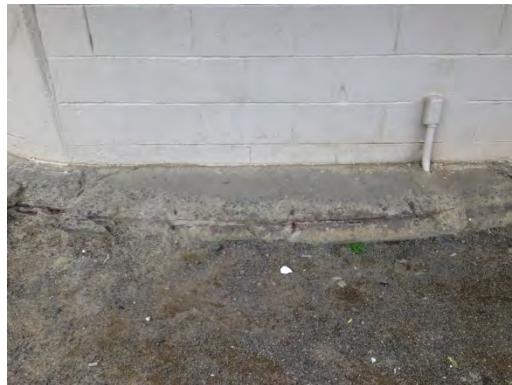
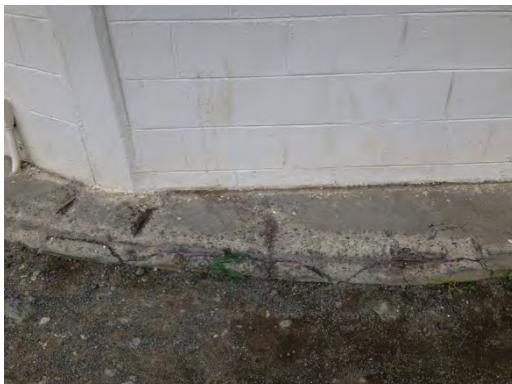
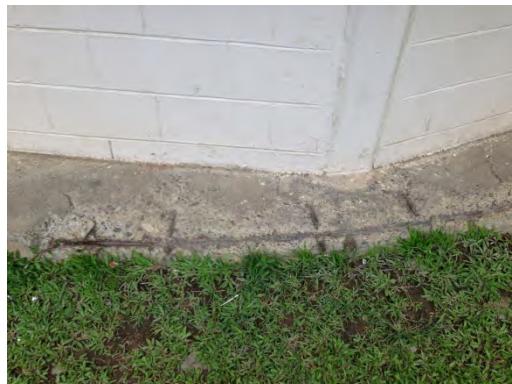
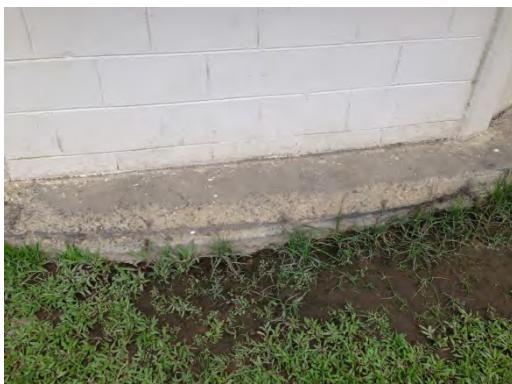
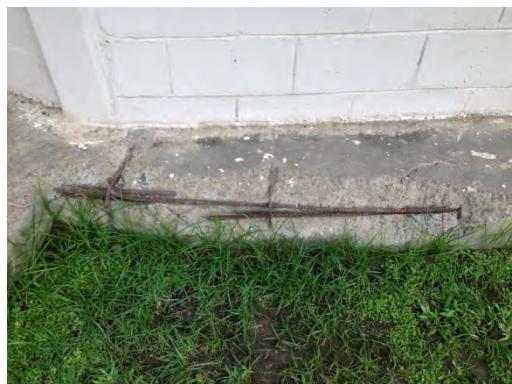
Phase III Site Visit (March 2015)

Building 16 (Classroom Building) is a typical oval-shaped reinforced concrete and wood framed fale structure. During the 2013 Phase II site visit, the exterior slab-on-grade was observed to have cracks and spalls with exposed reinforcing at the edges. It does not appear to be any change in the condition between the 2013 Phase II and the 2015 Phase III site visits.

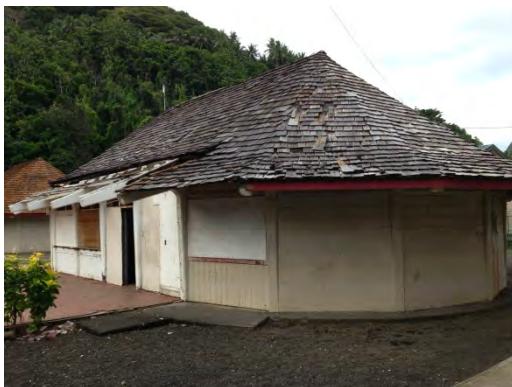
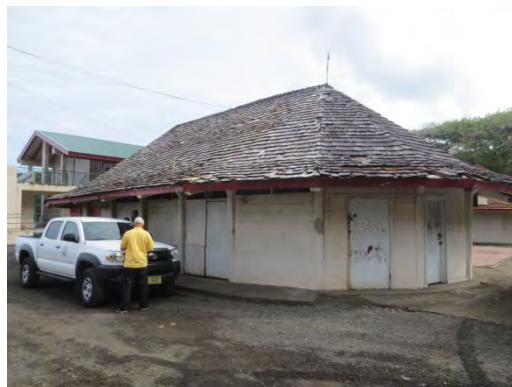
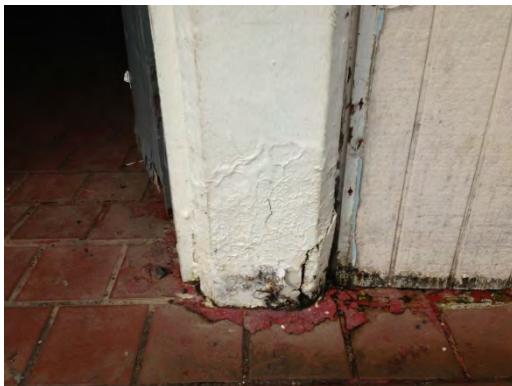
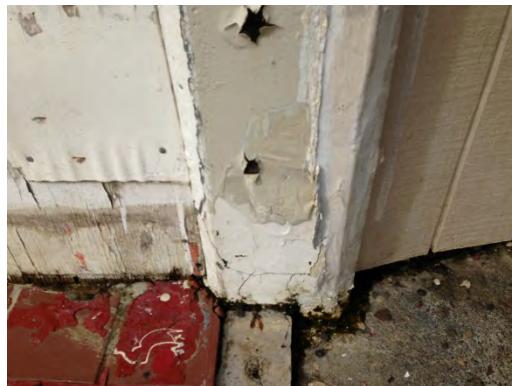
### Phase III Site Visit (March 2015)

Building 21 (Kitchen Building) is a typical oval-shaped reinforced concrete and wood framed fale structure. During the 2013 Phase II site visit, the building was found in overall poor condition. Several of the concrete columns had severe and extensive cracks and spalls near the bottom. Severe loss of cross section had occurred at three columns on the ocean facing side of the building. Three concrete columns, also on the ocean facing side of the building) were also observed to have severe cracks and spalls at the top, near the beam/column joint. A life safety flag was therefore assigned to these damaged concrete columns. Dry rot damage was also observed to the wood decking at the roof overhang.

During the 2015 Phase III site visit, the building was found to be partially condemned. School and Department of Public Works officials noted the structure has not been demolished because the main power connection point for the school campus is within this building (there is a small partitioned space with electrical equipment on the north side of the building). The damage to the concrete columns was still present and appeared to be more extensive this time around. Although the building is not in use, it needs to be accessed regularly for maintenance of the electrical equipment. Therefore, the life safety flag for the concrete columns remains in place.

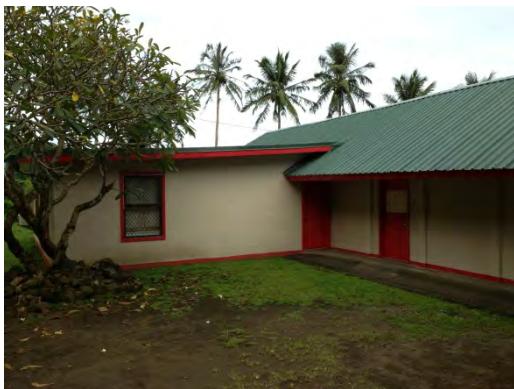
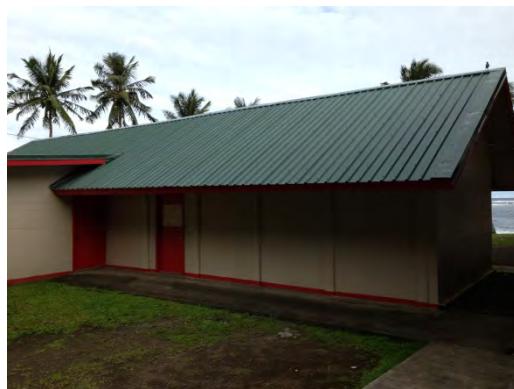
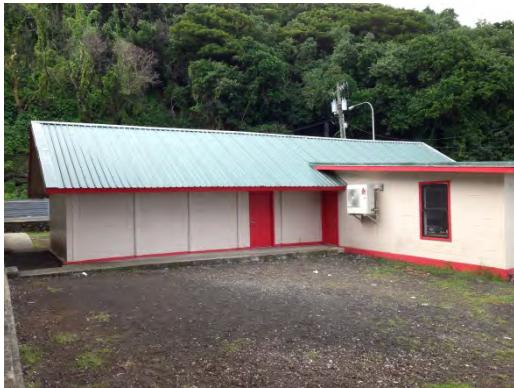
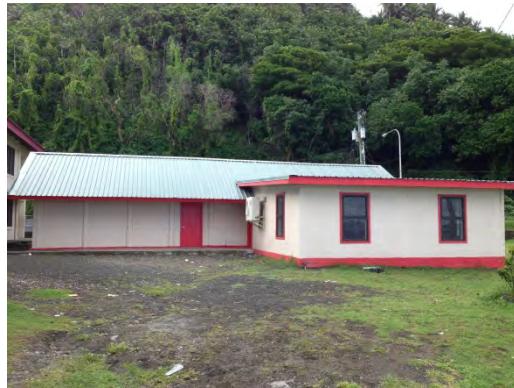
## 12C. Matafao Elementary School Building 17

Building 17 (Classroom Building) is a single-story building with a gable roof. The building superstructure consists of reinforced concrete frames (columns and beams) with concrete masonry unit (CMU) infill walls. The roof is framed in wood. During the 2013 Phase II site visit, the building was found to be in overall good structural condition.

During the 2015 Phase III site visit, the building was found to be completely renovated. Access to the interior was not possible during this last site visit. All structural members visible from the exterior appeared to be in excellent condition.

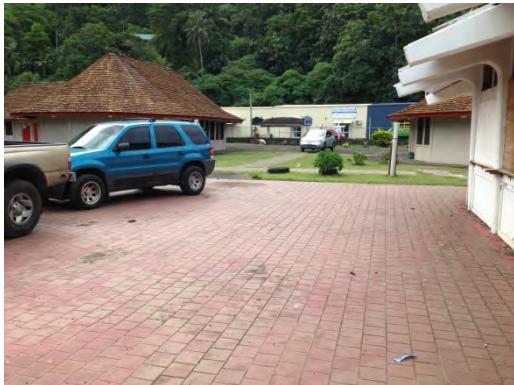
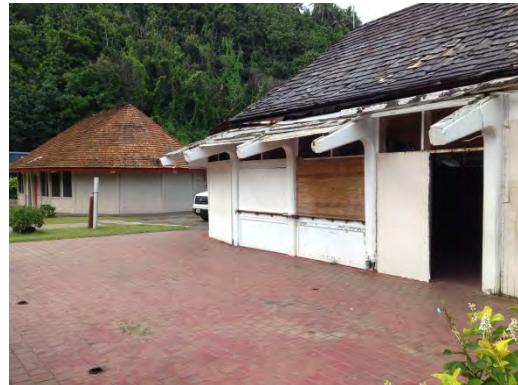
## 12D. Matafao Elementary School Building 18 (Canopy)

Building 18 is a wood framed canopy located immediately adjacent to the west façade of Building 14 (Classroom). During the 2013 Phase II site visit, the canopy was found in overall poor condition. Dry rot damage was also observed to the wood decking at the roof (portions of the decking were warped and ongoing leakage was visible).

During the 2015 Phase III site visit, the building was found to be completely demolished.

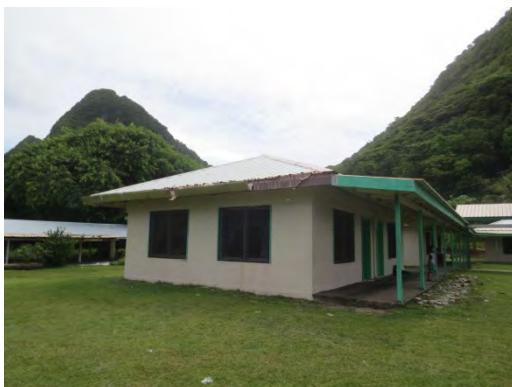
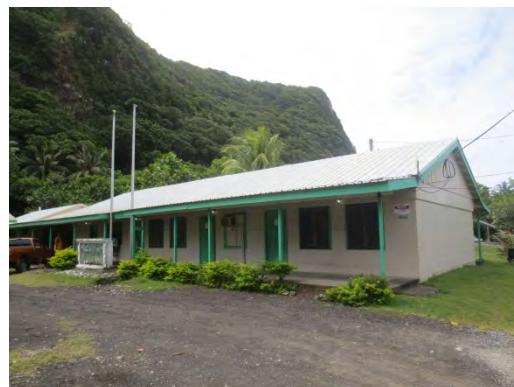
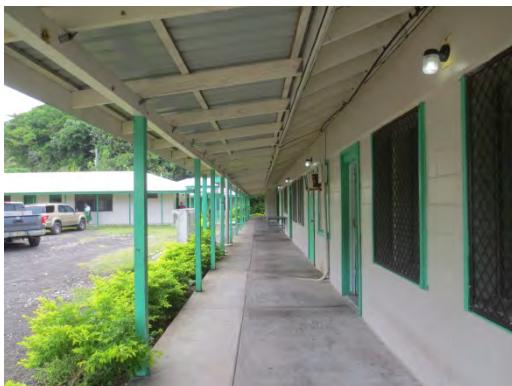
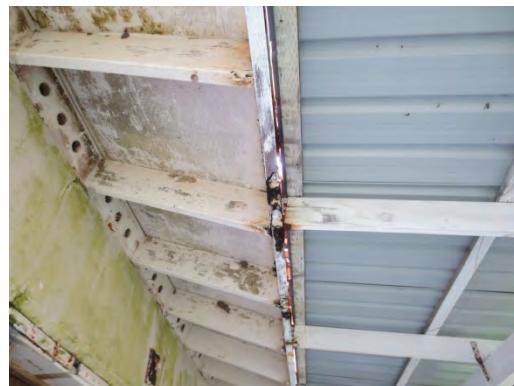
### **13A. Mt. Alava Elementary School Building 1, 2, and 7**

Building 1, 2, and 7 (Classroom and Administration Buildings) are single-story buildings with a gable roof. The superstructures of the buildings consist of concrete masonry unit (CMU) exterior and interior walls and plywood sheathing over wood trusses at the roof. At the time of the 2013 Phase II site visit, the exposed structural elements on all three buildings were found to be in excellent condition.

By request of personnel from the Department of Public Works, a site visit to this school was made in 2015 to observe leaks and damaged roof members at the three buildings in question. It was found that a covered walkway exists on the front (and back in the case of Building 7) of these buildings. The roof of the walkway butts directly against the edge of the overhang in the building's roof. It is at this interface between structures that water infiltration occurs. In terms of structural, damage was for the most part observed at the edges of the buildings' roofs: minor to moderate wet rot at the plywood sheathing, at the fascia beam, and at the tips of the top chords of the trusses (top chords extend past the perimeter wall to frame the overhang). The walkway roof framing appeared to be in general good condition.

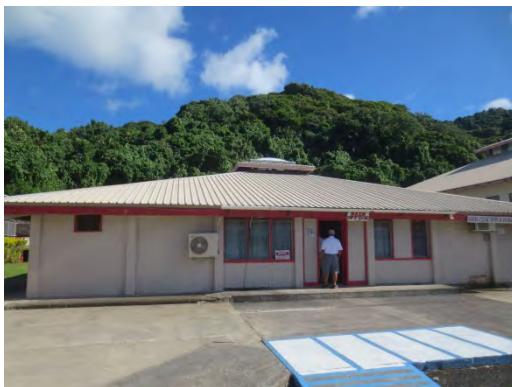
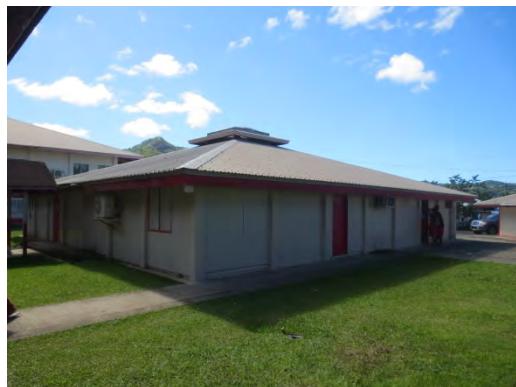
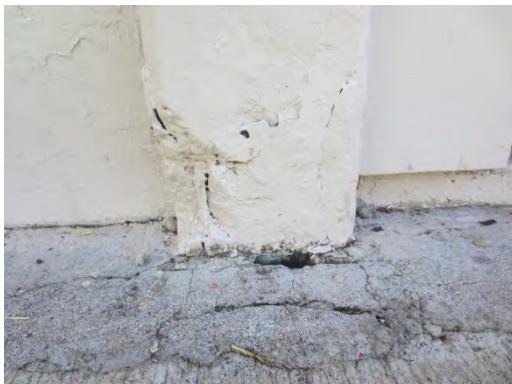
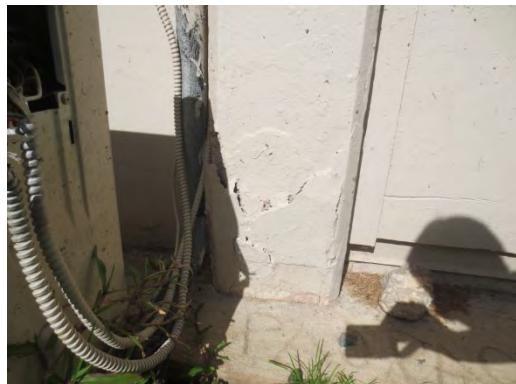
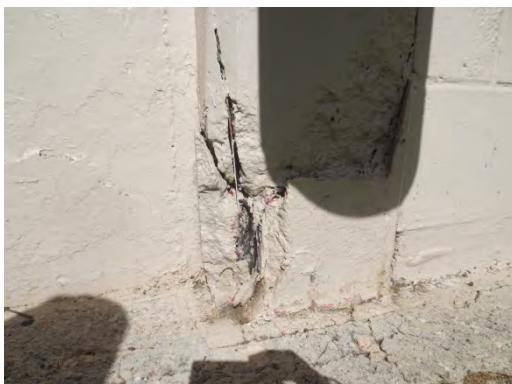
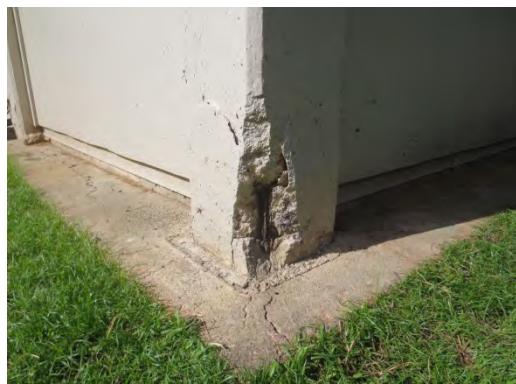
## 14A. Faga'itua High School Building 5

Building 5 (Administration/Classroom Building) is a single-story building with a gable roof. The building superstructure consists of reinforced concrete frames (columns and beams) with concrete masonry unit (CMU) or wood-framed infill walls. The roof is framed in wood. At the time of the 2013 Phase II site visit, minor to moderate spalls were found on a few of the concrete columns near the base.

During the 2015 Phase III site visit, it was verified that the spalls at the bottom of the columns had not been repaired. It appeared like the spalls have progress in size and extent and reinforcing was exposed in a few locations. In the case of a corner column, loss of cross section has further developed.

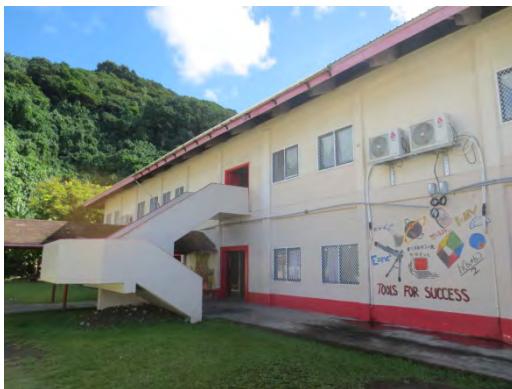
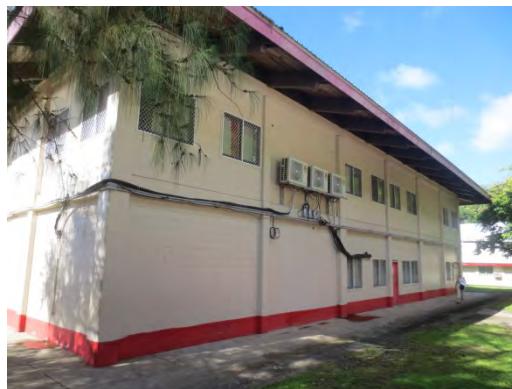
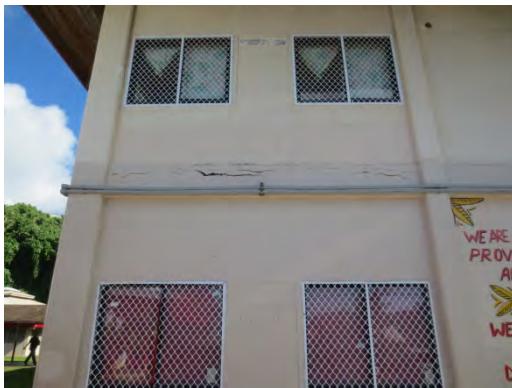
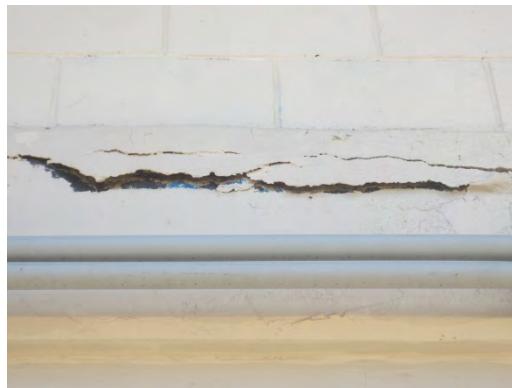
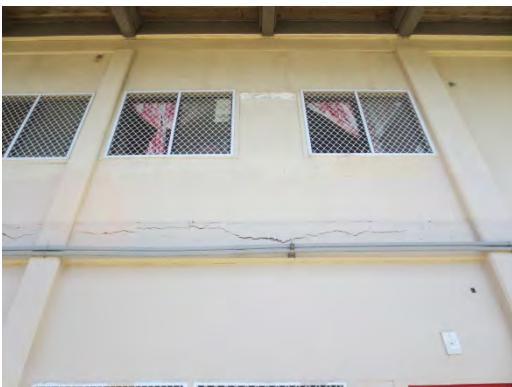
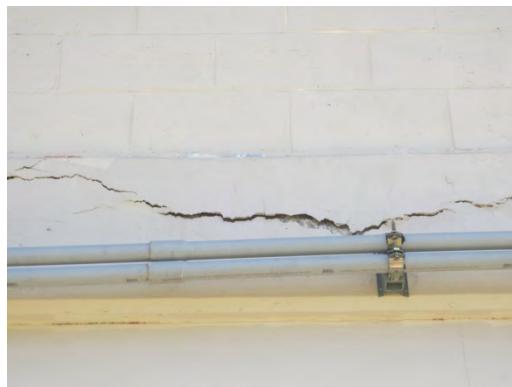
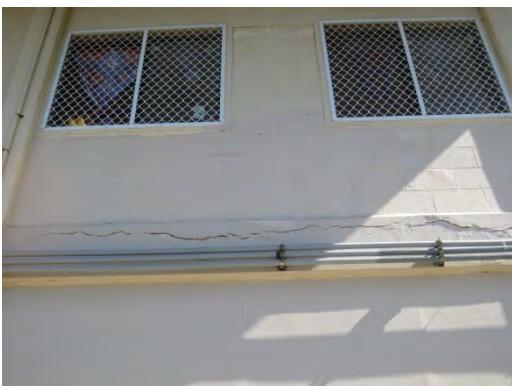
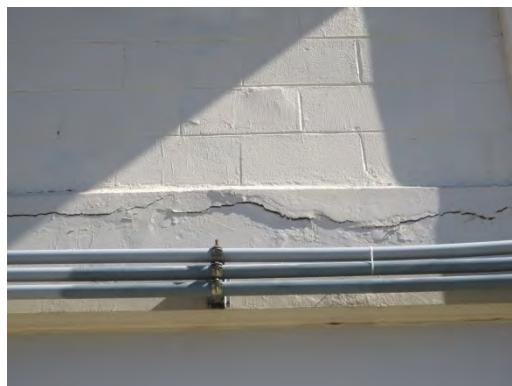
## 14C. Faga'itua High School Building 9

Building 9 (Classroom Building) is a two-story building with a gable roof. The building superstructure consists of reinforced concrete frames (columns and beams) with concrete masonry unit (CMU) infill walls. The second floor framing consists of a suspended reinforced concrete slab and the roof framing is made up of wood decking over heavy timber rafters and trusses. At the time of the 2013 Phase II site visit, moderate to severe spalls were found on the exterior face of the second floor concrete spandrel beams on the south and east faces of the building. The spalls vary in size and extent but are typically located on the top of the beam (the second floor exterior masonry wall is offset a few inches towards the interior).

During the 2015 Phase III site visit, a representative of the Department of Education raised concerns about spalls on the envelope of the building. A quick walk around the building revealed that the spalls on the exterior face of the second floor concrete spandrel beams had not been repaired since the 2013 site visit. These spalls constitute a falling hazard for the building occupants below. Hence, a life safety flag has now been given to the concrete beams in this building. The life safety flag was inadvertently omitted during the 2013 Phase II site visit.

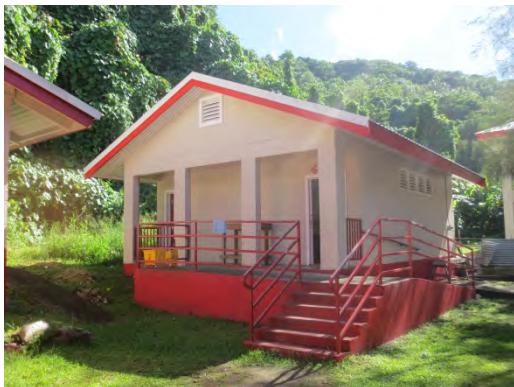
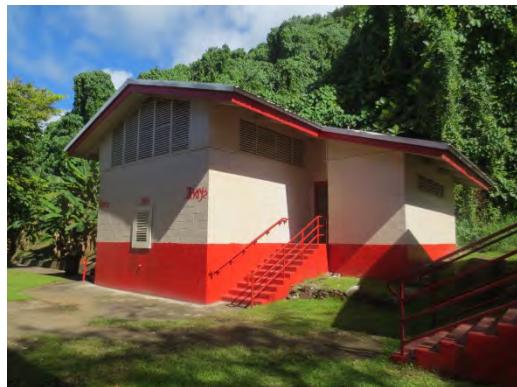
#### **14D. Faga'itua High School Building 12 (New Building)**

Building 12 (Restroom Building) is a new single-story building located due east of Building 10. The building superstructure is constructed with reinforced concrete (footings and retaining walls), concrete masonry unit (exterior and interior walls), and wood (roof decking and rafters). All structural elements appeared to be in excellent condition at the time of the 2015 Phase III site visit. The building was reported by personnel from the Department of Public Works to have been recently completed. At the time of the visit, the building was occupied.

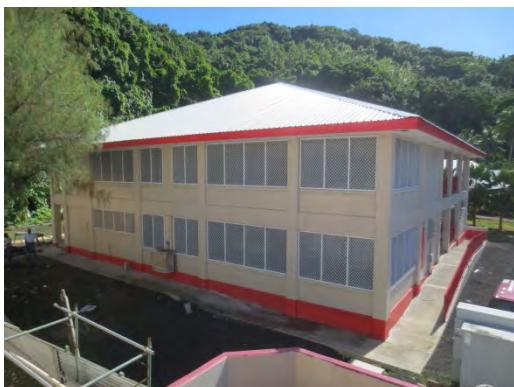
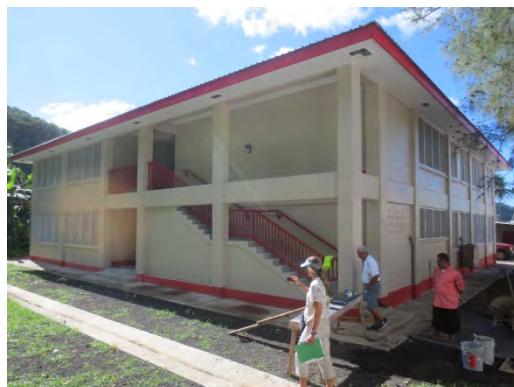
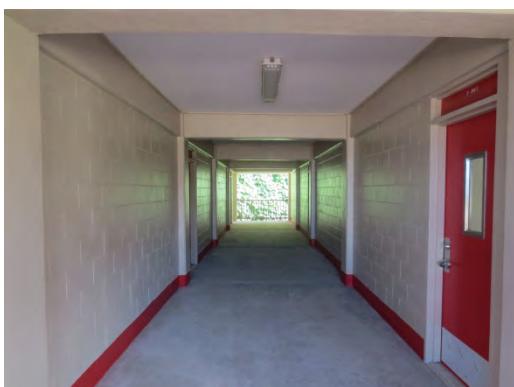
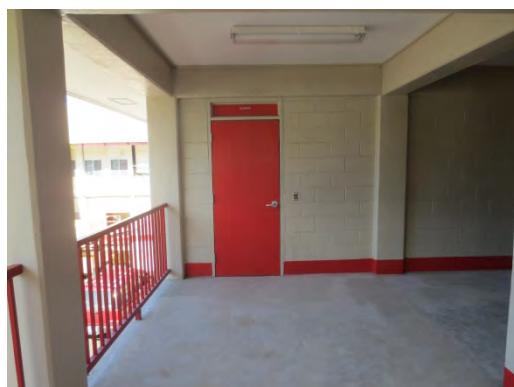
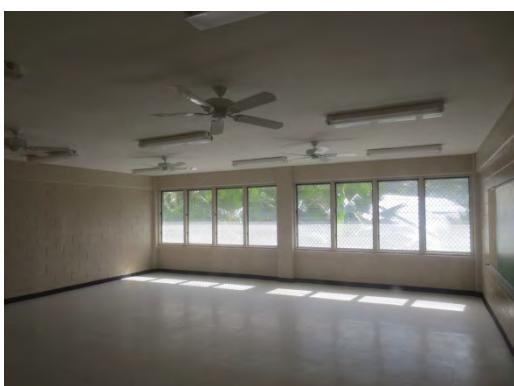
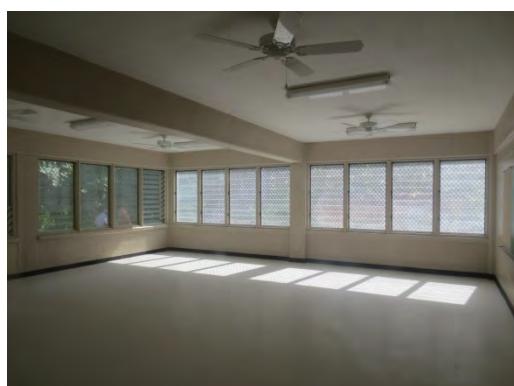
Phase III Site Visit (March 2015)

Building 13 is a new two-story classroom building constructed on the former site of Building 6. The buildings superstructure is constructed with reinforced concrete (footings, columns, beams, and slabs), concrete masonry unit (exterior and interior walls), and wood (plywood decking, purlins, trusses). The building is a double-loaded corridor structure. All structural elements appeared to be in excellent condition at the time of the 2015 Phase III site visit. The building was not occupied at the time of the visit.

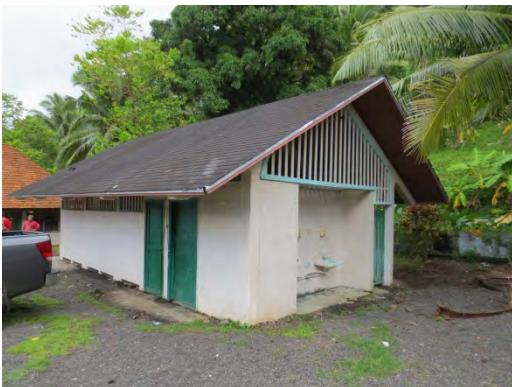
Phase II Site Visit (March 2013)

Building 2 (Restroom Building) is a typical rectangular-shaped reinforced concrete and wood framed fale structure. During the 2013 Phase II site visit, several columns were observed to have moderate to severe spalls near the base near mid-height.

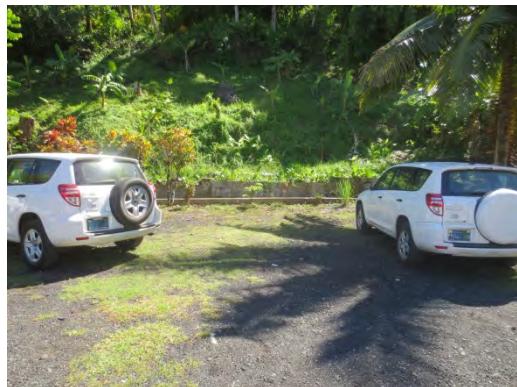
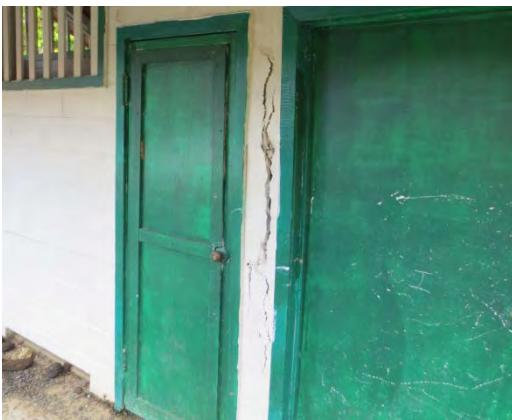
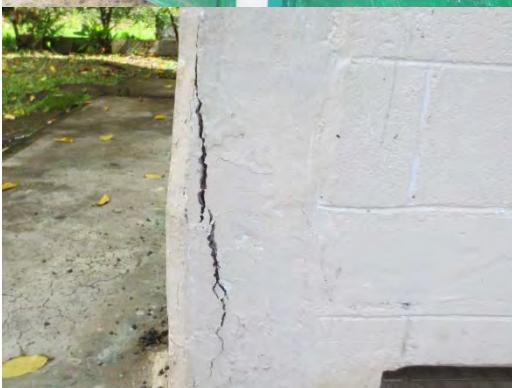
Phase III Site Visit (March 2015)

Two years later, during the Phase III site visit, the building had been completely demolished. At the time of the visit, no new structure had been built on the site of former Building 2.

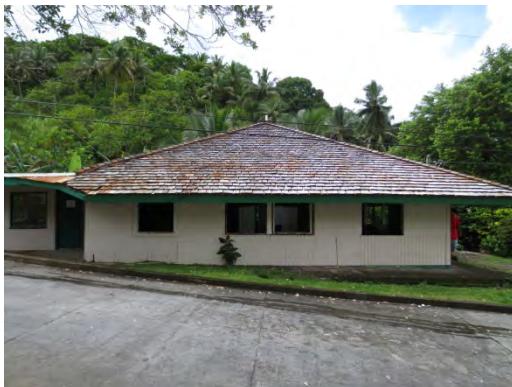
Phase II Site Visit (March 2013)

Building 4 (Classroom Building) is a single-story wood frame structure with a gable roof. The roof is framed by rafters supported by two king-posts in the middle of the structure. Exterior walls are framed in wood. At the time of the 2013 Phase II site visit, the building was ongoing renovation. It was observed that one of the two king posts supporting the roof had been cut near the bottom essentially leaving a large portion of the roof unsupported. A life safety flag was issued for the cut wood post and it was recommended that the post be spliced or replaced.

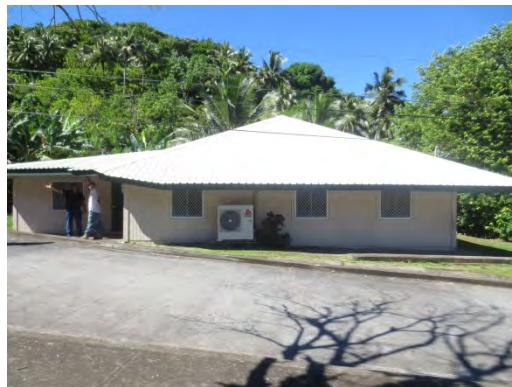
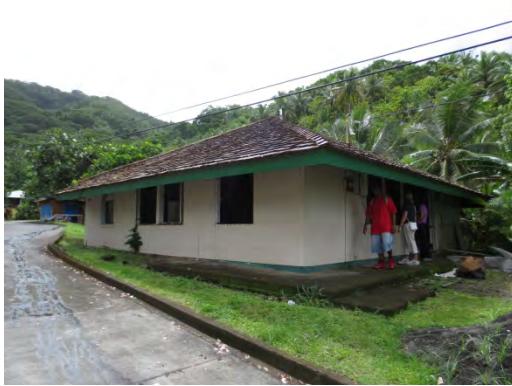
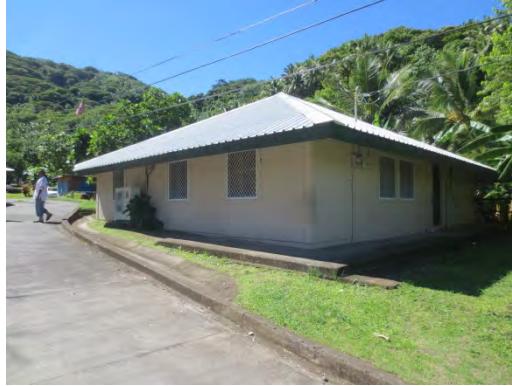
Phase III Site Visit (March 2015)

Two years later, during the Phase III site visit, the renovation of the building had been completed. The cut king post was reported by school officials and by Department of Public Works staff to have been replaced during after our 2013 site visit. The two king posts are now concealed within a partial height partition wall used as a room divider. It was, therefore, not possible to verify that the post was spliced or replaced. Nonetheless, the life safety flag will be removed since it is highly unlikely that the framing would have remained stable if the post was not replaced. All visible structural elements were found to be in excellent condition at the time of this last site visit.

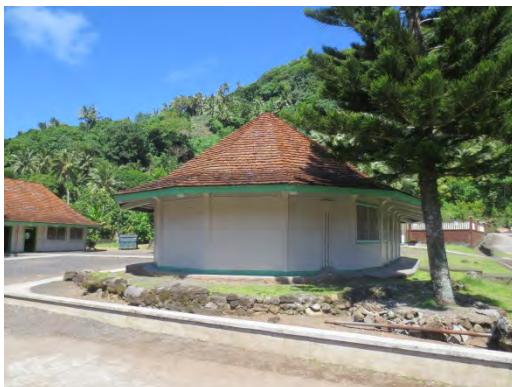
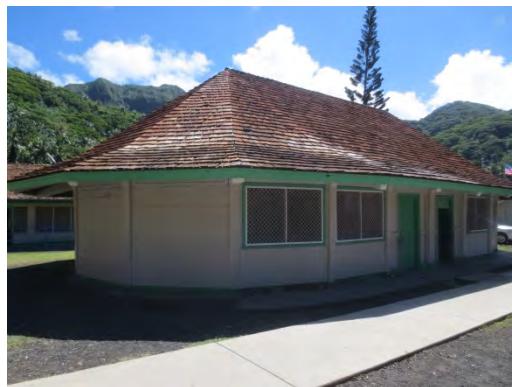
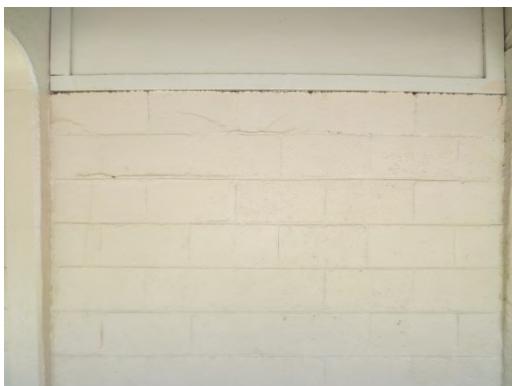
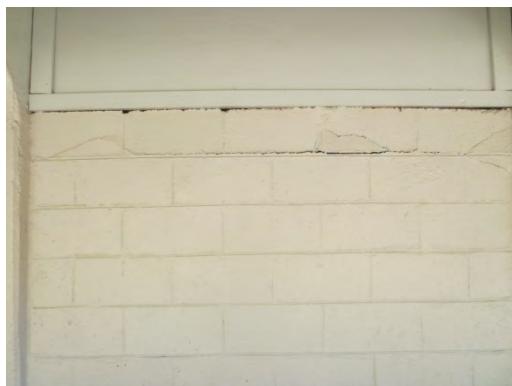
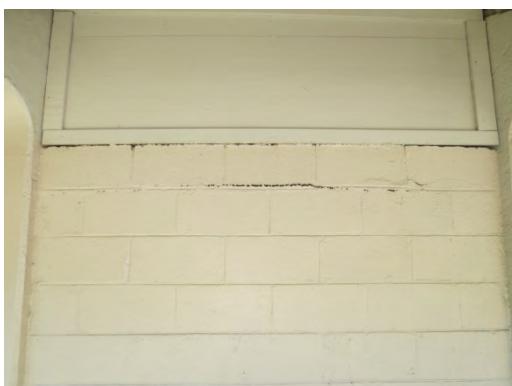
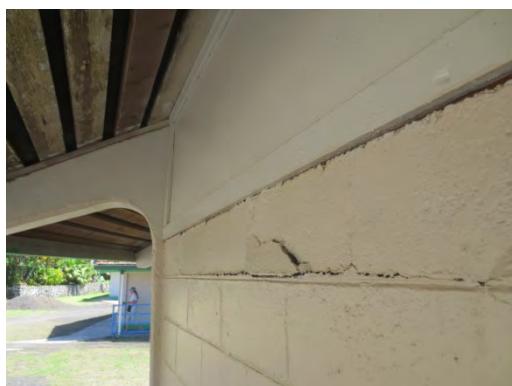
Phase III Site Visit (March 2015)

Building 8 (Classroom Building) is a typical oval-shaped reinforced concrete and wood framed fale structure. During the 2013 Phase II site visit, the top course of the exterior masonry wall was observed to have cracks and spalls. The damage had likely occurred because the walls are unreinforced and not grouted. It does not appear to be any change in the condition of the masonry walls between the 2013 Phase II and the 2015 Phase III site visits.
