# INSULAR ABC'S INITIATIVE

Phase III Task 1 - Civil Engineer Findings

## COMMONWEALTH OF NORTHERN MARIANA ISLANDS Civil Site Maps for Required Projects

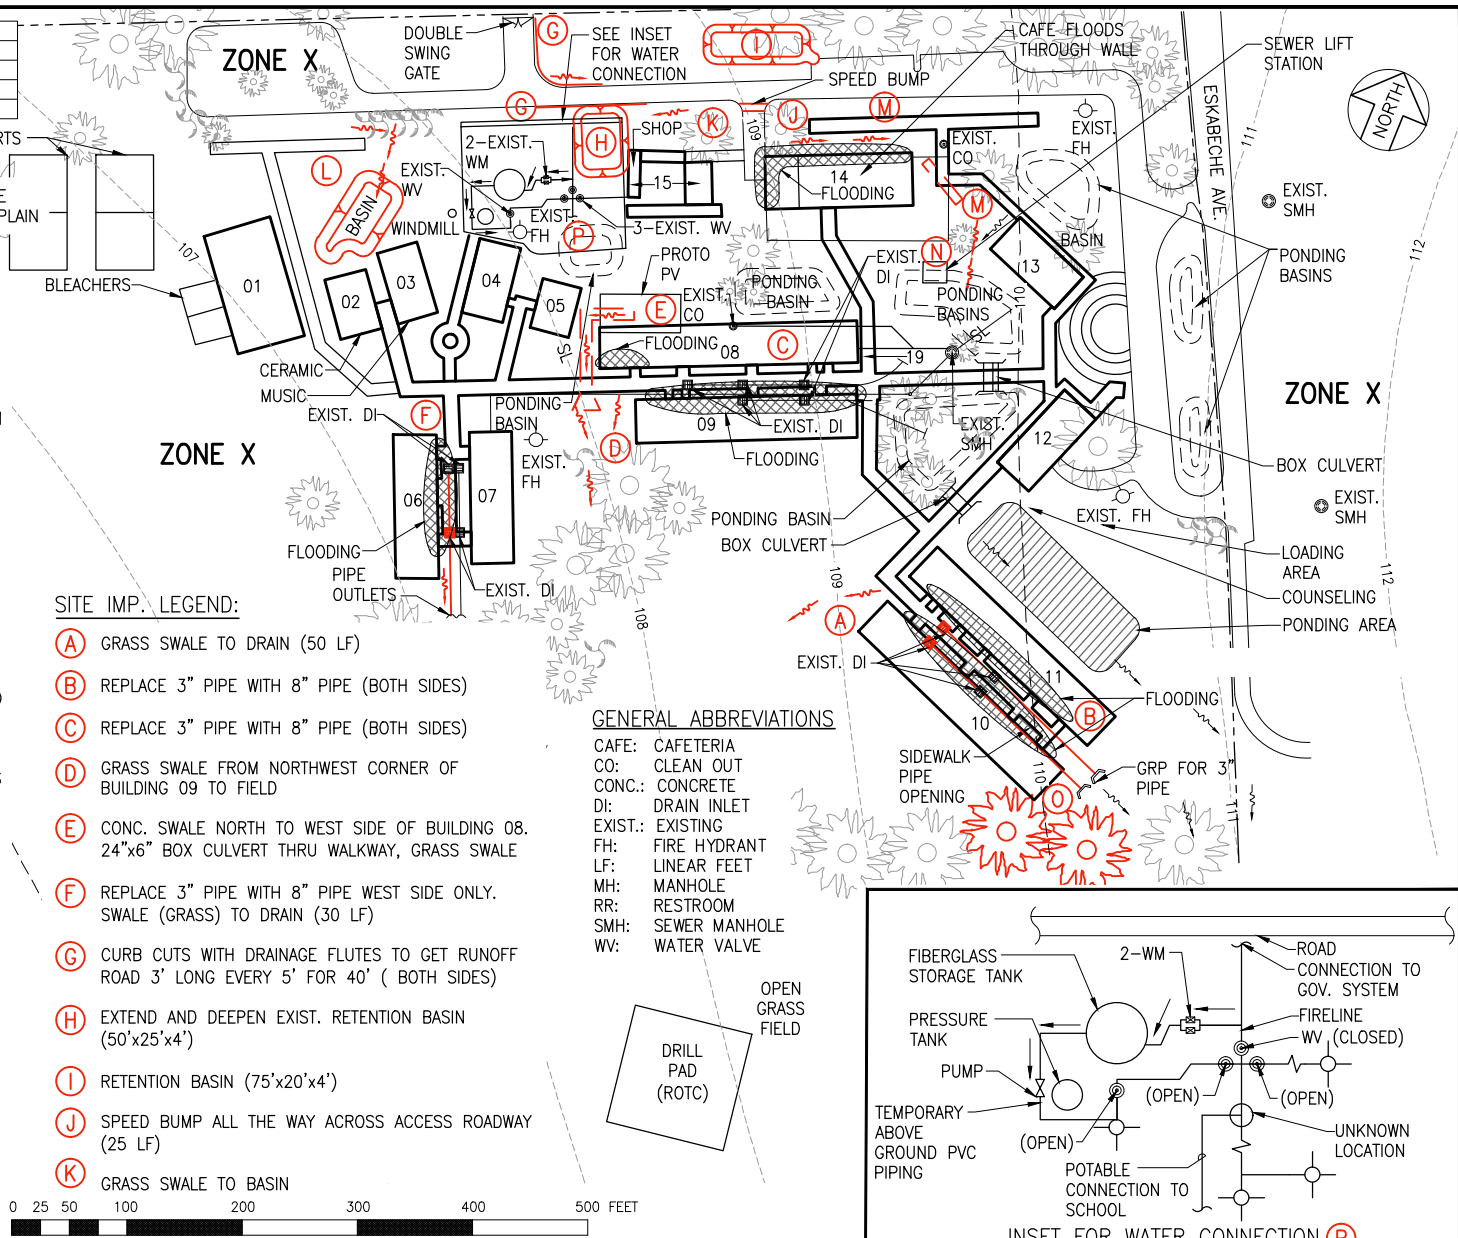
- POTABLE WATER SERVICE IS PROVIDED BY THE CUC WATER SYSTEM. WATER PRESSURE IS LOW FOR THE SCHOOL. THE CUC POTABLE WATER IS PUMPED FROM AN EXISTING FIRE HYDRANT AND A TANK/PUMP SYSTEM IS UTILIZED. THE PUMPS ARE CHANGED ONCE A YEAR. THE TANK APPEARS TO BE LEAKING AND DUE TO A CONTRACT DISPUTE WITH THE CONTRACTOR WHO CONSTRUCTED THE SCHOOL, IT IS UNCLEAR HOW THE WATER SYSTEM WAS INSTALLED. PSS WOULD LIKE TO FIX THE WATER SERVICE TO THE SCHOOL AND NOT HAVE IT BE PROVIDED THROUGH A FIRE HYDRANT. CUC AND PSS PLAN TO TEAM AND DEVELOP A SOLUTION. SEE INSET FOR POSSIBLE WATER SYSTEM CONNECTION LAYOUT.

- (A) REGRADE AND PROVIDE CONC. SWALE TO DRAIN (30 LF)
- (B) ADD CONC. THRU GUTTER (4' S/W), CONC. SWALE TO EXIST. DI. DEMO CONC. HW, DEMOLISH EXIST CMU WALL ALONG BUILDING 14 S/W.
- (C) RESET CONC. PAD FRONTING DOOR TO FLOW AWAY (4'x25' AREA).
- (D) REGRADE TO PROVIDE 3' GRASSED SWALE (200 LF).
- (E) INSTALL NEW FH W /6" WATER LINE.
- (F) REPLACE SEPTIC TANK AND ADD LEACHING FIELD.
- (G) REPLACE WATER TANK PUMPS

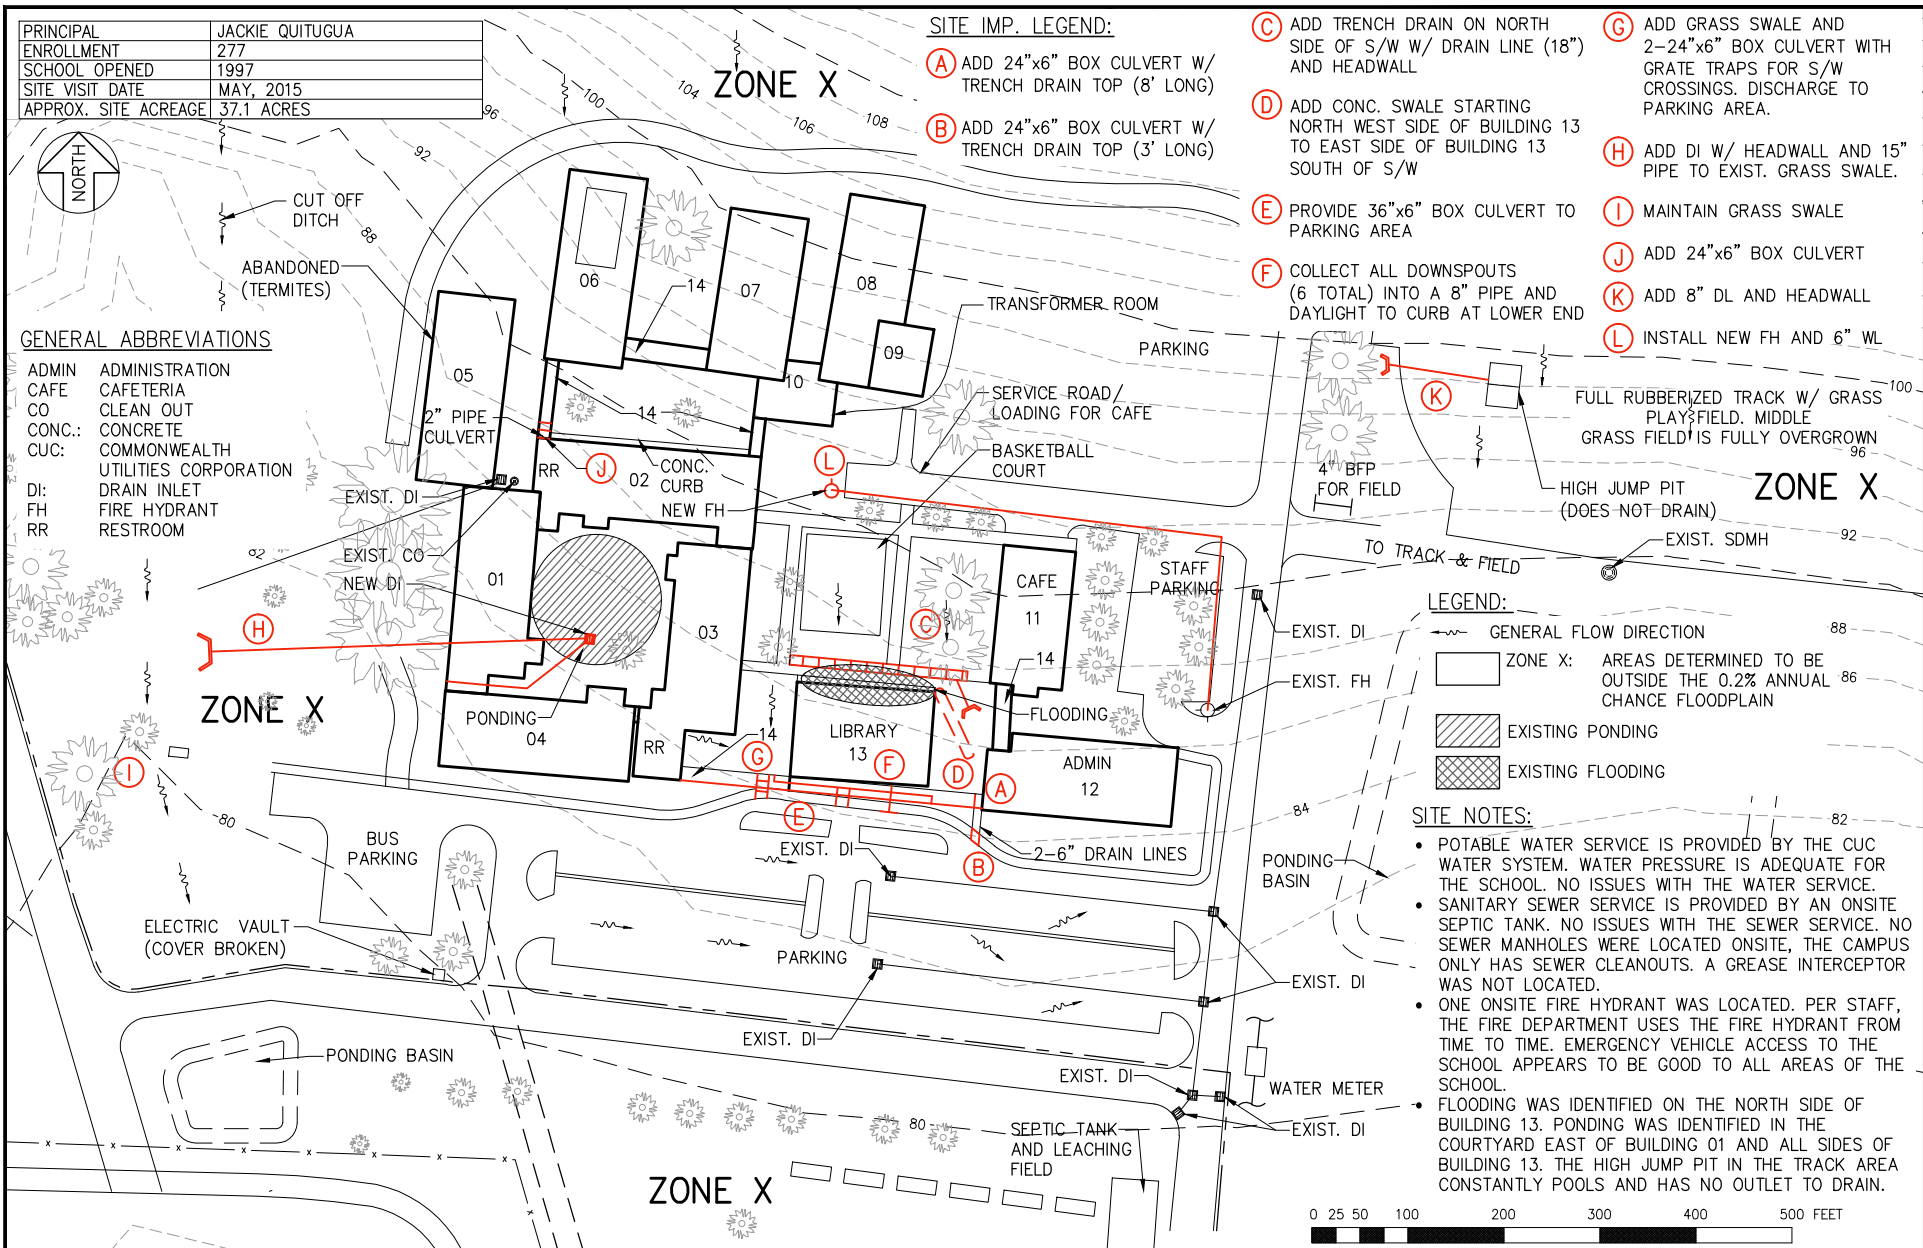
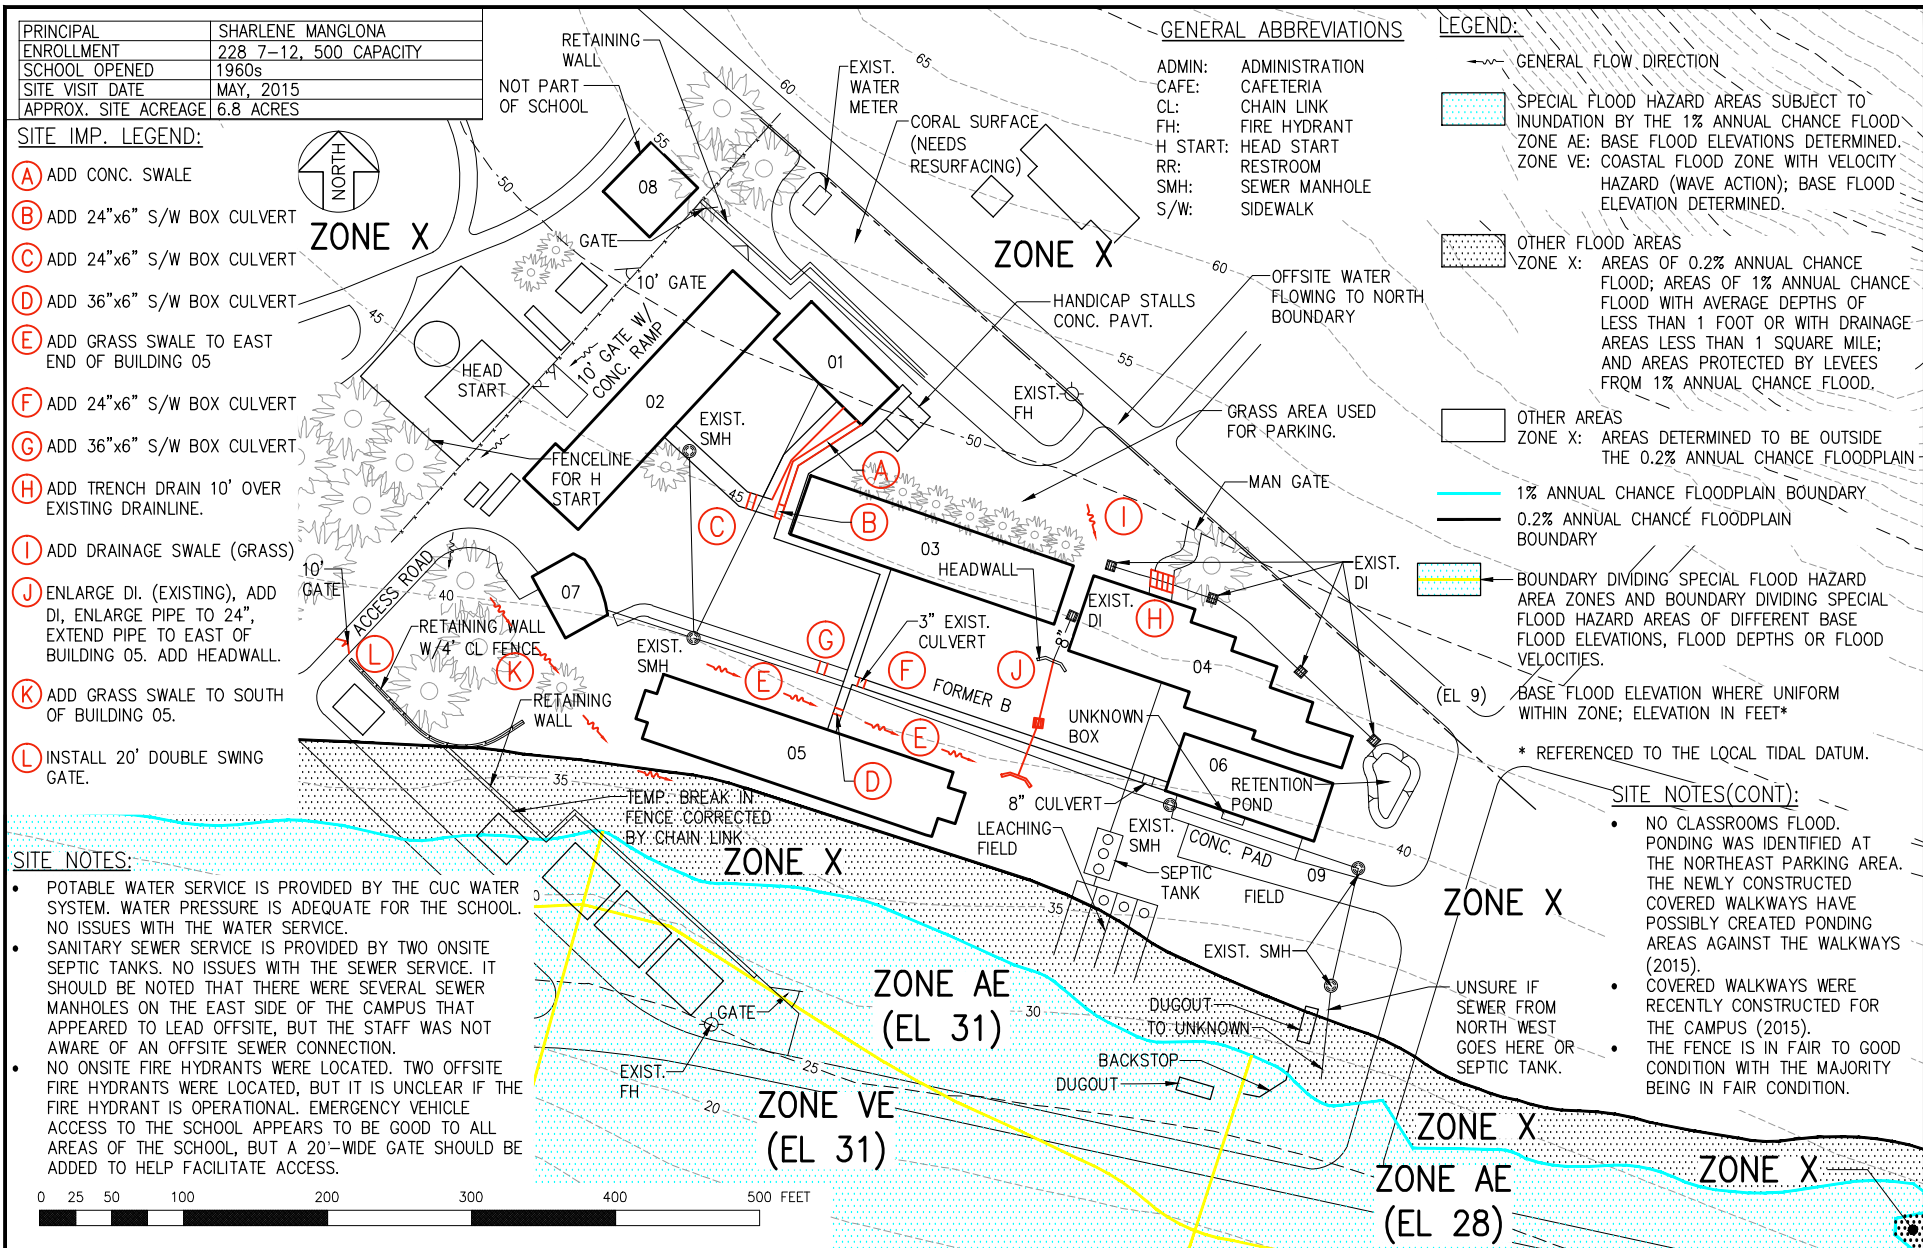
PRINCIPAL	SHARLENE MANGLONA
ENROLLMENT	UNKNOWN
SCHOOL OPENED	1982
SITE VISIT DATE	MAY, 2015
APPROX. SITE ACREAGE	21.2 ACRES

- NO ONSITE FIRE HYDRANTS WERE LOCATED. TWO OFFSITE FIRE HYDRANTS WERE LOCATED, BUT IT IS UNCLEAR IF THE FIRE HYDRANTS ARE OPERATIONAL. EMERGENCY VEHICLE ACCESS TO THE SCHOOL APPEARS TO BE GOOD TO ALL AREAS OF THE SCHOOL, BUT A 20'-WIDE GATE SHOULD BE ADDED TO HELP FACILITATE ACCESS.

- FLOODING WAS IDENTIFIED ON THE NORTH SIDE OF BUILDING 03. MAJOR PONDING WAS NOT IDENTIFIED BY STAFF.
- THE SCHOOL WAS CLOSED IN YEAR 2011.
- ROTC AND P.E. CLASSES FROM ROTA JUNIOR/SENIOR HIGH SCHOOL CURRENTLY USE BUILDING 04 AND THE GYM (BUILDING 06), RESPECTIVELY.
