# **INSULAR ABC'S INITIATIVE**

## **Phase III Task 1 Findings and Recommendations Commonwealth of the Northern Mariana Islands**

October 2015

ARCHITECTURAL SUMMARY REPORT  
COMMONWEALTH OF THE NORTHERN MARIANA  
ISLANDS  
October 2015

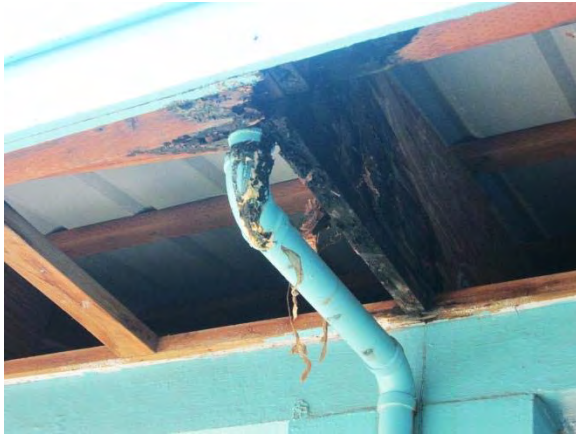
Gutters were removed from the covered walkway. In some locations the downspout is leaking, causing mold to form at the walkway rafters.

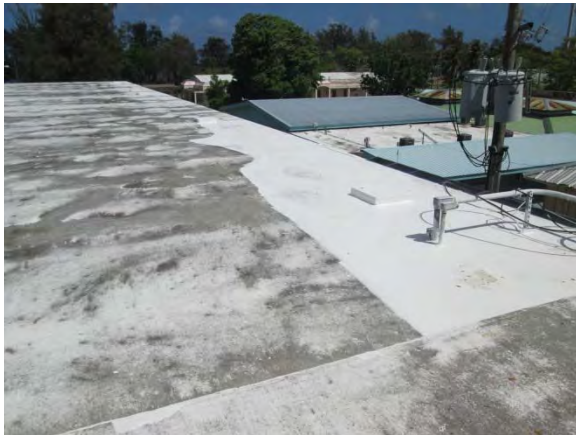
Roofs at buildings 1-4 (A-D) were patched [product: Roofmate, same product as 2013 roofing projects]. The previous roofing was done in 2005; these buildings were not reroofed in 2013. A new stainless steel gutter was installed at the eaves above the covered walkways. Some roofing repairs were done at the Gym by a contractor, but there is still some leaking.

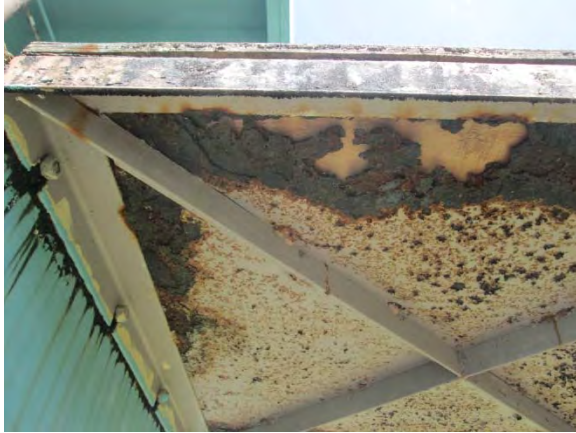
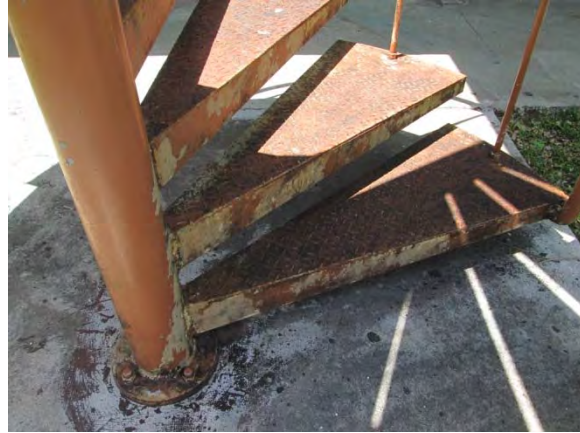
The steel spiral fire escape stairways at Buildings 1-4 and 6 (A – E) have corroded further. Plywood was installed at the top landing platform due to the corrosion of the floor plate, but there is extensive corrosion in the plate and the steps and handrail connections are also rusting. The plywood has helped to reduce the safety hazard, but the top landing plate should be replaced, and the stairways should be cleaned, the rust removed, and they should be painted to help slow further deterioration

The steel spiral fire escape stairways at Buildings 1-4 and 6 (A – E) are extensively corroded, particularly at the top landing. Plywood was installed at the top landing platform due to the corrosion of the floor plate, but there is extensive corrosion in the plate and the steps, and handrail connections are also rusting. The plywood has helped to reduce the safety hazard, but the stairs need to be repaired or replaced.

- Remove existing floor plate
- Examine landing structure to determine integrity, and repair if required
- Install new galvanized steel floor plate.
- The stair treads should also be examined and replaced or repaired where needed
- Establish schedule for repainting to prolong life of stair

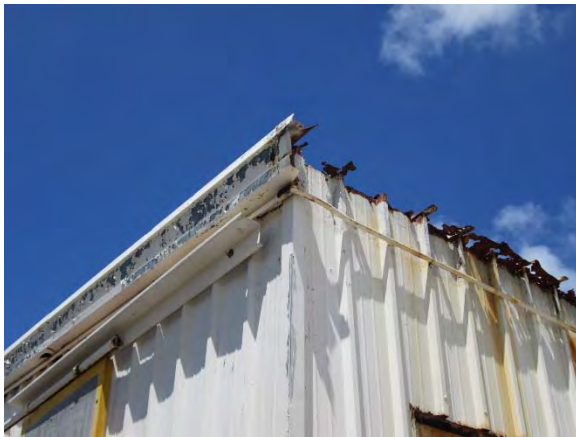
Building 16 (T-south) and 14 (T-north) buildings are still in poor condition. School staff stated that they would like to repair the buildings and use for storage. The metal roofing and siding is rusted and in poor condition, and the steel columns at T-south would require repair.

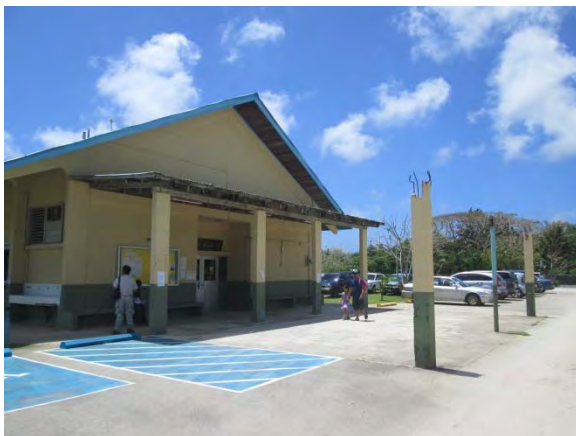
The Bus Shelter (Bldg 12) roof that was identified in Phase 2 as unsafe was mostly removed, with a small portion remaining to offer some rain protection. It is no longer a safety hazard.

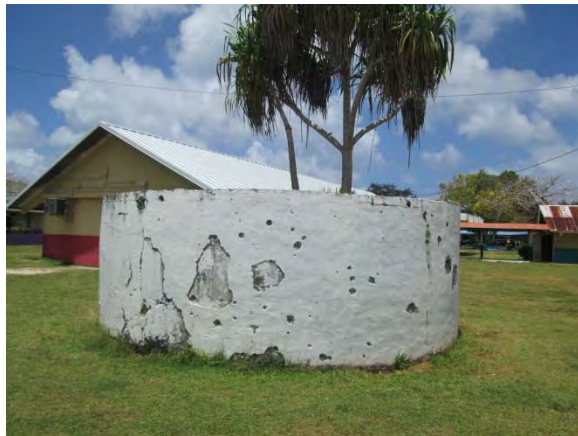
Two historic WWII Japanese water tanks are located on the east side of the campus near Building 3. One has a tree growing out of the middle of the structure; this should be removed to prevent further damage to the structure. The water tanks should be monitored and plants, trash and debris removed to help extend the life of the historic structures.

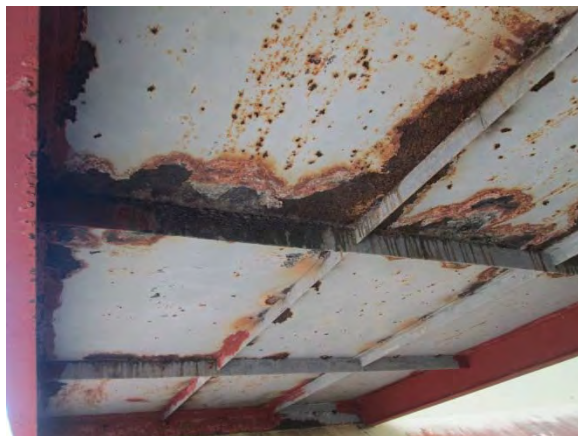
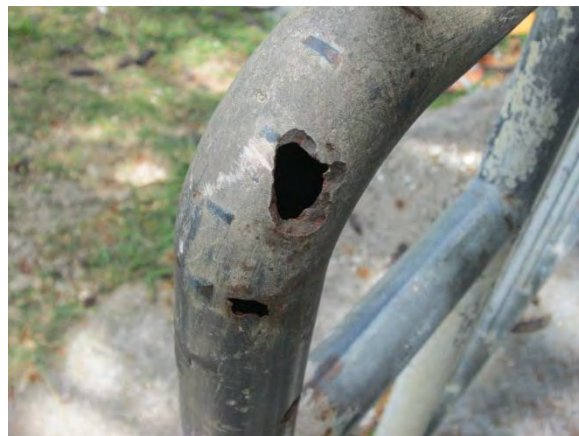
Some concrete repairs at the metal entry ramp leading to Building 4 (A) helped with the drainage and have provided some support for the structure. The ramp could use some additional support (see structural report), and the floor plate is rusting. Portions of the handrail have rusted holes, which could cut people's hands and is a safety hazard, and should be patched. The bottom of the handrail is also rusting and will eventually become loose. Due to these multiple issues, plans for replacement of the ramp should be put in place.

Portions of the handrail have rusted holes, which could cut people's hands and is a safety hazard. The bottom of the handrail is also rusting and will eventually become loose

Where railings are rusted at the base, the railing should be removed and re-welded

- Cut railing off at each base and remove railing
- Removed rusted portion of the base
- Weld new base to ramp and then weld base to railing, ensuring that railing height meets building code requirements.

Where railings are rusted at other locations:

- Remove rusted metal and clean rail surface
- Weld railing as required to repair rusted areas and holes

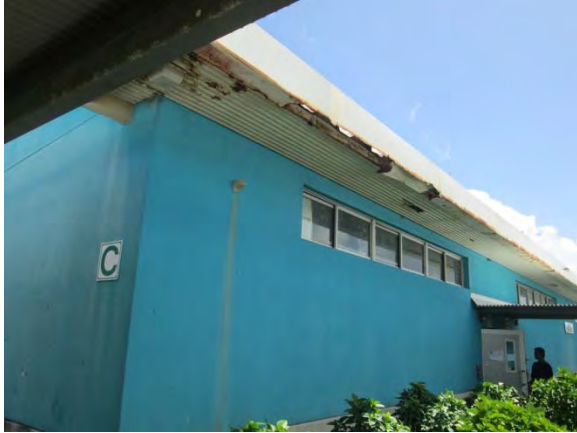
The metal gutters that were noted in the Phase 2 survey as extensively deteriorated have not been removed or replaced, although portions of the rusted metal that were dangling were removed. More of the gutters have rusted, and they are still a safety hazard. The damaged portions of the gutters should be removed. Due to the failed gutters, water continues to pour onto the buildings when it rains, potentially causing damage to the building exterior and interior elements. The gutters should be replaced.

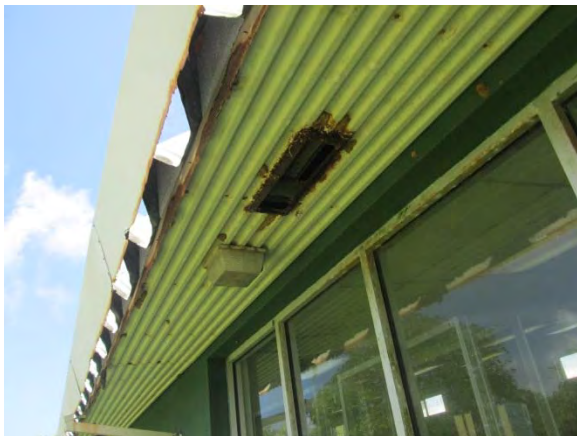
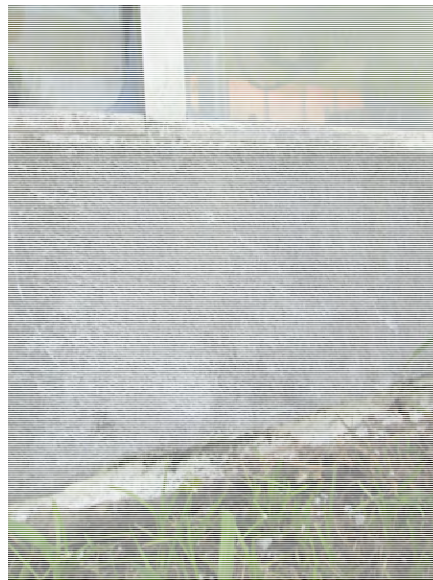
Water has been periodically found on the Library interior floor; it is not apparent if the water is coming through an inadequate window seal, from the wall above, or from the exterior wall where the finish system has been damaged, most likely from maintenance staff using weed whackers. Some patching was done to the window seal, but the leaking persists.

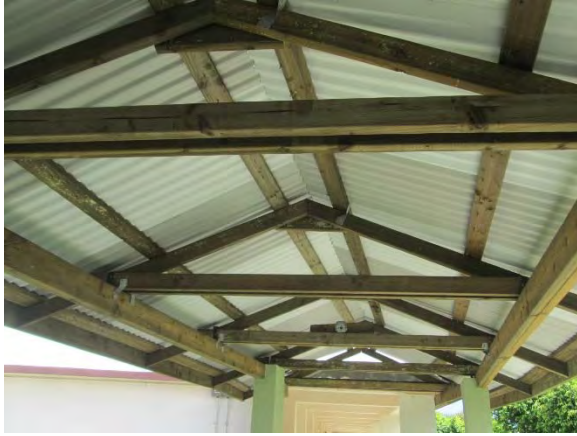
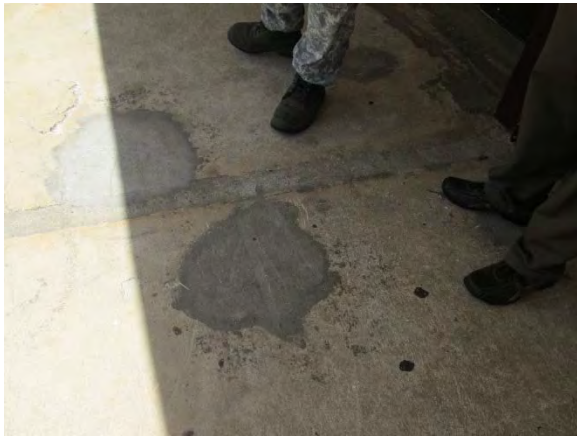
Some work has been done to repair the covered walkways, while parts are still damaged and need repair. Some of the spalled areas at the concrete floor have been patched.

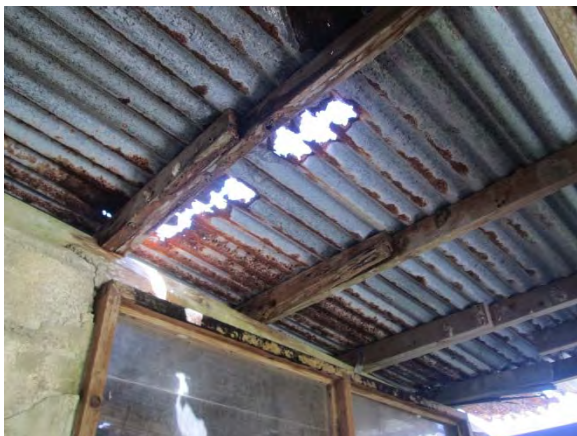
The roof structure and roofing at Building 12 is still in poor condition and should be replaced.

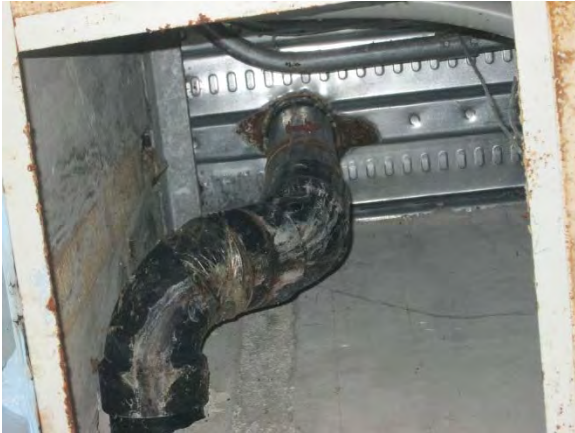
The roofs are leaking at buildings 2, 5 and 8 (D, E, F). The maintenance staff said that it appears that when the previous roofing was removed, nails were left in the sheathing, which perforated the new corrugated metal roofing and is causing the leaks. Roof leaks in the Cafeteria are likely from poor seals around the roof drains, as leaks are isolated to the roof drain locations.

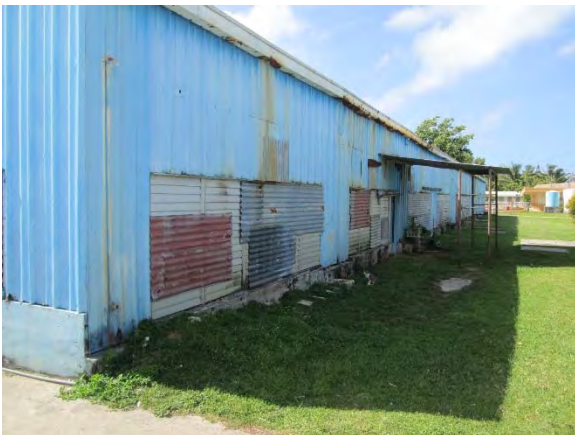
Building 12, the Maintenance building, is still in poor condition. Whether or not this building will be repaired and retained is undecided, but the building is currently full of stored items that can't be thrown away and must be properly disposed of (like computers), so likely nothing will occur until these items are dealt with.

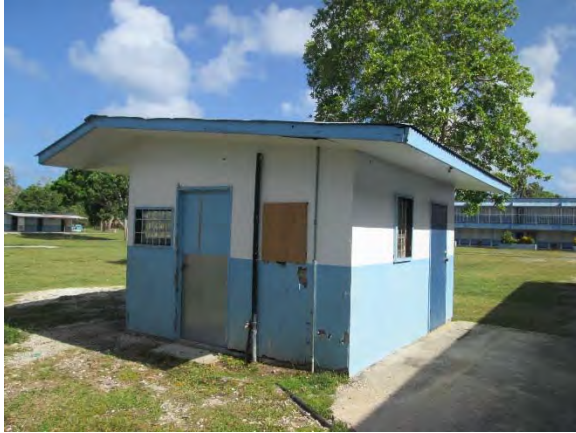
The Canteen (Building 17) is still in poor condition, and although it is still in use, it is being considered for demolition. The exterior siding is termite damaged, and it is likely the building structure is also termite damaged.

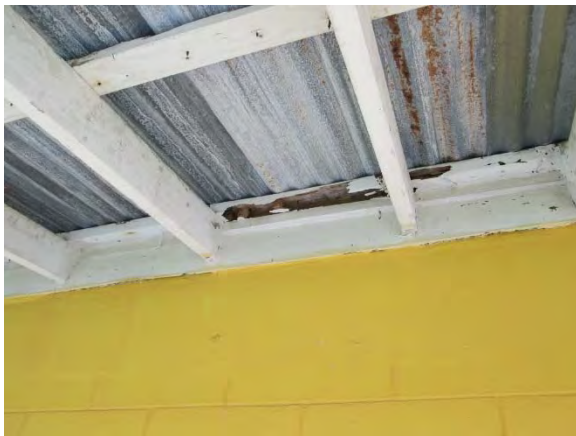
The school has problems with termites, and several buildings including 2, 4, 7, 8, and 10. Termites are causing damage to building structure, interior walls, furniture and books in the classroom. School staff stated that they are not permitted to spray termite treatment on the ground due to the proximity to the ocean.

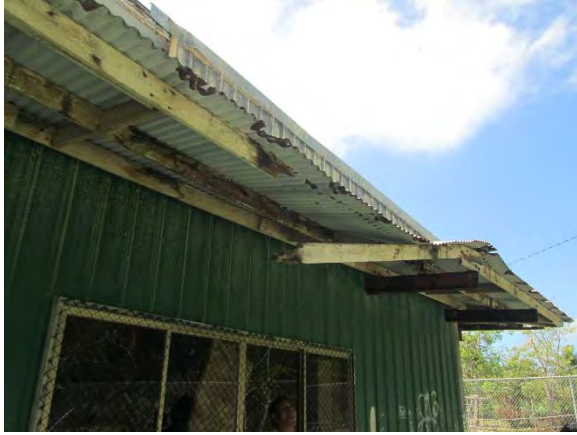
Buildings 15 and 17 are still in poor condition; the school is still deciding to repair or demolish them. The eave is broken and collapsing at the west side of building 15; this is a safety hazard and should be repaired.

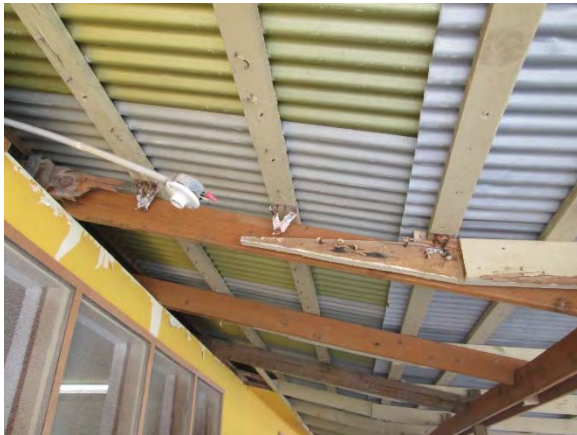
At the covered space on the west side of Building 10, the rafters collapsed; the maintenance staff sistered new rafters on and added some posts, but additional supports should be installed.

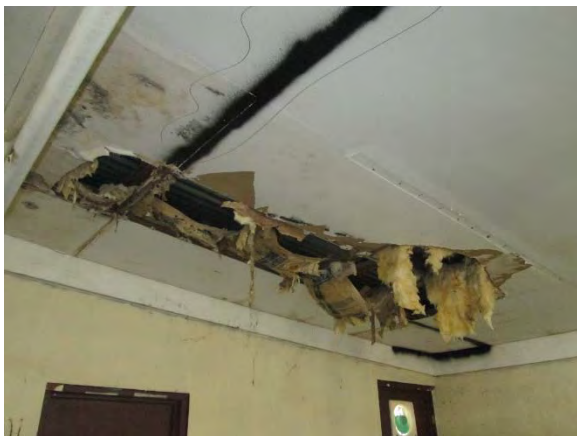
At Building 7 (M), termite damage and a hole in the roofing has created a large hole in the roof, which is allowing water in. This is causing damage to the building structure and interior finishes, and it should be repaired if this building is to be used in the future.

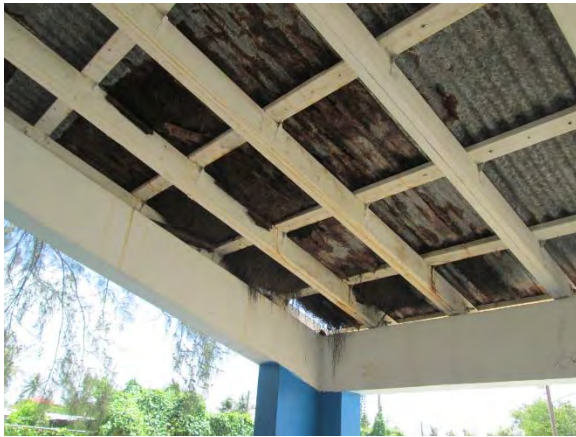
The deterioration of the corrugated metal roofing at Building 9 is likely being accelerated by the pine needles that collect on the roof, deposited there by a nearby Ironwood tree. The needles should be cleaned off, particularly in wet periods, to help prolong the life of the roofing.

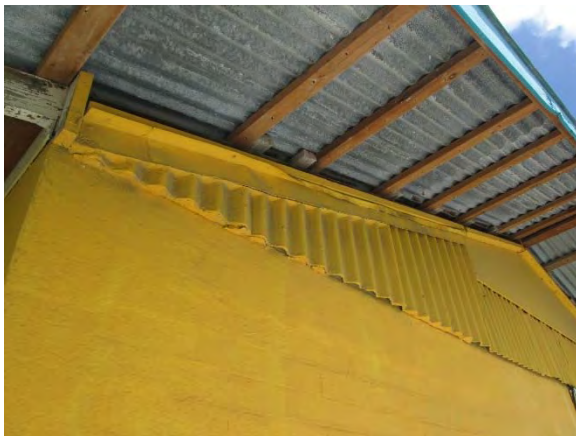
Some existing siding at the gable end wall of Building 2 (A) appears that it might be corrugated asbestos. The material should be tested prior to any renovation, repair or demolition work that would affect this material.

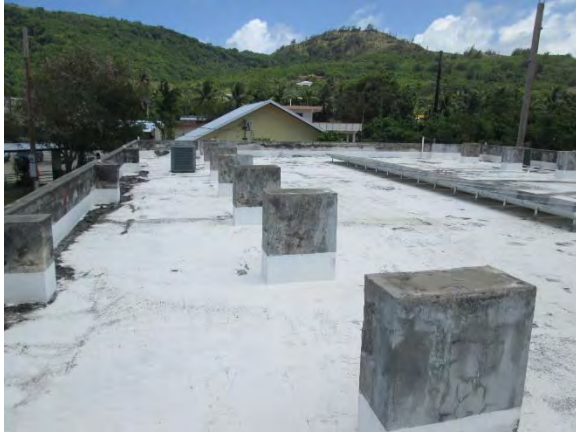
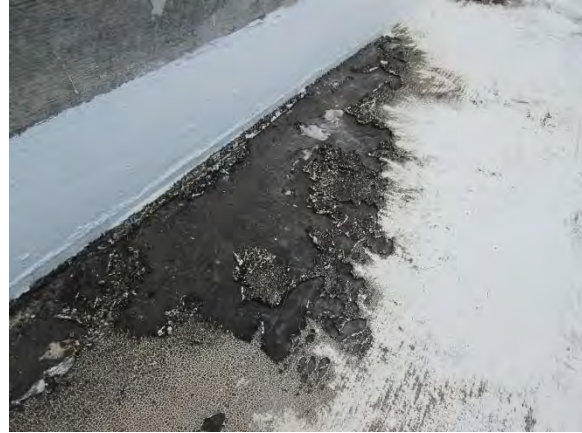
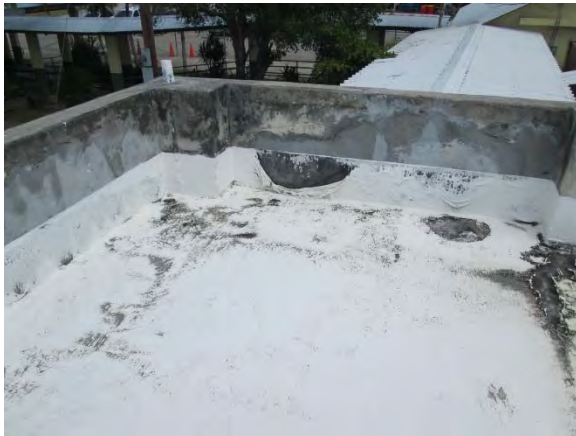
The roofing at Building 2 is in poor condition; reroofing is planned for the summer 2015, and is reportedly under warrantee.

The roofing at Building 2 is in poor condition; reroofing of is planned for the summer 2015, and is reportedly under warrantee. If the roofing contractor is not able to replace or repair the existing roofing, it must be patched in order to help prevent leaking below.

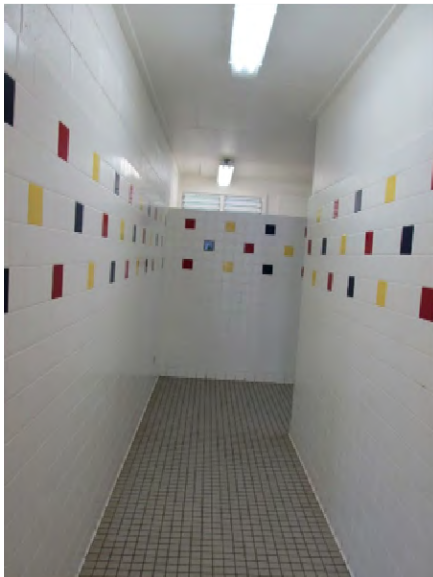
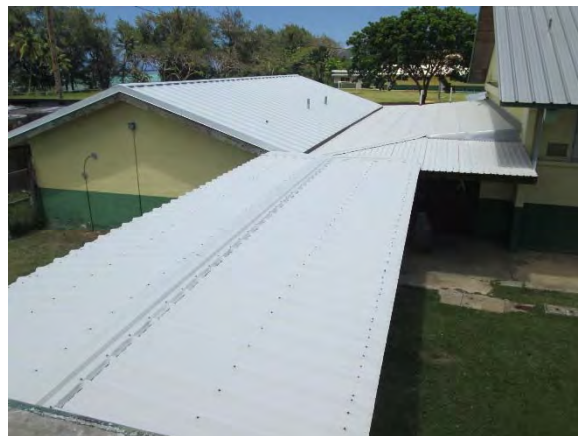
The maintenance area behind the Cafeteria received new roofing and gutter, as has the covered walkway leading from the restroom (4) to Building 2. The restrooms (4) have been renovated on the interior, and have new roofing. Building 1 has also been reroofed.

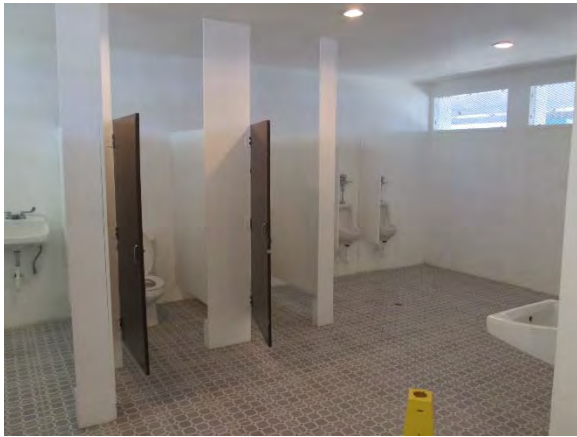
Building 10 (J) is currently under renovation. The bathroom (Building 9) has new roofing and has been renovated on the interior. Concrete spalls on this building were repaired by a contractor.

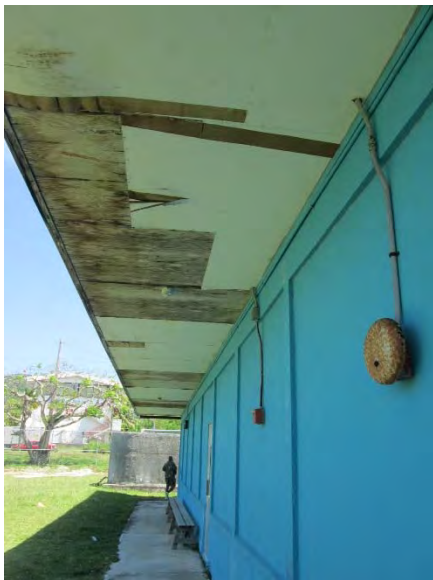
Building 13 (F) also has new roofing, installed in 2013, but needs new plywood at the soffit.

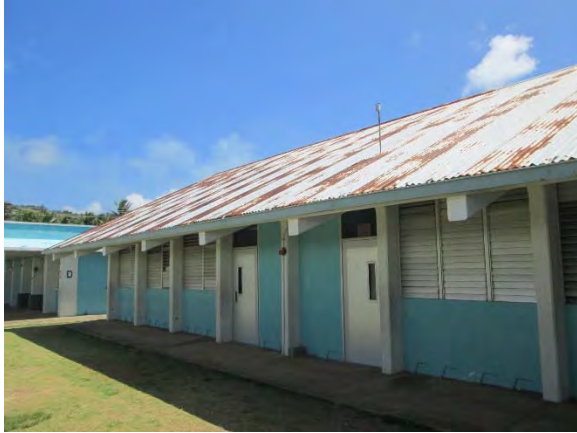
The restroom in Building 5 (B) was also renovated on the interior. New fencing was installed around the school. Building 7 (C) needs new roofing.

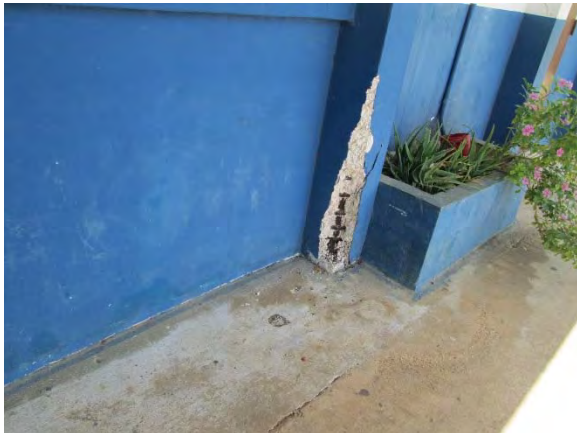
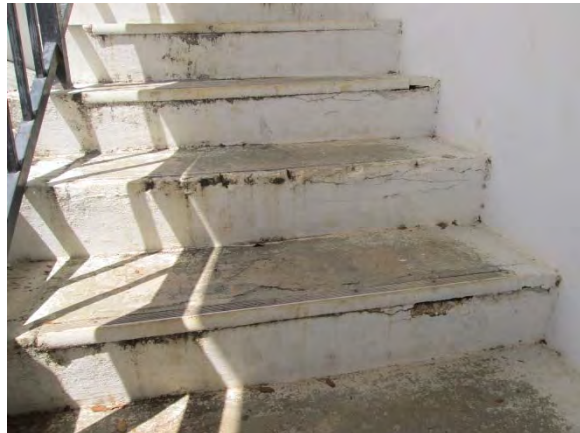
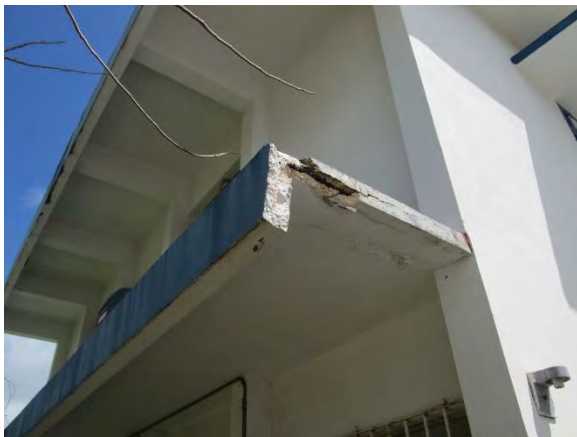
Some interior work has been completed on Building 10, but the exterior still has spalling at the exterior stairs, walls, and awning. The door on the east side of the second floor has swollen from moisture and is unopenable.

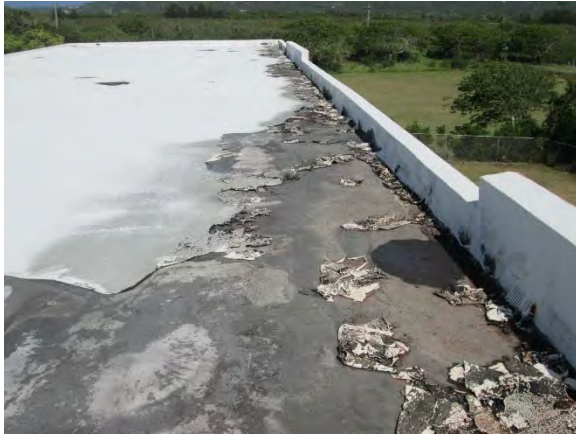
The roofing at all of the buildings is failing, and some of the buildings have roof leaks.

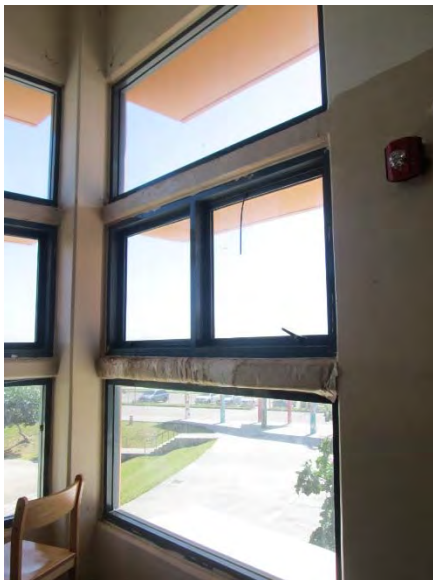
At the Library (Building 2), it is leaking around the windows in the corner of the main room. It appears to be from poor seals in the sash frames not able to keep out wind-driven rain.

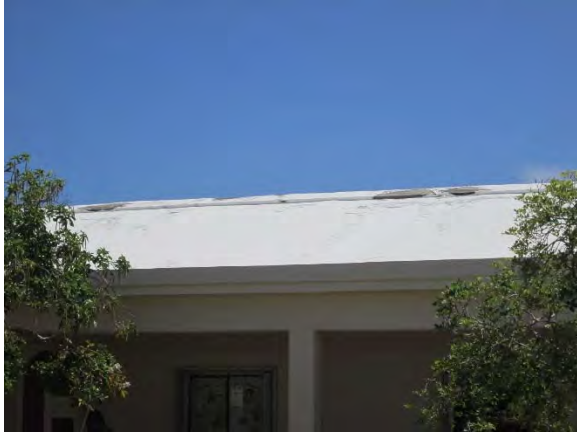
No new issues were observed at this school except for the failure of some of the roofing, mostly at the top of the gabled roofs.

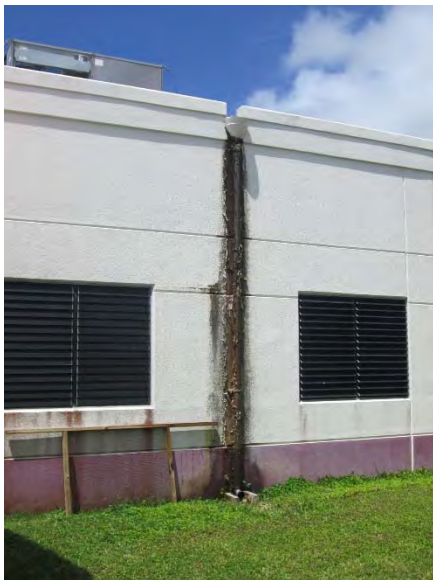
There are signs of some roof leaks, mostly isolated to the location where sloped roofs meet the flat roof of the exterior walkway. The exterior downspouts, noted as deteriorated in the Phase 2 survey, have not been repaired and have continued to deteriorate. The uncontrolled water is damaging the building exterior.

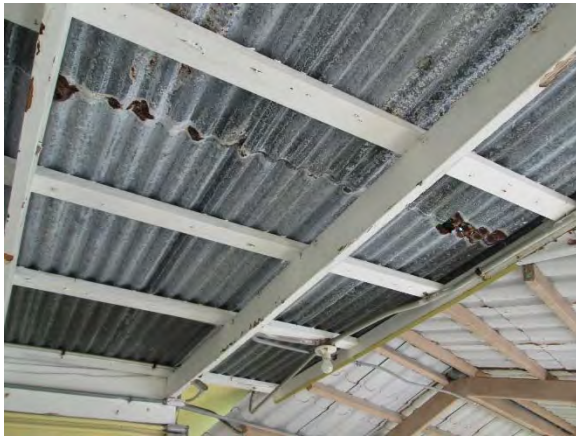
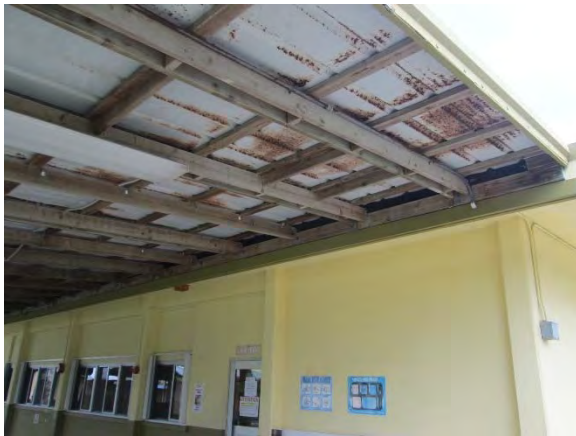
Maintenance staff stated that there are currently no roof leaks, but deteriorated metal roofing was noted in the covered walkways, and Buildings 9 and 13.

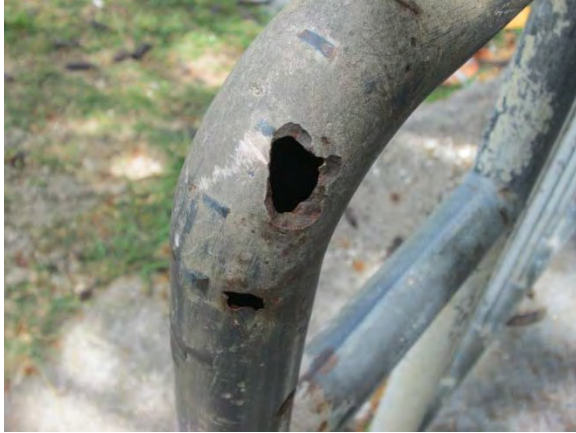
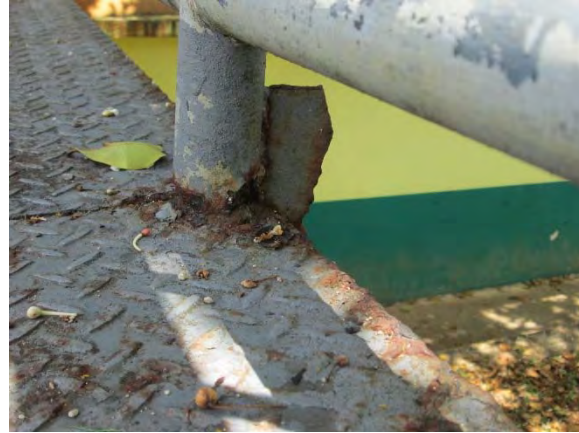
##### 1. Rusted metal railing

Location: San Vicente Elementary School, Building 4

**Recommended Scope of Work:**

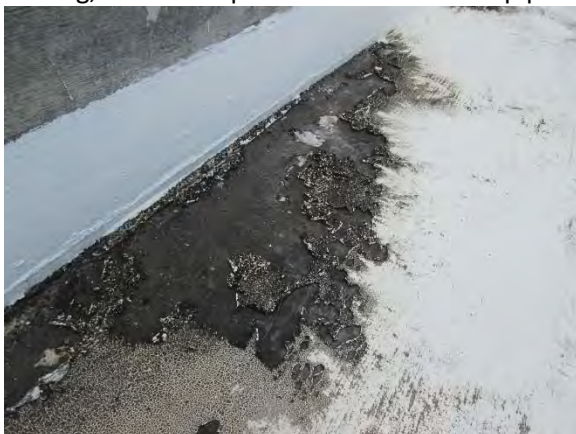
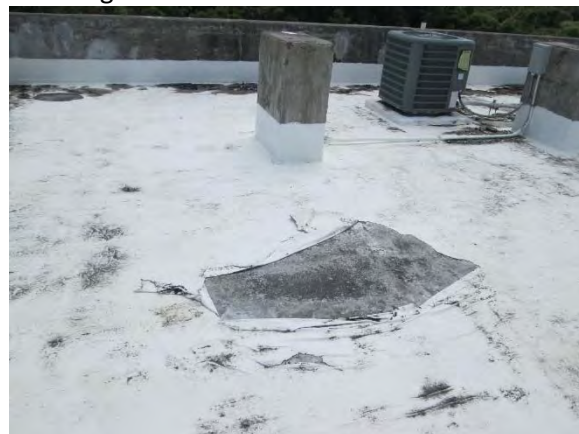
**2. Isolated areas of deterioration of Fluid-applied roofing**

Location: GT Camacho Elementary School, Building 2; Chacha Middle School, all buildings

The roofing can be patched, but will likely last only a few years at the maximum before the entire roof should be re-roofed.

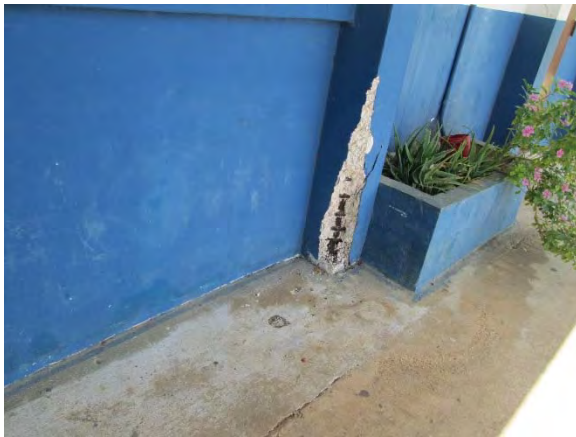
### 3. Spalling concrete (non-structural elements)

Location: Garapan Elementary School, Building 10

The concrete is spalling at several locations at this building. The spalling is typically caused by moisture getting into the concrete and rusting the steel reinforcing, which expands as it rusts and causes the concrete to crack and eventually break off. Where cracked and spalling concrete is on ceilings or is on columns or walls above, it is a safety concern as they create a falling hazard to the building occupants.

Recommended Scope of Work:

To repair non-structural concrete spalling, the following steps should be taken:

- Remove all loose concrete
- Remove as much rust as possible from steel reinforcing elements
- Replace reinforcing as necessary. Consider using fiberglass reinforcing bars
- Treat steel with a rust-preventing compound
- Fill all cracks and patch spalls with new concrete

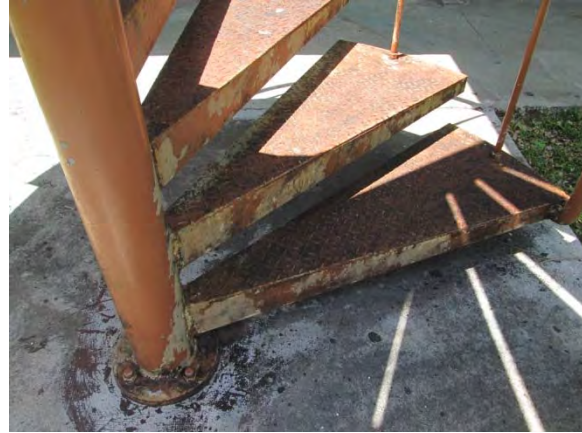
### 4. Rusted Fire Escape

Location: Marianas High School, Building 1, 2, 3, 4, 6

**Recommended Scope of Work:**

The rusted top landing floor plates should be replaced:

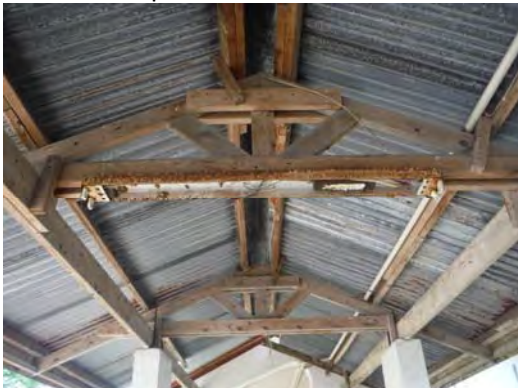
General Walkway Area

OIA Phase III survey found that walkway light bulbs should be replaced.

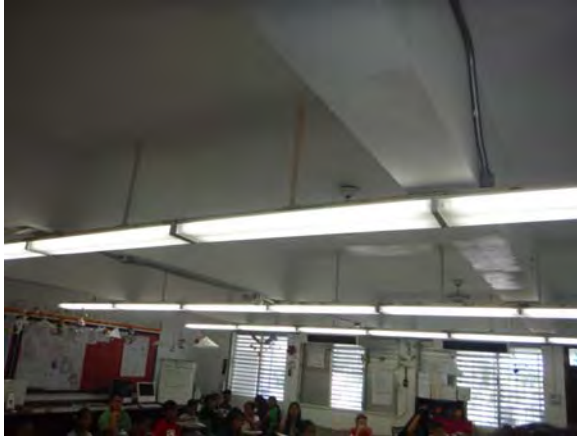
Building D:

OIA Phase III survey found that lighting fixtures have been replaced.

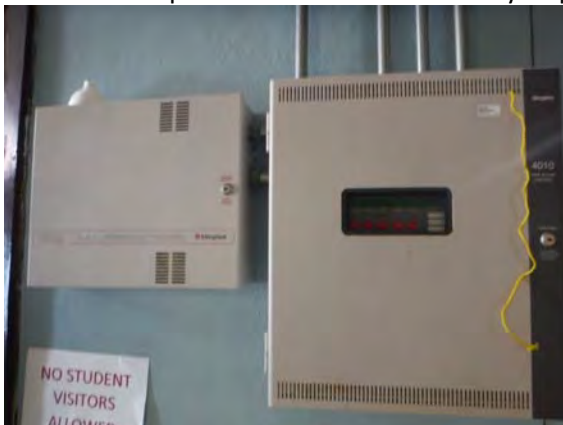
1. Fire alarm system

OIA Phase III survey found the fire alarm panel power was off. This condition poses a safety hazard to the occupants. The fire alarm system requires servicing and repairs to ensure that functions and performance meet fire safety requirements.

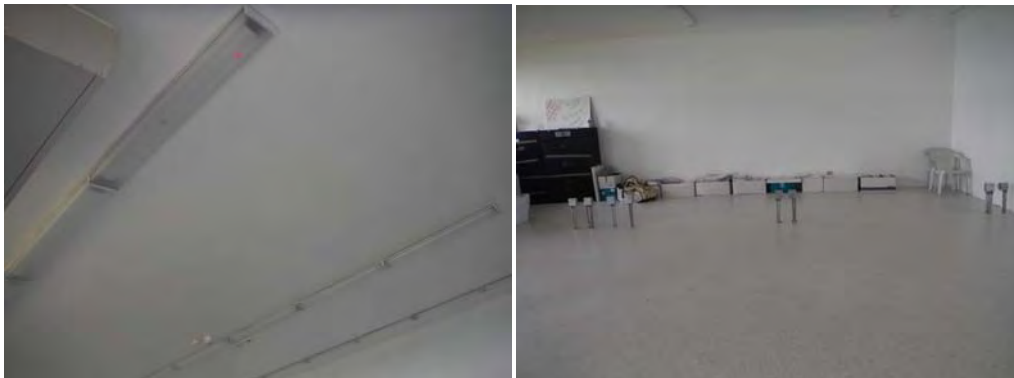
Building 13-F

OIA Phase III survey found that the building interior was renovated.

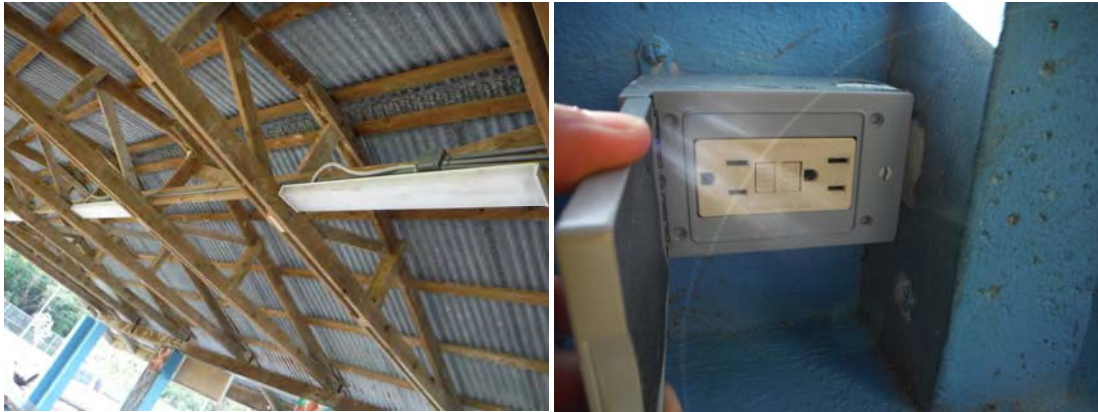
#### Building 02 Bus Shelter

OIA Phase III survey found that lighting fixtures have been replaced. Weather proof covers have been installed on receptacles.

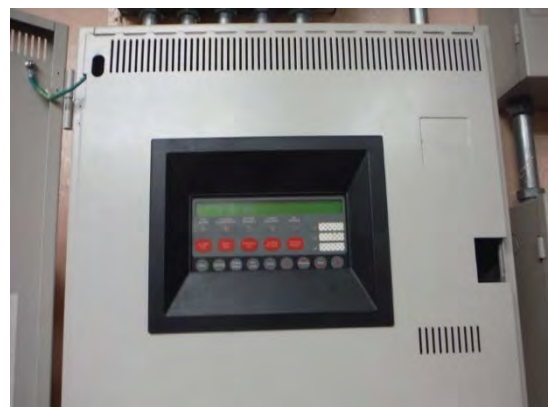
##### 1. Fire alarm system

OIA Phase III survey found the fire alarm panel power was off. This condition poses a safety hazard to the occupants. The fire alarm system requires servicing and repairs to ensure it functions and performs per fire safety requirements.

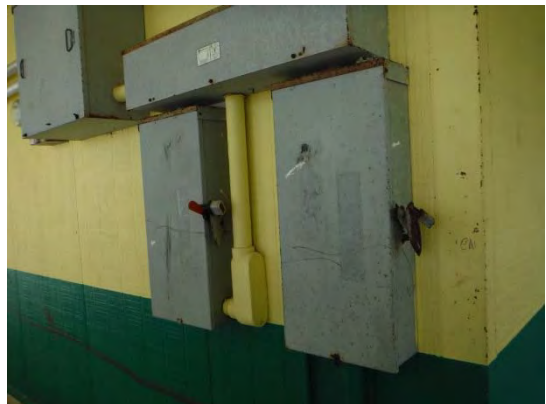
2. Building 04-A:

OIA Phase III survey found that the service disconnect on the exterior of the building is padlocked in the closed/on position.

OIA Phase III survey found that the building's ground floor receptacles have been replaced.

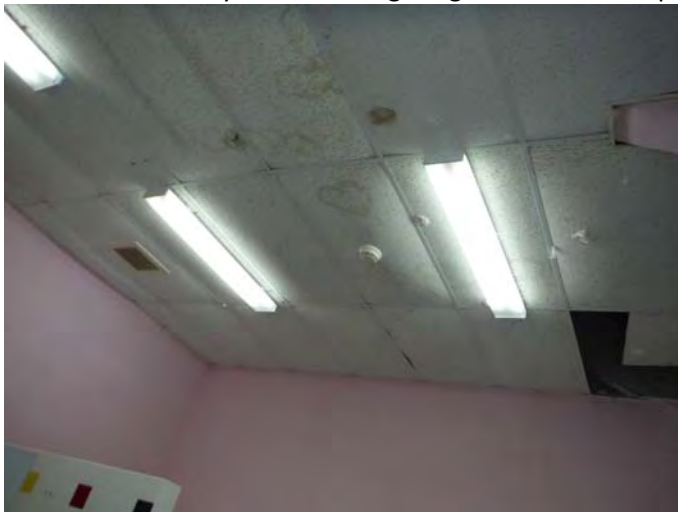
Building 13-H

OIA Phase III survey found that lighting fixtures were replaced.

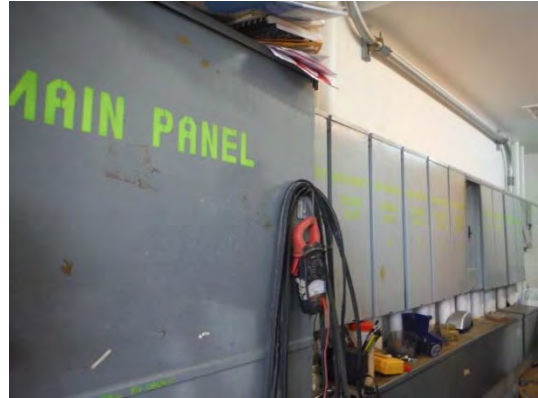
2. Electrical/lighting:  
Service Connection  
OIA Phase III survey found that each building has a dedicated electrical service connection.

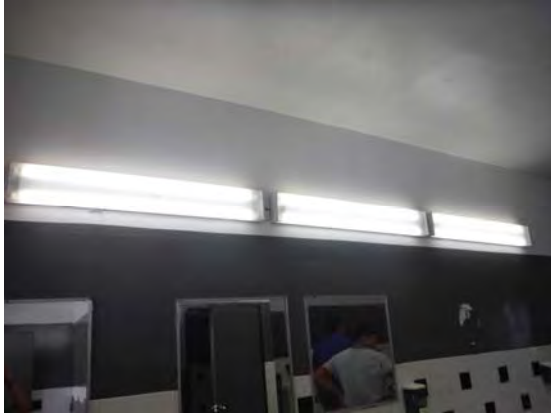
#### Building 04-A

OIA Phase III survey found that men and women's restroom lighting fixtures were replaced.

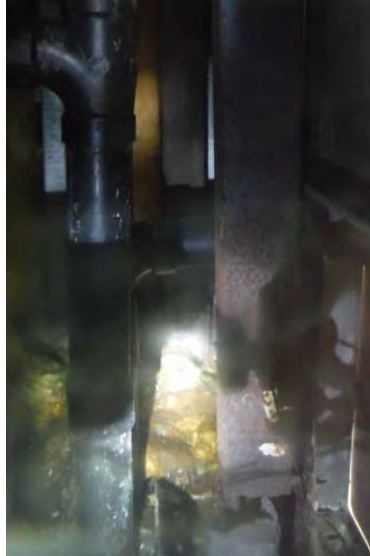
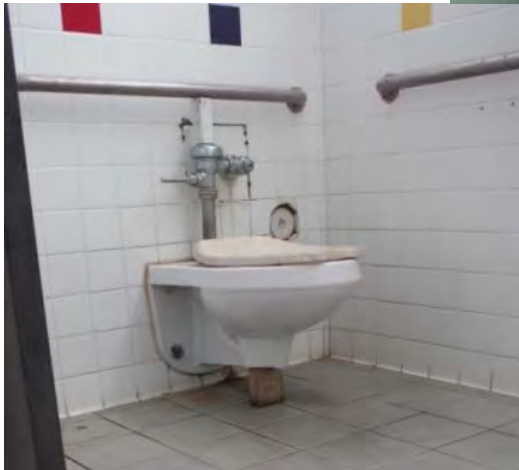
2. Building 6

OIA Phase III survey found some steel carriers of plumbing fixtures were broken due to corrosion. The steel carriers should be replaced in order to support the plumbing fixtures. The broken fixture carriers posed safety and health hazard to the occupants.

- Use appropriate material and repair plumbing fixture supports as soon as possible.
- Provide corrosion protective coating to steel plumbing fixture carrier.
- Repair water leak preventing aggravated corrosion damages to plumbing carriers and water damage to building elements.
- Provide access panel to pipe chase and inspect pipe chase regularly.

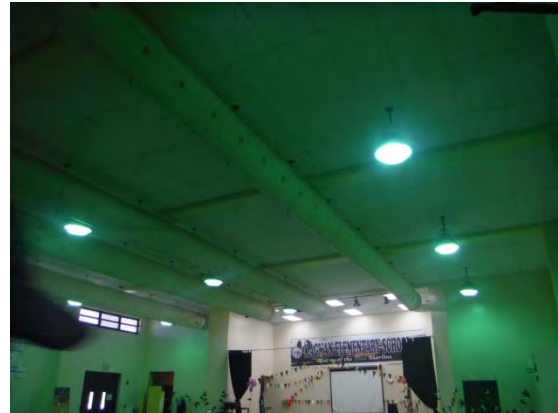
### Building 5 Cafeteria

OIA Phase III survey found that cafeteria high bay lighting dims green.

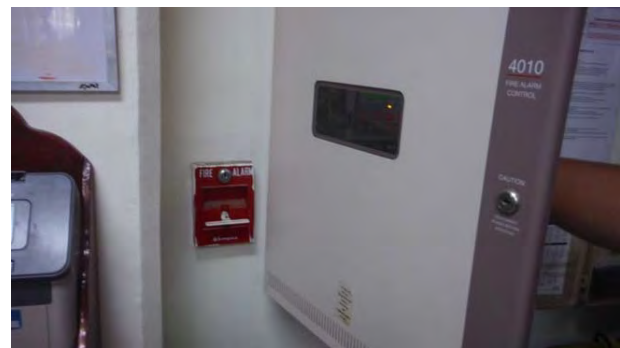
#### 1. Fire alarm system

OIA Phase III survey found the fire alarm panel had trouble signals. Some manual pull stations were required service and reset. It was a safety hazard to the occupants. The fire alarm system required services and repairs to ensure its functions and performance meeting the fire safety requirements.

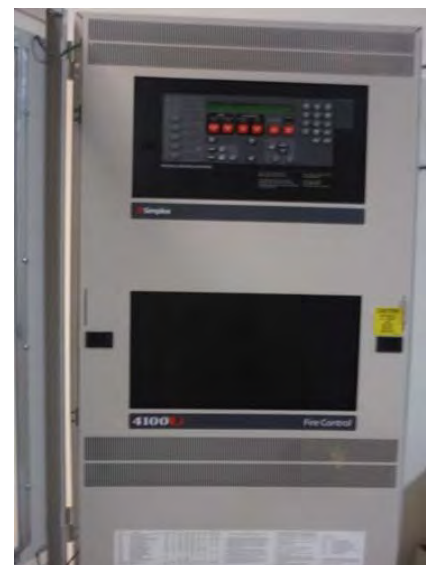
#### 1. Fire alarm system

OIA Phase III survey found the fire alarm panel power was off. This condition poses a safety hazard to the occupants. The fire alarm system requires servicing and repairs to ensure its functionality and performance meet fire safety requirements.

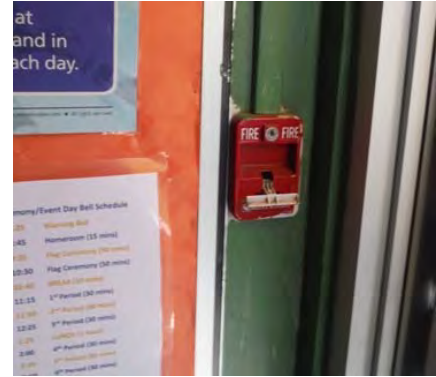
3. Building 22, Classroom

OIA Phase III survey found manual pull station was pulled. Fire alarm system should be serviced and maintained by qualified contractors to avoid and correct the false alarms and system troubles.

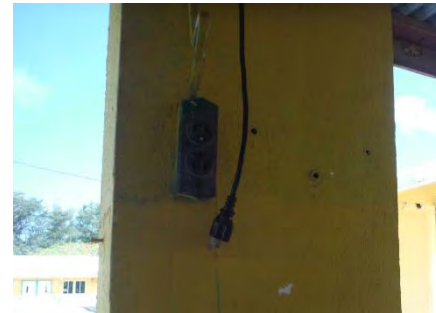
Building 03

OIA Phase III survey found that exterior receptacles should be GFCI installed with a weatherproof cover.

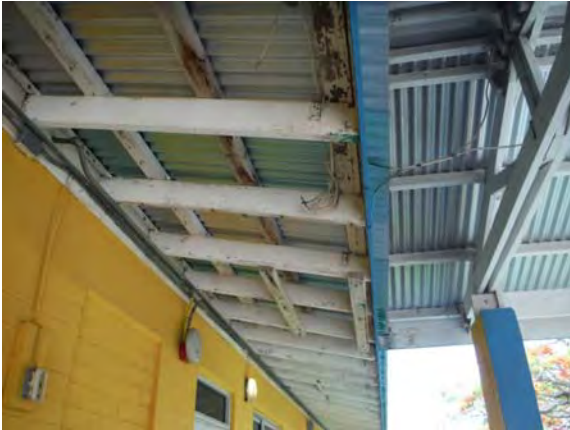
OIA Phase III surveys found that there are exposed wiring on the corridor ceiling.

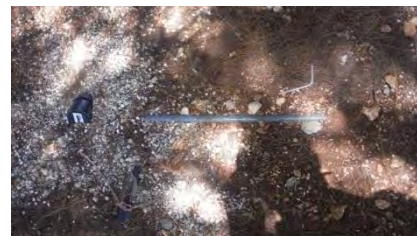
OIA Phase III survey found the newly installed buried plumbing piping to the outdoor hand sinks were too shallow and partially exposed. The exposed buried piping would be damage without proper coverage and pose a tripping hazard to the occupants.

Location: San Vicente ES, Building 2, Cafeteria – the buried plumbing pipe is too shallow and partially exposed. The pipe could be damaged easily.

Recommendations:

- Provide sufficient bedding material and cover to underground plumbing pipe.

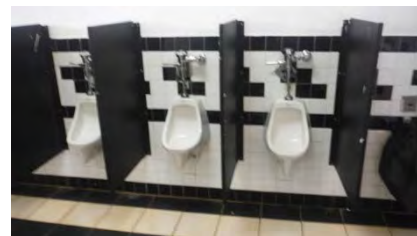
OIA Phase III survey found the new flush valve did not operate properly. They needed adjustment or replacement.

Location: Saipan Southern HS, Building 8, Classroom – The flush valves do not operate properly.

Recommendations:

- Adjust flush valves and water supply pressure for proper flushing operation.

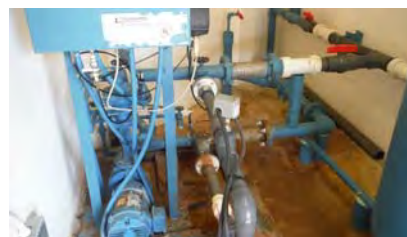
Location: Kagman HS Building 5, Cafeteria and Building 16, Water Tank –

OIA Phase III survey found the municipal water directly supplied domestic water to the school. School did not have single phase booster pump to be hooked up to emergency shelter standby generator provided by CNMI EMO. Water tank overflowed and caused soil erosion at the discharge. It should be corrected.

Existing booster pump at Building 5 uses three-phase electrical power supply. This system is not compatible with the emergency power generator from the Emergency Management Office (EMO) when the school is used as a shelter. The existing booster pump is by-passed. Water piping network was modified so that city water feeds to campus directly. Water tank at Building 16 has been overflowing after the piping modification.

Recommendations:

- Replace booster pump with a single phase, 240 Vac booster pump that is compatible with EMO's emergency power generator.
- Install a check valve at booster pump discharge to prevent water from back-feeding into the water tank.
- Troubleshoot and correct the water piping to stop overflow at water tank.

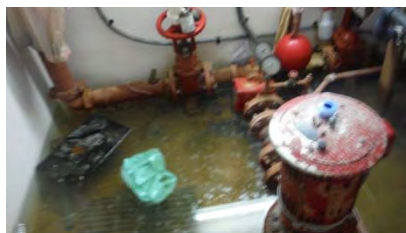
Location: Marianas HS Building 19, Gymnasium –

OIA Phase II survey found the fire pump, fire controller and fire hose system were inoperable. Fire pump was installed in a below grade pit that flooded. OIA Phase III survey found these fire safety systems remained inoperable. The pump pit is subject to flooding, and the inoperable fire pump and fire hose are safety hazard to the occupants. Fire protection system should be properly and regularly serviced and maintained.

Fire pump is installed at a flooded pump pit. Fire pump and controller are not operable.

Fire protection valve installation supervision was not completed for fire pump control valves.	Fire hose system is deteriorated.

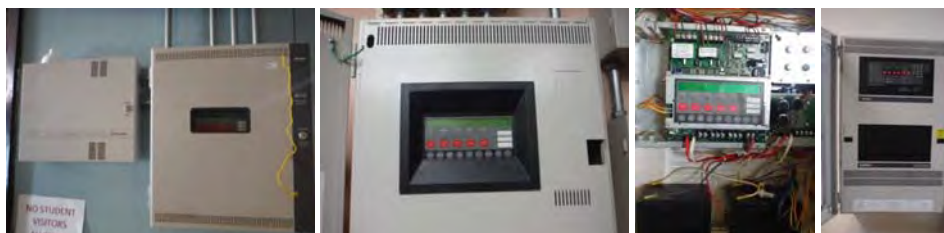
Location: Fire alarm panels are inoperable at all OIA III surveyed schools.

Fire alarm panel power is off at Tanapag ES, San Vicente ES, Kagman ES, and Dandan MS.

- Perform routine maintenance and testing to fire alarm systems per NFPA 72 by qualified technicians. If possible, establish fire alarm technical team within PSS to perform troubleshooting, repair, maintenance and routine testing and certification.
- Repair fire alarm system deficiencies quickly.
- Maintain fire alarm system information, manuals, maintenance and testing records on site.
- Provide regular operation training of fire alarm system to school staffs. Establish fire safety awareness program to promote fire safety awareness to the staffs and occupants.
- Conduct regular tests and fire drills. Coordinate and invite fire department to participate fire test and fire drill.

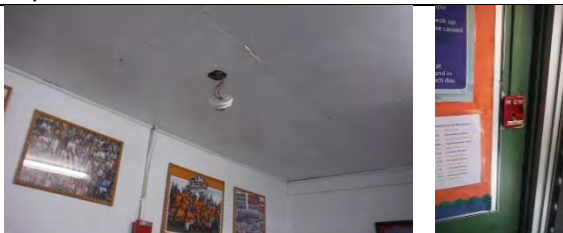
Obstructed pull station at Garapan ES.	Defected pull station and smoke detector at Hopwood JHS.

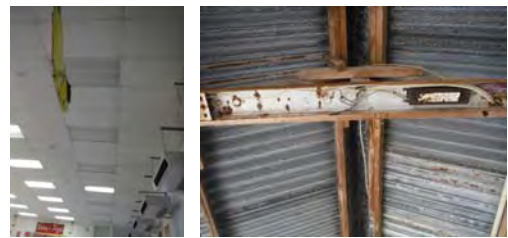
Location: Garapan Elementary School

A column of light bulbs in the cafeteria are burnt out. Some walkway lighting needs bulb replacement or an overall fixture repair.

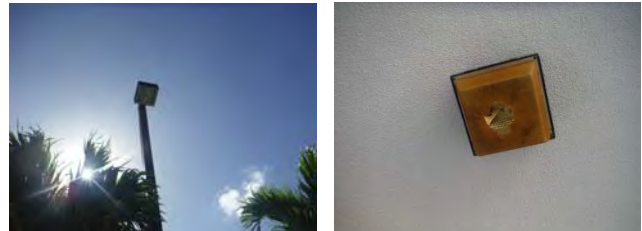
Location: Kagman Elementary School

Walkway lighting is inoperable. Casing and bulbs are defective. Parking lighting is inoperable due to incorrect bulb retrofitting or a defective circuit.

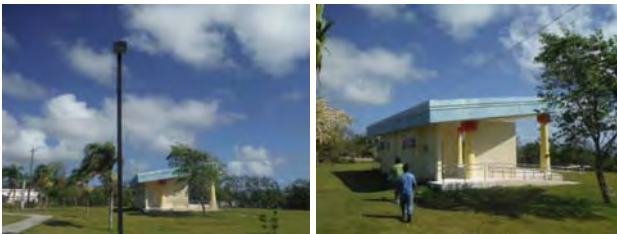
Location: Kagman Elementary School

A temporary exposed power line supplying the stage has not been removed.

Recommendations:

- Provide GFCI receptacles with weatherproof covers for all exterior, weather exposed outlets.
- Replace all degraded/rusted electrical enclosures.
- Remove unused exposed wiring.
