# **INSULAR ABC'S INITIATIVE**

## **Phase III Task 1 Findings and Recommendations Commonwealth of the Northern Mariana Islands**

October 2015

ARCHITECTURAL SUMMARY REPORT  
COMMONWEALTH OF THE NORTHERN MARIANA  
ISLANDS  
October 2015

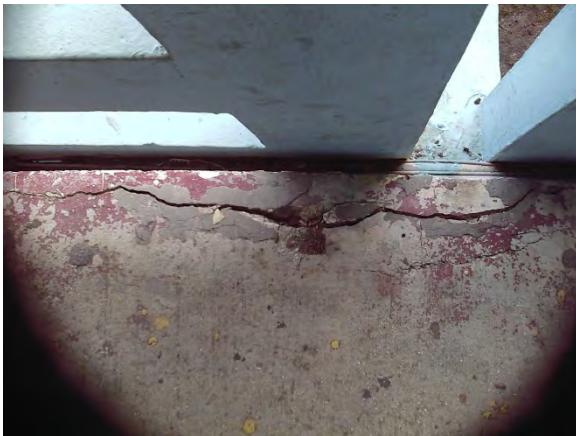
Phase II Site Visit (September 2012)

Repairs to the slab soffits through the full thickness of the slabs have been completed. Some soffit surface spall repairs have also been completed but appear to have some shrinkage cracking and potential for delamination. It is probably that there was too much water in the repair mortar. The use of a specifically formulated latex modified patch repair mortar may improve the performance of future similar repairs. The repair areas should also be undercut to create clean edges, rather than feathering the patch material to zero thickness.

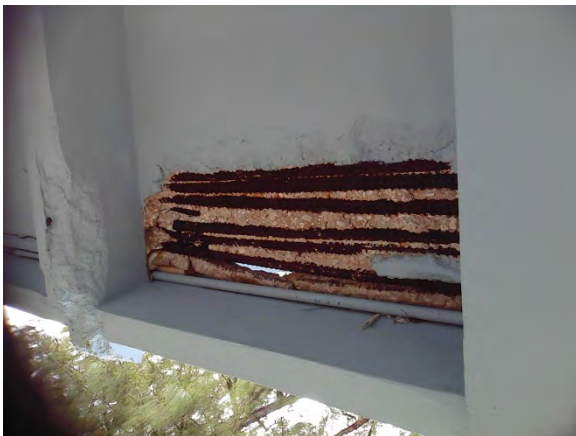
Phase II Site Visit (September 2012)

Repairs to the slab soffits through the full thickness of the slabs have been completed. There are some beam spalls that were not repaired. They have at least been painted to reduce the impact of reinforcing corrosion.

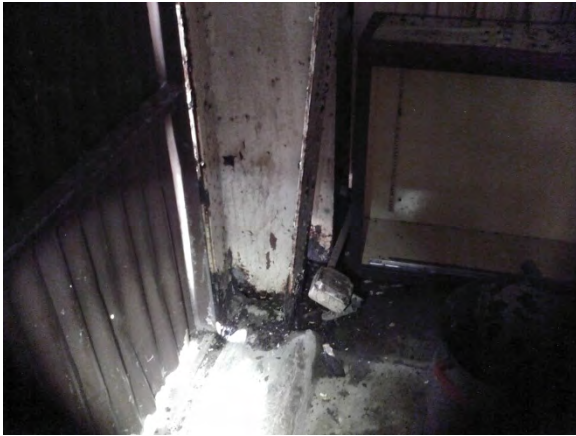
Phase II Site Visit (September 2012)

The extensive corrosion at the column bases remains. This remains a life safety issue as several of these columns are potentially unstable.

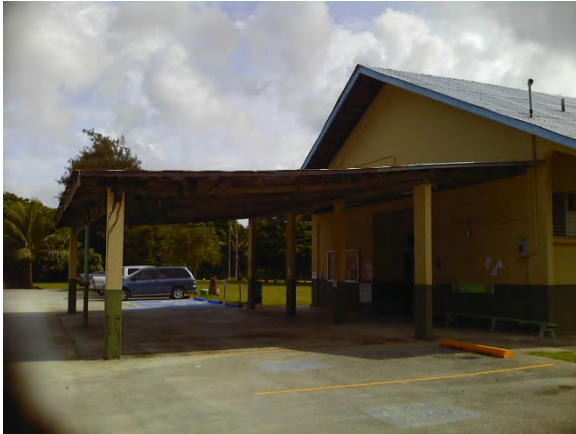
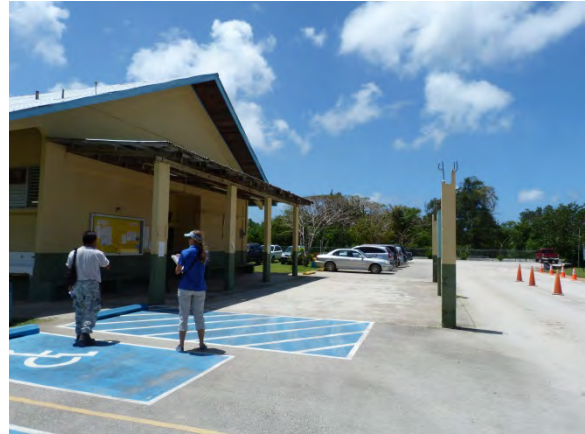
## **2A. Oleai Elementary School – Bus Shelter**

The bus shelter has been partly demolished to remove the long span sagging roof framing that was previously observed. A new bus shelter structure has been proposed that will replace the existing structure. This needs to be designed meet the current building code for wind and other loading.

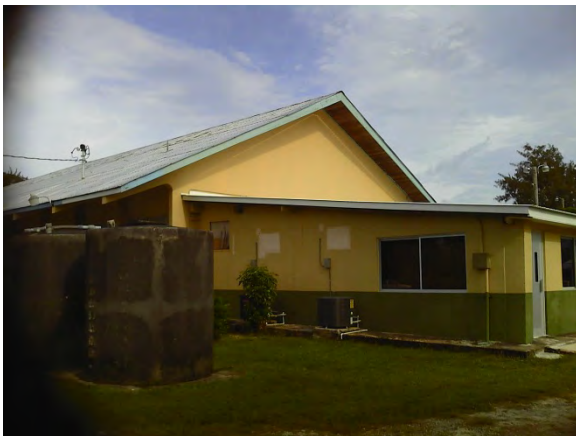
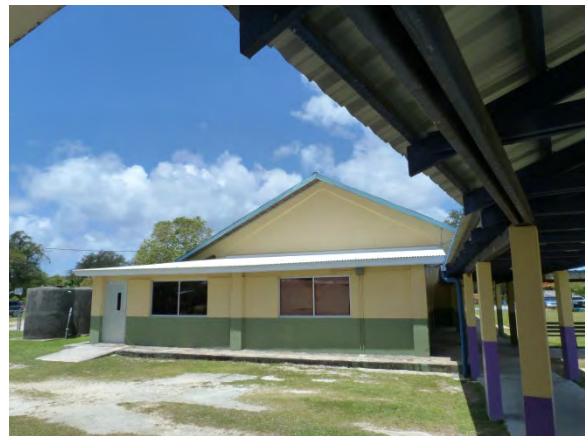
## **2B. Oleai Elementary School – Building G**

The roof of Building G adjacent to the cafeteria still has visible signs of termite damage and is sagging due to its long span. It needs repair or replacement.

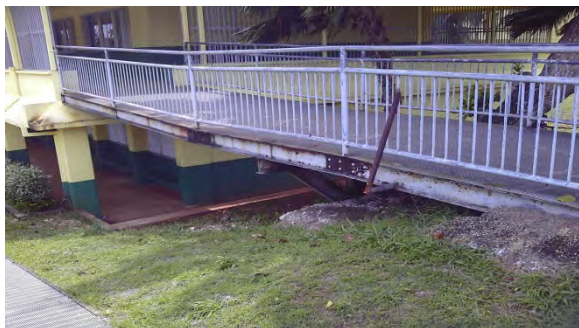
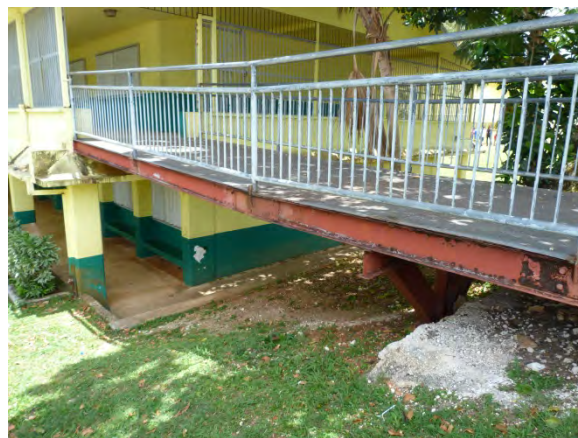
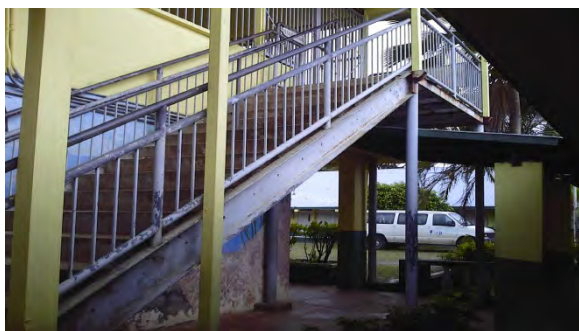
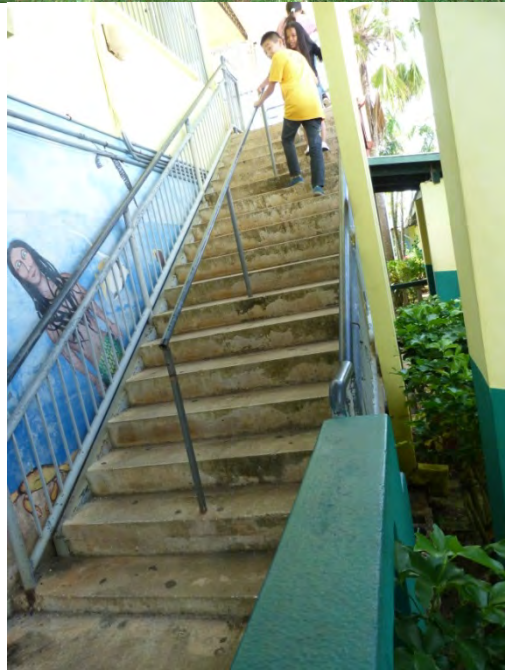
### **3A. San Vicente Elementary School – Building A (Ramp and Stairs)**

Building A has a steel framed access ramp that was observed to be corroded and potentially inadequately supported with damage to the joints between the steel support girder segments. The ramp has been painted to provide some protection and appears to have had some modifications to divert drainage around the ramp. The adequacy of the supports for the ramp is still questionable. It is recommended that an additional support be provided under the span between the building and the current column support.

The stairs at the other end of the building were corroded at the treads. An additional concrete topping was added to protect the treads. Although this has resulted in uneven stair riser heights at the top and bottom of the stair that do not meet typical building code requirements, due to the potential trip hazard associated with stairs having inconsistent riser heights.

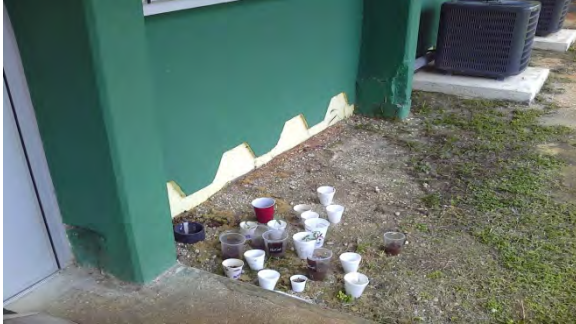
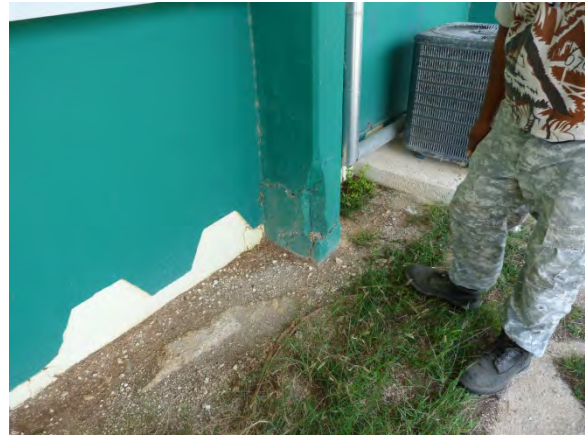
**3B. San Vicente Elementary School – Building K**

Spalling around the base of a number of the columns in this building remains.

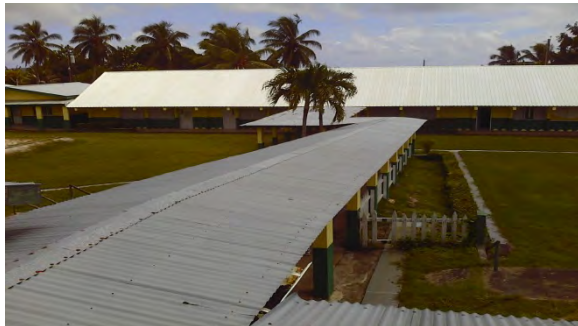
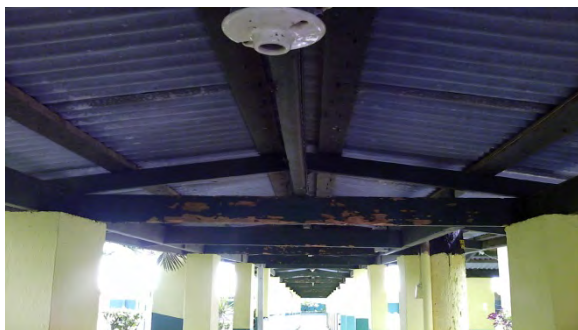
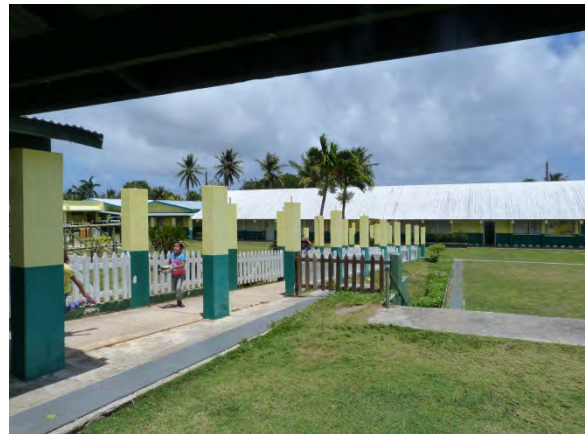
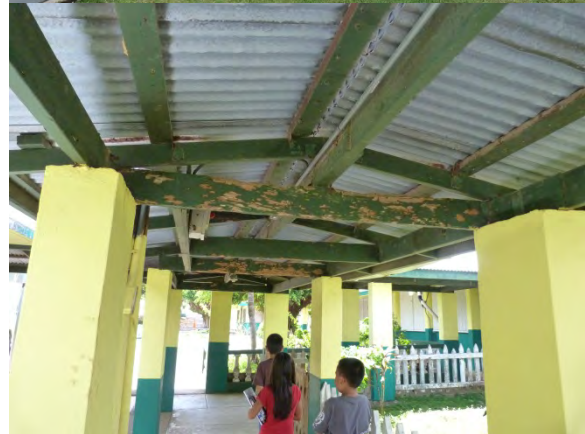
### 3C. San Vicente Elementary School – Covered Walkways

Portions of the covered walkways were blown down during a recent tropical storm and have subsequently been removed. These are yet to be rebuilt but have eliminated most areas of roof with severe termite damage. There is some termite damage that remains. These areas of the covered walkway roofs should be replaced. Plywood has been used for the fascia of some of the covered walkways, and other buildings, which is severely degraded. It should be removed and replaced.

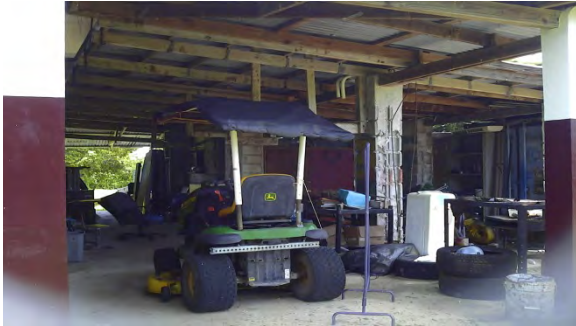
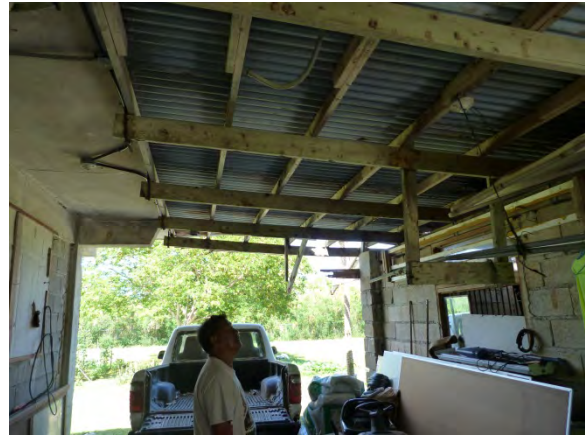
Part of the maintenance shed roof was damaged during a recent tropical storm and is yet to be repaired.

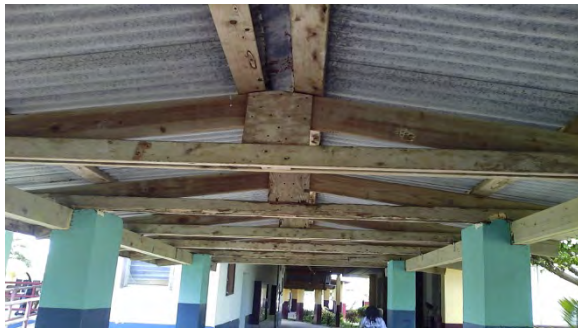
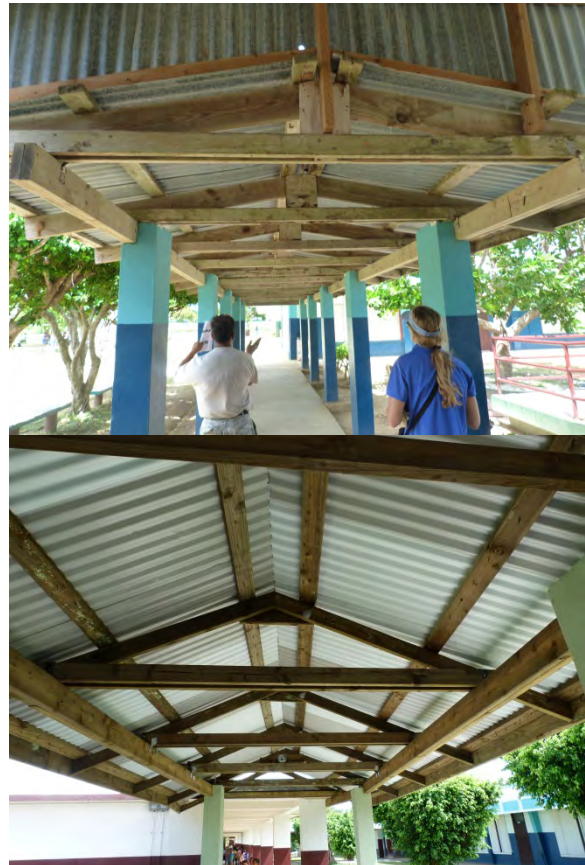
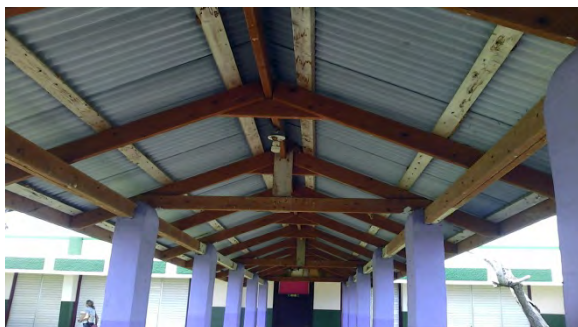
## 5B Koblerville Elementary School – Covered Walkways

A segment of the covered walkways has quite severe termite damage. This was considered a safety hazard in Phase II and remains as such. Another section, which is understood to have been added quite recently, is in good condition by missing a vertical web member in the roof trusses. Other segments have no bottom chords in the trusses. These have limited strength and are vulnerable to a tropical storm.

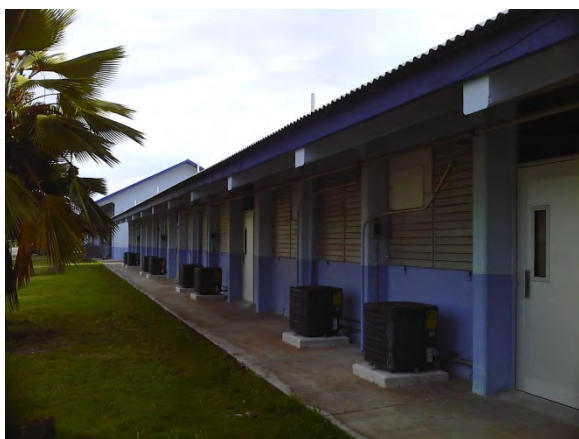
#### **6A Reyes Elementary School – Buildings D, D2, E and F**

These buildings are of a common construction type. Their original roofing was reported to be cedar shingles over the wood tongue and groove decking. It is understood that when the shingles were replaced, not all the nails were completely removed. When they placed the new waterproof membrane over the decking and under the metal roofing it was penetrated by the nail heads. As a result these buildings have leaks in a number of locations. Any reroofing project, for these buildings and other similar buildings, needs to remove these nails and provide a smooth substrate for a new waterproofing membrane and roofing.

Spalling at the base of the columns remains, primarily on the west side of Building E.

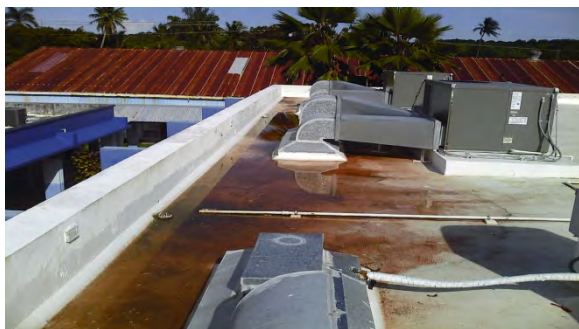
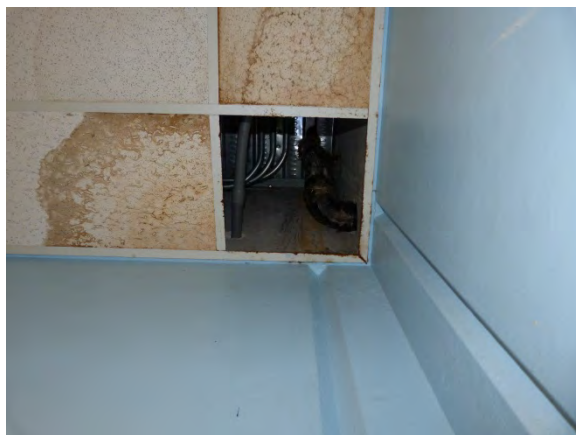
#### **6B Reyes Elementary School – Cafeteria Building A**

The cafeteria has a flat roof with a parapet and internal drains. Blockage of the drains and other problems persist, first observed at the Phase II site visit. There are leaks around the drains at a number of locations. It has not yet resulted in significant structural damage, but will lead to deterioration.

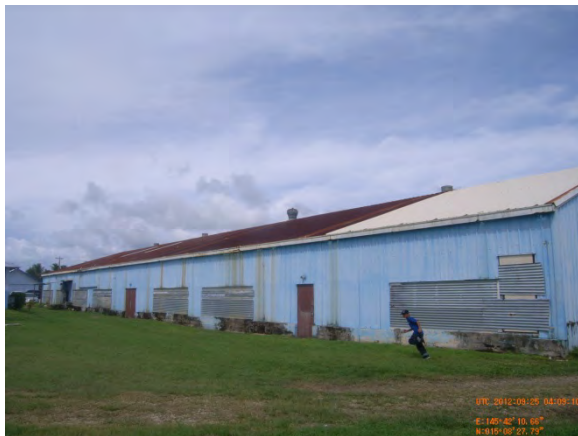
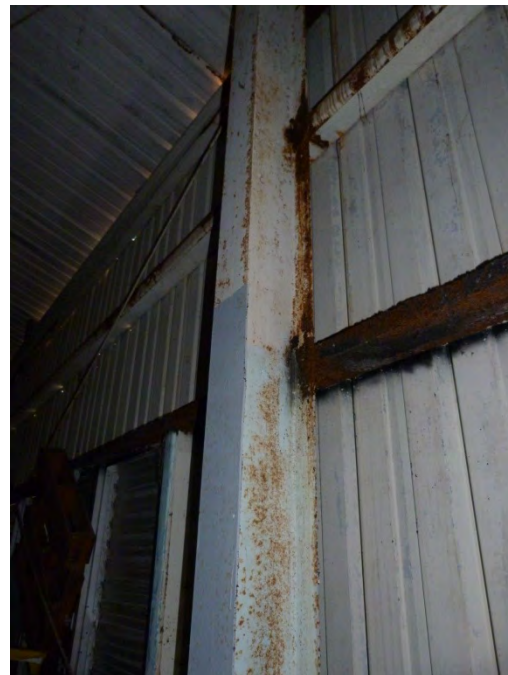
## 6C Reyes Elementary School – Maintenance Building

This structure is in poor condition. It is probably best to demolish the building. The Principal mentioned that it may be converted to a parking area. It may be preferable to construct a much smaller maintenance building elsewhere, not at the main frontage of the school.

If the building is to be reused, it needs to be completely re-roofed and new siding installed. The interior ceiling has mostly already been removed. The structural framing is in poor condition in isolated locations and fair condition elsewhere. For reuse it needs to have localized framing repairs and all the steel recoated.

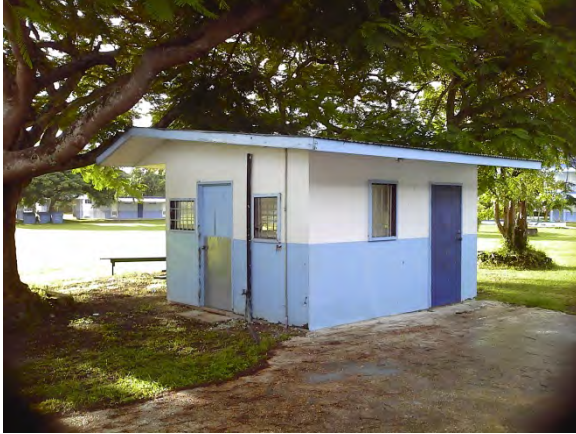
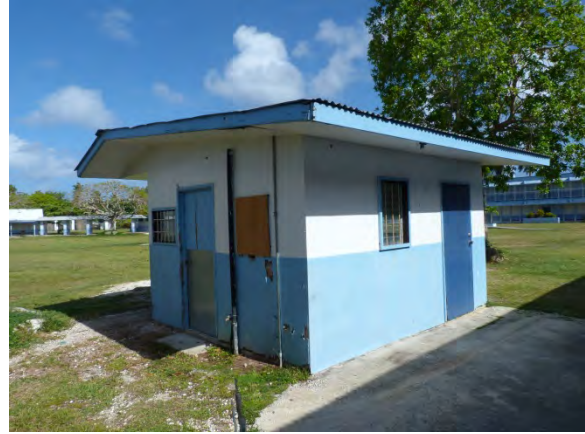
#### **6D Reyes Elementary School – Canteen**

The canteen is a small building, but extensively termite damaged and has deteriorated further since the Phase II assessment. It would be best to demolish and rebuild the structure, salvaging and reusing the any equipment and the slab-on-grade.

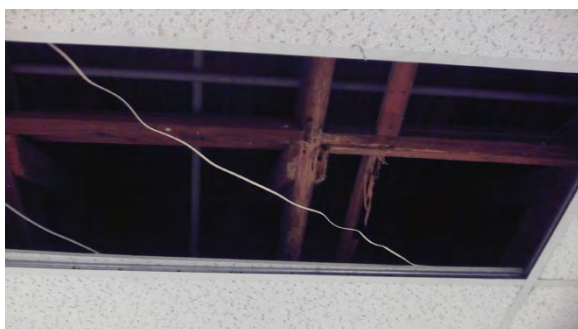
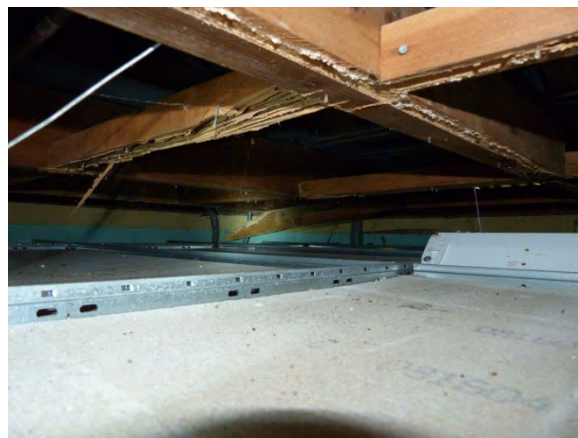
### **7A Hopwood Junior High School – Building A**

Extensive termite damage in the wood partition walls and roof framing was observed in Building A. It is not clear whether or not this termite activity is ongoing or has just occurred in the past. It is understood that termite abatement is ongoing with regularly scheduled ground treatments; however it may be that termite activity already in the building has not been completely abated. It is advised to consider termite tenting of this building so that any remaining activity is arrested. It is understood that the capacity for tenting is not currently available in the territory, but the capacity exists in Hawaii and other states. Alternatively, a thorough termite inspection and chemical spot treatment should be completed along with structural repairs.

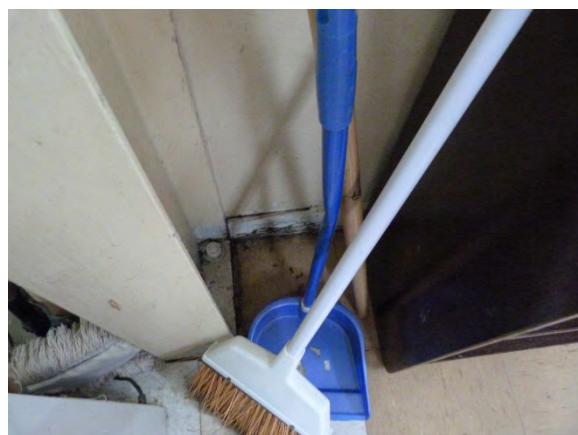
### **7B Hopwood Junior High School – Building B2**

The teachers were reporting termite activity in the cabinets and furniture of Building B2. The teacher had used a Bonide termiticide to kill the termites. There is a concern that the termiticide is not for interior use, according to manufacturer's instructions. Therefore this type of treatment should be discouraged and professional treatment provided. This building would also be a candidate for termite tenting or abatement.

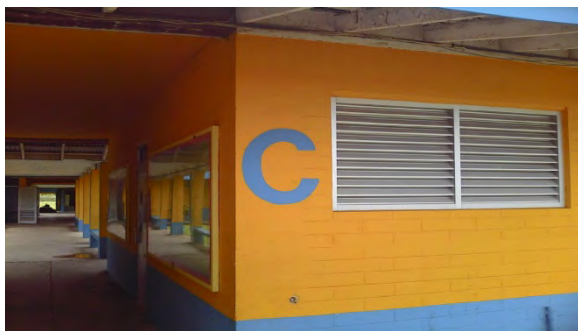
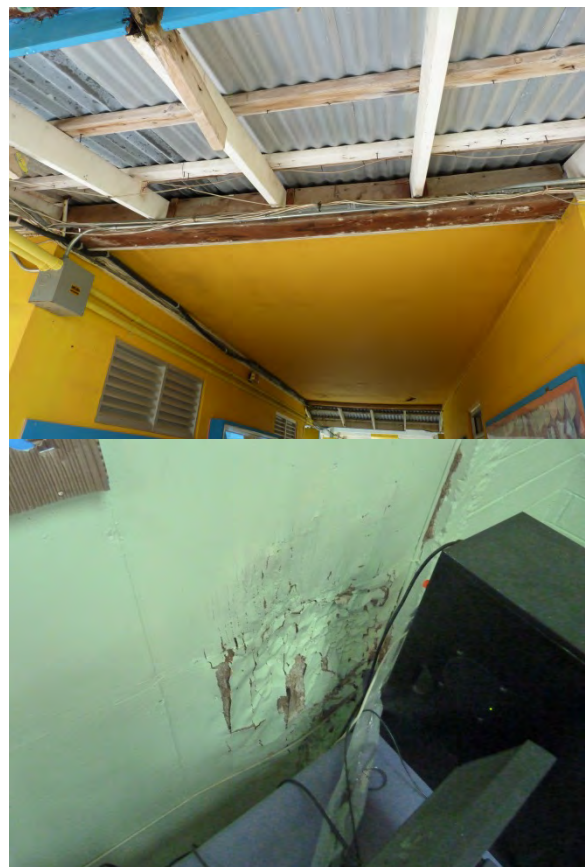
### **7C Hopwood Junior High School – Buildings C**

The section of roof in the pass-through between the two wings of the building was observed to be sagging. This is attributed to having no substantial beam supporting the roof trusses and rafters, just a flatwise oriented 2 inch deep wood member. In building A, wood beams have been added on either side of the building between the two wings to support a similar section of roof. Similar beams are needed in this building. The sagging may have been worsened by degradation from roof leaks. This is flagged as a safety hazard due to the potential for collapse of the roof in this area with further deterioration or overload.

Termite damage was also observed in at least one wood partition wall between two classrooms in this building.

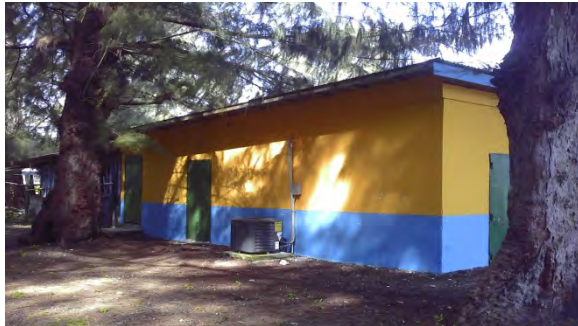
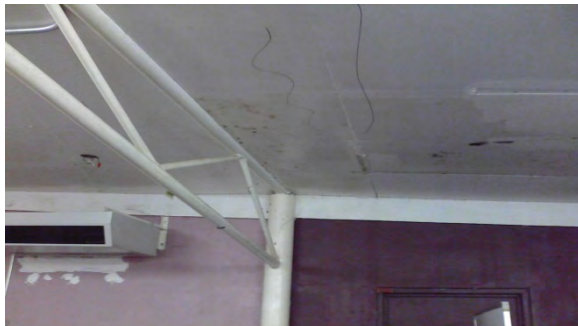
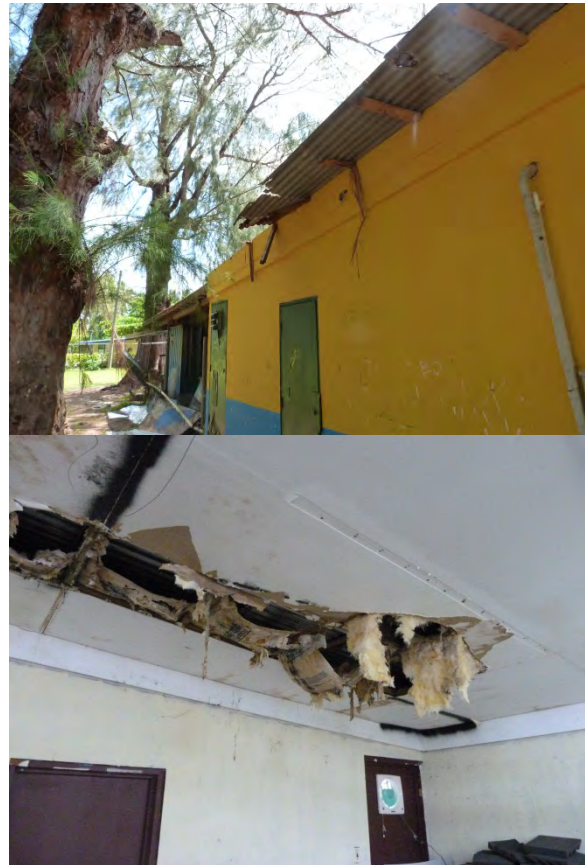
### **7D Hopwood Junior High School – Music Room**

A section of roof at this building was torn off during a recent tropical storm. This has resulted in water freely flowing into the building. This needs to be at least temporarily patched to prevent water flowing into the building and ultimately shall be reroofed. It is currently abandoned. In its current condition open to the elements it will deteriorate rapidly and will soon be not salvageable.

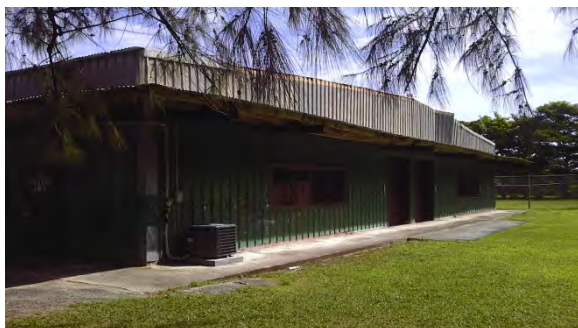
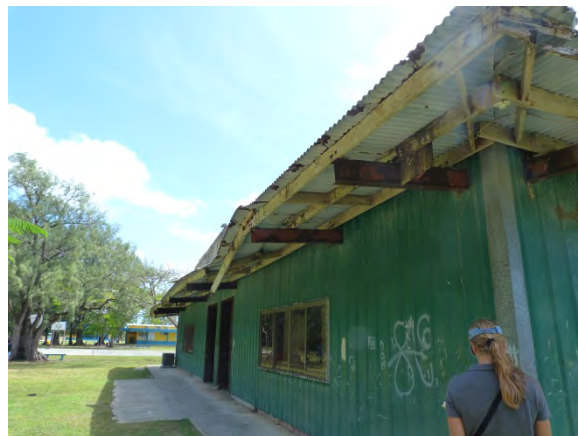
### **7E Hopwood Junior High School – LMA and VOC**

Both buildings have severe deterioration of the exposed steel that supports the exterior awnings. One segment of awning in the VOC building was damaged during a recent tropical storm. This segment needs to be immediately removed as it is likely to collapse and is a safety concern. Ultimately it is recommended that all of the awnings be removed. The interior steel framing condition, where not exposed to the weather, is significantly better.

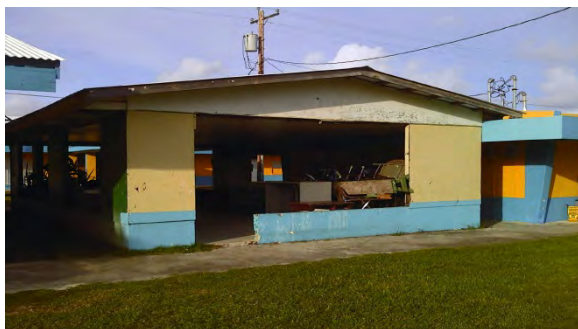
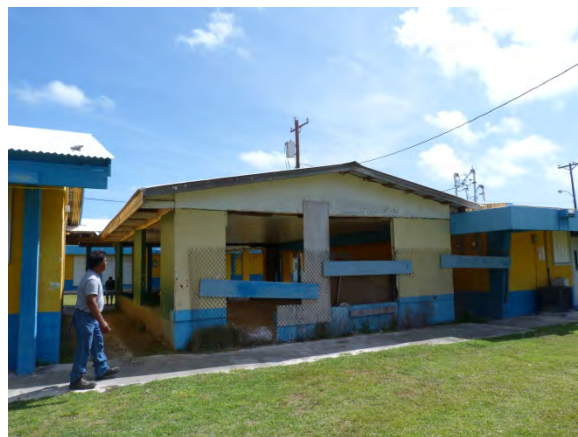
### **7F Hopwood Junior High School – Pavilion**

During the Phase II site visit this structure was a safety concern due to the lack of support for parts of the roof in this pavilion, where sections of walls in the original structure have been removed. This concern has not yet been addressed. The concern is at the side walls, those walls perpendicular to the face shown in the photos, as these walls support the roof trusses. There are no headers at the wall openings.

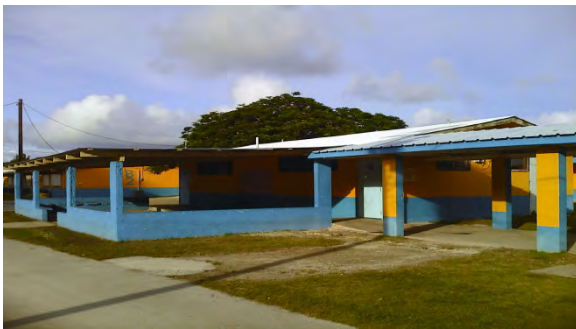
## **7H Hopwood Junior High School – Palapala Restroom and Attached Awning**

During the Phase II site visit it was observed that the roof framing for the awnings was added to the eave extensions for the roof trusses of the adjacent restroom. The awning roof framing had a very long span for the size and the rafters with joints sistered near their midspan. These rafters had very limited structural capacity to support the roof. During the Phase III site visit it was observed that an additional beam and row of posts was added to help support the end of the rafters adjacent to the restroom. This reduces the stresses on the restroom roof framing and helps to increase the strength of the roof framing, but it would still be best to reduce the long span of the discontinuous rafters or reframe and reroof the awning.

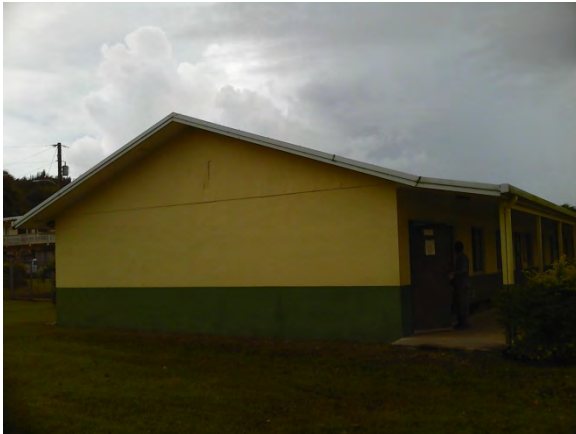
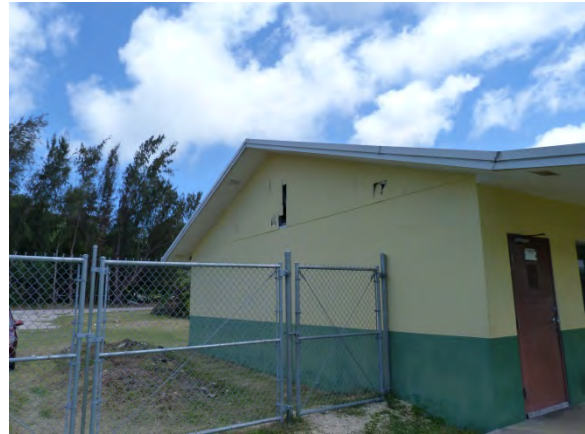
### **8A GT Camacho Elementary School – Building D**

The hole in the cladding at the gable end has increased in size since the previous site visit. This is a source of moisture into the building and will start to damage the framing, ceiling and walls.

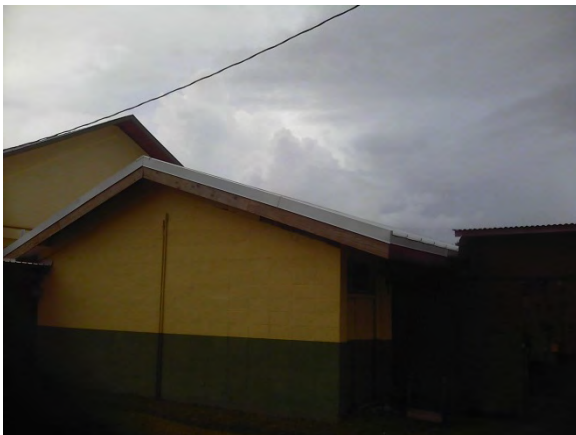
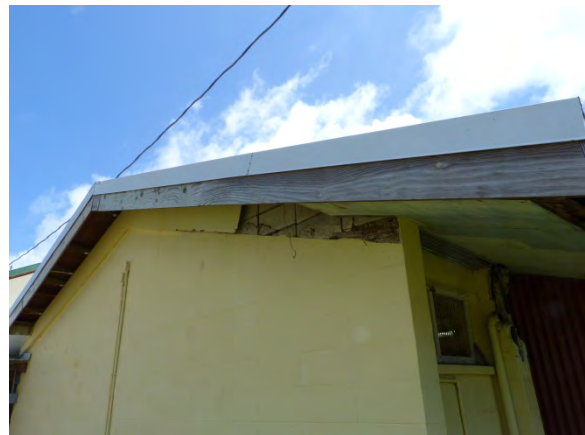
### **8B GT Camacho Elementary School – Restroom**

There is new damage to the restroom siding that was not evident during the Phase II site visit. There is exposed reinforcing and spalling at the top of one of the columns.

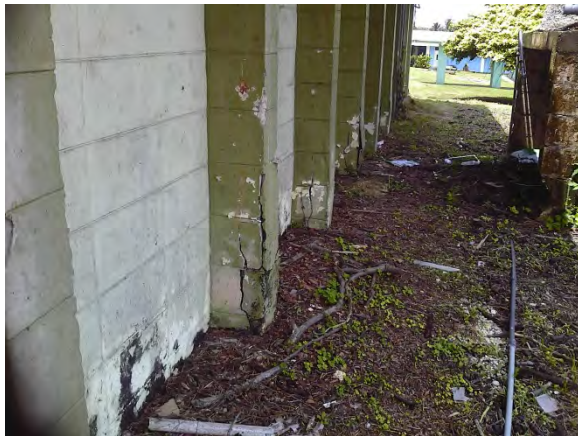
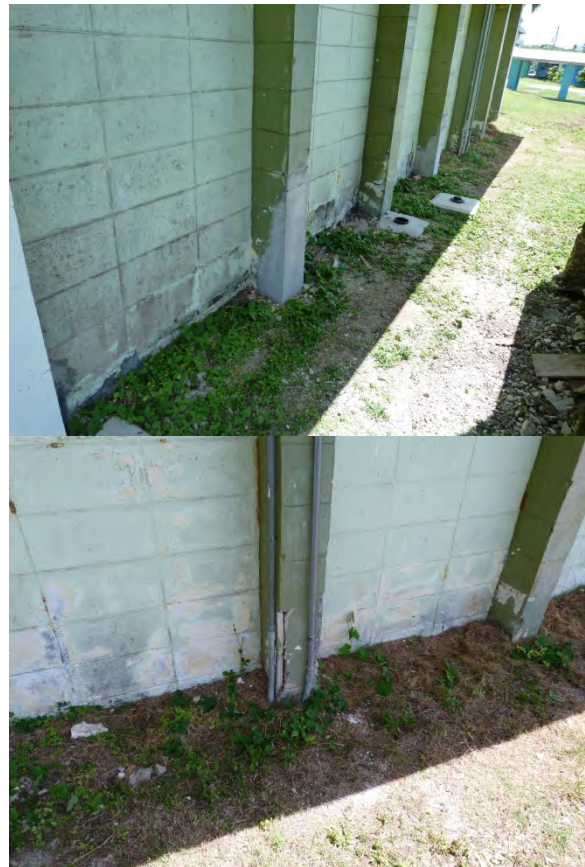
### **9A Tanapag Middle School – Restroom (formerly used for Storage)**

The major spalls around the columns and walls at this restroom have been repaired and the restroom has generally been renovated since the Phase II site visit. Small cracks and spalls remain. While, they are not significant structurally, these are a source of moisture and future deterioration. It is recommended that when a building such as this is renovated the smaller cracks and spalls are also repaired, or at least sealed and painted.

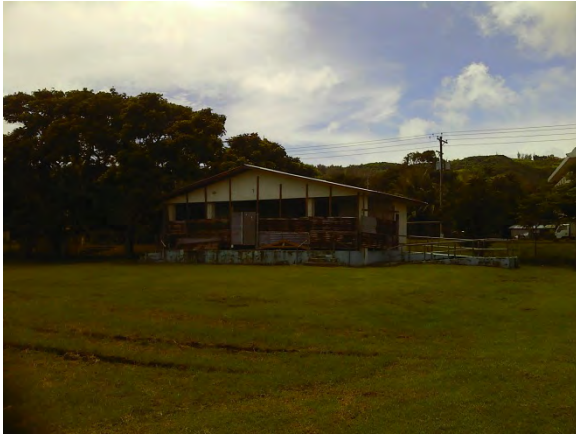
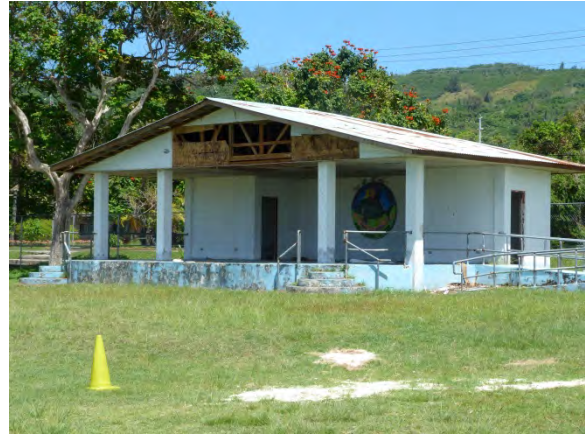
### **9B Tanapag Middle School – Stage**

The stage is aesthetically in poor condition with missing cladding at the gable end. Structurally the roof framing appeared to be in good condition during the Phase II site visit. It is underutilized as the area in front of the stage suffers from poor drainage, therefore can only be used after dry periods of weather.

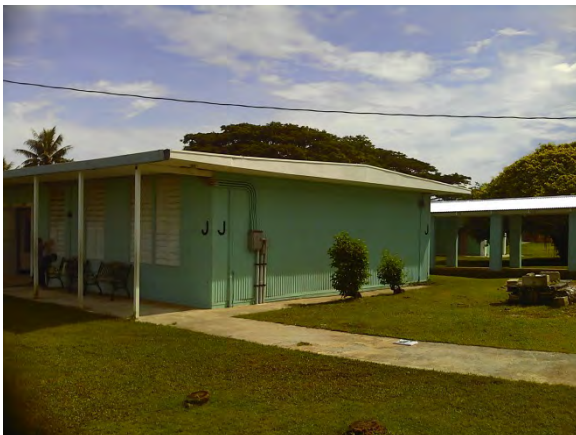
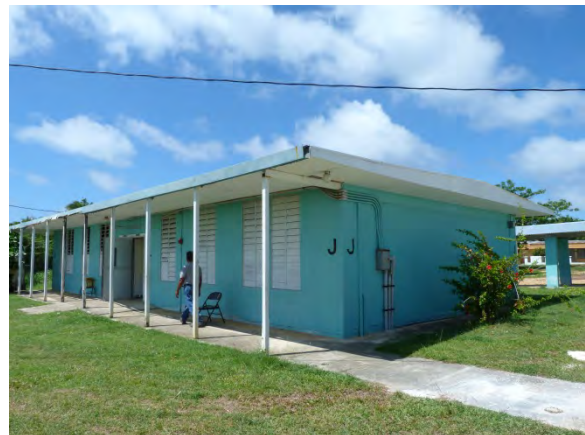
### **9C Tanapag Middle School – Building J**

This building was undergoing renovation during the Phase III site visit.

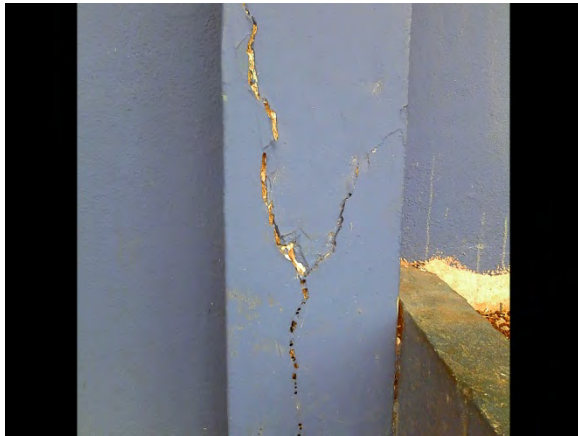
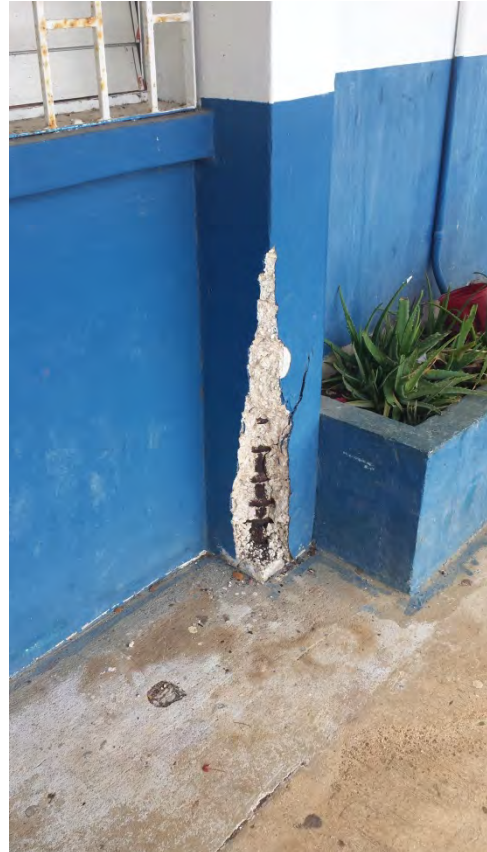
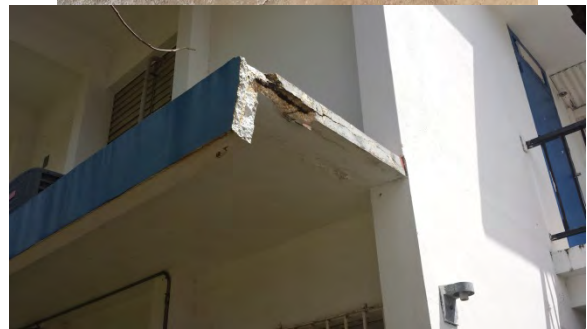
### **10A Garapan Elementary School – Title 1/Bilingual Building (Former SPED)**

This building has undergone a minor interior renovation, but still has a number of spalls and exposed reinforcing around the exterior. These have worsened since the Phase II site visit. Some delaminations are potential falling hazards; therefore, the building has been identified as a potential safety hazard.

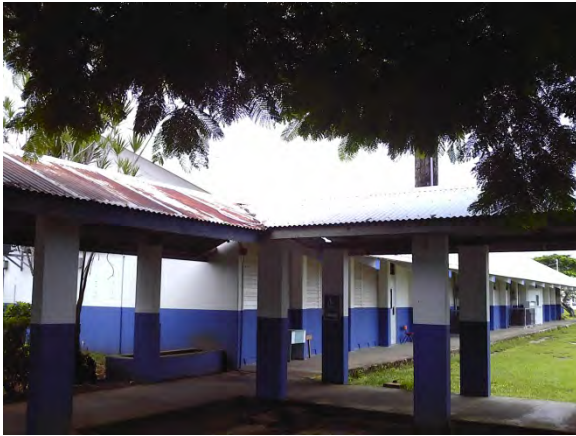
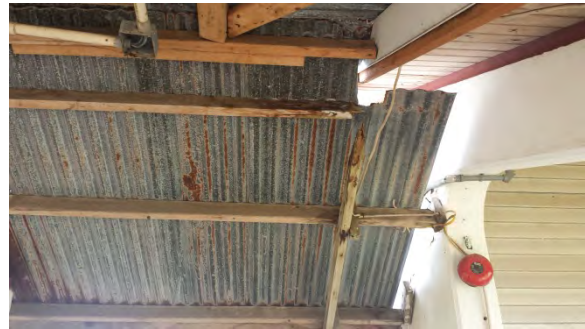
### **10B Garapan Elementary School – Covered Walkway**

One section of covered walkway is largely unsupported where it adjoins Building A. An additional support is needed.

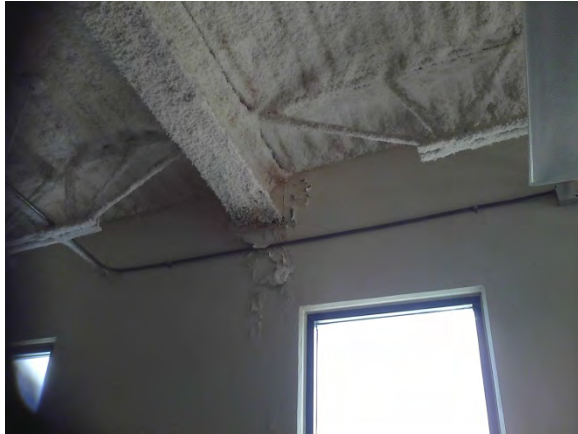
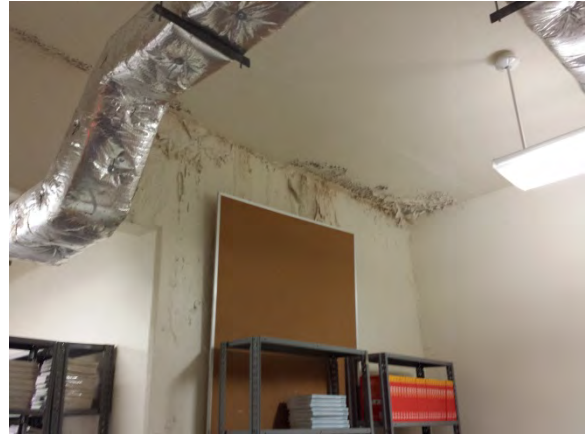
### **11A Chacha Middle School – Library Building**

Leaks in library remain at the low point of the roof where there is an internal drain and parapet wall. Leaks also remain at some of the windows. These are not significant structural issues at this point, but will become structural issues with further moisture infiltration.

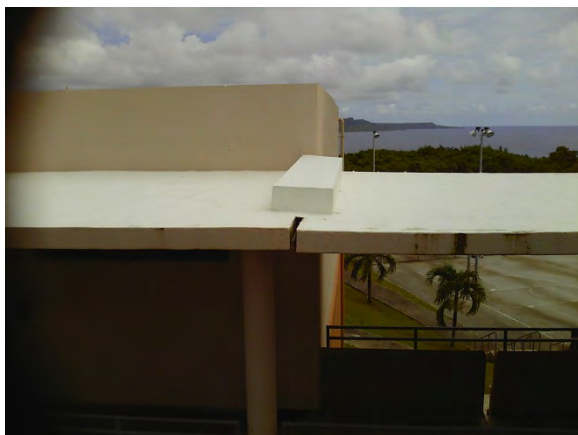
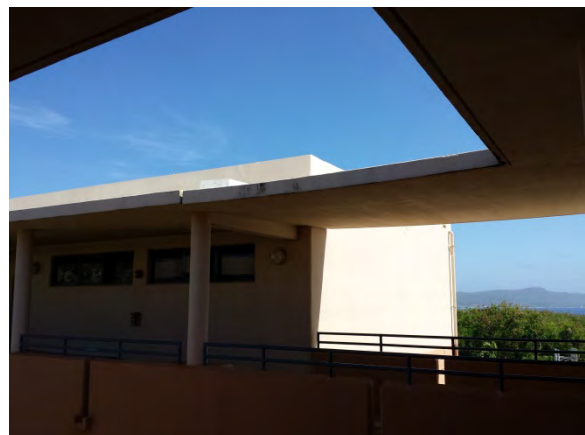
### **11A Chacha Middle School – Covered Walkway Joint**

The joint between the library building and Building B does not appear to provide adequate vertical support at the end of the slab. The slab is visibly sagging already and there is a notable vertical offset between the slabs on the two sides of the joint. This warrants further investigation and possible retrofit as it may be a structural safety hazard.

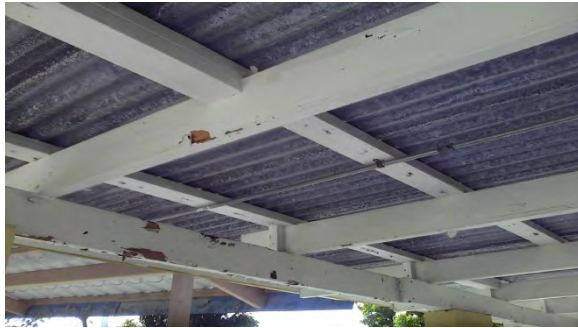
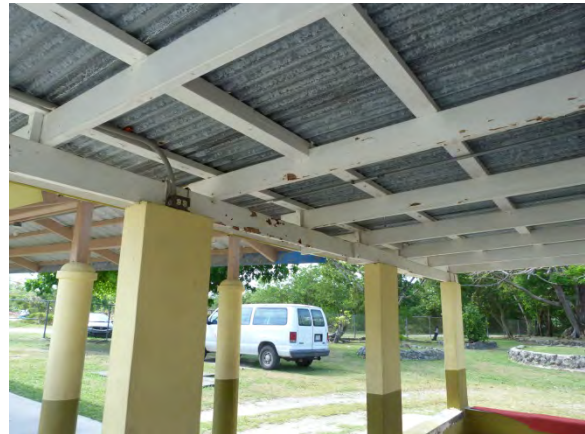
There is significant termite damage at some of the wood framed covered walkways and the awning in front of the main office. The condition appears to be similar to that previously observed in Phase II, therefore the termite mitigation may have at least arrested further deterioration. Repairs are necessary as the structural integrity of several framing members has been severely compromised.

Replace the termite damage sections of the covered walkways following the guidelines in Appendix C. Install bottom chord framing and vertical web members where these are missing to increase the resilience of these covered walkways during an extreme wind event.

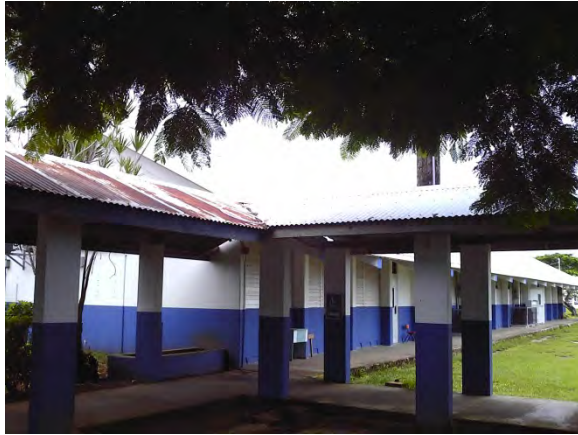
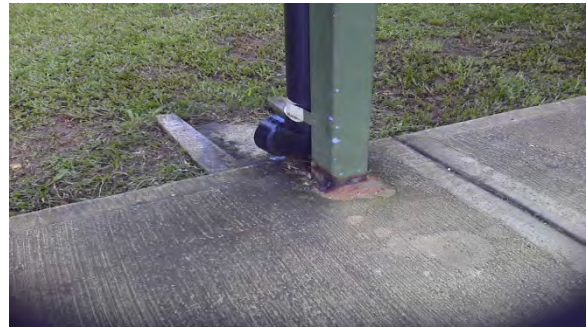
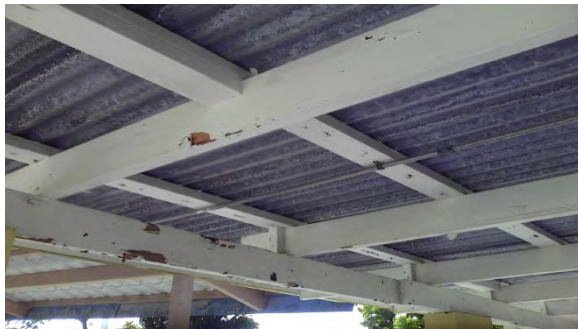
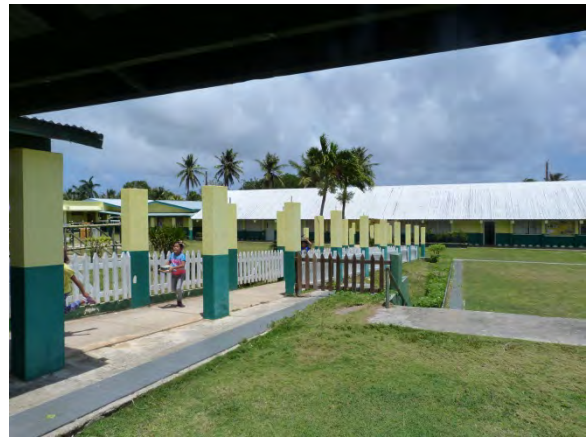
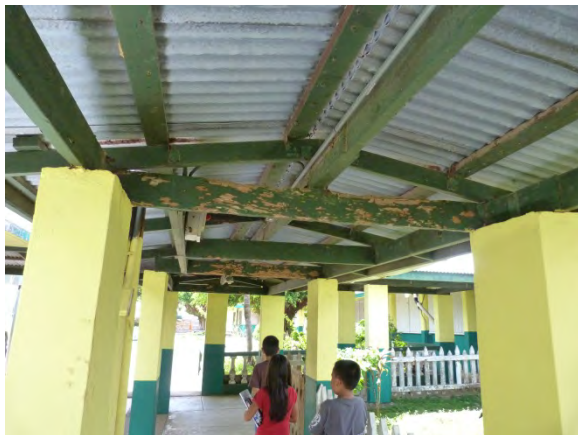
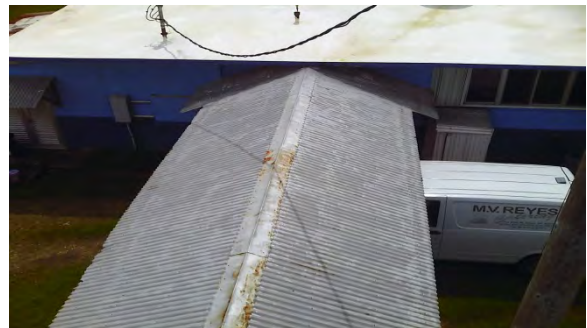
### **RECOMMENDED COVERED WALKWAY WITH WOOD FRAMING AND METAL DECKING REPAIR PROCEDURE**

Deterioration of these structures generally starts with corrosion of the roof framing leading to holes and moisture damage and decay of wood framing below. Where there is plywood decking under the metal decking it is common for moisture to get trapped between the metal decking and plywood, causing mold and decay of the plywood before the metal decking and wood framing deteriorates. It is recommended that when replacing these structures, the plywood be removed and not replaced. Presumably the purpose of the plywood was to add to the in-plane diaphragm strength of the covered walkway roof structure. However, the corrugated metal panels will generally have sufficient diaphragm strength alone. It is unlikely that the roof will fail due to an in-plane failure of the diaphragm during an extreme wind event. It is more susceptible to wind uplift and dependent on: the type of fasteners connecting the decking down to the framing; the strength of the framing, or; the lateral capacity of the columns. To provide adequate wind uplift capacity, appropriately sized wood framing is required and the decking shall be fastened with decking screws rather than nails as they have superior strength in resisting withdrawal from the wood framing. The steel columns must have adequate anchorage at the base of the columns.

The steel decking has a limited lifespan, particularly if not painted. Alternatives to the steel decking should be considered for replacement decking, including non-metallic or aluminum decking sheets with stainless steel fasteners. Selected decking must have appropriate impact and wind resistance.

Sometimes there is deterioration around the base of the steel or other columns. This can be prevented by improved site drainage to prevent ponding around the base of the columns and a good quality waterproof coating around the base of the posts.

- 01 Define the area of covered walkways to be replaced and the items to be replaced: decking; purlins; beams; columns.
- 02 For column replacement, columns shall be equal or greater size than the original. Steel posts shall be anchored at the base with a baseplate and four bolt minimum connection or embedded into a concrete footing to match the existing column conditions. Wood posts shall not be used unless the covered walkway is braced back to an adjacent building.
- 03 Replace wood framing as required with sizes equal to or greater than the original sizes. Provide galvanized steel ties to resist vertical uplift forces from the column to joists. Paint the framing with a specified paint system. Framing shall provide at least 1:12 slope in direction parallel to roof decking.

- 04 For decking replacement, remove any plywood decking and install the new specified decking directly to wood framing. Use stainless steel, screw type fasteners.
- 05 Where the geometry or framing needs to be strengthened or modified, contact a licensed structural engineer to design the required components.
