# **INSULAR ABC'S INITIATIVE**

## **Phase III Task 1 Findings and Recommendations**

### **Guam**

October 2015

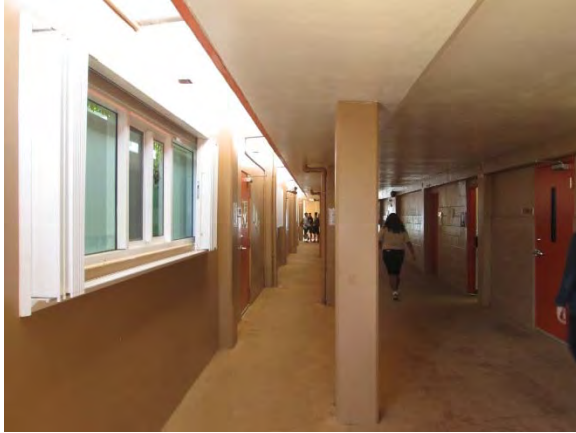
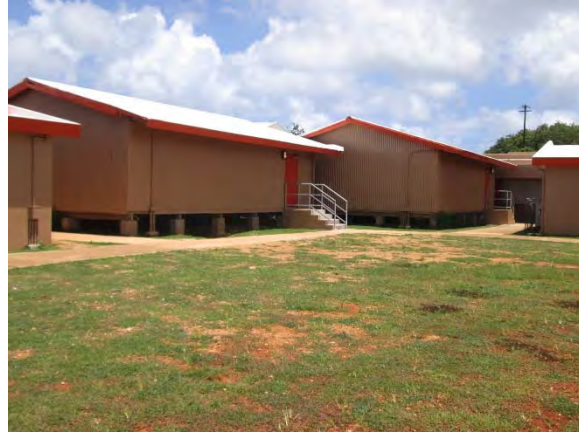
This school has received extensive renovations including doors, windows, interior finishes, etc. Three new classroom buildings were constructed; two were constructed inside existing courtyards, which has reduced the natural ventilation and natural light available to the adjacent buildings as well as the new buildings. Temporary buildings 1-4 were moved to new locations on the property, and a new building was constructed in their original location.

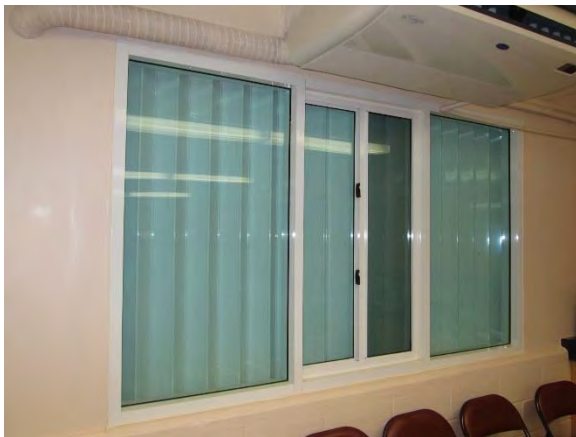
After renovation, many buildings now have windows on only one side, and the temporary buildings have no windows; this could pose a problem if the A/C fails and there is lack of natural ventilation, making rooms uncomfortable. At nearly every window, the storm shutters are kept closed to help prevent vandalism. As a result, limited natural light is available.

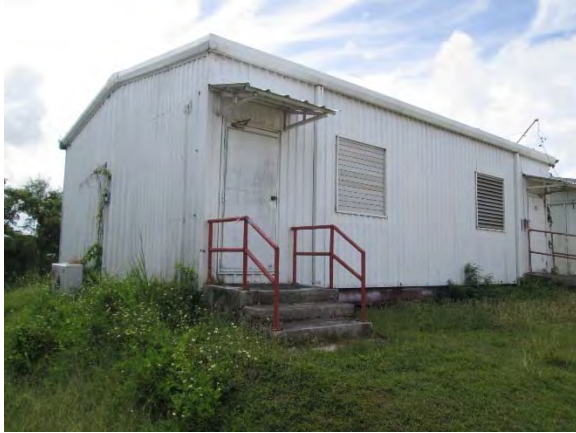
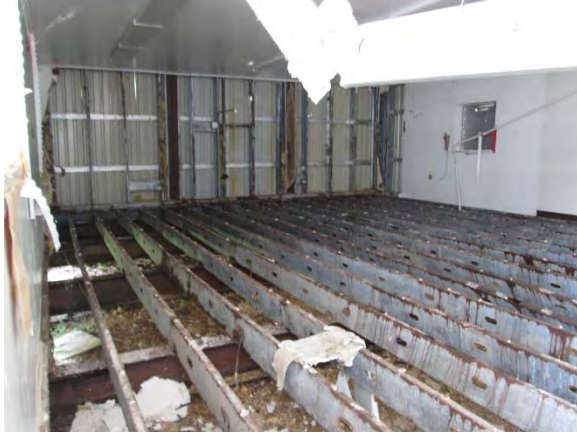
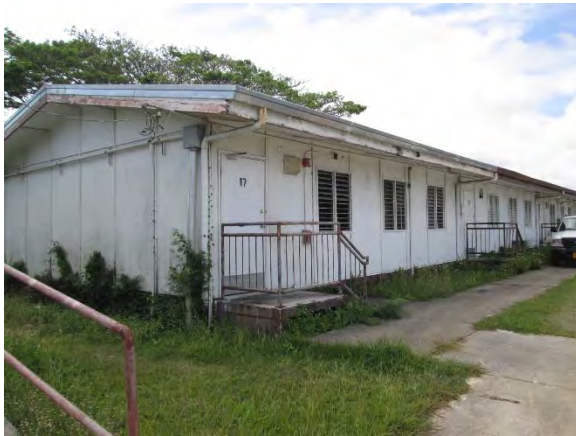
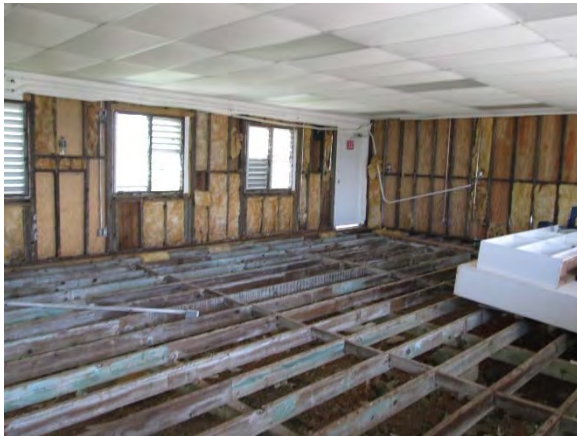
New roofing was installed on most buildings. There is typically deteriorated roofing and sheathing at the covered walkways.

Buildings 16 and 17 are not in use, and the flooring and most wall finishes have been removed. At Building 16 (T7) the metal structure is quite rusted and is in poor condition. At Building 17 (T8) the wood structure is in fair condition, and the building could be refurbished and reused if space is needed.

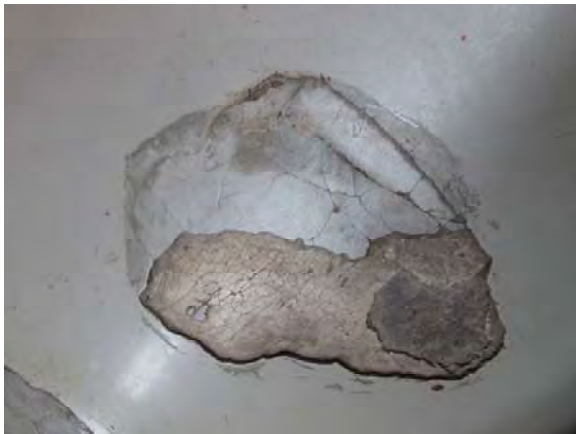
Building 19 (A) was determined to have asbestos floor tiles, so the tiles were encapsulated in an epoxy coating. The epoxy is now cracking and bubbling in some areas; likely either the tiles below are detaching from the slab, or the epoxy is detaching from the tile. In some areas concrete was used to patch places where the tile detached and peeled off.

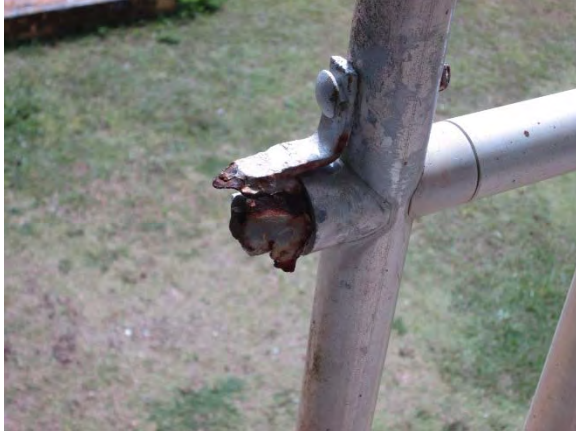
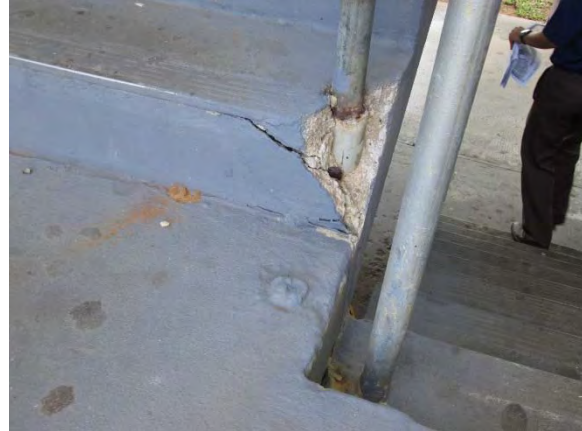
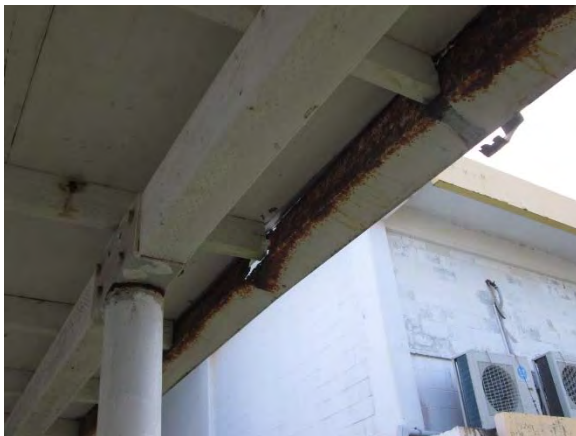
Gutters are in poor condition in several locations. There are some roof leaks in need of repair (Library, C-wing, A-wing), new exterior paint needed, and some railings need repair and repainting.

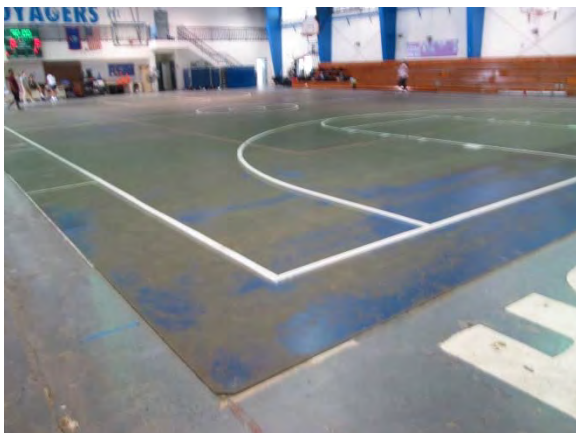
The Gym (Building 15) has received extensive renovation, but new flooring is needed at the basketball court.

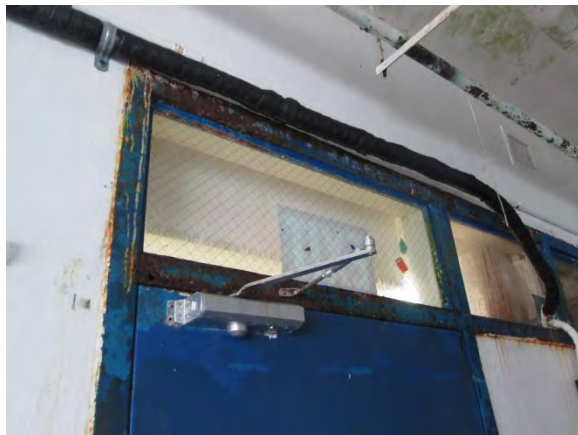
Concrete repairs has been done as well as roofing work at the Cafeteria, which has for now stopped water leaks. At several locations, but predominantly at Building 14, condensation is forming on the outside of the building due to low room temperature inside and no insulation; moisture is damaging steel door and window frames, light fixtures, paint, and causing mold to form.

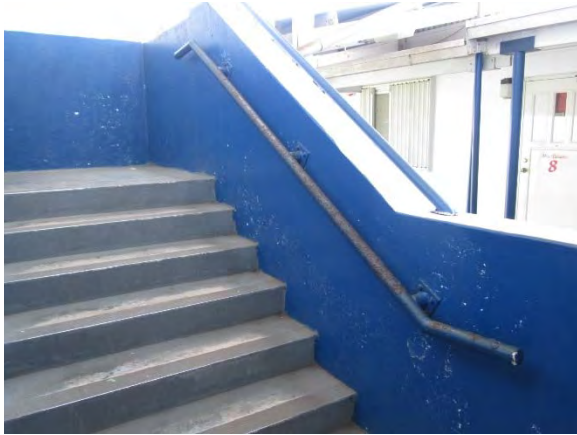
Buildings 9 and 12 have moisture/water issues inside due to earth outside of wall. Installation of a moisture barrier is needed at the walls and floor. Most concrete roofs have received new roofing except at buildings 6 and 7. Some metal railing repairs are needed.

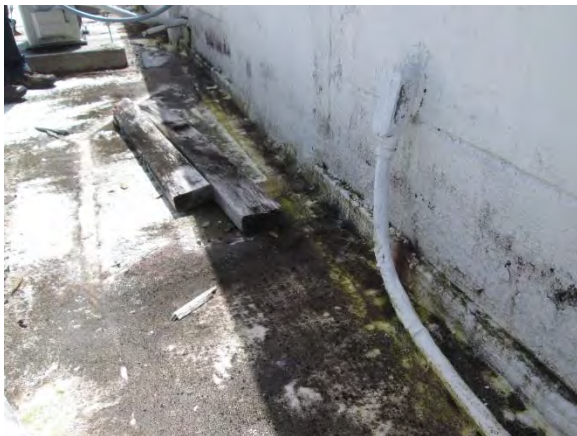
The roofing is generally in good condition, except in some areas where ponding occurs, and the roofing is starting to peel up. At the Cafeteria and adjacent offices it leaks when it rains; this appears to be from needed waterproofing at the joint between the building roof and the exterior walkway roof.

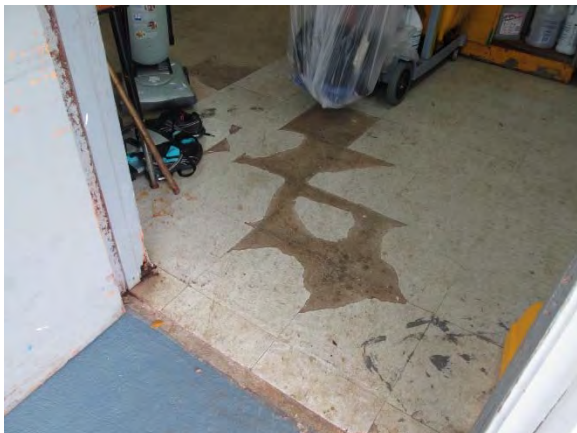
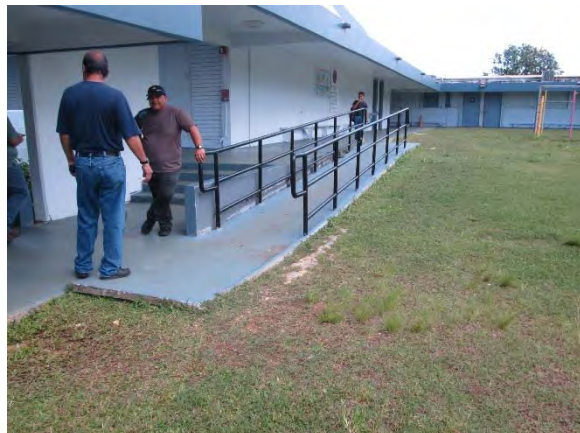
The previous moisture issues at Building 13 seem to have been solved with weep holes and painting. Building 6 needs repairs, including windows, doors, and flooring. The accessible ramp near Building 3 needs a roof to protect the ramp and its users from rain.

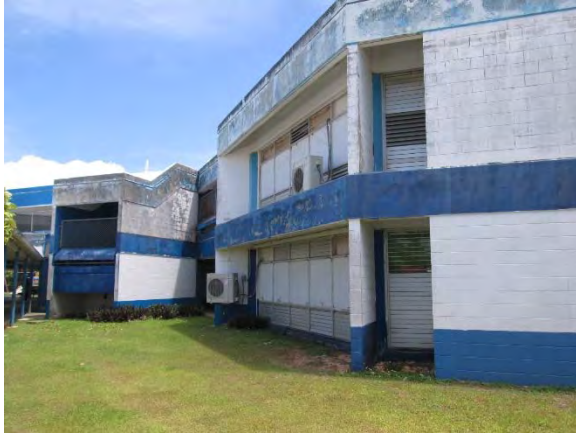
Concrete spalls were repaired last year at several buildings, including 11-16 and the covered walkways. Several of the fast track buildings (5-10) had leak issues that were resolved, but they need constant repairs at the building joints. Building 3 is not in use, and is planned for demolition. All buildings need exterior painting.

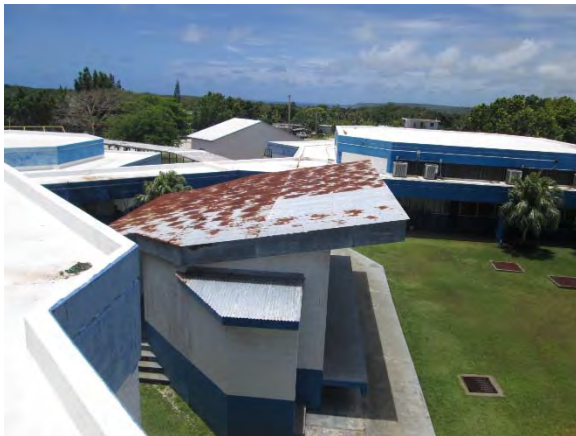
Some ponding areas were noted at the roof, but roofing at the concrete roofs is in good condition. New metal roofing is needed at the Stage (Building 17). The covered walkways on the southeast side of the campus are dilapidated and need new gutters.

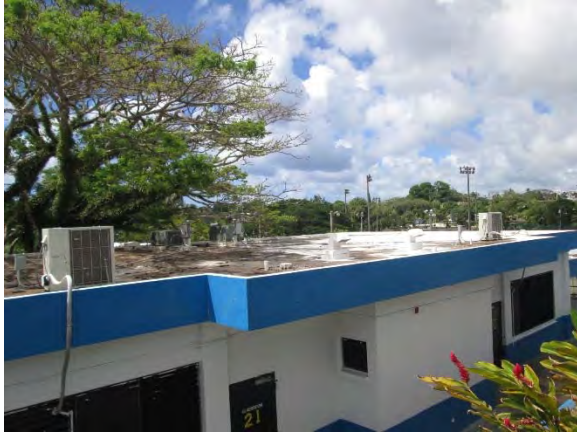
Buildings 2, 12 and 5 are not in use and are planned for demolition. Some new gutters and downspouts were installed at Building 1. Tree debris is causing clogging of gutters, and debris on roof will hold moisture and cause damage to the roofing. The covered walkways with concrete roofs need new roofing.

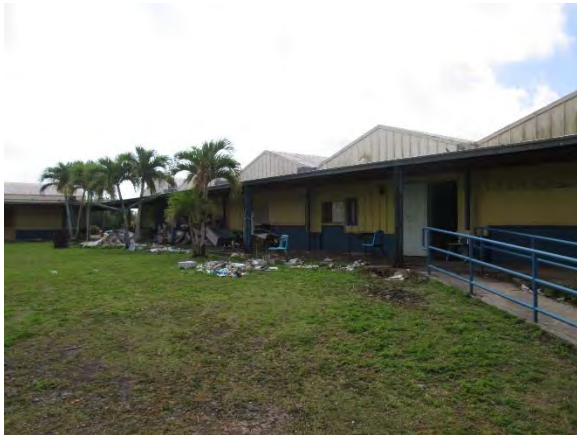
Buildings 1, 2, 3 are planned for demolition, but are still used by staff. Trash has accumulated around these buildings and near the adjacent classroom building (4).

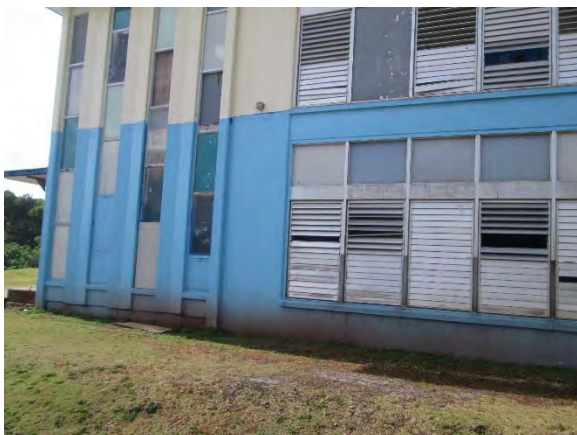
There are some roof leaks at cafeteria despite new roofing. Termites are in the wall boards and furniture at Building 8, and should be treated by an exterminator. Broken windows often patched with plywood, which blocks natural light and invites more termites. New glazing or plexiglass should be installed instead. Many louvers are broken and need to be replaced.

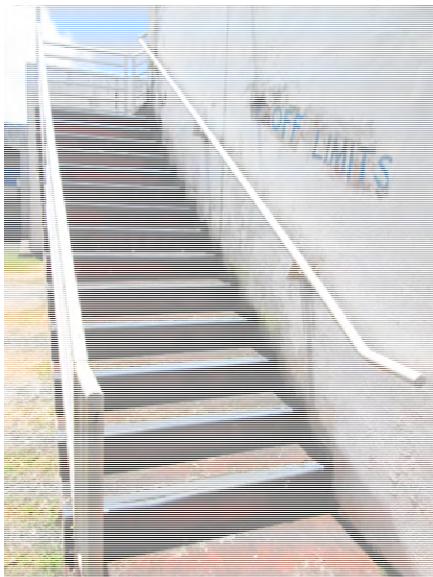
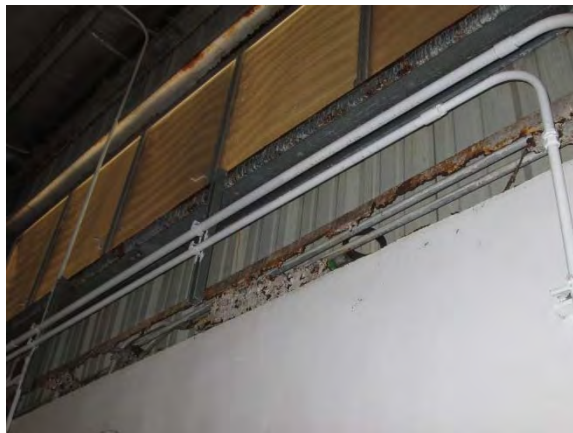
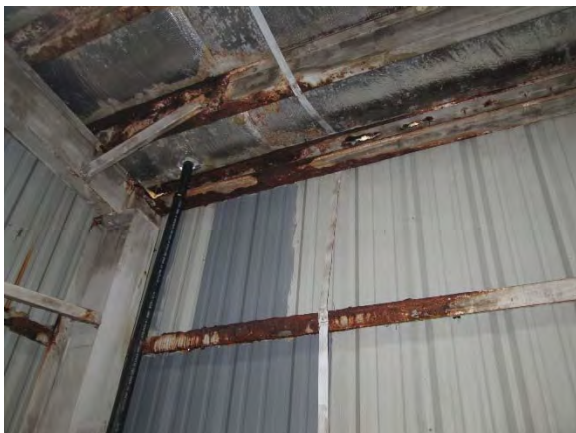
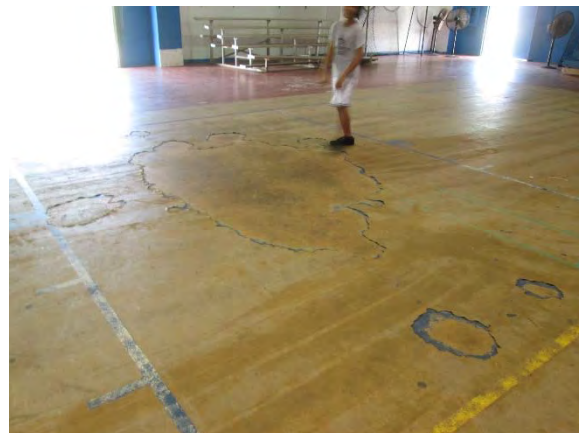
The hazardous stair issues at the Gym have been repaired. The Gym has rusted girders and leaks at the roof above the 2<sup>nd</sup> floor mezzanine; new edge flashing may help to resolve the leak issues. The gym flooring needs to be replaced. The rusted girders are a safety hazard due to falling pieces of rusty metal.

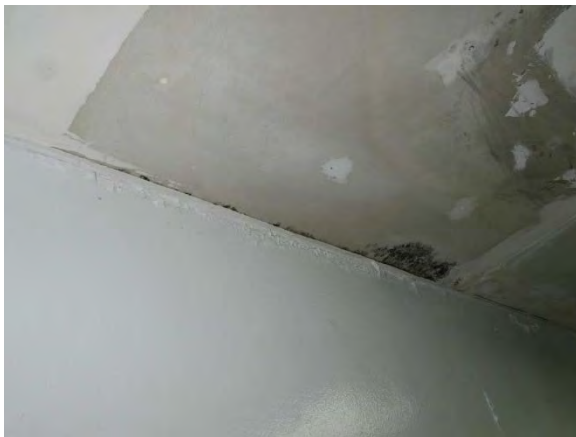
The Auditorium (Building 12) and Gym (Building 11) have been renovated. The roofs are leaking at the Gym, Nurse's Office, and Building 6 (5000); mold is forming in the wet ceiling of the restroom at the Nurse's office. In several locations the gutters are rusting; it appears that they are not properly sloped and so water sits in the gutter for an extended time.

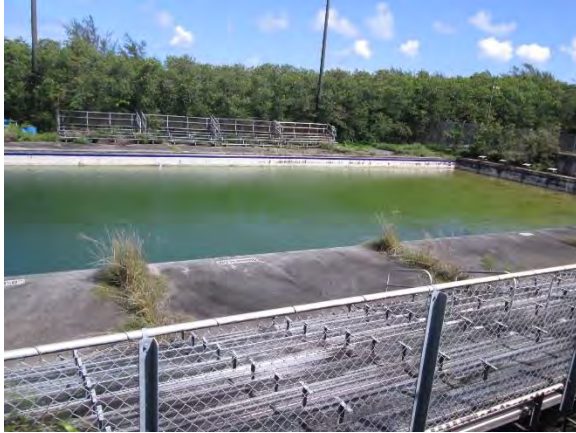
The recreation buildings at the baseball field, pool and track not used and are not maintained; the pool full of water, which is unsafe and also a breeding ground for insects.

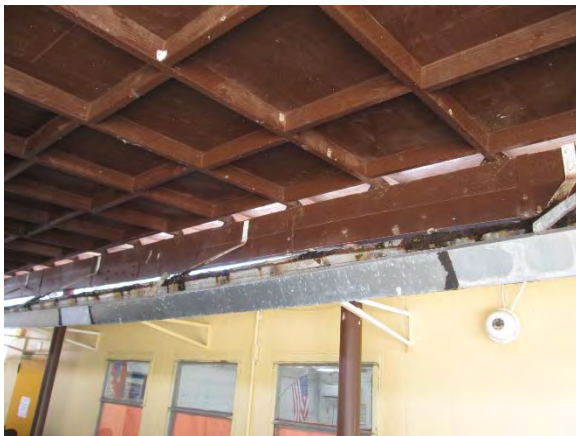
The roof is leaking at library; also it appears the bottom of the wall at the addition is not properly flashed/sealed and is leaking inside during rains. New gutters are needed in several locations. Some trees were removed, but several of the remaining trees put debris on roofs and clog up the gutters and downspouts. The trees should at least be trimmed to reduce debris on the buildings.

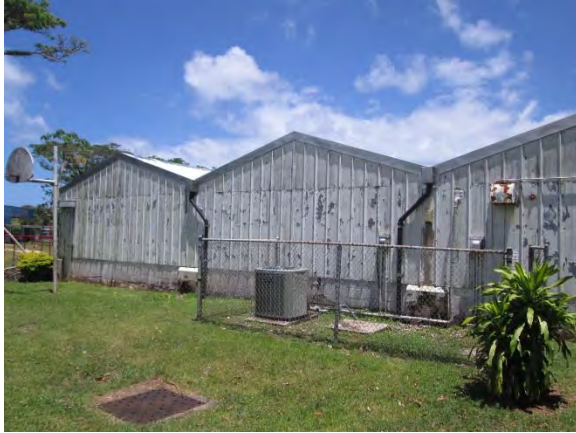
Most buildings have received new fluid-applied or metal roofing. The covered walkways need new gutters and roofing, and Building 3 needs new metal roofing, gutters and flashing.

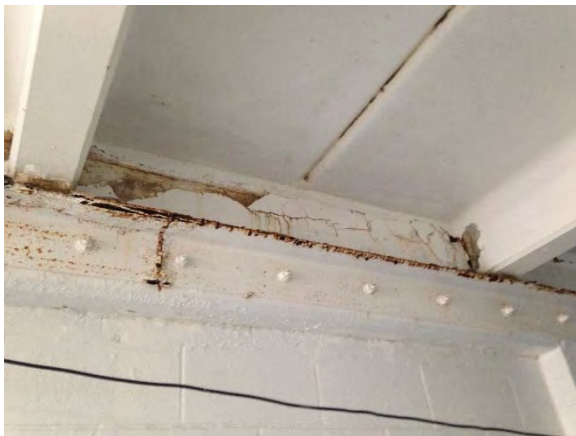
At the joint between Buildings 1 and 5, the steel beam is rusted and the concrete is spalling. The Gym has rusted girders, broken bleachers, and the gym needs a new floor.

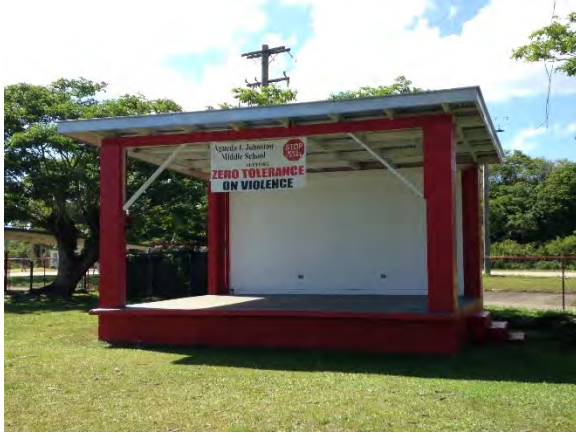
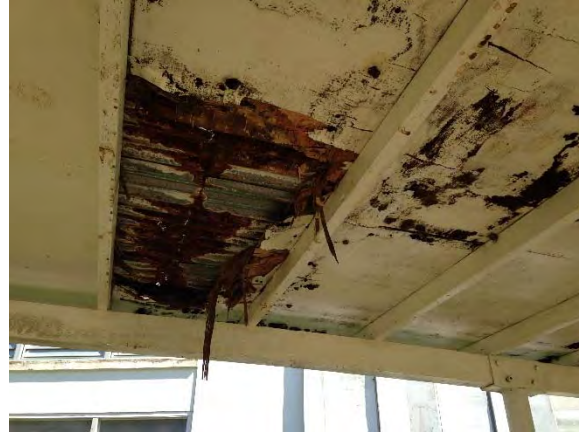
The Stage, considered a safety hazard in the Phase 2 assessment, has been repaired. The Covered walkways need new corrugated metal roofing. The plywood sheathing should be eliminated, as it traps moisture and attracts termites. The plywood was reportedly installed to meet a FEMA detail/requirement for a walkway structure.

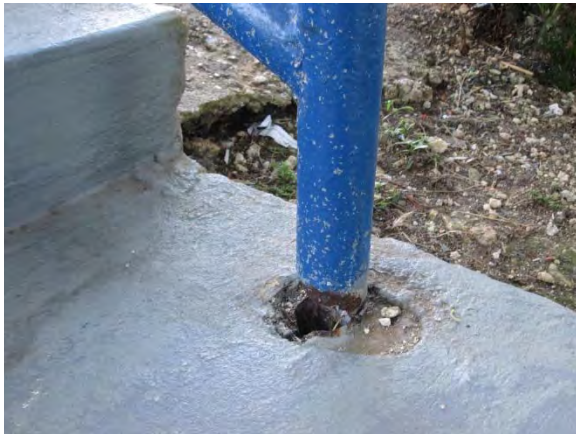
2. Rusted metal railing

Location: JQ San Miguel Elementary School, various locations

Where railings are rusted at the base, the railing must be removed and a new metal railing base installed in the concrete.

- Cut railing off at each base and remove railing
- Cut out the metal bases in concrete and remove all loose concrete
- Install new metal railing bases in concrete with hydraulic concrete. Weld bases to railing, ensuring that the railing is the height required by building code.

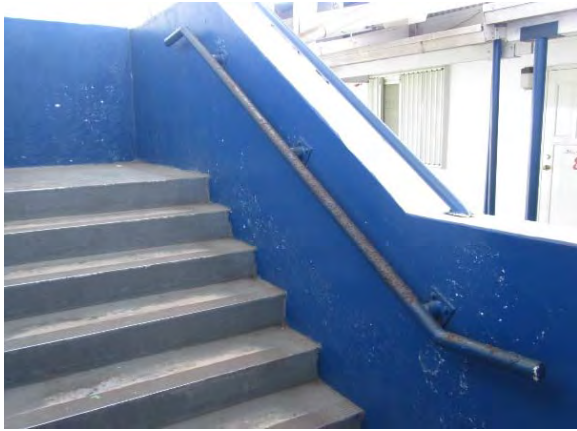
3. Rusted metal handrail

Location: JQ San Miguel Elementary School, various locations; FB Leon Guerrero Middle School, Building 13

Several of the handrails are heavily rusted on the top surface, in some areas to the point that the pocked rusted areas may cut people's hands, and are therefore a safety hazard. The railings should be repaired, or replaced with aluminum railings.

To repair the existing railing:

- Grind/sand the railing surface until there are no sharp edges
- Treat with a rust inhibitor
- Paint with an appropriate primer for final coat to be used
- Paint with a heavy catalyzed coating such as Amerlock Sealer
- Repaint as needed to keep an integral coating and help prolong life of railing

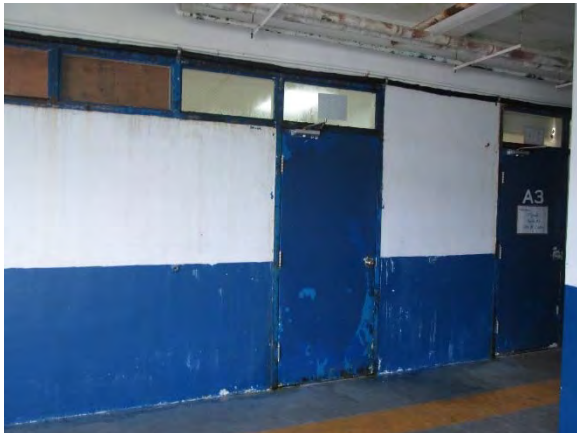
**4. Rusted metal door and window frames**

Location: JQ San Miguel Elementary School, Building 14

The extreme temperature difference between the outside air and the heavily cooled classrooms in this building causing moisture to condense on the outside of the walls, doors and windows. The moisture is causing the metal doors and metal frames to rust.

In order to prolong the life of these metal frames and doors:

- Remove paint from frames and doors
- Remove as much rust as possible
- Treat with a rust inhibitor

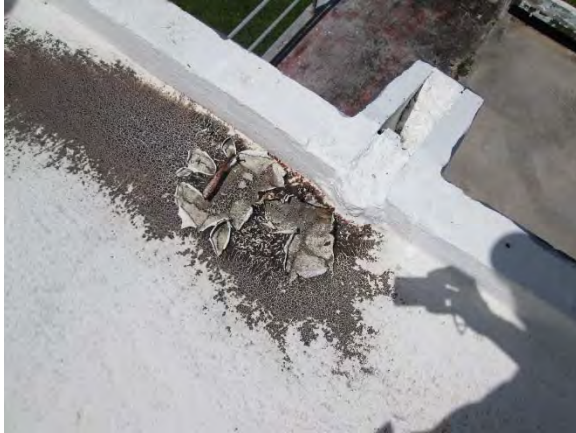
5. Isolated areas of deterioration of Fluid-applied roofing

Location: Carbullido Elementary School, various locations

The roofing is generally in good condition, except in some areas where ponding occurs, and the roofing is starting to peel up.

To patch deteriorated area:

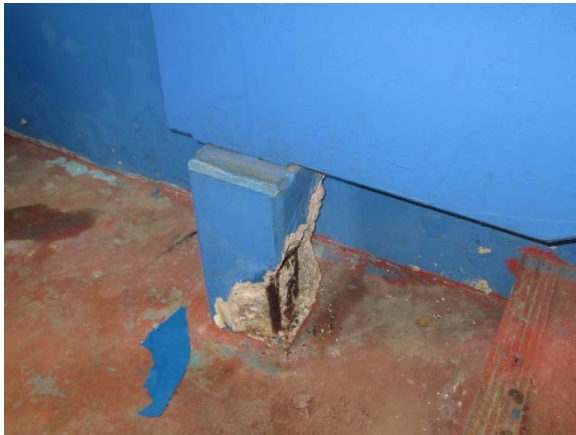
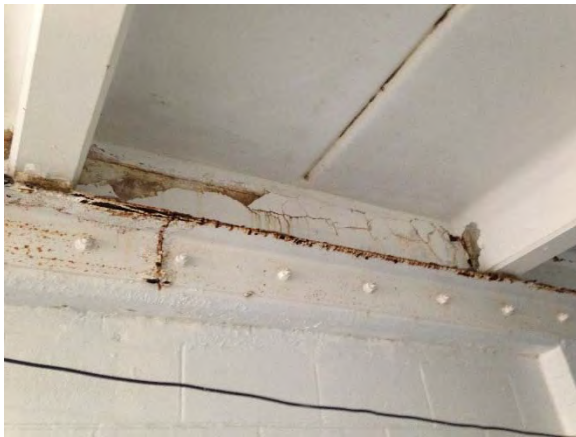
6. Spalling concrete (non structural)

Location: FB Leon Guerrero Middle School, Buildings 1, 4, 5 and 6; Inarajan Middle School, Building 1

The concrete is spalling at several locations on this campus, including at several stairs. The spalling should be repaired before it becomes worse and further compromises the integrity of the concrete element.

To repair non-structural concrete spalling, the following steps should be taken:

- Remove all loose concrete
- Remove as much rust as possible from steel reinforcing elements
- Replace reinforcing as necessary. Consider using fiberglass reinforcing bars
- Treat steel with a rust inhibitor compound
- Fill all cracks and patch spalls with new concrete

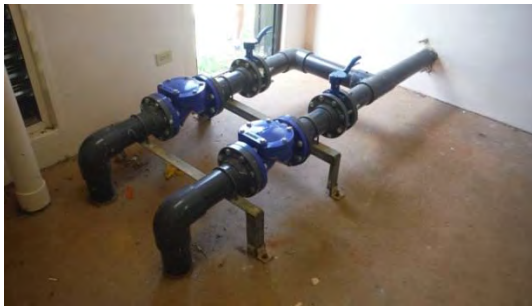
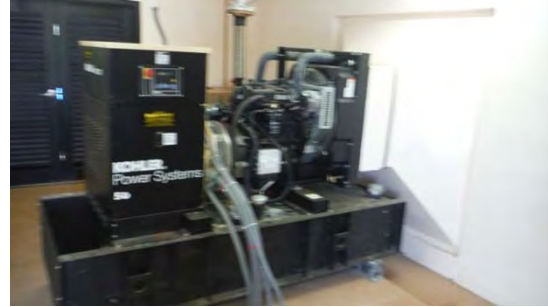
OIA phase II survey found the emergency power generator and sewage pumps at the sewage lifting station building needed repairs and restoration. These equipment were restored and operational during the Phase III survey.

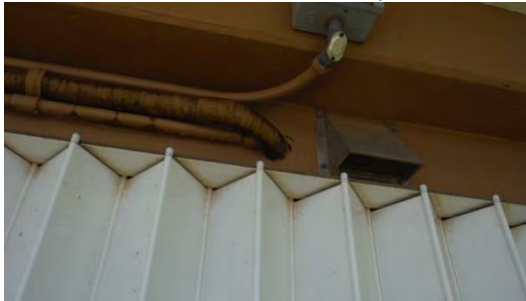
Air conditioning equipment was replaced during the renovation. Ductless DX split systems were installed at the classrooms with provision for outside air.

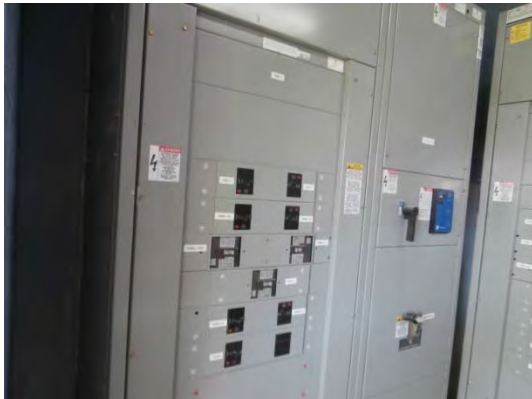
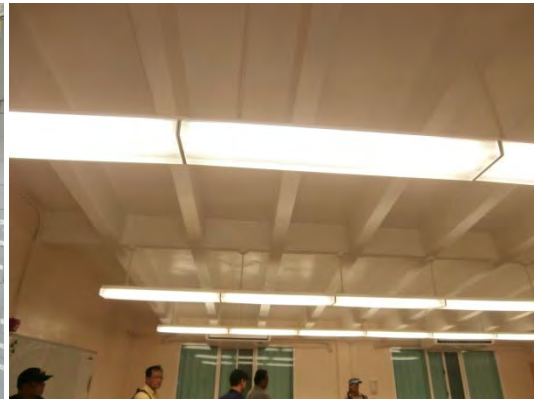
A new main switchboard was installed in the electrical room. All lighting fixtures are slowly being replaced with higher efficiency lighting.

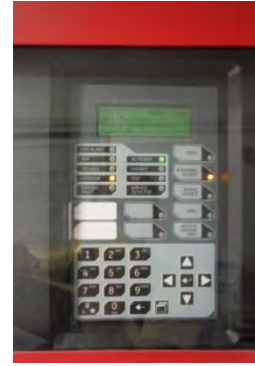
OIA Phase III survey found the fire alarm panel had trouble signals. The fire alarm system requires services and repairs to ensure its functions and performance meet fire safety requirements.

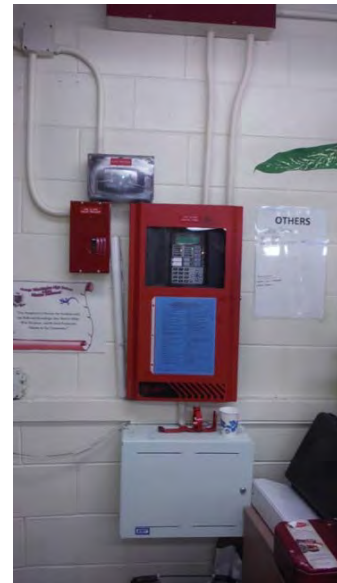
OIA Phase III survey found the fire alarm panel had trouble signals. The fire alarm system requires services and repairs to ensure its functions and performance meet the fire safety requirements.

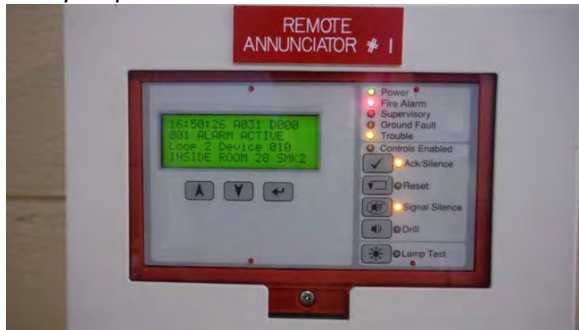
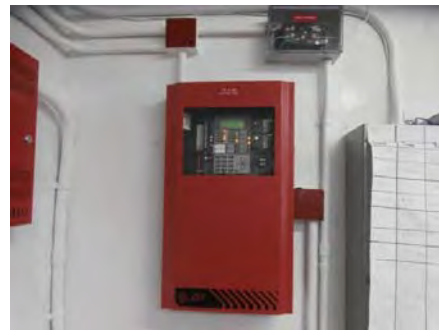
OIA Phase III survey found the fire alarm panel had trouble signals and silenced alarms. The fire alarm system requires services and repairs to ensure its functions and performance meet fire safety requirements.

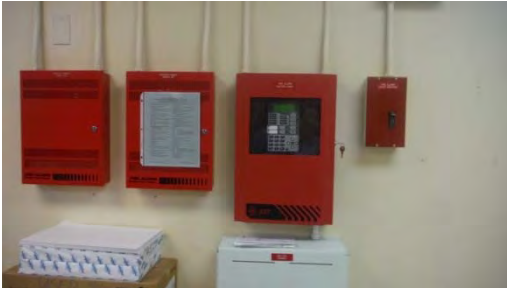
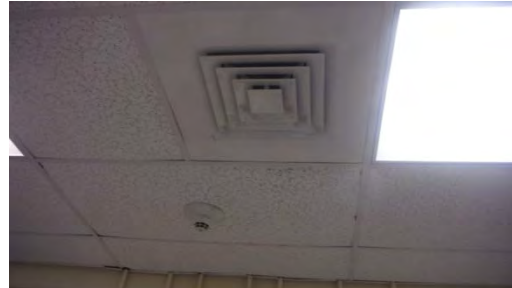
OIA Phase III survey found the fire alarm panel was at normal operation. Some smoke detectors were less than 36" from supply air diffusers which were noncompliant installation to NFPA 72.

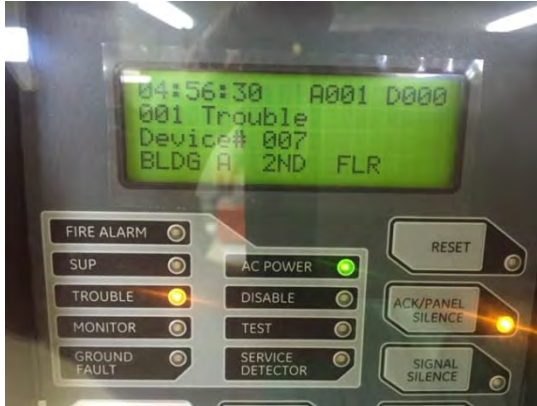
OIA Phase III survey found the fire alarm panel had trouble signals. The fire alarm system requires services and repairs to ensure its functions and performance meet fire safety requirements.

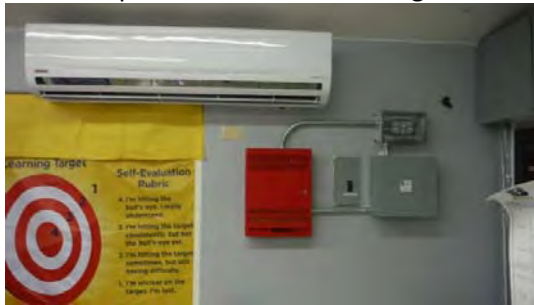
Fire alarm extender panel at Building 22 was below a ductless split indoor fan coil unit. Ductless fan coil unit will have condensation occasionally and potentially damage the fire alarm extender panel or cause trouble signal.

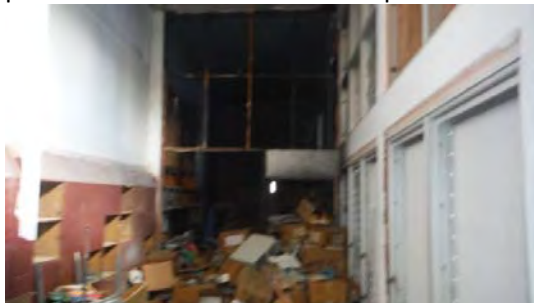
OIA Phase III survey found Building 11 had pile of damaged books and papers left from a previous fire. These substances pose a fire hazard and should be cleared.

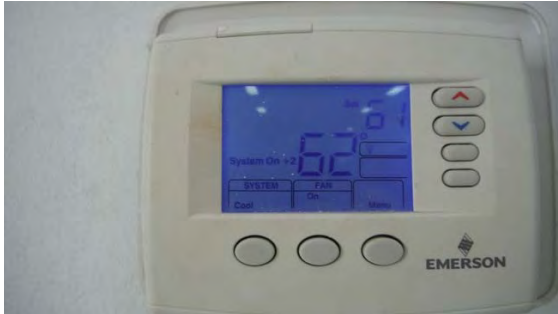
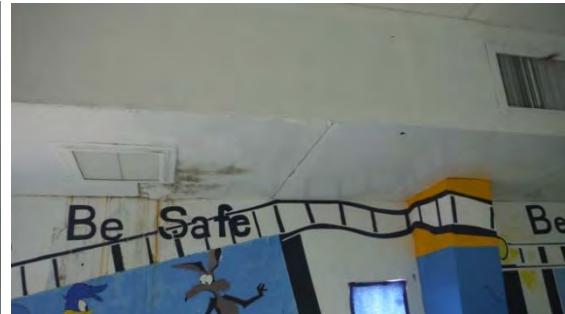
OIA Phase III survey found the space temperatures were low. Cafeteria ceiling was damaged due to air conditioning system condensation. Condensation drain did not pipe and discharge to proper location. Condensation at hallways occurred due to low space temperatures at the classrooms above.

Space temperature at Building 13, Cafeteria, was set at 61° F. It was too low and caused condensation, mildew growth (indoor air quality concerns), excess power consumption, and compressor operation.

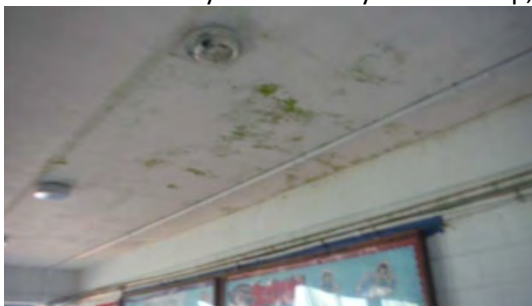
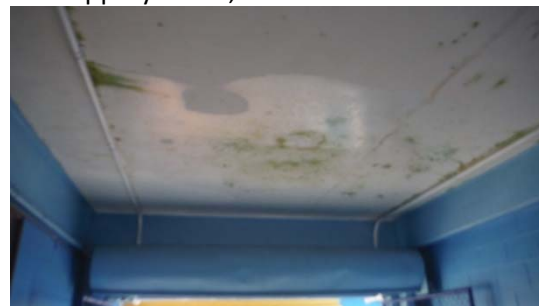
Condensation occurred at hallway ceiling at Building 8 and Building 11. Condensation and subsequent mildew growth were because of low room temperatures in air conditioned rooms above the hallway. The hallways were damp, with slippery floors, due to the condensation.

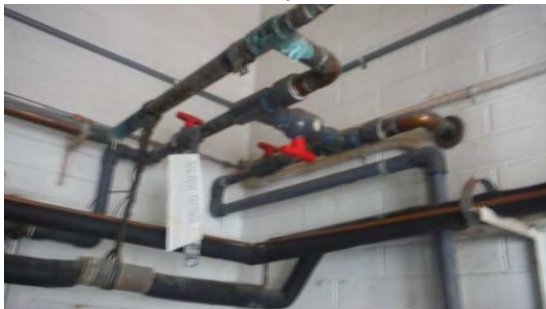
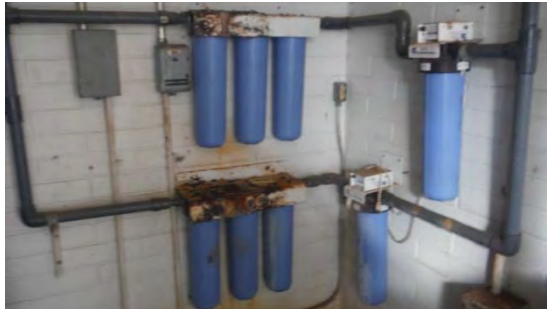
OIA Phase III survey found the domestic water piping and water filters at Building 16, Cafeteria, leaked and should be repaired.

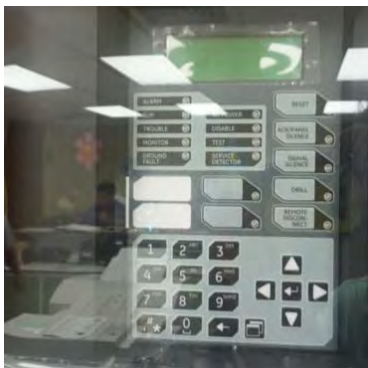
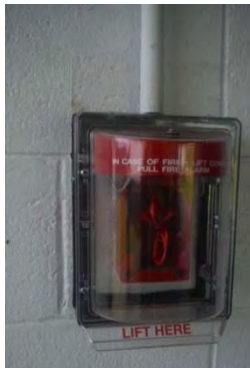
OIA Phase III survey found the fire alarm system was damaged by lightning. The fire alarm system power was off. Some manual pull stations were missing at Building 2 and Building 3. The fire alarm system requires services and repairs to ensure its functions and performance meet fire safety requirements.

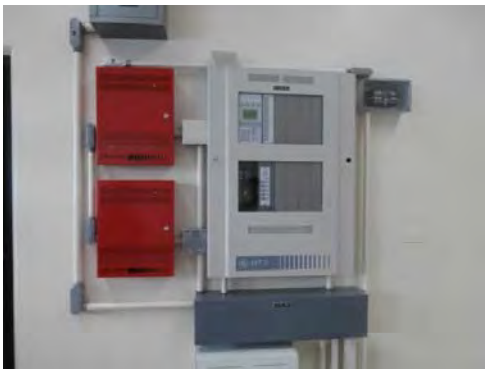
Fire alarm panels at Building 11, Gymnasium

OIA Phase III survey found the school had three fire alarm systems not interconnected. Fire alarm system at Building 11, Gymnasium, was at normal condition but the transient surge protector was not powered and needed repair. Fire alarm system at Building 12, Auditorium, was at normal condition. Fire alarm system at Building 15, Main office, power was off. This system protected all school buildings except Building 11 and Building 12. GDOE explained that a project for the replacement of the fire alarm system at Building 15 was being bid.

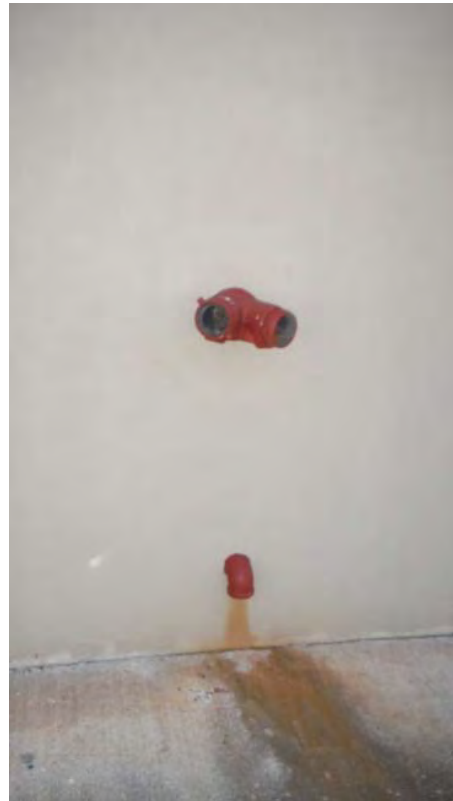
FDC at Building 12, Auditorium

OIA Phase III survey found the fire sprinkler systems were not serviced per NFPA 25. Control valve at Building 11, Gymnasium, was not supervised per NFPA 13 and Internal Fire Code (IFC). Fire department connection at Building 12, Auditorium, had no cover protection. The fire sprinkler systems require regular servicing and tests to ensure functions and performance meet fire safety requirements.

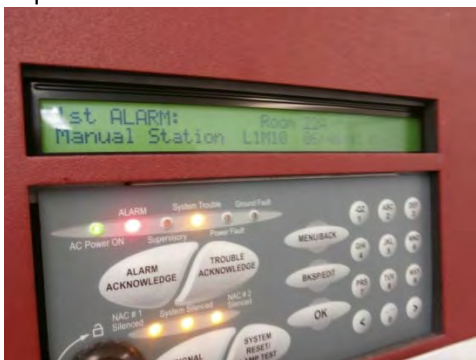
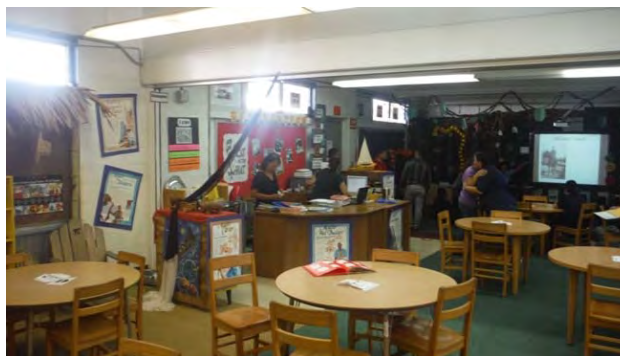
OIA Phase III survey found the fire alarm panel had trouble signals and silenced alarms. Fire alarm notification devices at Building 5, Library, were covered by decorations. The fire alarm system requires services and repairs to ensure its functions and performance meet fire safety requirements.

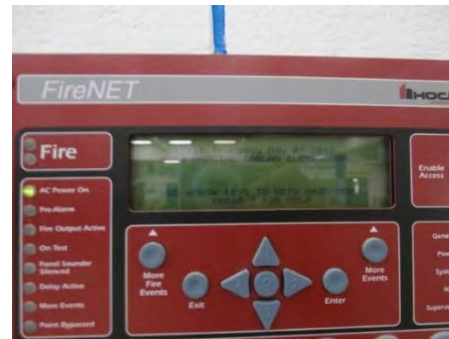
OIA Phase III survey found the fire alarm panel was at normal operation. The fire alarm system required services and repairs to ensure its functions and performance meeting the fire safety requirements.

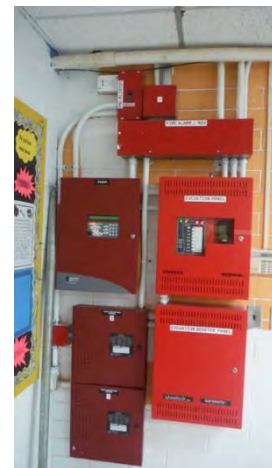
OIA Phase III survey found the fire alarm panels had trouble signals and silenced alarms. The fire alarm system requires services and repairs to ensure its functions and performance meet fire safety requirements.

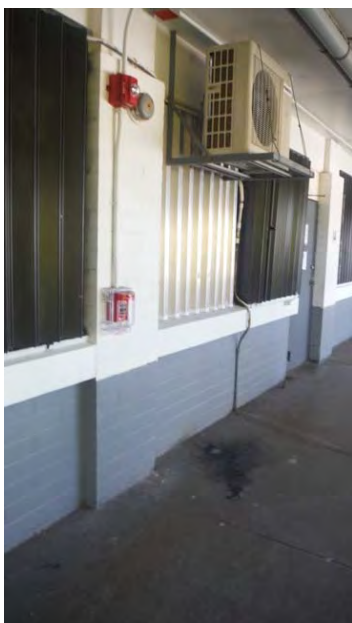
OIA Phase III survey found some new installed air conditioning units dripped at the walkway. Ventilation fans at Building 2, Gymnasium were not operational and needed repair.

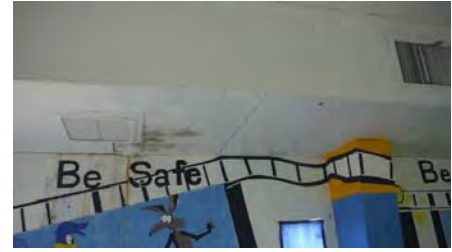
Location: Vicente Benavente MS, Building 13 – Cafeteria  
ceiling is damaged due to air conditioner condensation.  
Repairs to ceiling and air conditioner are needed.

- Repair air conditioning deficiencies, water leak and condensation as soon as possible.
- Maintain inadequate outside air and space comfort levels to the occupied spaces per ASHRAE standards. Provide treated outside air using dedicated outdoor air system wherever is possible.

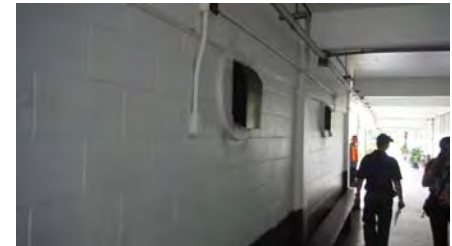
Location: George Washington HS Building 21, Restroom  
– Toilet exhausts discharge to walkway.

- Provide new toilet ventilation system per ASHRAE 62.1 and International Mechanical code.
- Provide dehumidifier and turn off air conditioner at classroom when it is unoccupied during holidays.

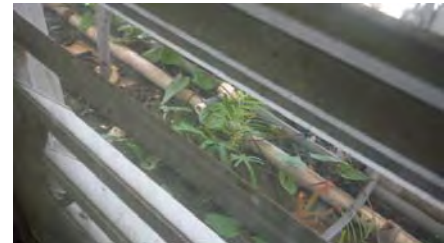
Location: Vicente Benavente MS Building 10 – Classroom  
condensate drain discharges at the building overhang  
creating corrosion and vegetation problems at the  
overhang.

- Provide proper sized and sloped condensate drain lines to collect and convey the condensate drain. Minimum 1" (25 mm) diameter pipe and 2% slope are preferred. Provide clean out not more than 180 degree change in direction and 50 ft apart.
- Condensate drain should be discharged to dry well or indirect drain with P-trap to waste line.
- Provide condensate drain pan for air conditioning equipment

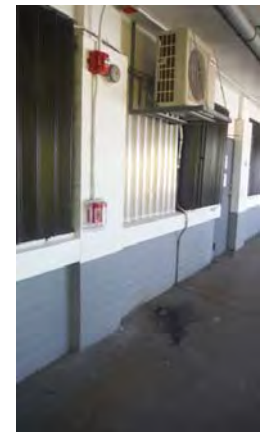
Location: Inarajan MS  
Building 5, Classroom  
Condensate of condensing unit drips on walkway

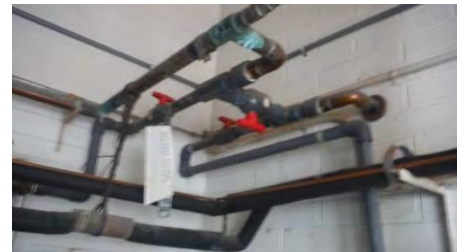
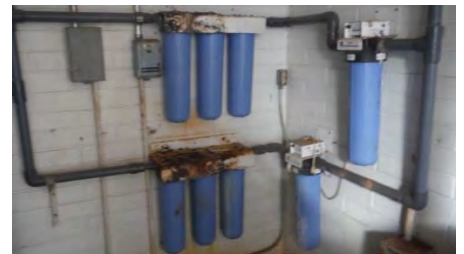
Location: Wettengel ES Building 16 has leaks at domestic water piping and filters.

- Repair water leak and plumbing fixture as soon as possible.

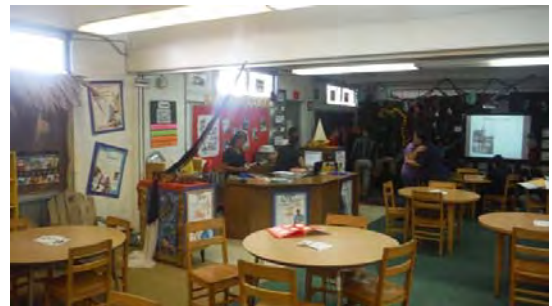
Location: Truman ES Building 5 – Library. Notification device is covered by decoration.

- Rectify and repair fire alarm system deficiency.
- Maintain fire alarm system information, manuals, maintenance and testing records on site.
- Provide regular operation training of fire alarm system to school staffs. Establish fire safety awareness program to promote fire safety awareness to the staffs and occupants.

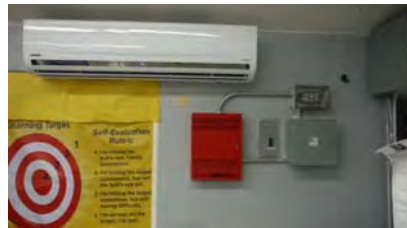
Building 22, Classroom

Fire alarm extender panel is installed under ductless split indoor DX fan coil unit. Fan coil unit will have condensation occasionally and potentially damage the fire alarm extender panel or cause trouble signal to fire alarm system.

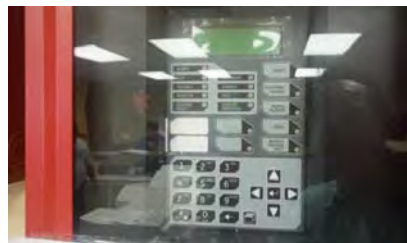
Location: Finegayan ES Building 1, Office

Fire alarm system was damaged by lightning.

- Upgrade fire alarm system at Southern HS Building 15 and main campus. Interconnect fire alarm systems at Building 15, Building 12 and Building 11.
- Repair lightning damaged fire alarm systems at Finegayan ES and Upi ES.

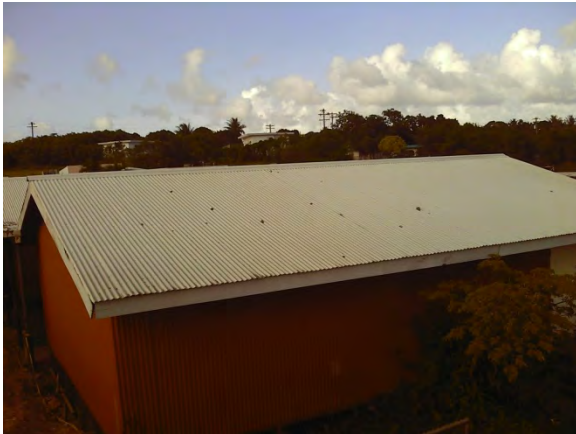
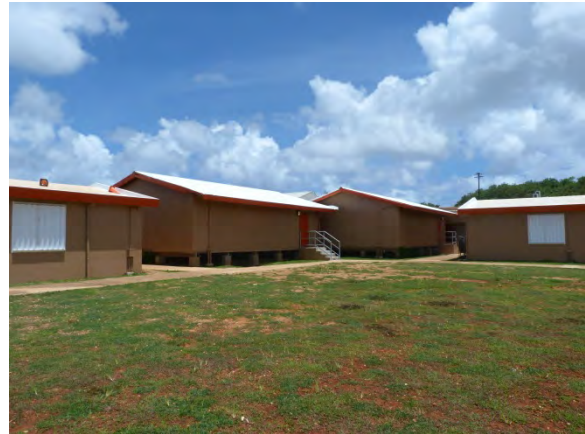
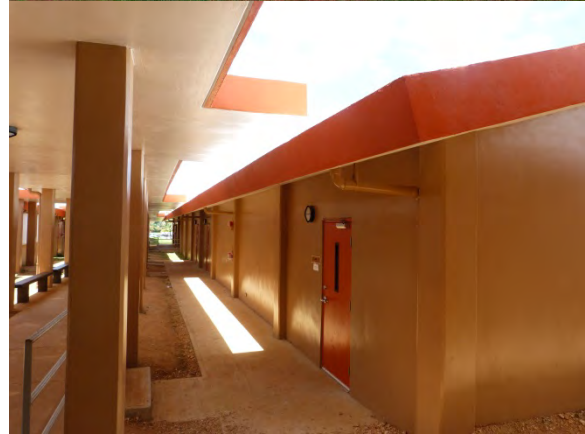
These four buildings were relocated to make way for a new classroom building. They were founded on new concrete blocks with ties to the wood beams above and are now in good condition.

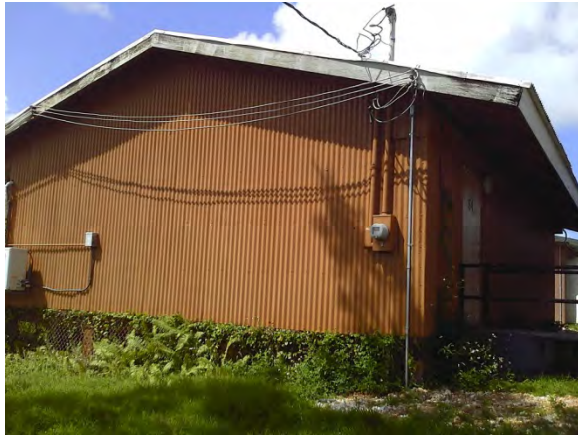
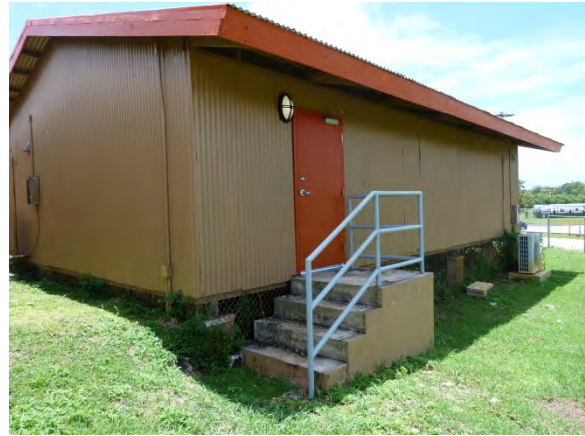
**1B. L.P. Untalan Middle School – 8 and 10 - Rooms T9, T8**

The buildings were renovated with new paint coatings for protection of the structures. There were no other significant structural changes.

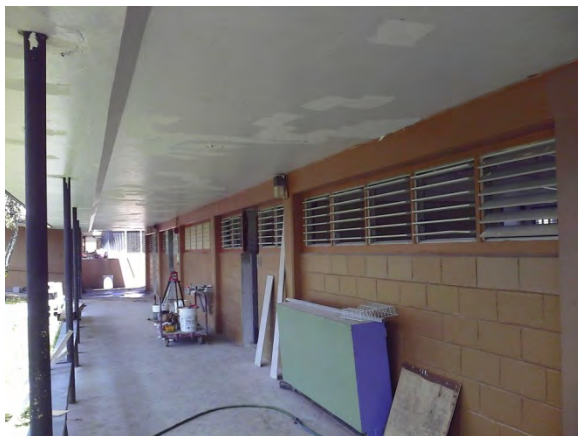
**1C. L.P. Untalan Middle School – 12 - Rooms 21-28**

The building was being renovated during the Phase II site visit. The renovation is now complete.

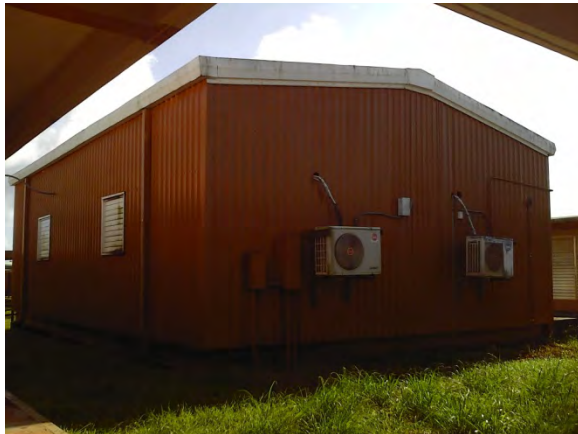
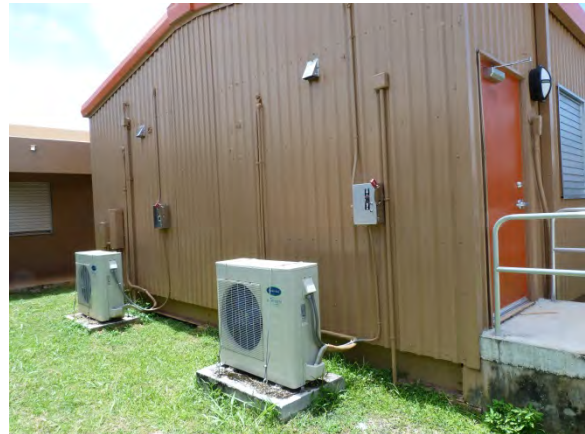
**1D. L.P. Untalan Middle School – 16 – Rooms T-3**

The building has been renovated with fresh exterior paint. New entry ramps have been constructed. The corroded beams observed previously were cleaned and painted. The close proximity of the beams to the ground and exposed flanges that collect water will require regular maintenance of these conditions. The foundation conditions remain the same.
