# **INSULAR ABC'S INITIATIVE**

## **Phase III Task 1 Findings and Recommendations**

### **Guam**

October 2015

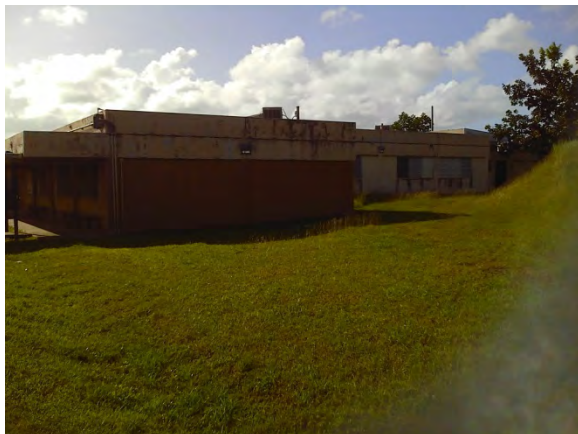
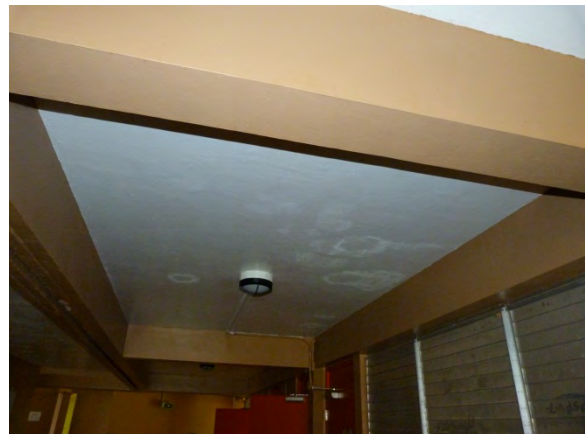
**1E. L.P. Untalan Middle School – 17 – Rooms 42-45**

The building has been renovated, including soffit spall repairs. No water penetration or stains from the roof were observed. The patch repairs were reportedly made by mixing Thoro Acryl 60 with cement and fine aggregate. The admixture is specified to improve adhesion and the condition of the repairs appears to be good, although as they were completed very recently, it is not possible to gage their durability.

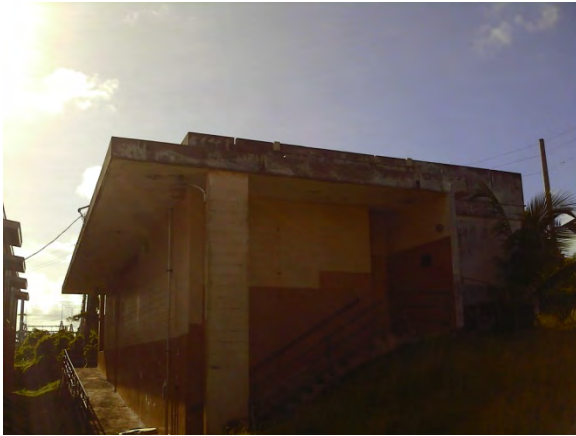
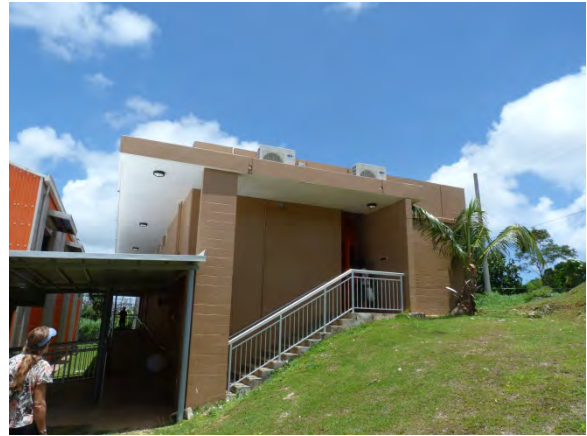
**1F. L.P. Untalan Middle School – 19 – Rooms 37-39**

This building has been extensively renovated with spall repairs and new paint. Its condition is significantly improved since the Phase II site visits.

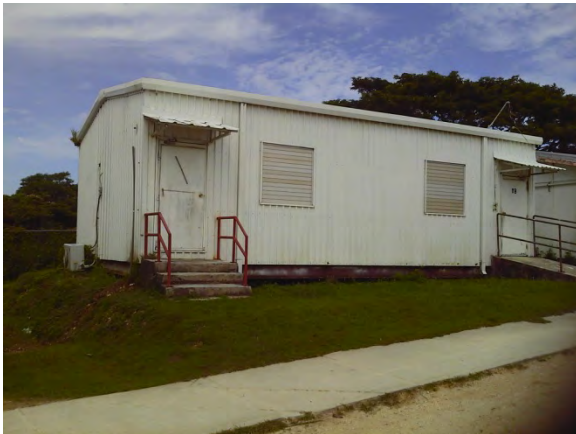
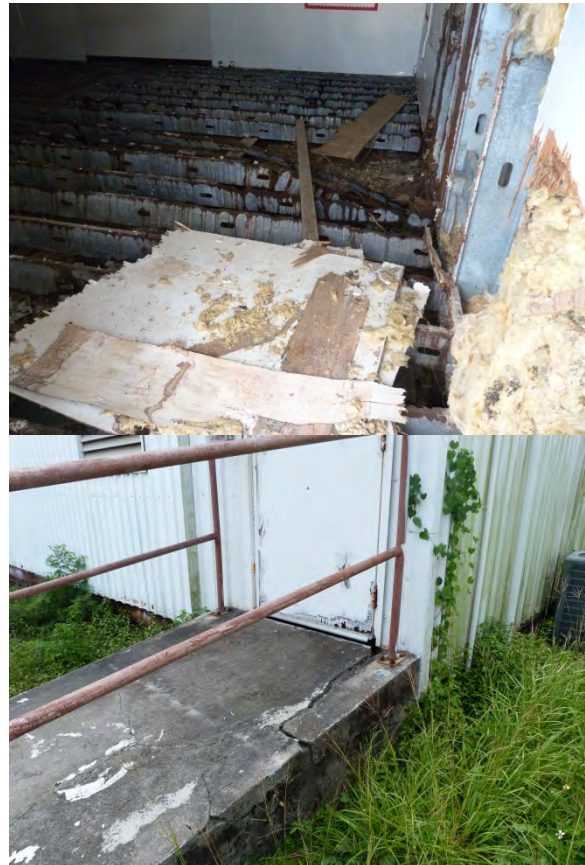
**2A. Capt. Price Elementary School – 16 – Room T8.**

This building was in a partial stage of demolition with the floor decking having been removed and steel joists exposed. Corrosion of the steel joists was more apparent. The foundations were still in the same condition as observed in Phase II. The entry ramp and rail was observed to be damaged. There is little salvageable about the building and it may be best to completely demolish it.

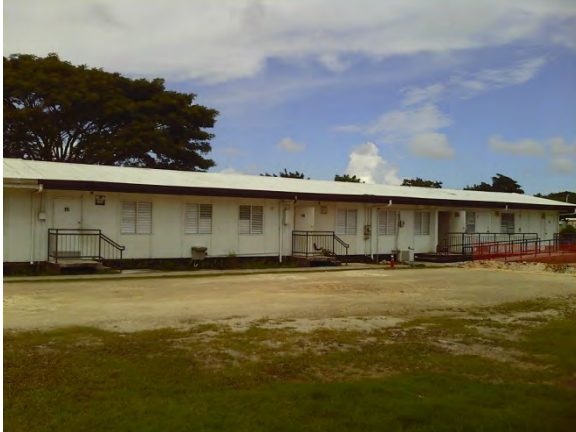
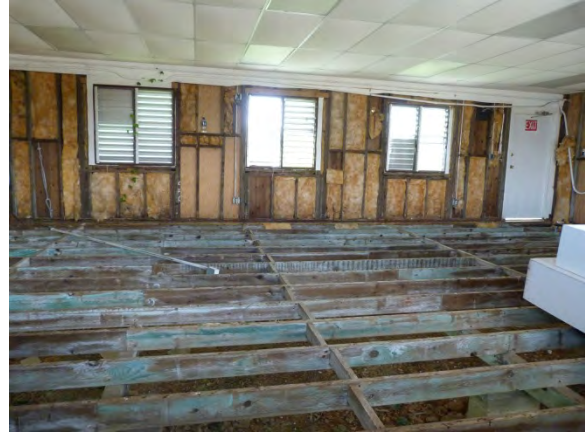
**2B. Capt. Price Elementary School – 17– Room T8.**

This building was also in a partial stage of demolition with the wood floor decking having been removed. The wood joists appear to be in good condition, therefore the building can reasonably be renovated with new interior sheathing and finishes.

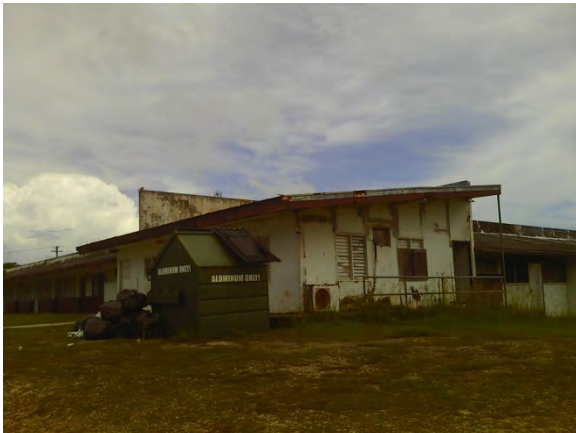
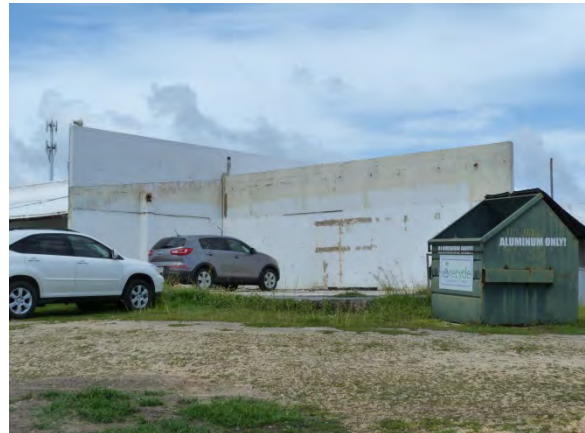
**2C. Capt. Price Elementary School – 21– Condemned Metal Shed**

The building, which was observed to be abandoned during the Phase II site visit, has now been demolished down to the slab.

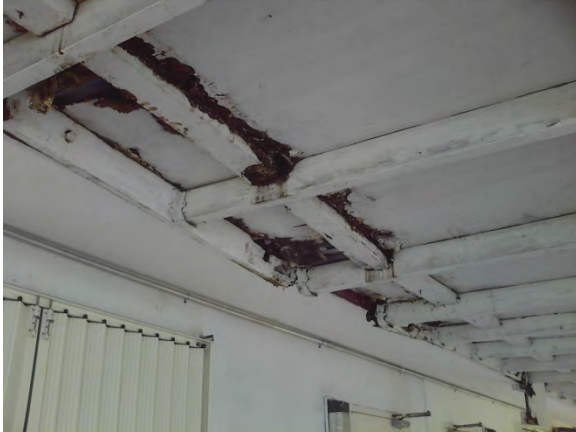
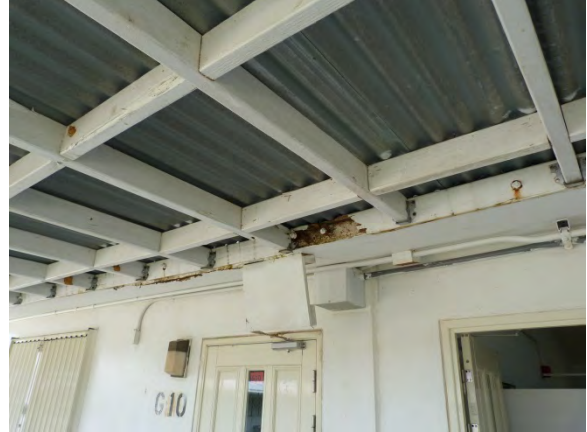
## **2D. Capt. Price Elementary School – 22 - Covered Walkways**

One area of covered walkway was reported to be unstable during the Phase II site visit and reportedly subsequently collapsed. This section has been repaired. Generally the covered walkways are still in poor condition in places and in need of repairs and replacement, although there are no longer any immediate safety concerns.

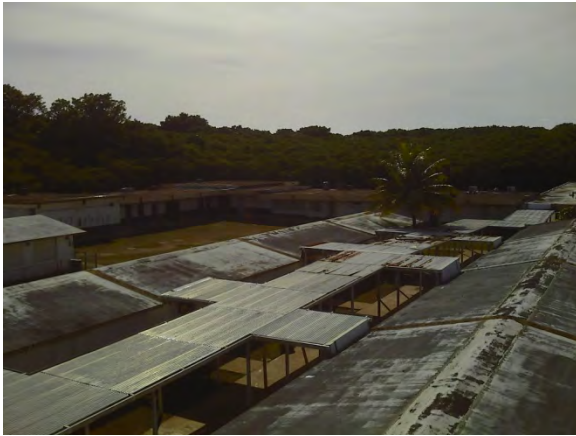
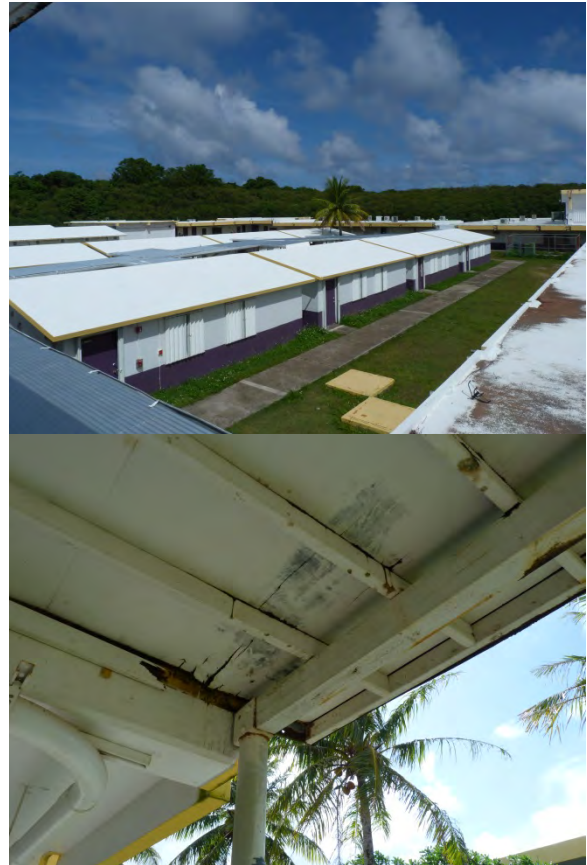
### **3A. George Washington High School – 15 – Covered Walkways**

The roof has been replaced over almost all of the covered walkways except one small section between Buildings 11 and 15 that is in need of some repair.

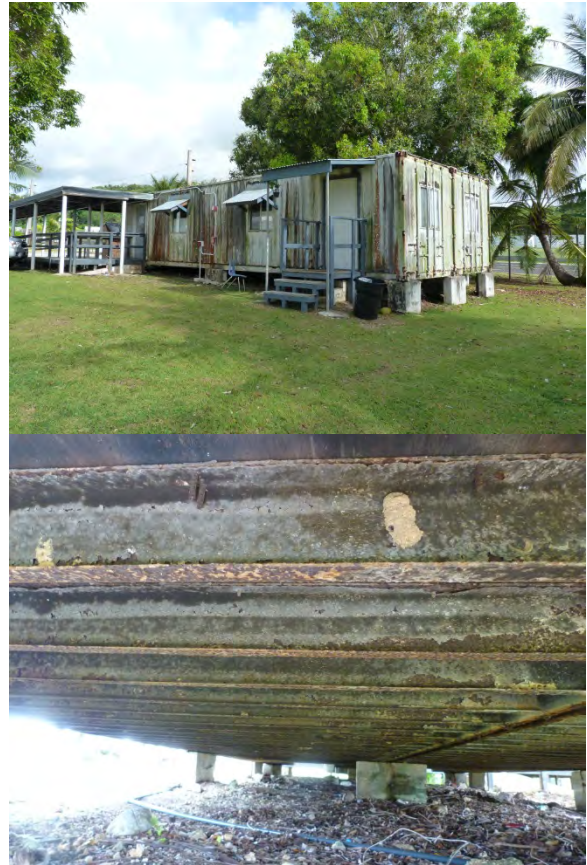
#### **4A. Jose Rios Middle School – 01 – Rooms T1, T2**

This temporary building is constructed from two shipping containers. The floor framing is quite corroded and susceptible if heavily loading. It should be repaired or retired from use.

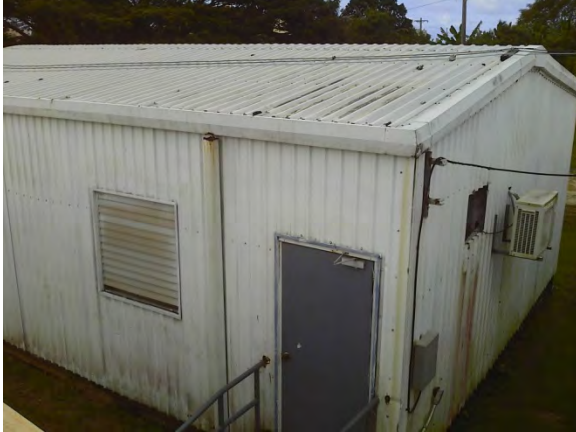
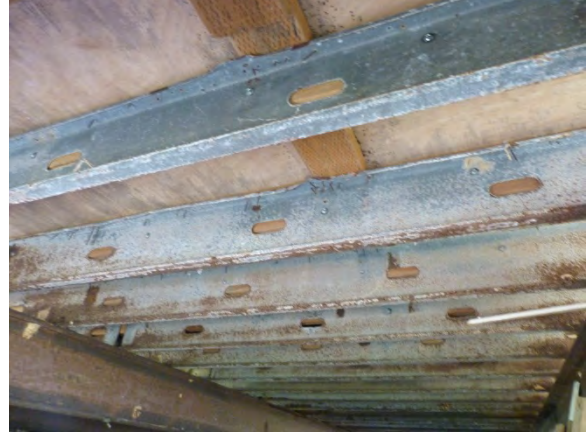
**4B. Jose Rios Middle School – 05, 06 - T3, T4-T7**

The floor decking was replaced in these two buildings. The framing still has some corrosion but is in sound condition. There is a hole in one of the exterior walls of Building 05 where an air conditioning unit appears to have been removed. This should be sealed up to prevent water infiltration from deteriorating the framing.

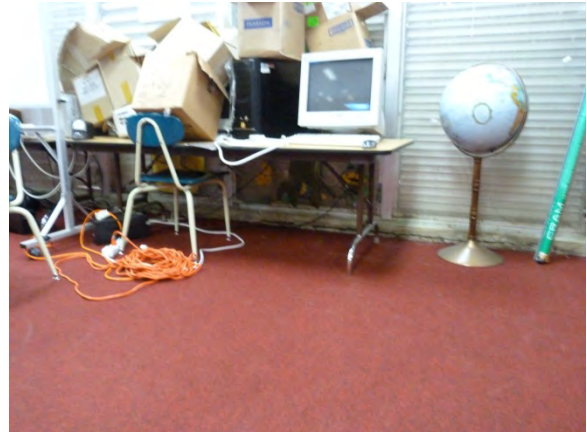
**5A. J.Q. San Miguel Elementary School – 05 – Library**

The cracks and spalls observed for this building have been repaired. There was one crack that was observed along the window sill in the library. It is not significant structurally but may allow water to seep into the building and should be sealed.

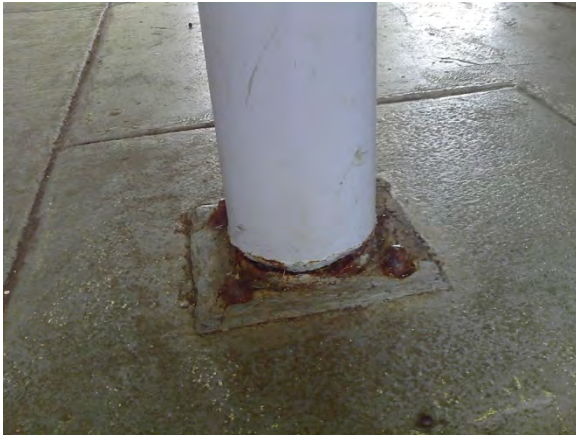
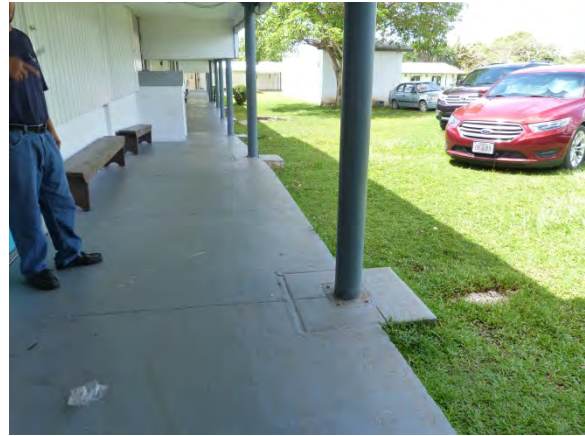
**6A. Carbullido Elementary School -13 - Rooms 5, 15, 20**

The base of the steel columns has been recoated to protect them from corrosion. Localized spalls at the top of the columns were repaired.

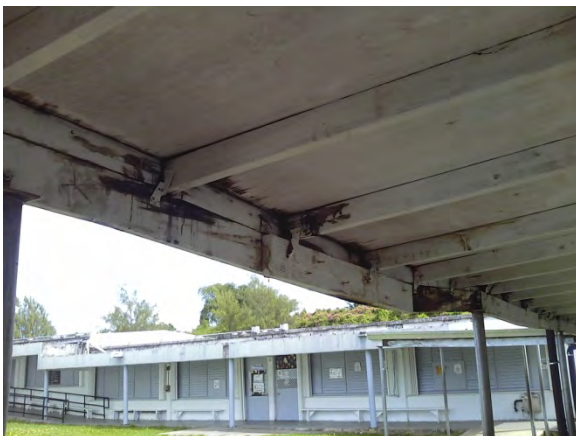
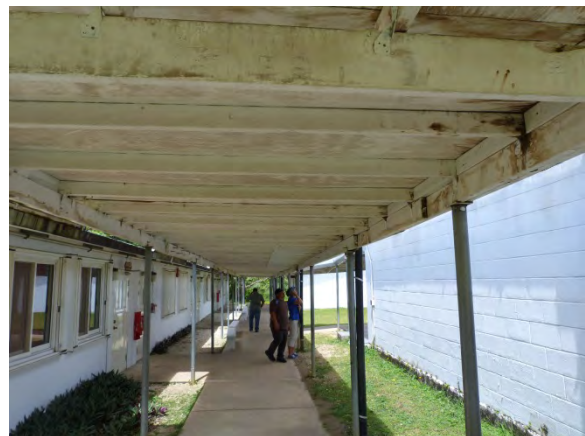
**6B. Carbullido Elementary School -16 - Covered Walkways**

Localised areas of rotted covered walkway framing, observed during the Phase II assessments, have been repaired.

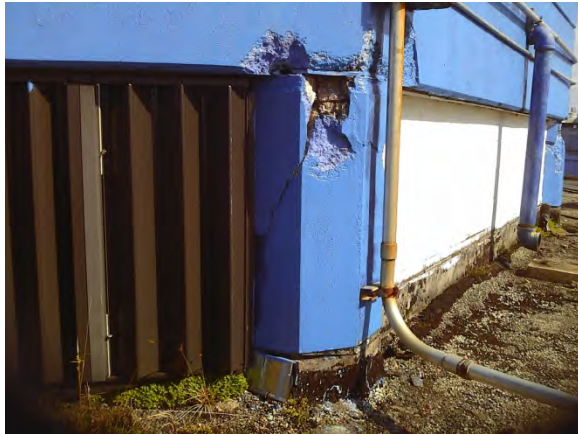
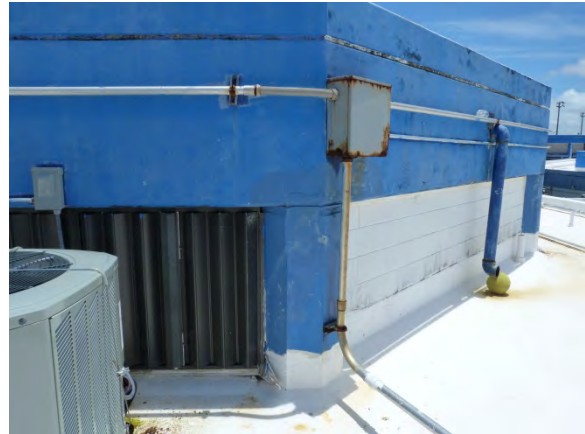
The spalls around the top of a number of columns in this building have been repaired. The patches were not well consolidated in some locations, although these appear to be earlier repairs. Poorly consolidated patches are likely to result in further spalling sooner than would be expected after a repair. For future repairs like these, it is recommended to undercut a section of the column to sound concrete to result in clean edges between the new concrete patches and existing concrete.

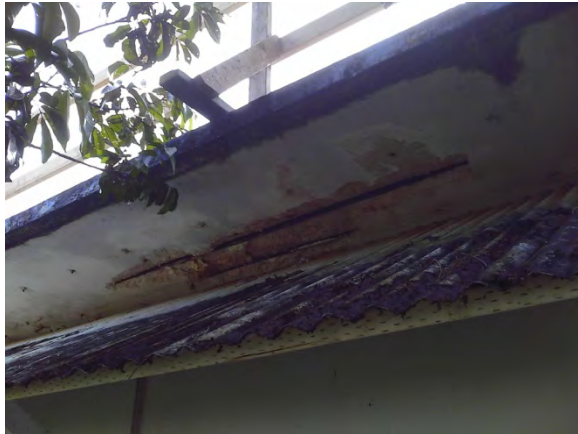
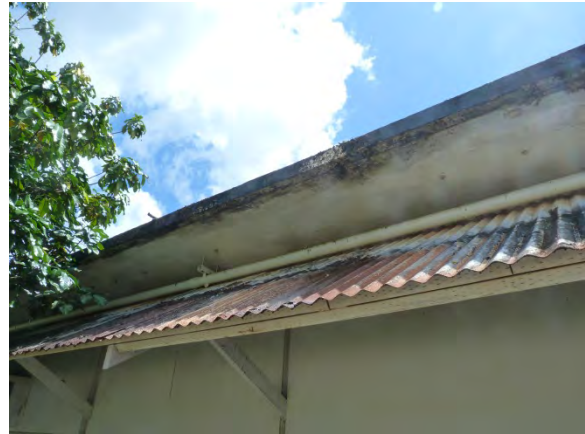
**8A. Agana Heights Elementary School – 01, 03, 09**

These buildings were being reroofed during the Phase II site visit. There were previously spalls observed at the soffit of the roofs, particularly at the exterior eaves. These generally appear to have been patched.

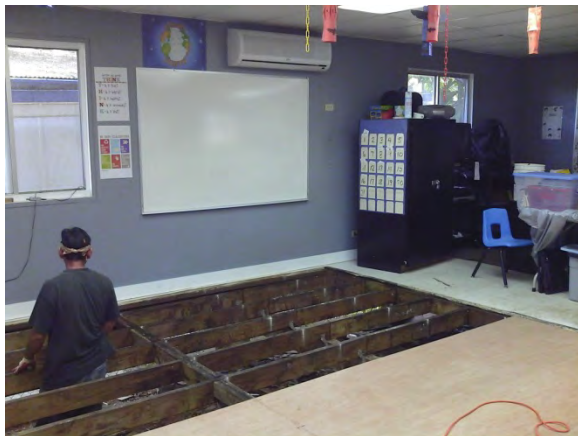
**8B. Agana Heights Elementary School – 05 and 12 – Rooms T3 - T6**

These rooms were reported to have severe moisture damage. The floor decking of one area had been removed during the Phase II site visit. They are now scheduled to be demolished and were not reassessed.

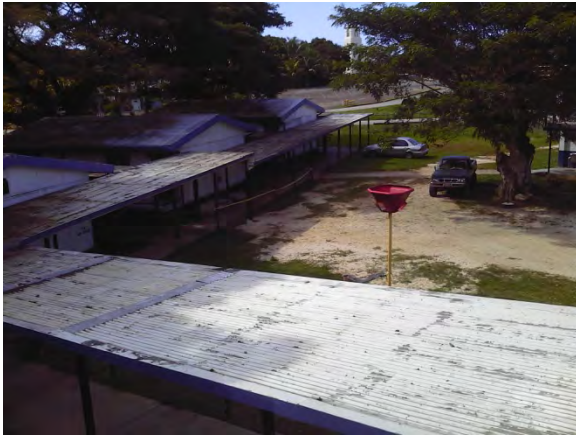
**8C. Agana Heights Elementary School – 08 - Covered Walkways**

The covered walkway adjacent to Room 04 – 06 (Building 05) was also in poor condition. It is presumed that this too will be demolished along with the buildings.

Demolish the covered walkways where the buildings are to be demolished. Any remaining light framed covered walkways in poor condition shall be replaced in accordance with Appendix C.

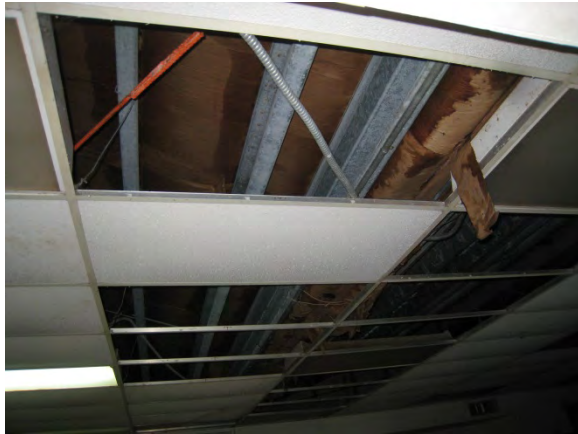
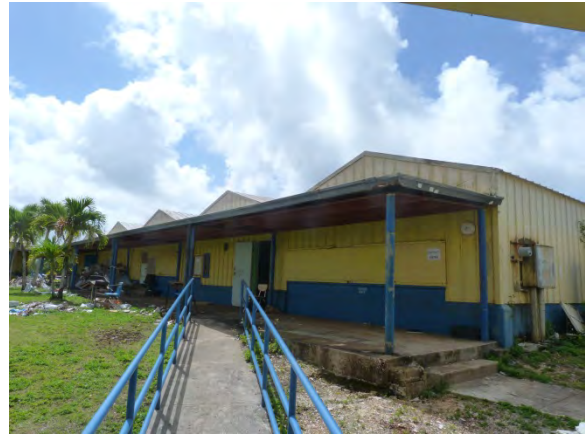
**9A. Vincente S.A. Benevente Middle School – 01, 02, 03 – Rooms A1 – A12**

These three buildings are to be demolished. Structurally they are in fair condition, therefore a complete renovation is feasible. However, it is understood there are a number of leaks and indoor environmental quality issues.

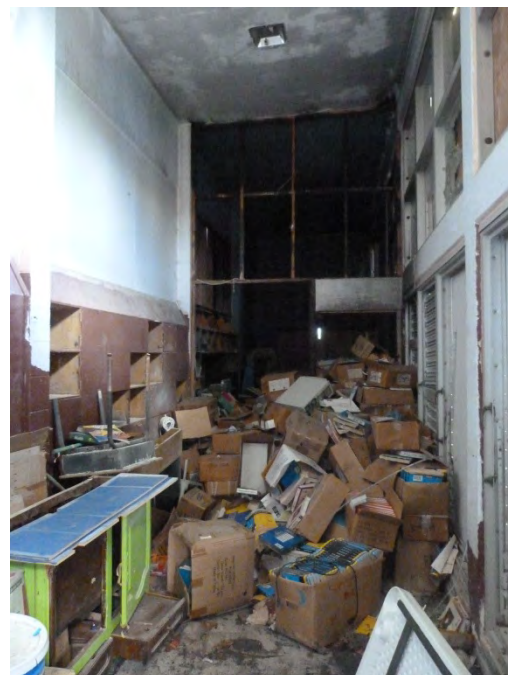
**9B. Vincente S.A. Benevente Middle School – 11 - Classrooms**

The west side of this building has a room that had a fire in the distant past and has been abandoned since then. The room was not closely inspected due to lack of access but there does not appear to be structural damage. It needs to be cleaned out and renovating it so that it does not become an environment health hazard.

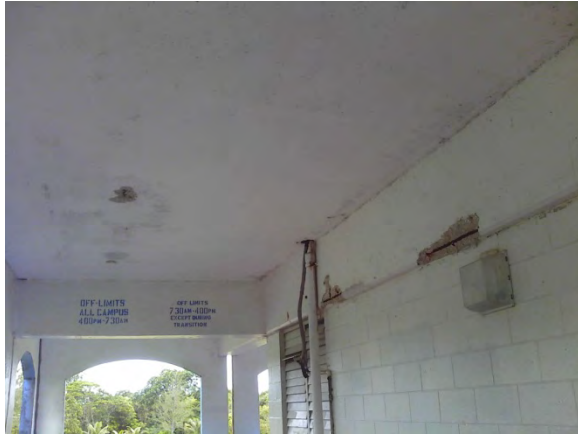
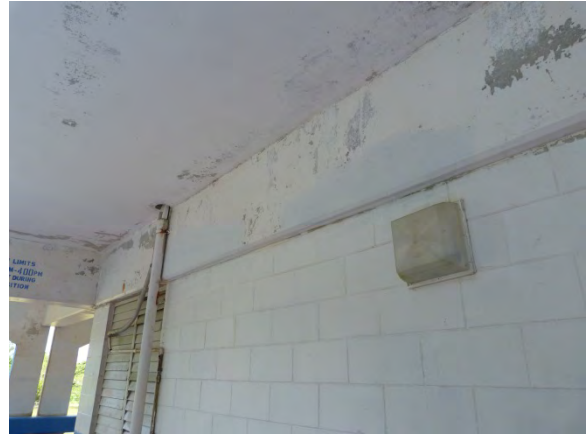
### **10A. F.B. Leon Guerrero Middle School – 01 – 06**

These buildings are of similar construction type and conditions. The buildings have been reroofed, which appears to have addressed the leaks that had caused a number of soffit spalls observed during the Phase II assessments. Spall repairs were completed throughout the buildings.

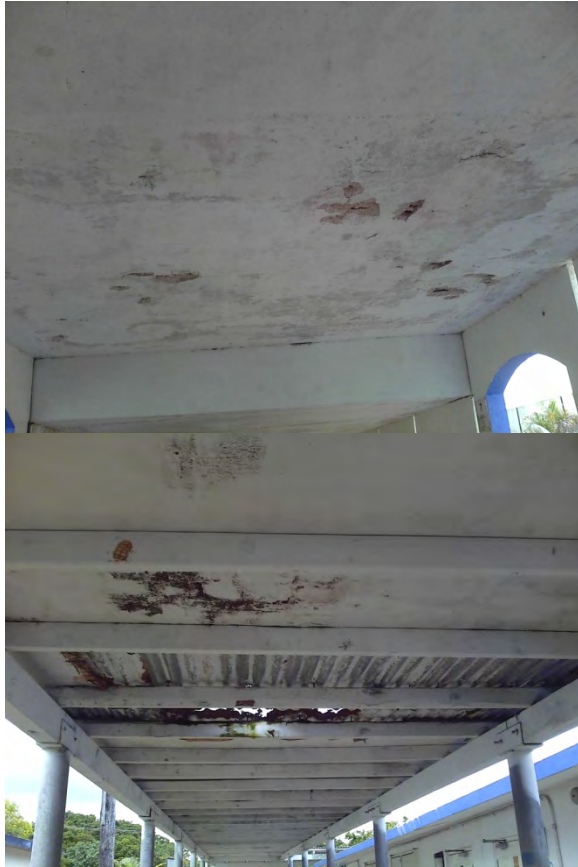
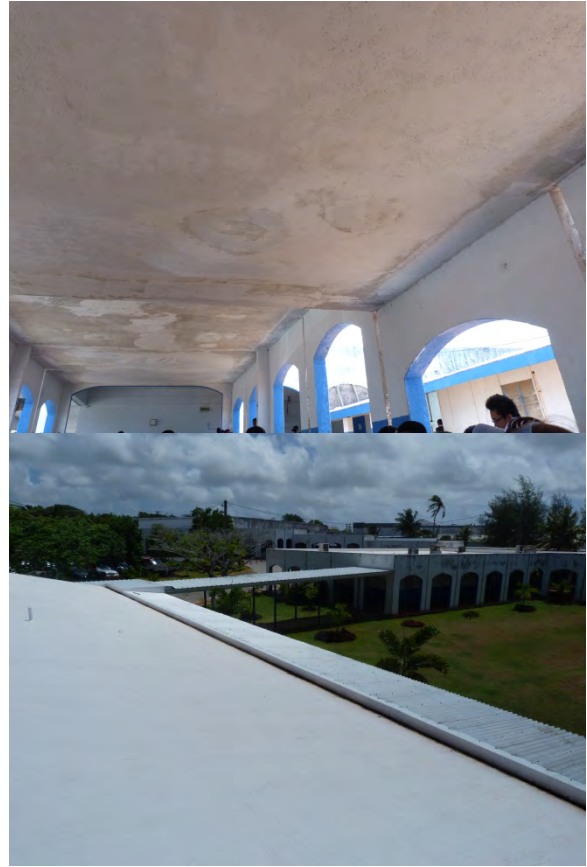
**10B. F.B. Leon Guerrero Middle School – 22 – Covered Walkways**

The spalls at the concrete walkway roof to the cafeteria have been repaired. For the covered walkways with steel roof decking, the decking has been replaced in most of the areas. The one area where the existing decking remained was in a relatively sheltered area between buildings and the decking was in fair condition.

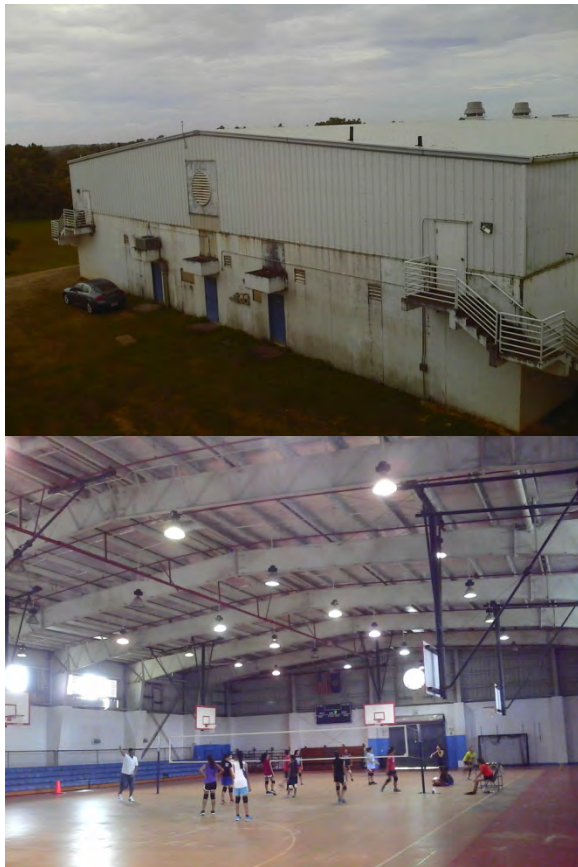
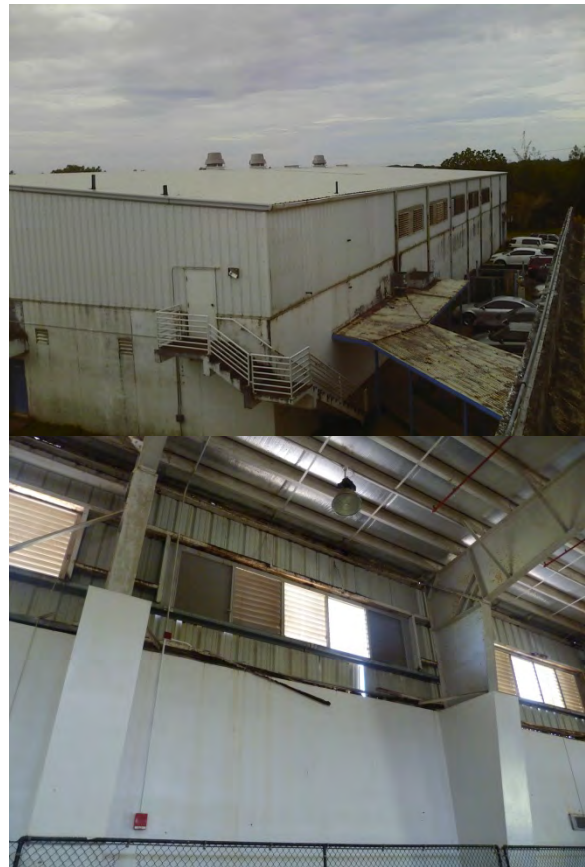
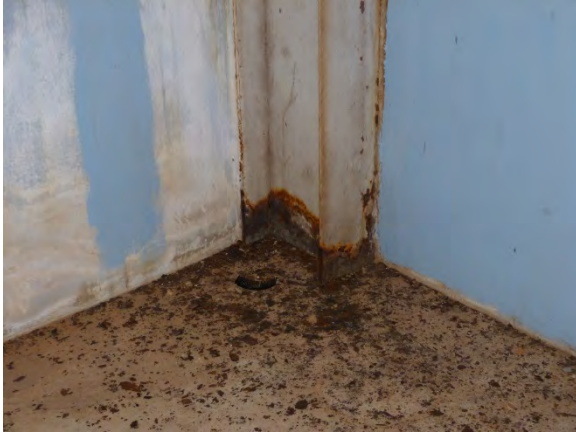
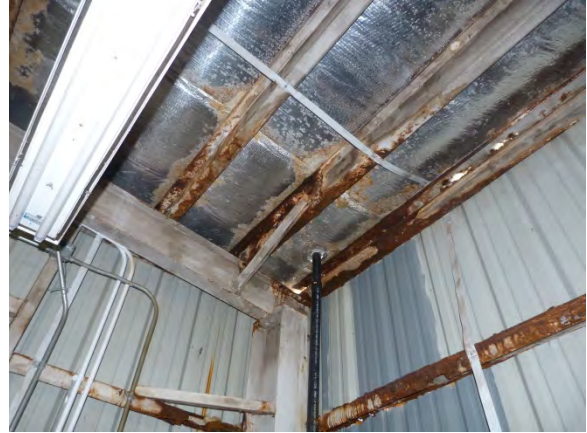
### **10C. F.B. Leon Guerrero Middle School – 13 - Gymnasium**

Some of the gymnasium framing was observed to have severe corrosion and has deteriorated since the Phase II site visit. The wall girts, particularly on one side of the building, are completely corroded, with the shards making for a potential falling hazard. This damage is attributed to wind driven and salt laden precipitation coming through the louver openings. Due to Z – configuration of the girts, water is able to get trapped on them, which accelerates corrosion.

Some of the roof purlins are also corroded due to past or current roof leaks. Portions the columns at the east end of the gym are also damaged. The siding and roofing the gymnasium appears to be in good condition, although it would be difficult to repair the girts without replacing the siding.

Have an architect, structural and mechanical and fire protection engineer perform a complete survey of the gymnasium and provide a design and construction documentation for repair and replacement of the severely damaged components. The renovation should also include ventilation, fire suppression and alarm upgrades. Remove the siding. Repair the affected roof purlins, temporarily removing roof decking as required. Repair miscellaneous steel framing such as columns that exceeds a predefined level of damage. Replace all the girts. Preferably replace with new girts that will not trap moisture. Replace the siding. Install new louvers or other form of protection to prevent wind driven rain getting into the building. Perform mechanical ventilation and fire protection upgrades.

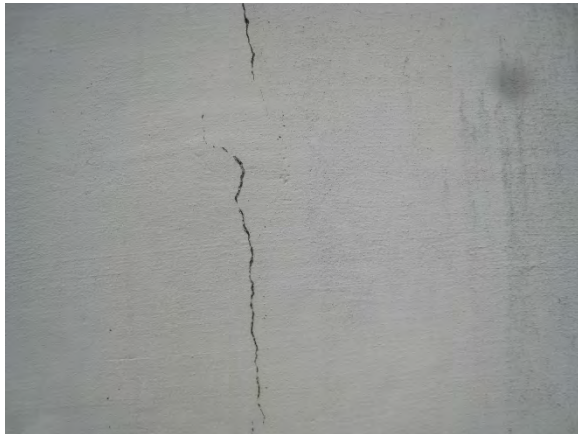
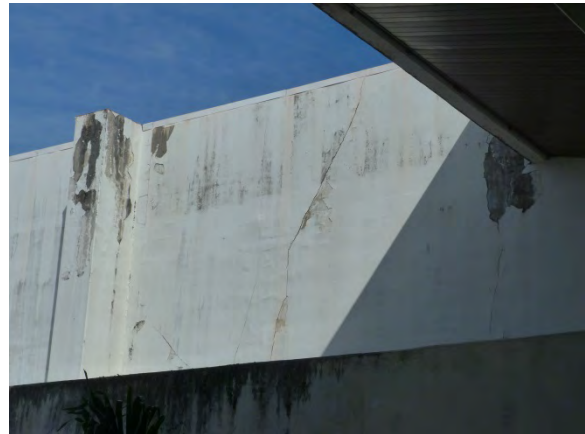
### **11A. Southern High School – 06 – CR**

This building was undergoing a renovation during the phase III site visit. A number of wall cracks were observed in this building during both site visits. While the building is being renovated, it would be best to seal any cracks over around 0.020 inches in width to prevent structural deterioration of the reinforcing in the walls. Finer cracks generally will not be able to absorb significant moisture.

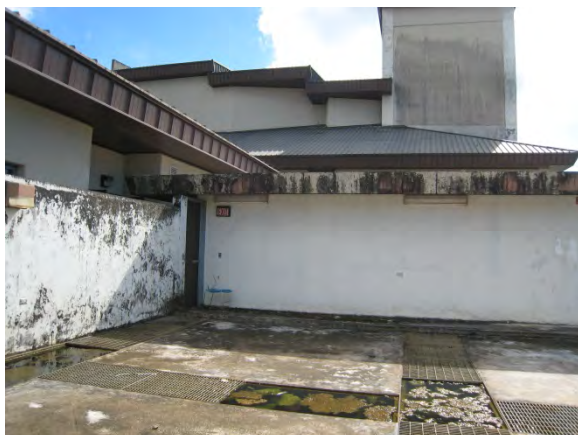
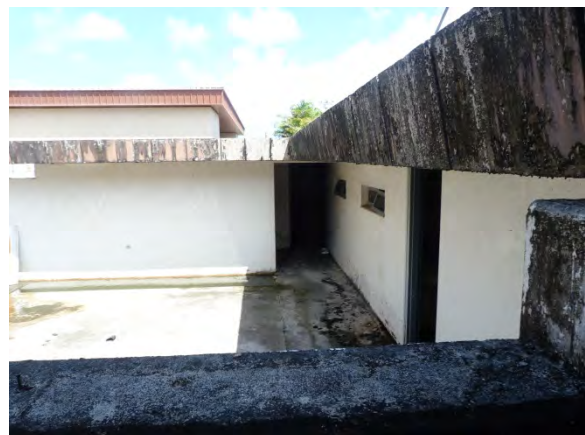
### **11B. Southern High School – 13 – AQ**

This building is abandoned but is in fair condition. Initially, due to the abandonment, it was proposed to demolish the building. However, after the Phase III site visit this is not considered to be warranted. Some non-structural maintenance, particularly to the trench drains, is required.

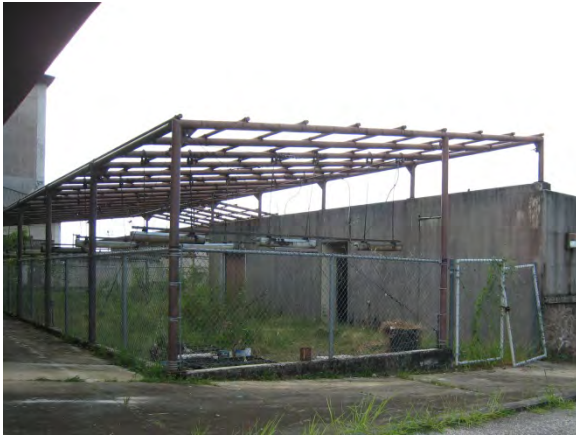
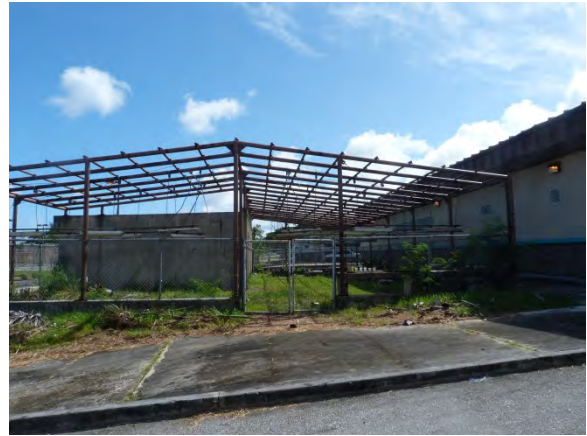
### **11C. Southern High School – 14 – Building G & H**

Like Building 13, this building is abandoned, but demolition is not necessary. It just requires some maintenance.

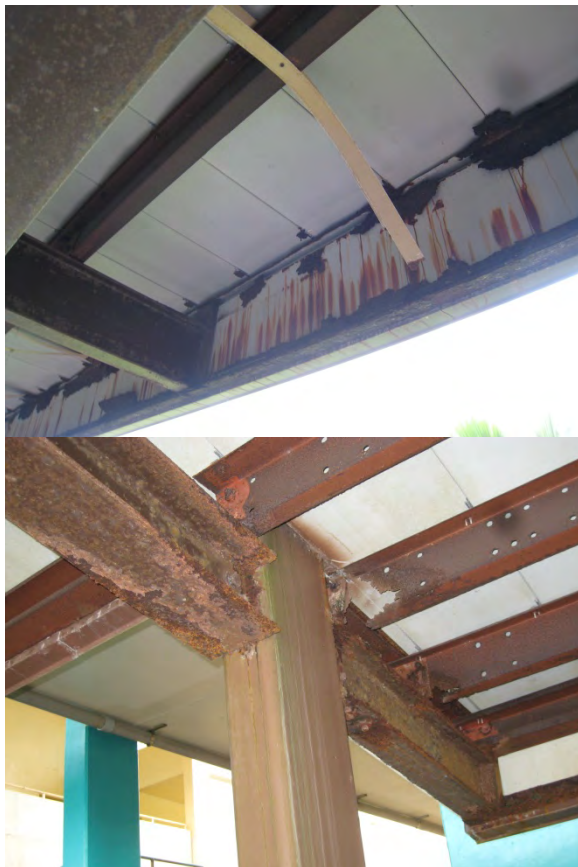
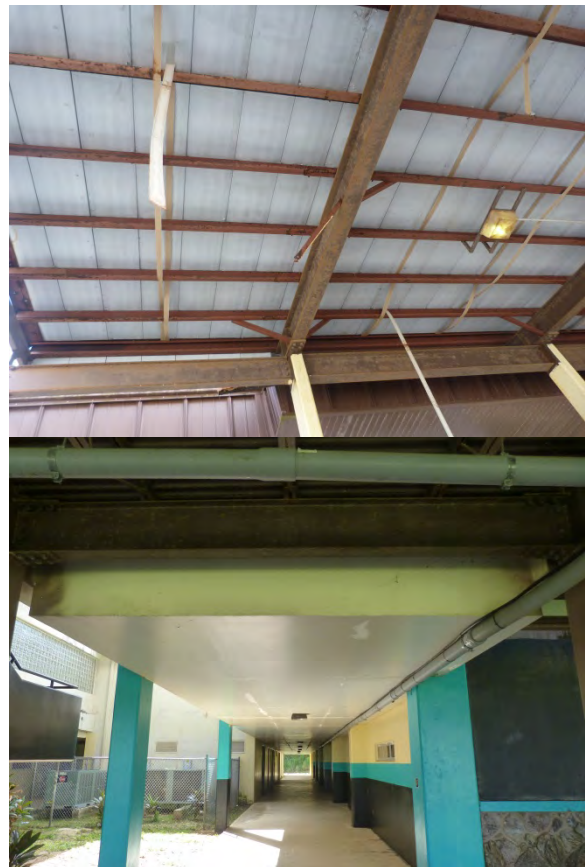
### **11D. Southern High School – 22 – Covered Walkways**

The only pre-existing structural health and safety item remaining from Phase II was the deteriorated purlins at few locations of the covered walkways. These conditions appear to remain since the Phase II site visit as this school has not yet been renovated, except isolated buildings. As the steel in the covered walkways is generally exposed, it deteriorates quite rapidly compared to the steel inside the air conditioned buildings. Diagonal bracing and bridging straps are missing in many places, which affect the stability of the purlins for high wind uplift loading.

There is a soffit at one covered walkway that was also observed during the Phase III site visit to have notable sag. This might indicate that the framing of the soffit is deteriorated, probably due to a leak in the roofing resulting in ponding of water and corrosion of the soffit framing. This could lead to future collapse of the soffit if it is not repaired. It is recommended that this be investigated and repaired and that the soffit supports for other similar conditions at the school also be investigated to determine any other potential deficiencies. This should be treated seriously, given the collapse of a similar condition at another territory where a teacher was seriously injured.

Remove a portion of the soffit at the sagging area. Have a structural engineer determine the cause of the deformation. Shore and stabilize or remove the soffit to prevent future collapse if deemed necessary. Structurally survey the other similar conditions.

Have a structural engineer perform a survey of all the exposed steel in the covered walkways and identify all areas that have deterioration exceeding a threshold that is determined to be unacceptable, for example 10% of loss of the steel cross section. Design and prepare construction documentation for repairs where necessary. It is recommended to replace the bridging straps with more substantial members given the exposure and propensity for light gage straps to corrode and fail after a short time. Repair the framing shown in the construction documentation. Clean and recoat all the exposed steel framing of the covered walkways with a durable coating system, such as one with a zinc based primer and epoxy finish coating.

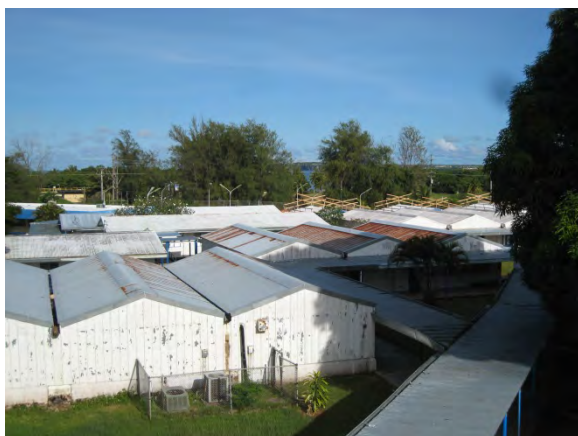
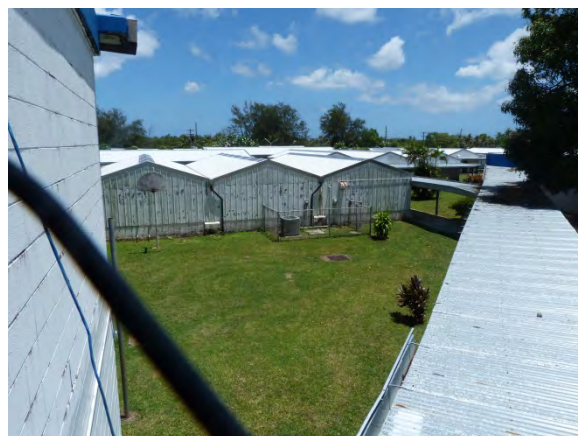
**12A. M.A. Sablan Elementary School – 04 (Stage), 09, 10, 11, 12, 13 16 17, 18**

These buildings were all reroofed with aluminum roofing and stainless steel trim. This stainless steel trim is a good feature as this has been observed to be the first part of the roof to deteriorate with these types of roofs in other locations. The floor decking in Buildings 11, 12 and 17 is understood to need replacing due to the moisture damage from past roof leaks. The beams and joists at these floors were generally observed to be in good condition, although this does not preclude the possibility of localized damage, which will be uncovered during decking replacement.

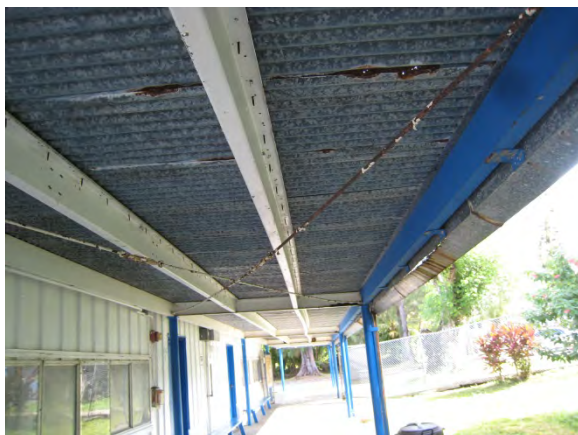
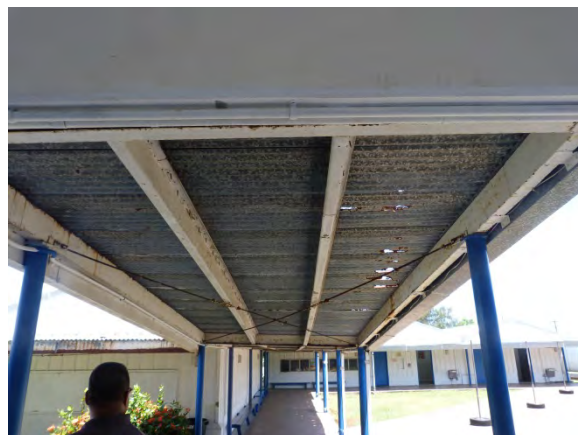
**12B. M.A. Sablan Elementary School – Covered Walkways**

These covered walkways were not reroofing with the rest of the metal roof buildings. The walkways generally have low slopes on the roofs, collecting debris, ponding water and accelerating deterioration. In some cases the corrugations are perpendicular to the direction of the roof slope. Reroofing with a larger slope on the roofs and correctly oriented corrugations would be beneficial. Some trees have been removed from the site to lessen the debris on the roofs.

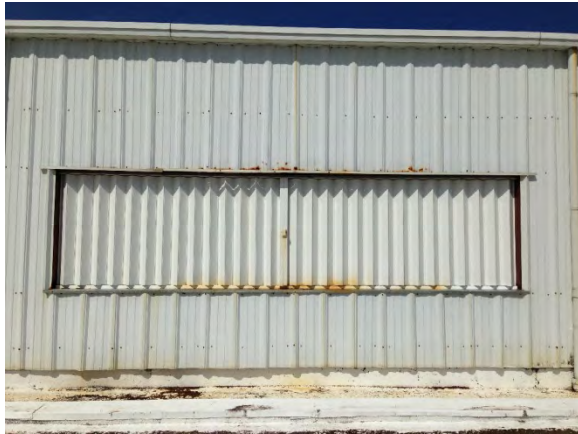
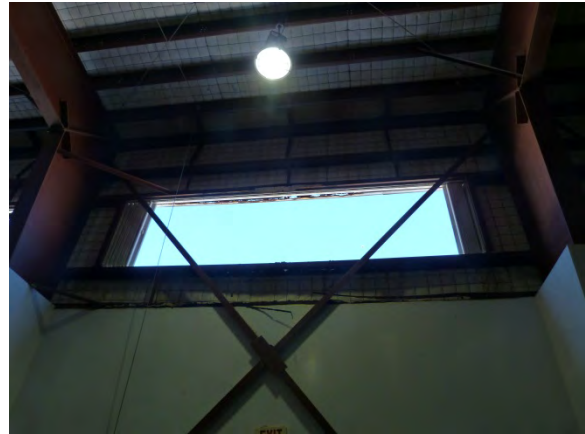
### **13A. Inarajan Middle School – 02 – Gymnasium**

This gymnasium was enclosed in the 1990s. There is corrosion to the wall girts resulting from moisture coming through the shuttered wall openings and settling on the web of these girts. The bleachers no longer operate as rolling bleachers.

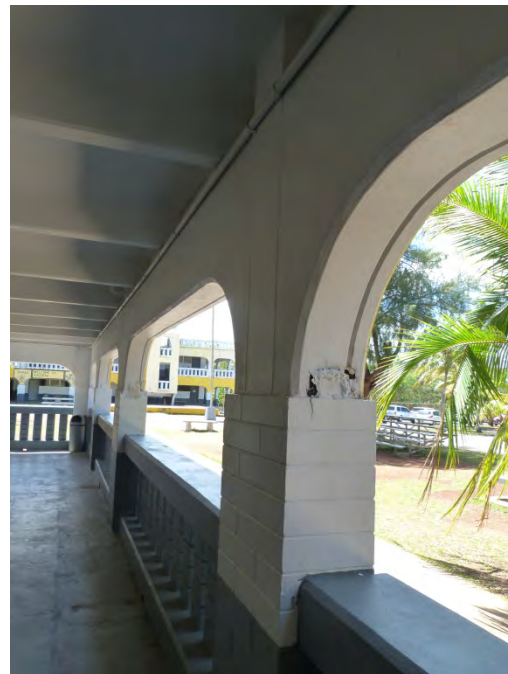
### **13B. Inarajan Middle School – 05 – Rooms 7-10, 25-28**

Connection plates for precast concrete column and archway components are consistently corroded. There were leaks observed in the joints between this building and the adjacent Building 01.

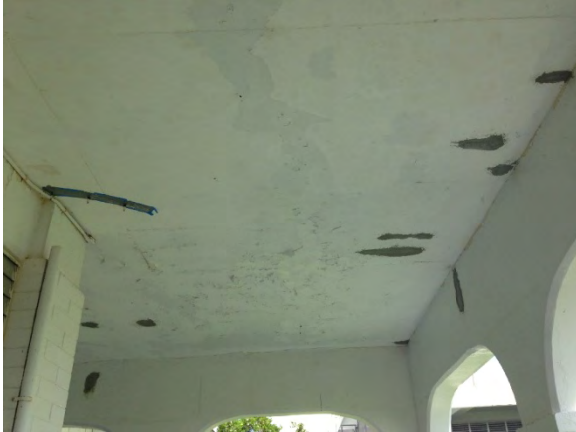
**13C. Inarajan Middle School – 15 – Rooms 45 - 46**

Crack and spalls repairs to the roof slab of this building were being completed during the Phase II assessment. These repairs have been completed and no problems were observed during the follow-up visit.

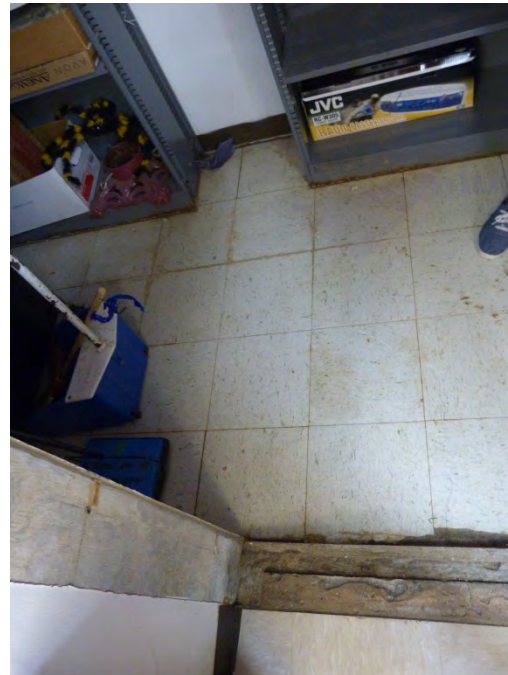
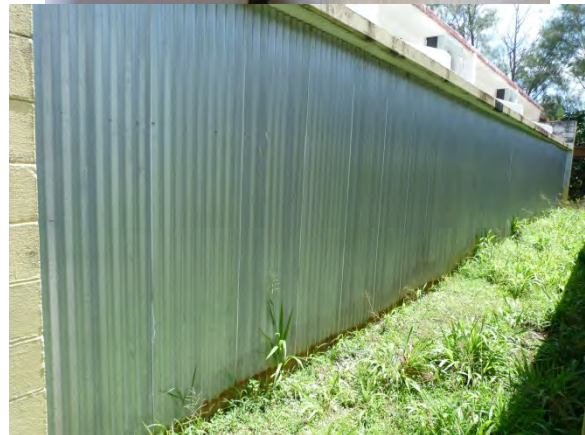
#### **14A. Truman Elementary School – 05 – Library**

In the past the exterior sidewalk adjacent to this building was enclosed to add internal space to the library. The resulting slab is lower than the adjacent original interior slab and is prone to flooding. The bottom of the exterior siding is also corroded where water tends to pond. It is recommended to raise the level of the slab at the lower area to match the adjacent slab and raise the base of the siding accordingly.

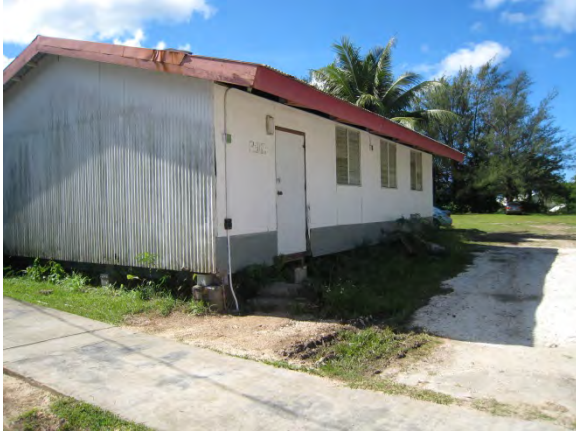
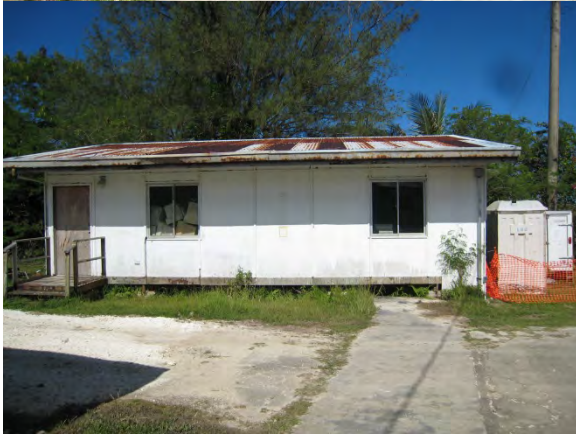
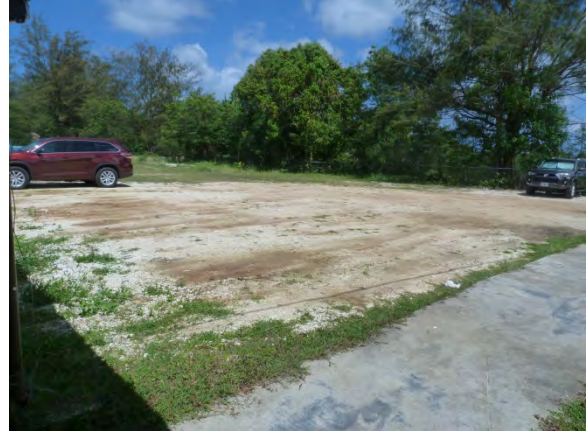
**14B. Truman Elementary School – 11 and 13 – Rooms 21 and 24, 25**

These buildings were demolished since the Phase II assessments.

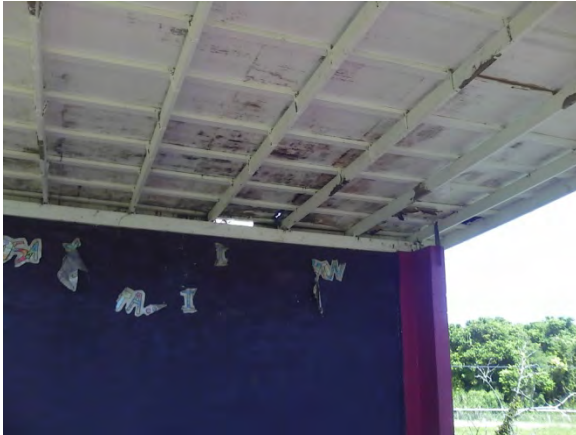
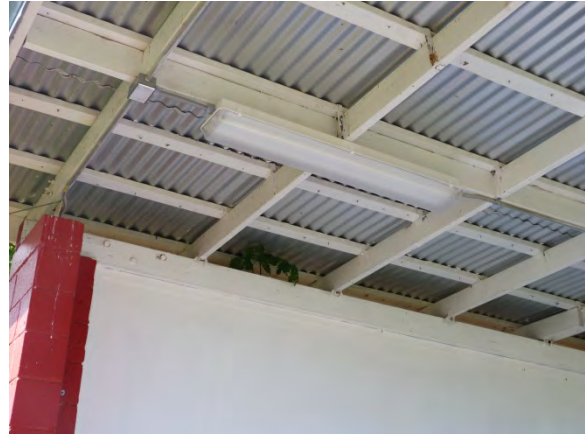
### **15A. Agueda Johnston Middle School – 06 – Stage**

The stage has been reroofed and roof framing replaced where necessary.

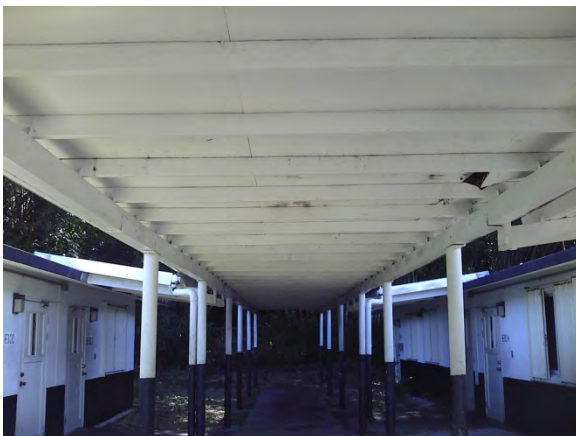
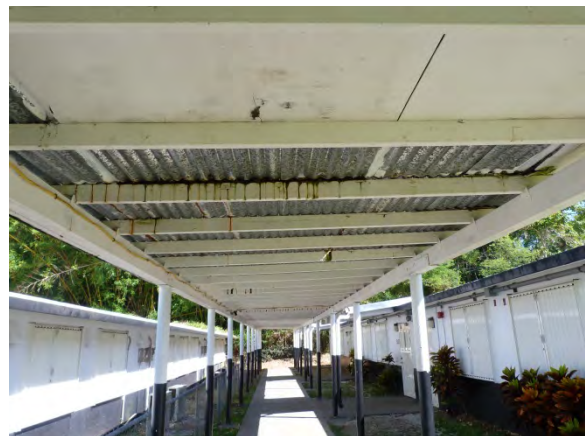
Phase II Site Visit (November 2012)

The covered walkways have areas of the roof that are corroded and subsequent localized decay to wood framing. The condition appears to have worsened since the Phase II assessment. It needs reroofing with isolated framing repair.
