INSULAR ABC'S INITIATIVE

Phase III Task 1 Findings and Recommendations

United States Virgin Islands

October 2015

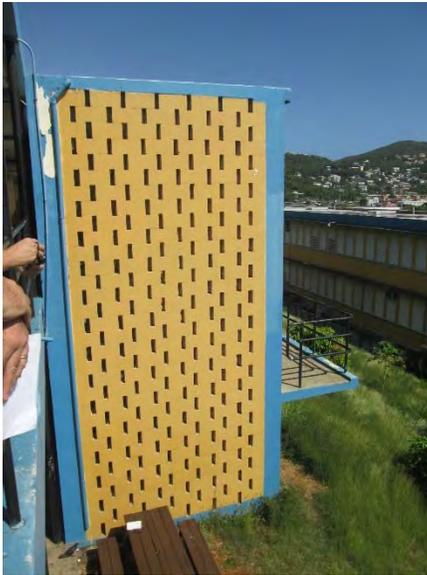
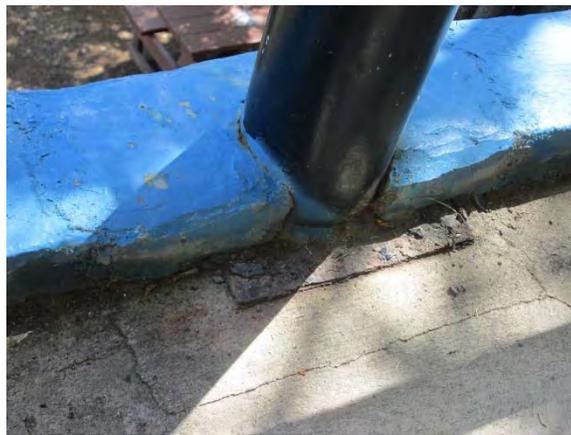
VIDE staff indicated that the roof over one of the exterior stairwells was removed due to excessive spalling. It was observed that this did occur. Removal of the roof is an adequate solution, although it does leave the students exposed to rain, and the stairs could potentially become slippery. In the future spall repairs should be conducted rather than removing the damaged element.

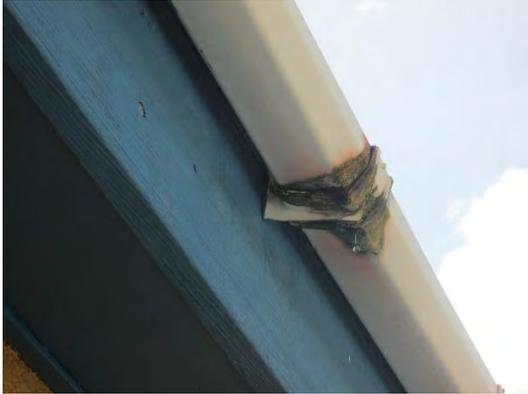
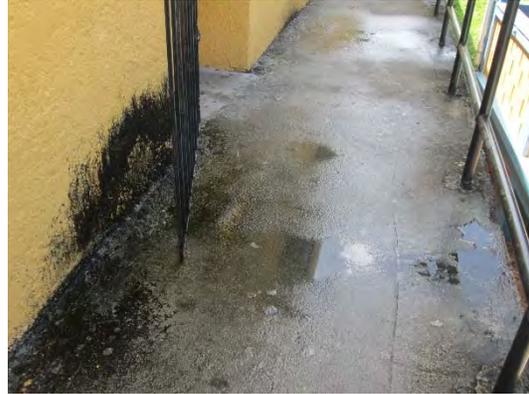
Building 19

Both of these buildings were observed to have easily repairable gutter and/or downspout issues that are causing damage to the building and potential Safety issues due to wet and slippery walking surfaces. At Building 19, the gutter connections are leaking, and at Building 21 the end of the gutter is missing, allowing water to pour over the building wall and exterior walkway surface. These gutter issues should be repaired.

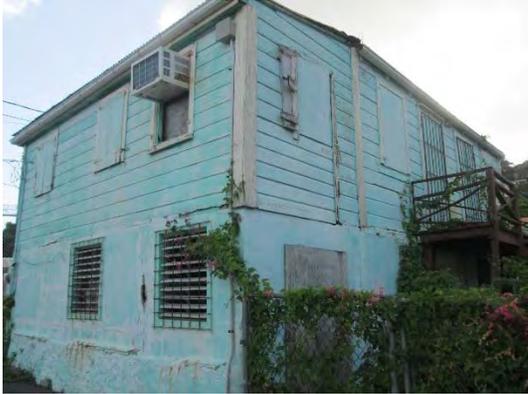
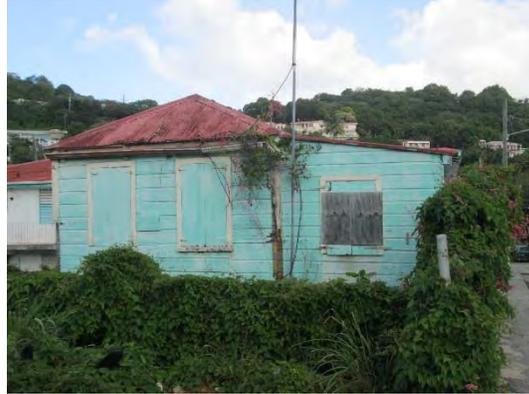
1. Building 2

This building was being used for storage and as a location for the school's IT equipment during the Phase 2 survey, but it was even at that time known to have structural problems and extensive roof leaks, which have cause damage to the building interior. They building is now not in use, and VIDE stated that they are aware that the building may be historically significant, so no renovation or demolition is planned until the building's significance can be accessed.

Re-survey of this building showed that while there is some damage to the building, mostly caused by the leaking roof, that the original portion and additions are fairly clearly defined, and that the building overall appears to have historical integrity. Further significance evaluations are recommended.

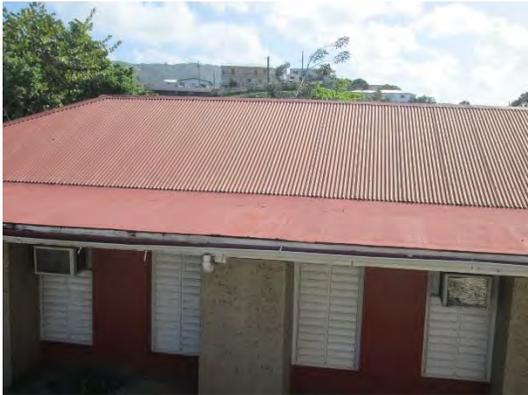
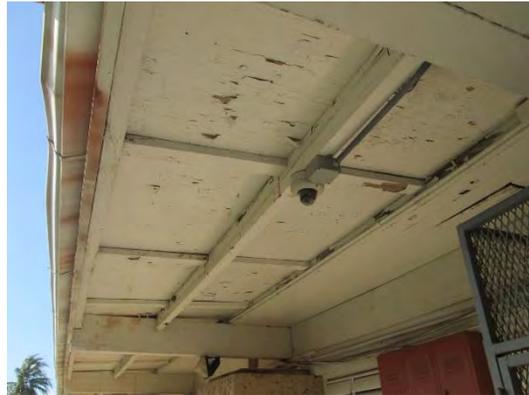
1. Classroom Buildings

The Phase 2 survey identified leaking roof issues, which were still present in the Phase 3 visit. Part of the problem at Buildings 2-6 and 13, 14 and 16 appear to be from the use of plywood as sheathing with no proper roofing coating at the exterior walkways/roof eaves. The plywood absorbs moisture, particularly at the ends, becomes warped, and allows moisture to enter the building along the top of the exterior walls.

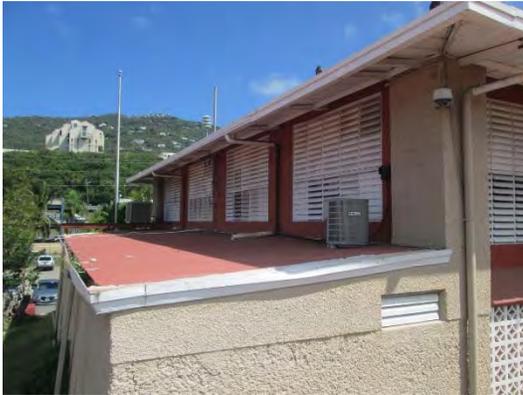
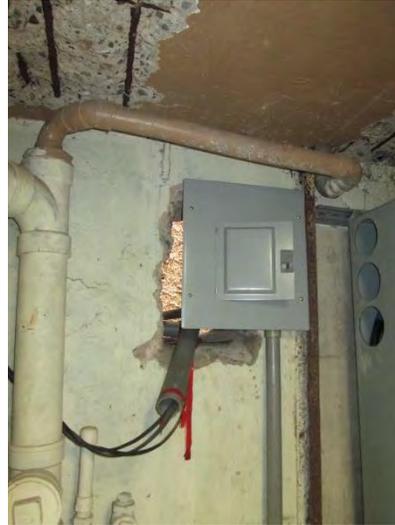
2. Buildings 8 and 9

Moisture is also entering the Library at Buildings 9 and 10, which has caused extensive formation of mildew, and the closing of the library. It appears the moisture is entering along the upper edge of the lower roof, in part due to missing flashing.

In addition, there is a large hole in the wall on the east side, which allows conduit to be run into the basement. This is allowing moisture (and vermin) to enter the basement, and is a contributor or perhaps the cause of flooding in the basement. Having the electrical equipment in an area that floods is a safety hazard. The electrical equipment in the basement should be relocated, and the hole should be closed up.

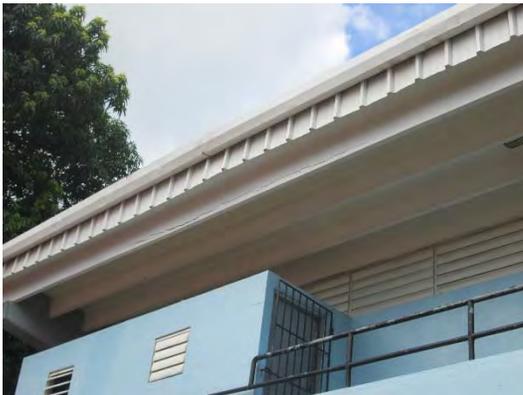
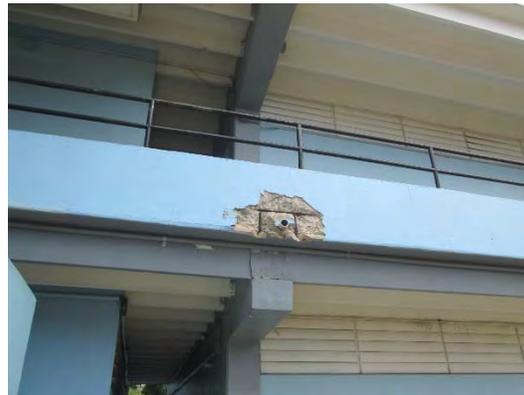
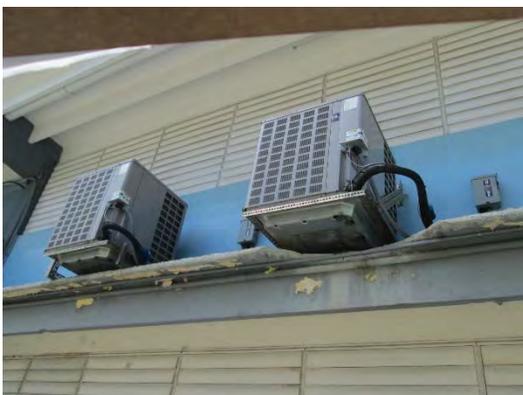
1. Buildings 3, 4 and 5

The Phase 2 survey identified some spalling issues, but it appears that the spalling has increased and now poses a safety hazard. The spalling areas should be repaired to prevent injury.

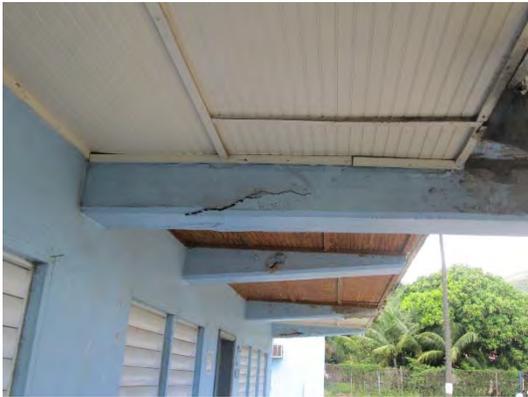
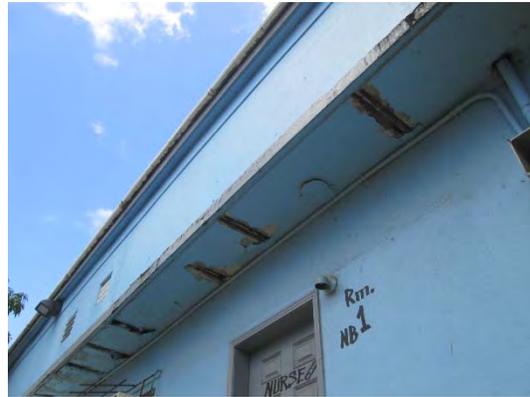
At Building 5, there is also a large crack all the way through one of the cantilevered concrete beams supporting the second floor exterior walkway and the stair. This is a safety hazard and should be immediately repaired.

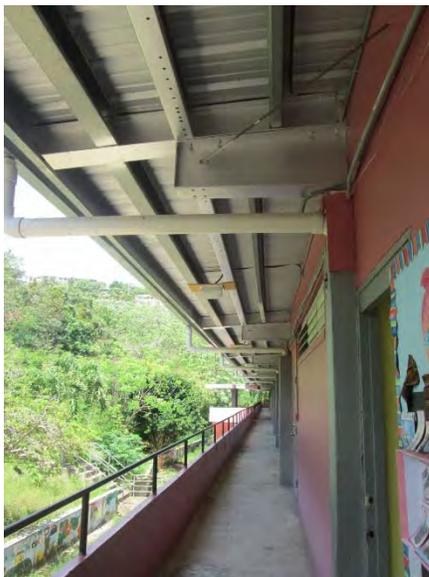
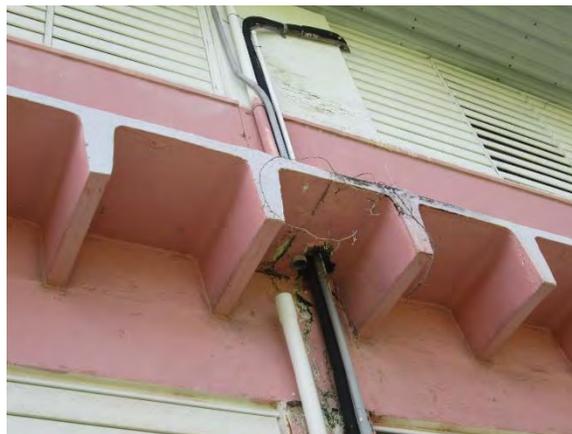
1. Building 4

This VIDE reported that a building soffit had collapsed at one of the buildings, injuring a teacher, and that the soffit had since been repaired. The school was visited to view the repair work and to see if any other repairs were needed to address any future danger. It appears that the entire soffit was removed and new eave supports were installed. The repair appears to be thorough and there is no additional danger from the soffit. Some of the gutter and downspout issues noted in the Phase 2 survey have since been corrected, but there are still some problems, like a disconnected downspout allowing roof runoff to run onto the outside of the building.

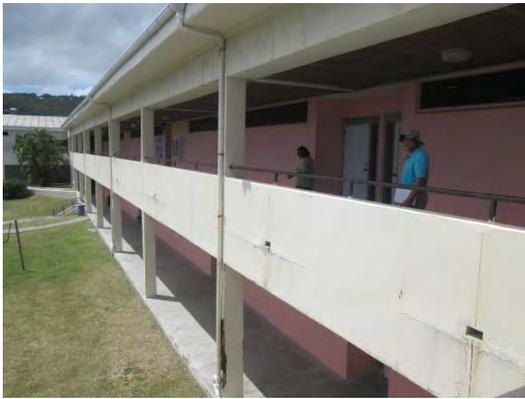
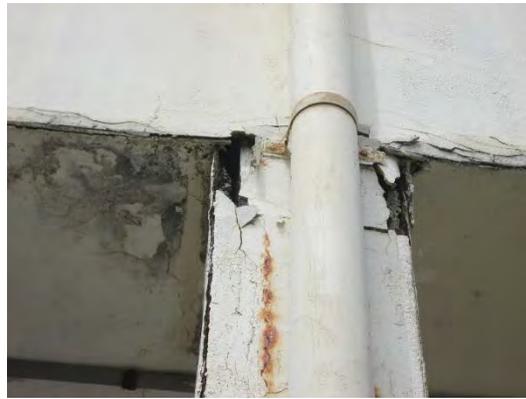
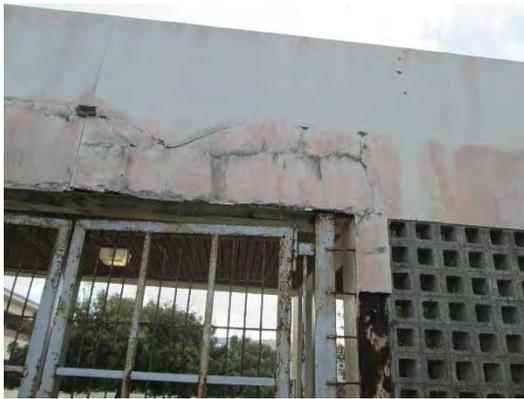
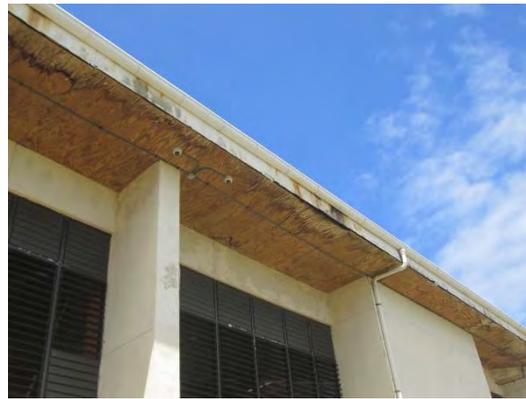
This school is predominantly constructed of steel framed buildings with an EFIS exterior finish on a metal wire mesh attached to the structure and to metal studs. During the Phase 2 survey, it was noted that the EFIS exterior finish was beginning to fail in several areas, and pieces had fallen off in a few locations. Prior to the Phase 3 site visit, the VIDE expressed that some repair work had been done at the exterior soffits, as a result of portions of the siding falling off, and that the remaining siding was continuing to fail. The Phase 3 site visit confirmed this to be the case. In several locations the EFIS finish had been removed at the soffit, and typically unpainted plywood has been installed in its place. The plywood typically also shows some water damage, and may eventually also be a safety hazard. It is only a matter of time before exposure to moisture causes severe damage to the building structural systems. The exterior finish at these buildings should be removed and replaced.

During the Phase 2 survey, it was noted that the EFIS exterior finish of most of the buildings on the campus was beginning to fail in several areas, and pieces had fallen off in a few locations. The Phase 3 assessment confirmed the condition has continued to worsen and more of the exterior finish is failing. The failure appears to be due to moisture and salt penetrating the finish material, either through cracks, joints, or due to a lack of a waterproofing membrane. The moisture then rusts the steel mesh and other steel components, causing the surface material to crack and fall off. In some areas entire panels have fallen due to the rusting of the metal connectors and furring components.

- In areas where no cracks or damage are visible, and there is no sign of moisture infiltration, coat the outside of the EFIS finish with an elastomeric to help keep moisture from penetrating.
- In cracked or damaged areas, remove all plaster
- Treat steel components that retain integrity with a rust-preventing compound
- Replace any steel components that have lost integrity
- Install new plaster finish with a moisture barrier
- Coat exterior of plaster finish with elastomeric

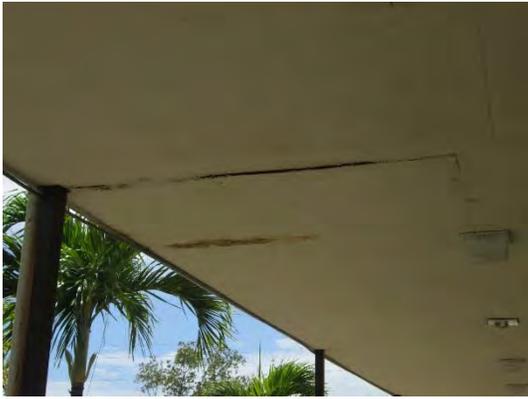
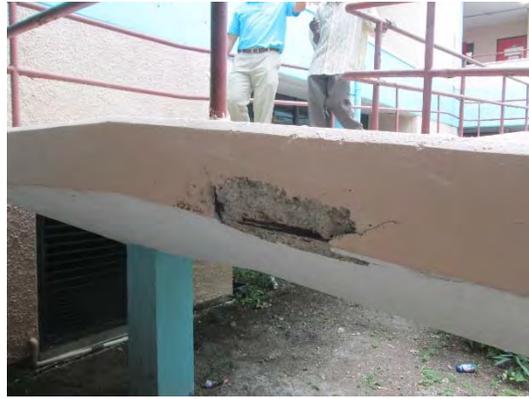
The survey team visited this school to address some MEP issues, but while there it was observed that the plywood ceiling at the entry walkway has incurred some water damage and is becoming disconnected from the structure. The ceiling could possibly fall onto someone below, and is a safety hazard.

It was also noted at the ramp in one of the courtyards that the concrete ramp wall is spalling.

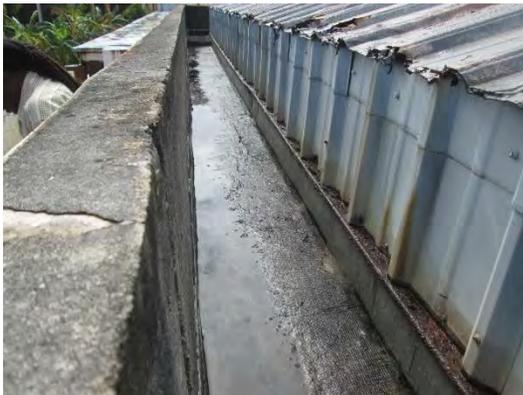
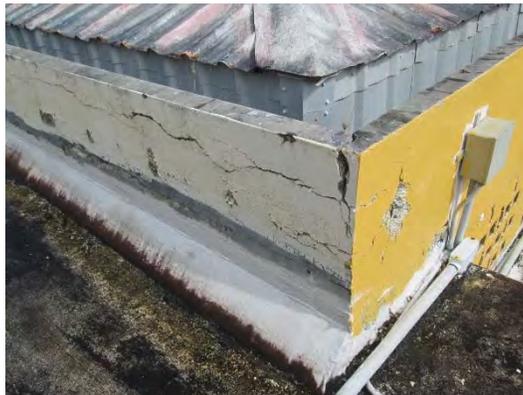
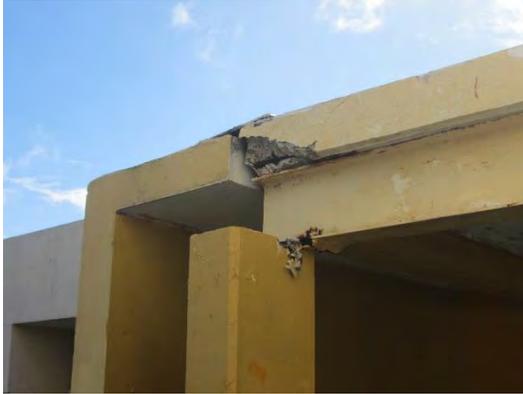
The VIDE expressed concern about this school for several reasons: the deterioration of some of the steel structural elements, and leaking at the roof, which has caused interior damage and extensive mildew. The Phase 3 site visit revealed that the steel structural elements are continuing to deteriorate, some to the point of being a safety hazard. The structural report has additional analysis and recommendations for the steel elements.

At the roof, some of the metal roofing panels are heavily deteriorated at the end, and have rusted so far up the panel that moisture is getting behind the vertical wall finish. Also, the downspouts in the large concrete gutters are clogged, which is causing water to back up in the gutters. This may also be causing water to get into the building interiors. The concrete gutter wall is spalling in several areas, as is the concrete roof slab. The spalling concrete is a safety hazard and should be repaired.

The buildings at this campus have several issues; many of the steel beams supporting the roof structure are exposed, and in several locations the steel beams have severely rusted to the point of losing integrity and the ability to function as required. See the structural engineer's write-up for the repair and replacement of these elements.

In addition, in several locations the metal roofing is rusting at the edges, in some areas it has rusted beyond the wall finish below, allowing water to easily enter the building. Some of the concrete gutters have clogged drains, and are often full of standing water, possibly also causing interior building leaks. Some of the concrete gutter walls are beginning to crack and spall.

- Where metal roof edge is just starting to rust, treat with a rust-preventing compound
- At areas of metal roofing where the rusting is significant (1" or more from edge), install a new piece of metal roofing underneath the existing roofing. New roofing should extend at least 24" into building past wall below, and should extend at least 3" beyond outside surface of exterior wall. Install connectors as required
- Repair cracked and spalled concrete areas by removing loose concrete, removing rust from exposed steel reinforcing, and patching with new concrete.

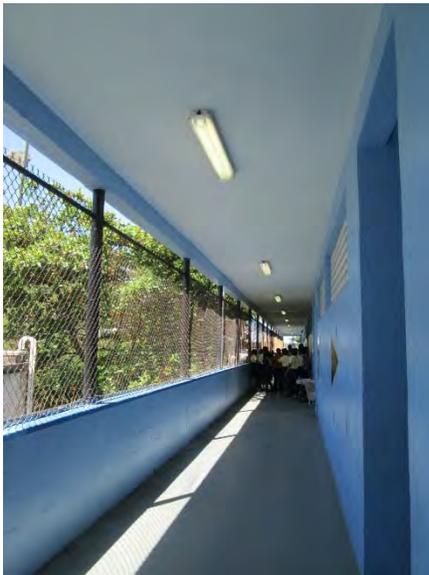
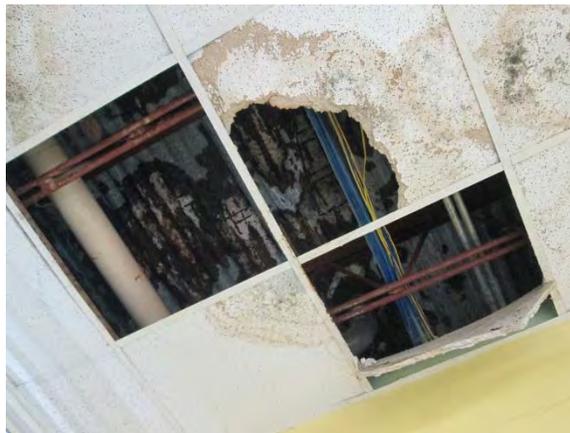
The Phase 2 survey revealed extensive concrete spalling at Building 5 (B). In 2014 a construction project was undertaken to repair the spalls. Survey of the building in the Phase 3 visit, as well as review of the construction documents, confirmed that the repair work was successfully accomplished.

The roof of this building is still leaking, causing damage to the ceiling tiles and other interior finishes, as well as creating puddles on the floor and possibly damaging the electrical wiring. Access to the roof was not available at the time of the survey, so further investigation was not possible during this visit. It is suspected, however, that the roof drain may be leaking where the drain sits in the roof structure.

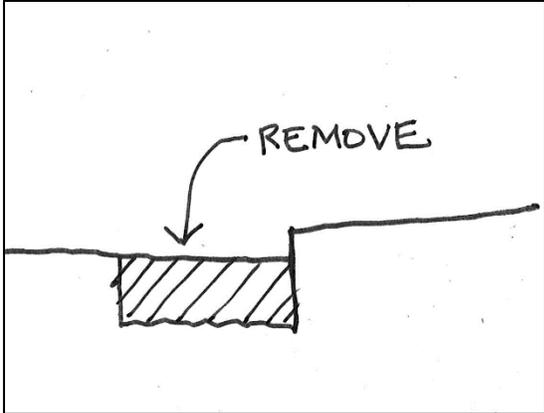
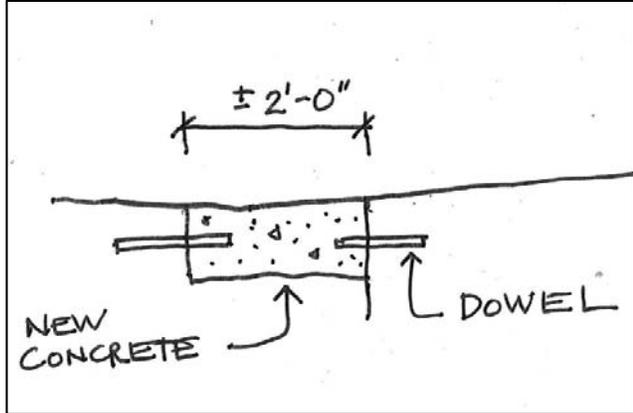
The concrete surface at several ramp and walkway surfaces are in poor condition and are a hazard for tripping. There are holes, spalled areas, rough edge transitions, and unsafe edge conditions.

Where holes or spalled areas have formed, remove all loose concrete and clean area/hole. Patch area with new concrete, ensuring that edges are smooth.

Where uneven edges at transitions are large enough to cause tripping hazards, simply adding a patch along the edge will typically eventually delaminate, and a new transition must be created.

- Sawcut at least 1" deep of concrete across slab at joint, more if doweling is needed. Cut strip wide enough to create smooth transition, at least 2 feet wide if doweling.
- Remove concrete
- Patch to two existing sides, inserting dowels if needed, and creating smooth transition at each edge.

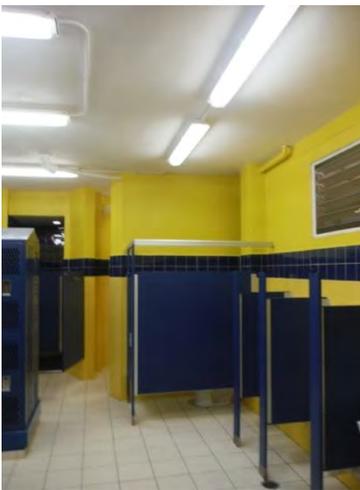
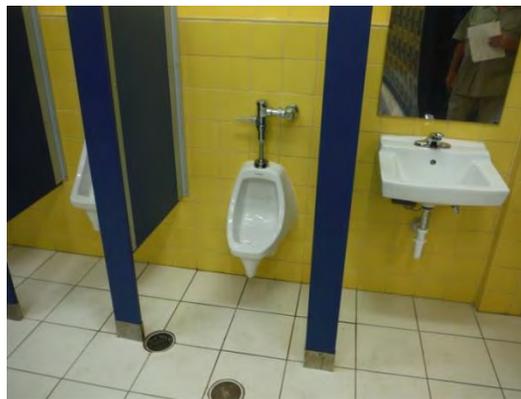
- A. Charlotte Amalie High School
 - 1. Building 14

Locker / restrooms were renovated. All plumbing fixtures, ventilation and lighting systems were satisfactory.

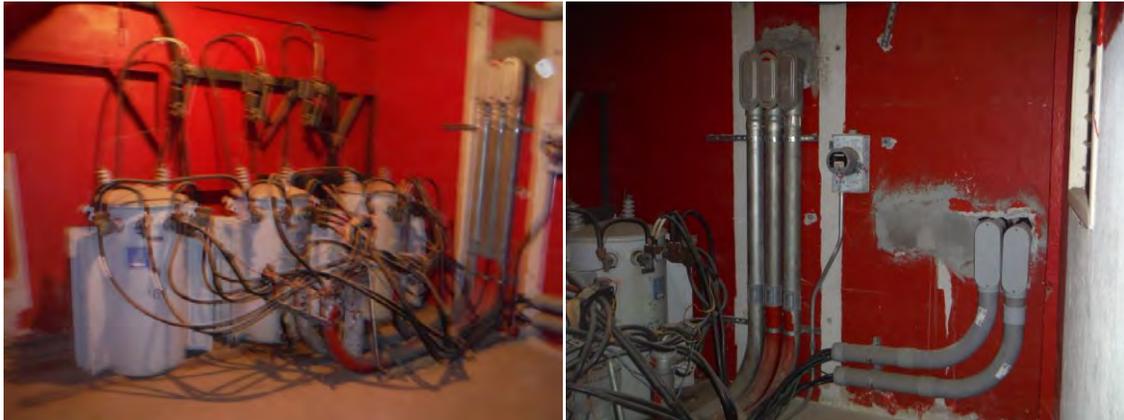
4. Electrical System

Transformers are inside a room at the lower level of the cafeteria building. An enclosed corridor has been added to the front of the transformer room. The electrical room is adjacent to the transformer room with unsealed openings.

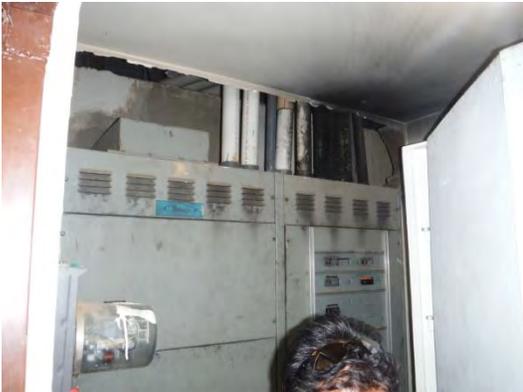
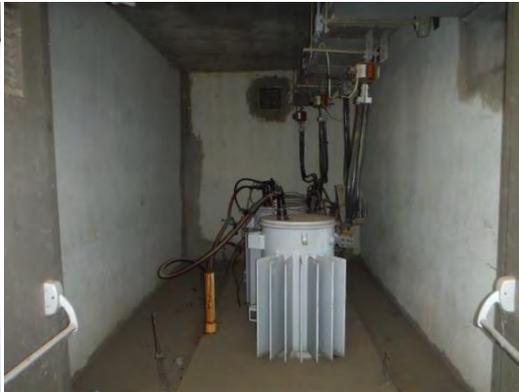
2. Electrical system

Transformers are located inside a room which has openings in the wall directly adjacent to the main electrical room. Main distribution panel has burn marks.

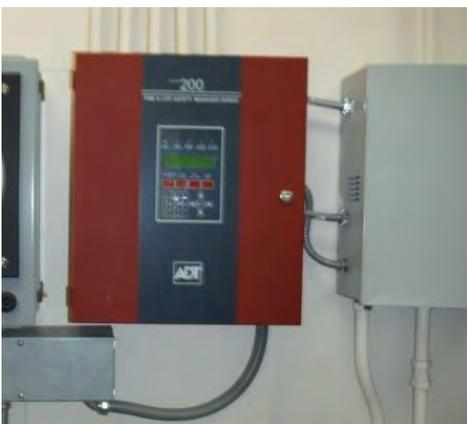
OIA Phase II survey found the fire alarm devices were inadequate. Since the Phase II assessments, the fire alarm was upgraded and now is in good operable condition.. The time and date of the fire alarm panel was inaccurate and should be corrected and be upgradable for future voice communication.

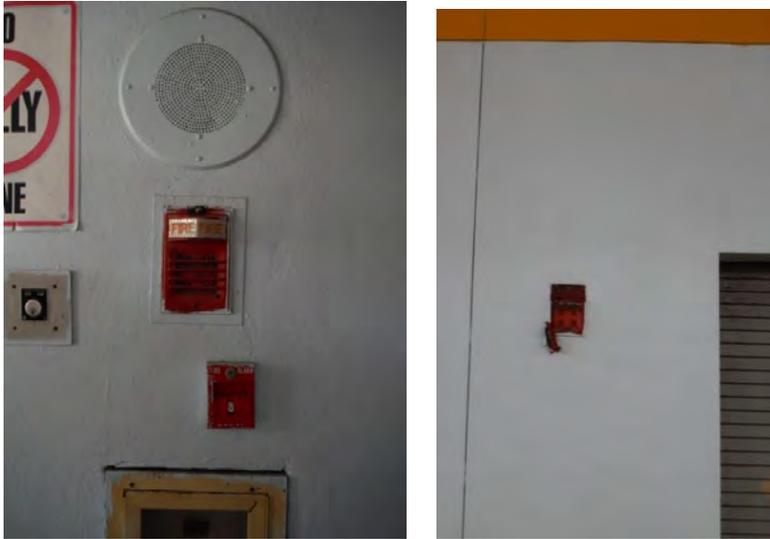
OIA Phase II survey found the fire alarm system was inoperable. The fire alarm was still inoperable at the start of Phase III. Fire alarm panel was silenced and had numerous trouble and alarm signals. Defected manual pull stations and fire alarm devices need to be repaired or replaced. These pose safety hazards to occupants. Fire alarm system should be serviced and repaired and be upgradable for future voice communication.

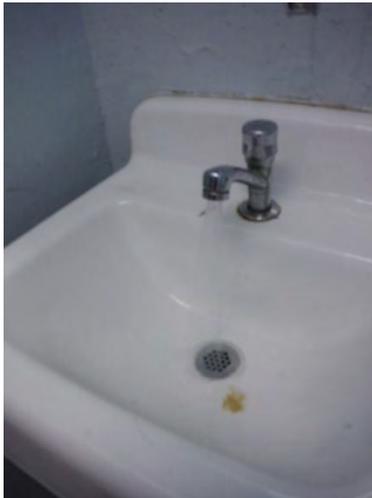
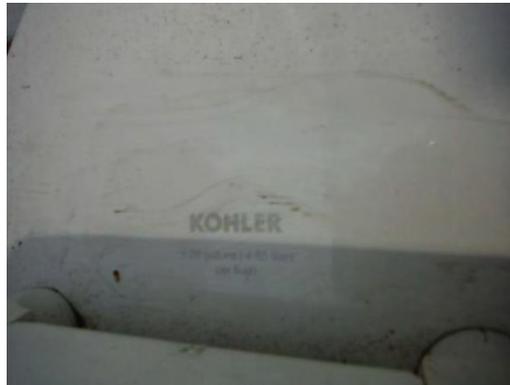
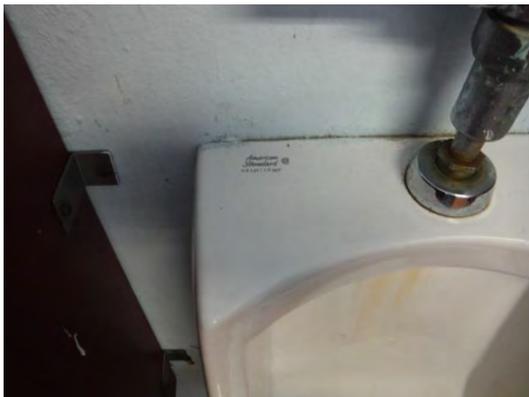
2. Low flow plumbing fixtures

Low flow fixtures were installed in portion of the school. At Building 01, push button faucets with aerators and 1.28 gallon per flush (gpf) water closets were installed. However, urinals were 1.0 gpf.

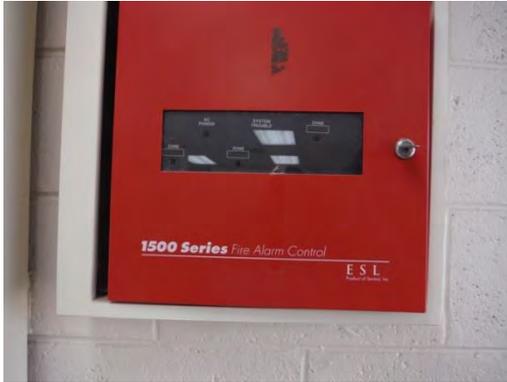
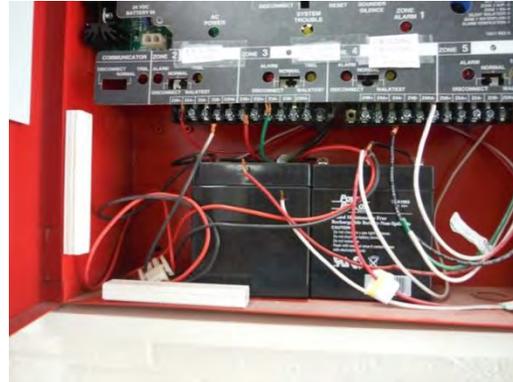
H. John Woodson Junior High School
1. Fire alarm system

OIA Phase II found the fire alarm system was inoperable. At the start of Phase III, the fire alarm system remained inoperable. Fire alarm panel power was off, wires were removed from the fire alarm panel terminals, and batteries were disconnected. Defected manual pull stations were not repaired or replaced. These are safety hazards to the occupants. Fire alarm system should be serviced and repaired and be upgradable for future voice communication.

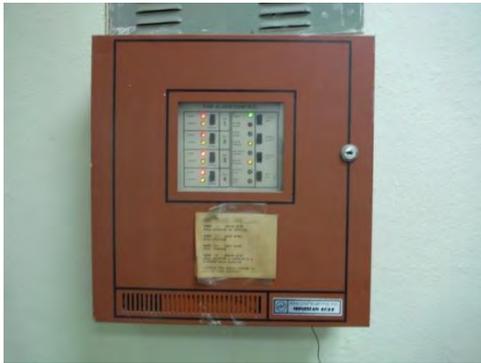
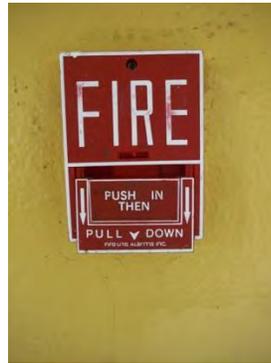
1. Fire alarm system

OIA Phase II found the fire alarm system was inoperable. At the start of Phase III, fire alarm system remained inoperable. Fire alarm panel had numerous trouble and alarm signals. Defected manual pull stations were not repaired or replaced. These pose safety hazards to the occupants. Fire alarm system should be serviced and repaired and be upgradable for future voice communication.

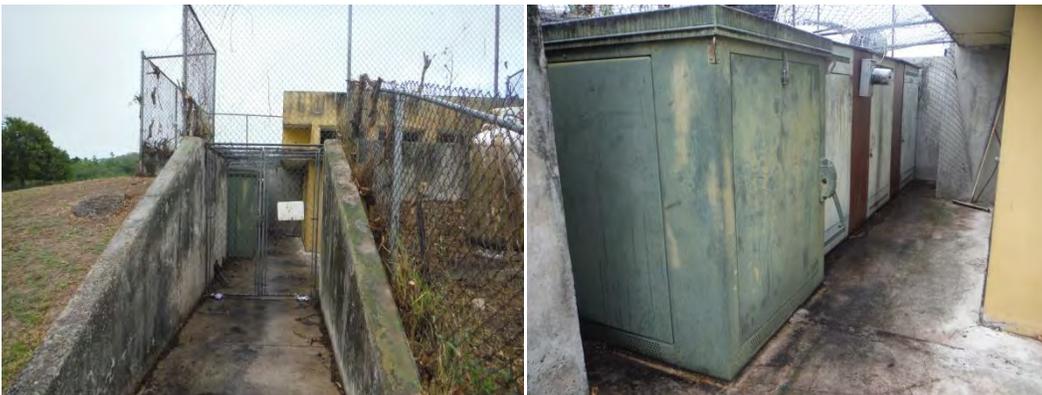
4. Electrical system

WAPA transformer installed in poor location and should be relocated for better access and safety.

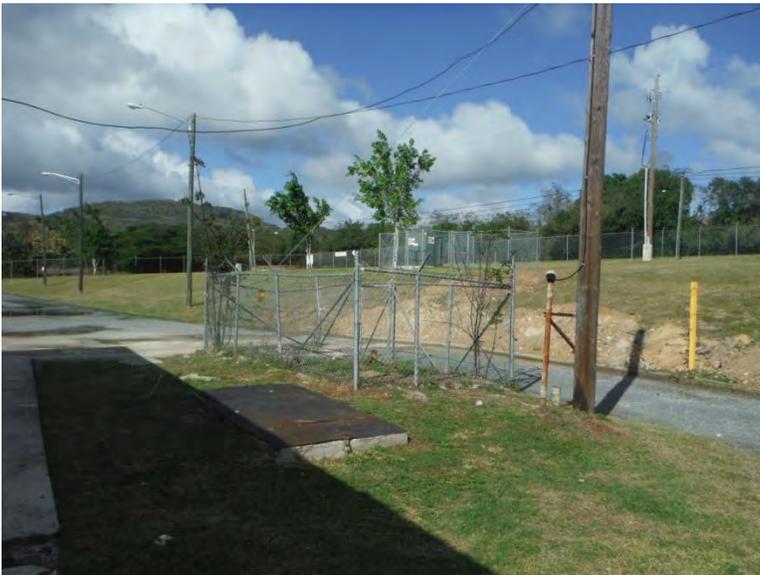
2. Electrical system

New WAPA pad mounted transformer installed above roadway and old transformer removed within fenced area.

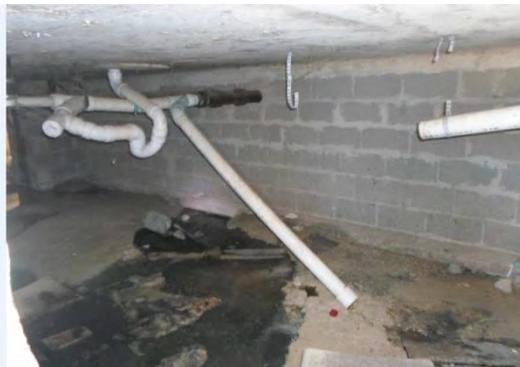
4) Pipe supports

Piping, and ducting and equipment should be proper to support and secure against gravity, vibration, thrust, expansion and seismic loads.

Location: Charles Emanuel ES Building 01, Library & Cafeteria.

Waste piping was separated due to snapped pipe stripe supports causing waste spilled inside the crawl space.

- Use proper anchor, hanger and pipe support system, such as steel rod, ring hanger, clevis hanger, and trapeze hanger.
- Use corrosion resistant material and coating for pipes and supports at humid and corrosive environment.

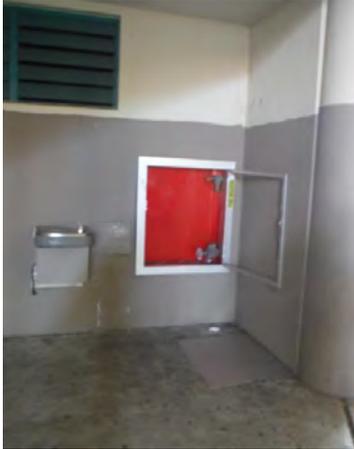
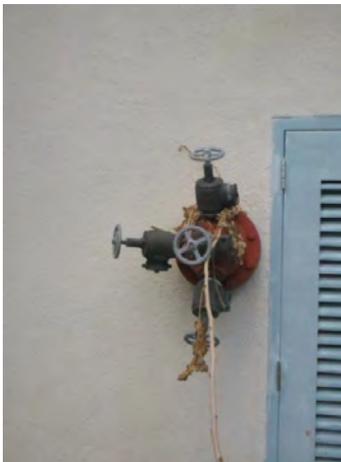
Location: St. Croix Educational Complex

Wet based fire protection systems including fire sprinkler, standpipe and fire pump were not maintained and tested in accordance with NFPA standards. Fire hoses were missing at fire hose cabinets. Sprinkler risers were obstructed by combustibles materials. Flow test header and fire pump were not maintained and tested. Fire protection systems are fire and life safety systems to protect the occupants and the properties. They should be maintained and serviced regularly to ensure their functions and performance. They should be repaired as soon as impairment is required.

- Provide regular maintenance to the water based fire protection systems in accordance with NFPA 25.
- Conduct regular tests and fire drills; invite and coordinate fire department participation.
- Establish fire safety awareness program to promote fire safety awareness to the staff and occupants.

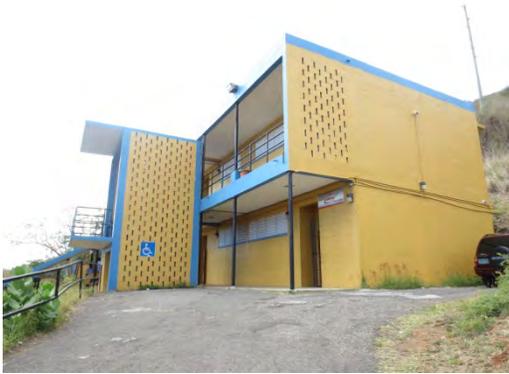
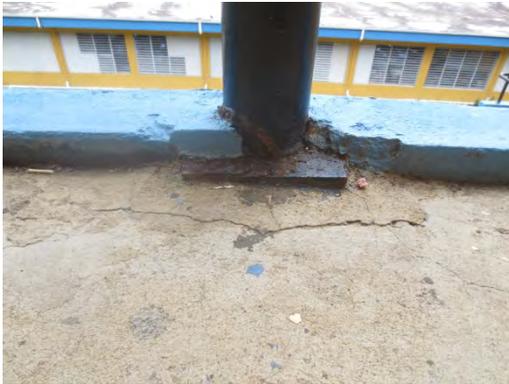
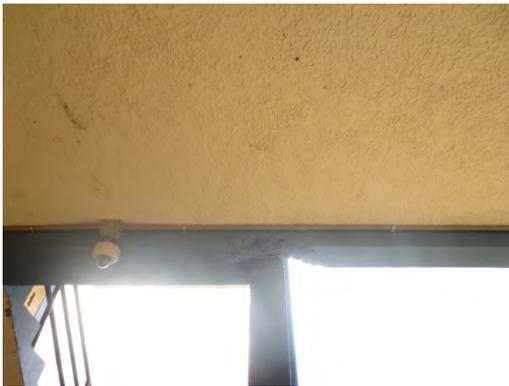
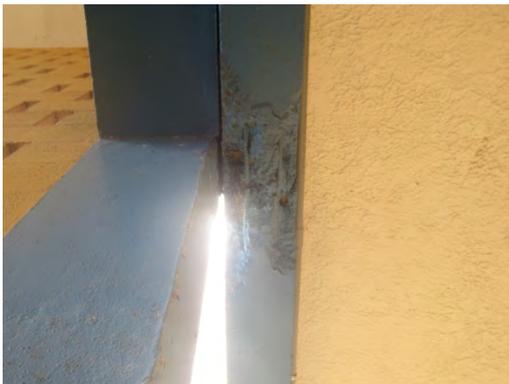
Phase II Site Visit (March 2013)

CHARLOTTE AMALIE HIGH SCHOOL BUILDING 10 COMPLETED REPAIRS

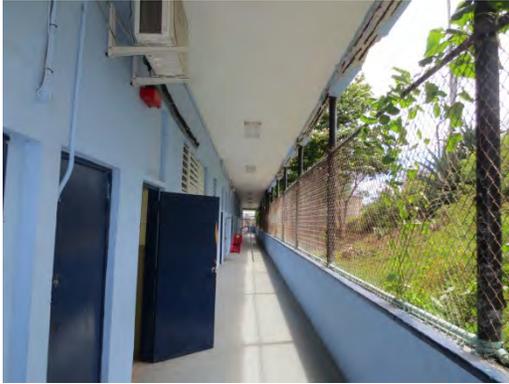
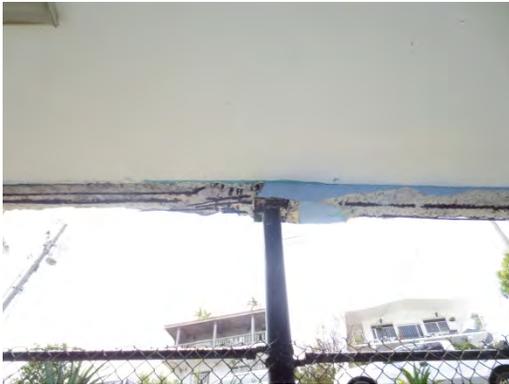
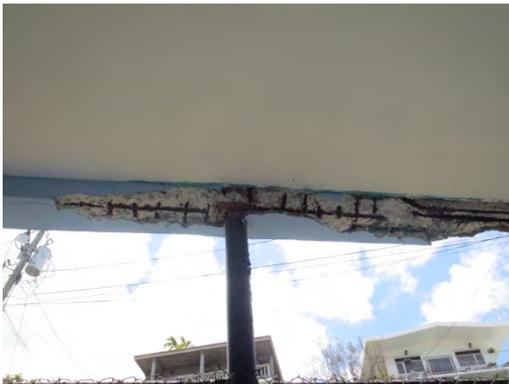
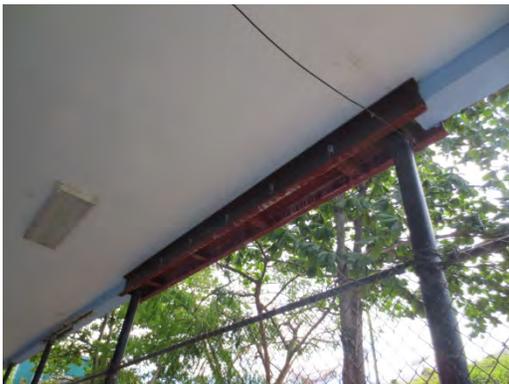
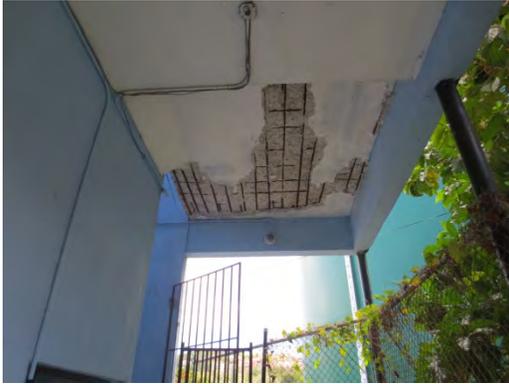
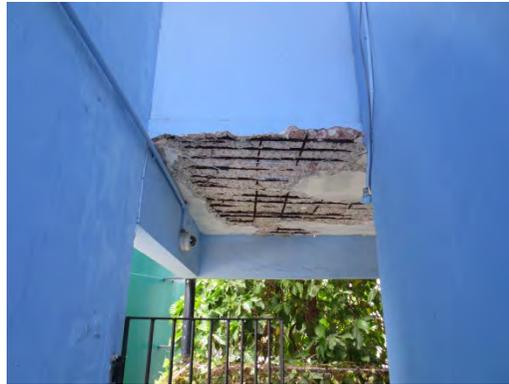
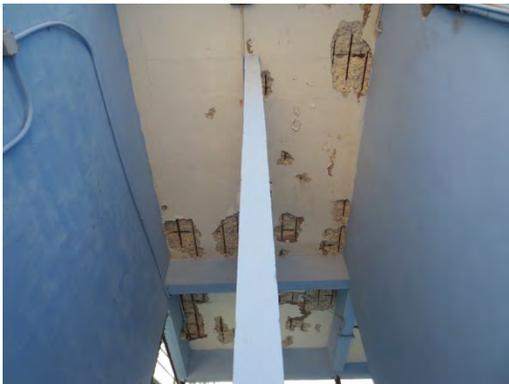
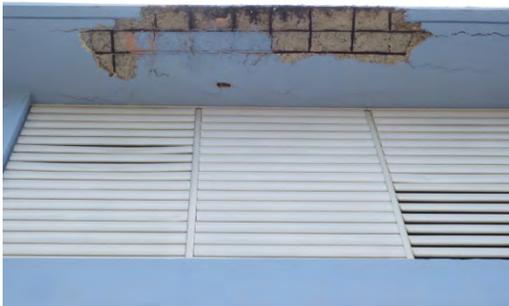
Phase II Site Visit (March 2013)

JULIUS SPRAUVE SCHOOL BUILDING 5 COMPLETED REPAIRS

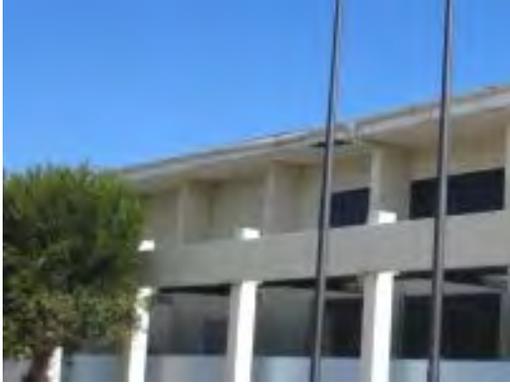
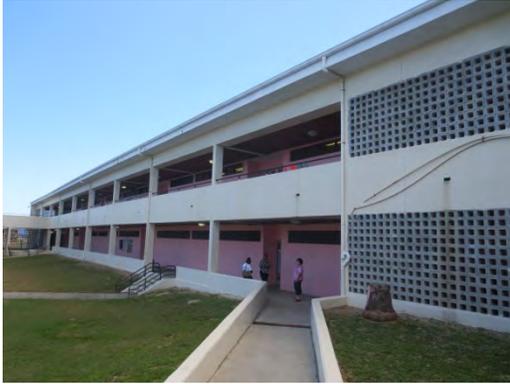
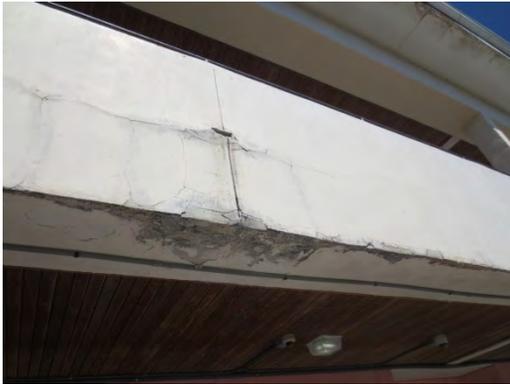
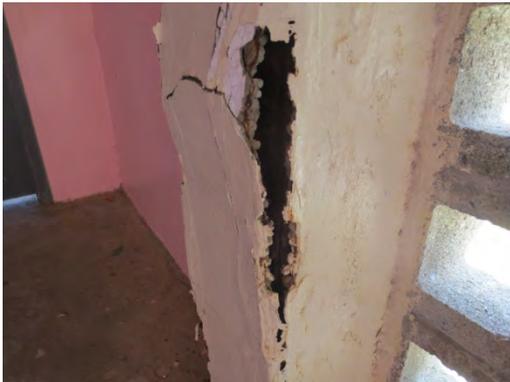
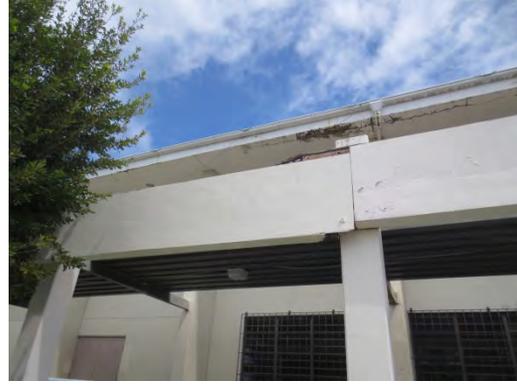
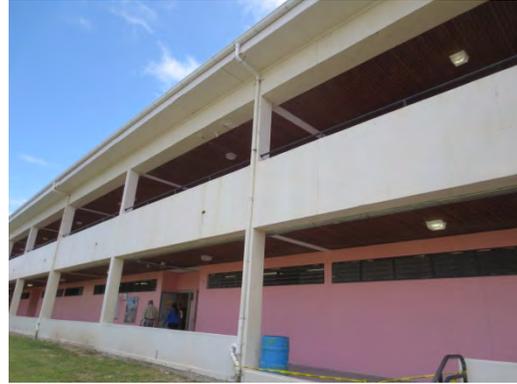
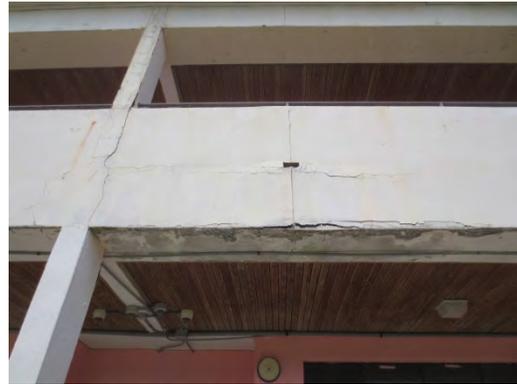
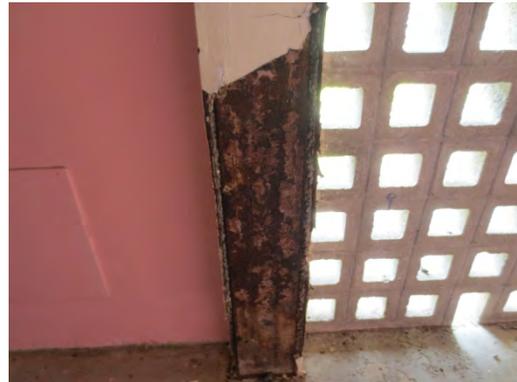
ELENA CHRISTIAN JUNIOR HIGH SCHOOL BUILDINGS 1 THROUGH 6

During the Phase III site visit (March 2015), it was confirmed that the damage to the non-structural cladding has progressed and worsened. The cladding material appeared warped and in some cases the seams between adjacent cladding panels have come apart creating an avenue for moisture and salt to penetrate through the envelope and reach the structural steel. Progression of the damage was most apparent at the trellis in front of the Building 2 (Library Building) and at the facades of Buildings 4 (Classroom Building) and 5 (Classroom building) facing the interior courtyard.

It was also apparent that repairs to the non-structural cladding had been performed, especially on the side of a second floor spandrel beam at Building 5. It was reported by VIDE personnel during the visit that a large portion of the cladding at this location had recently fallen and damaged a metal railing on the ground floor below.

In terms of structural damage, it was observed that corrosion to exposed structural steel members has continued to develop since the Phase II visit. Increases in corrosion were most evident at two ground floor columns at Building 4 and at several columns on the walkway connecting Buildings 4 and 5. Although damage to the exposed structural steel members has increased, no members with severe loss of cross section were observed. Consequently, no structural life safety flags were added to any of the buildings on this campus.

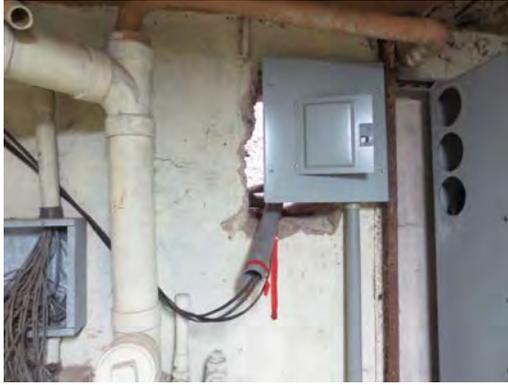
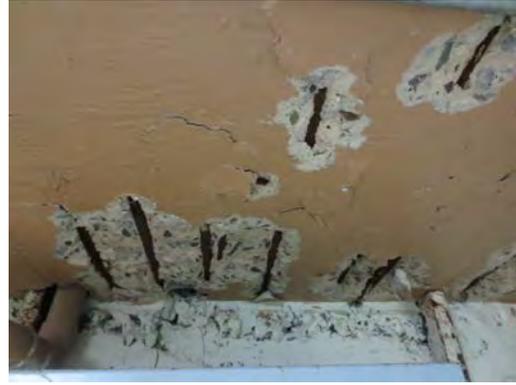
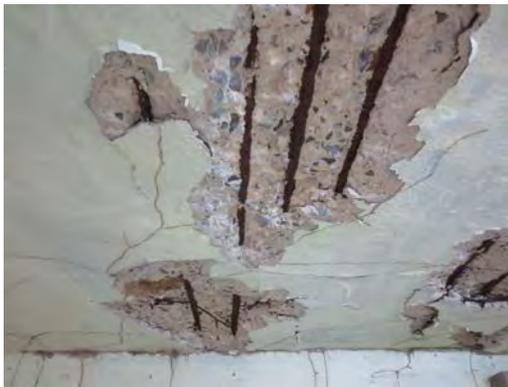
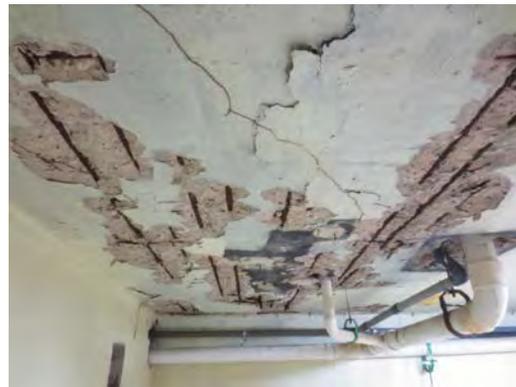
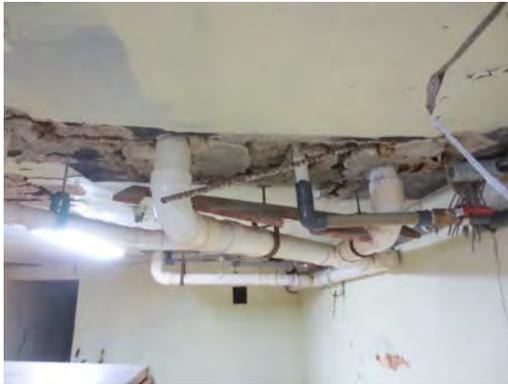
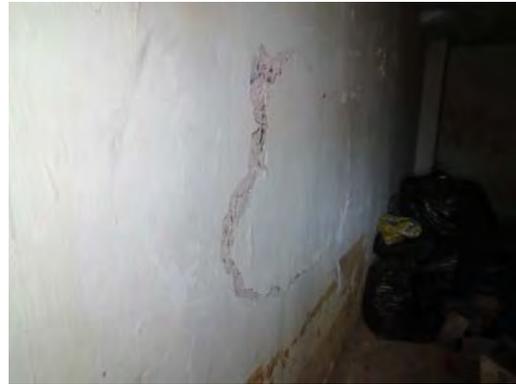
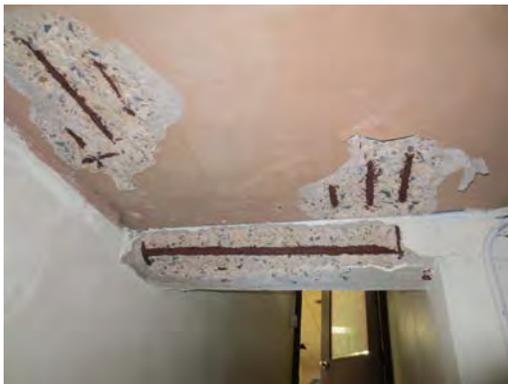
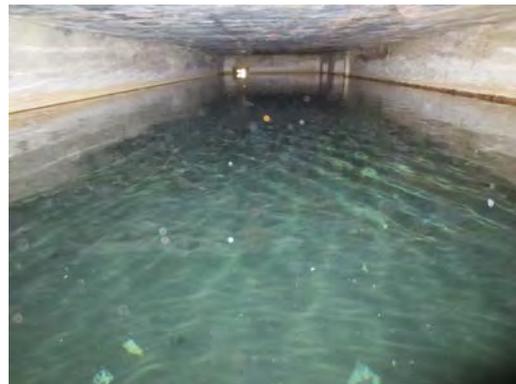
ADDELITA CANCRYN JUNIOR HIGH SCHOOL BUILDING 8

The basement is divided in two areas: one on the west end of the building under the library and one on the east end of the building under administrative offices. Both basement areas are independently accessed and there is no direct connection between the two. On the west area of the basement, moderate spalls were observed on the underside of the first floor slab and beams. Reinforcing was found exposed and moderately corroded. Two thirds of the west portion of the basement house a cistern that, although full of water, is reported to be abandoned. Only a small spall was observed on the underside of the slab above the cistern. The condition of the retaining walls and slab-on-grade at the cistern could not be assessed due to the water.

On the east area of the basement, moderate to severe spalls with exposed reinforcing were observed throughout the underside of the first floor slab. The spalls were extensive and in some cases, the reinforcing bars (bottom bars) have totally corroded away leaving the slab unreinforced for large portions along its span. An area of severe spalling was also observed on an area of the slab where utility piping has been run through the slab. The perforations for the pipes are oversized and reinforcing that was cut was not adequately trimmed back and patched. Hence, slivers of slab in between the pipes have spalled and broken apart from the slab. A large spall was also observed at one of the retaining walls. No damage was apparent on the top of the slab-on-grade. It was reported by the principal that the east portion of the basement floods regularly (an over-sized and unsealed utility opening was found on the top of one of the walls).

- 05 At the west portion of the basement, patch all concrete spalls per approved concrete repair procedures.
- 06 At the east portion of the basement, shore portions of the slab where bottom-reinforcing bars have lost more than 20% of their cross section.

- 07 At the west portion of the basement, patch all concrete spalls per approved concrete repair procedures. Replacement of bottom bars may likely be required over large portions of the slab where existing bars have lost more than 20% of their cross section. Where spalls occur around pipe penetrations, it is recommended that portions of the slab around the pipes be saw cut and replaced.

- 08 A licensed structural engineer shall design all concrete repair details and prepare all required specifications.
- 09 Address drainage issues at trench between the east portion of the building and the adjacent 2-story access ramp structure per Civil Engineer's recommendations.
