INSULAR ABC'S INITIATIVE

Phase III Task 1 Findings and Recommendations

United States Virgin Islands

October 2015

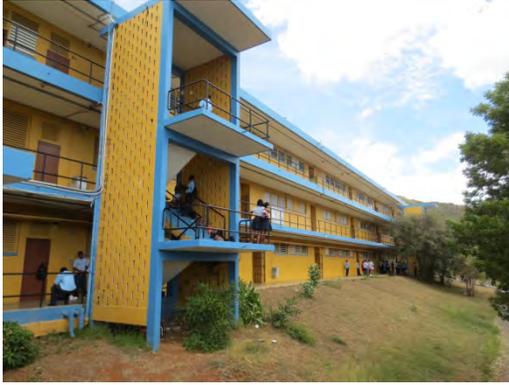
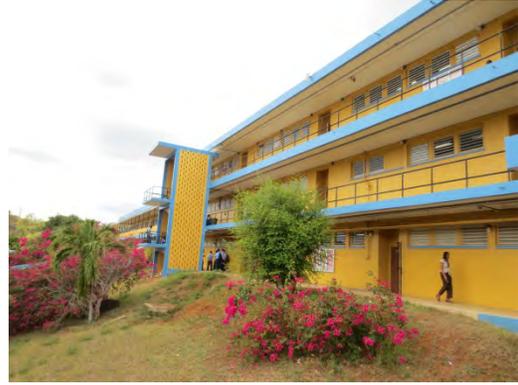
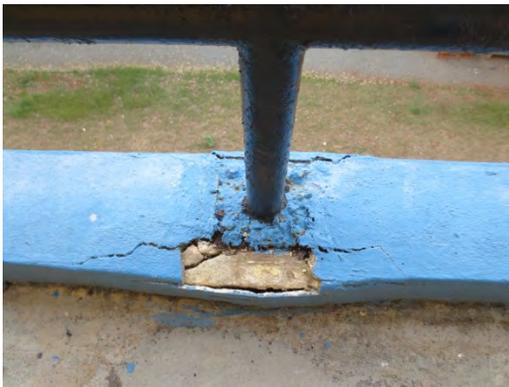
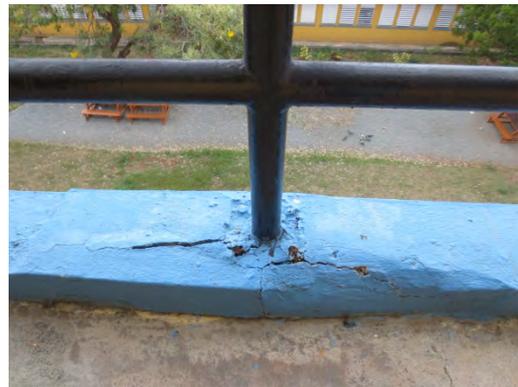
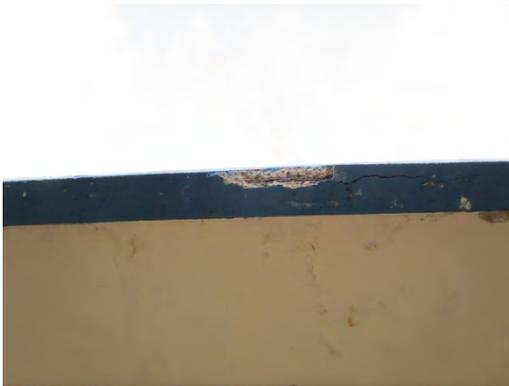
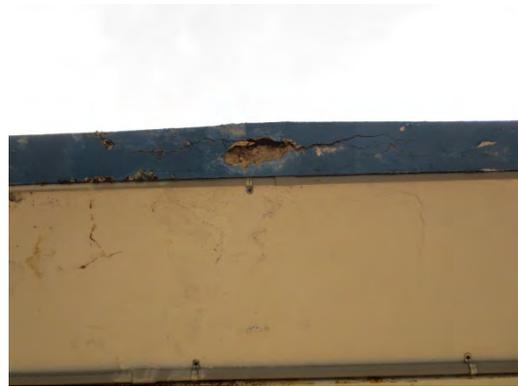
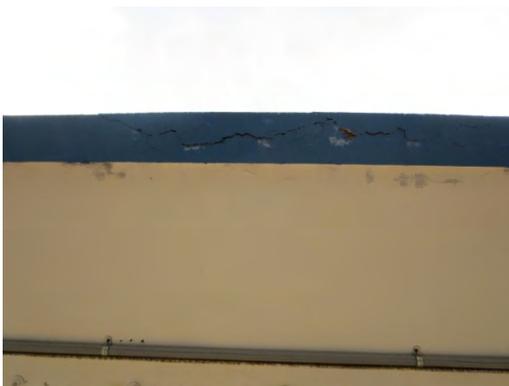
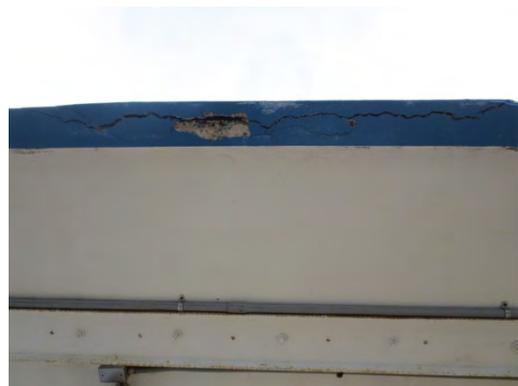
CHARLOTTE AMALIE HIGH SCHOOL BUILDING 11

It was observed that at the second and third floors, the base of the metal railing posts at the walkways has corroded and initiated spalling of the slab edge. The extent of the spalls (open and closed) varies depending on location along the building length. The spalls are likely caused because the base plate at the bottom of the railing post is embedded on a concrete curb at the edge of slab instead of being raised above the top of the curb. With the current post base detail, water ponds on top of the curb and accelerates corrosion of the post base plate. These spalls were identified as a life safety concern because they pose a falling hazard to the occupants of the building.

- 01 Conduct a survey of all cracks and spalls (open and closed) on the underside and edges of the floor and roof slabs along the south side of the building, particularly near railing post connections.

- 02 Fill all cracks and patch all spalls on the underside and edges of the concrete floor and roof slabs per approved concrete repair procedures. At spalls coinciding with locations of railing posts, clean the post base plate and its fasteners free of rust and replace curb reinforcing bars as required before installing patch material. Note that since the base plate of the railing post will remain prone to corrosion damage due to its elevation with respect to the top of the curb, this spall repair solution will only provide a short term solution.

- 03 As a long term consideration, replace the railing (or bottom portions of the posts and base plates) such that the post base plates are raised from the top of the curb via a grout bed.

- 04 It is recommended that the railing, particularly the posts and their base plates) be coated with a paint system appropriate for highly corrosive environments.

- 05 A licensed structural engineer shall conduct all surveys, design all concrete repair details, and prepare all required specifications.

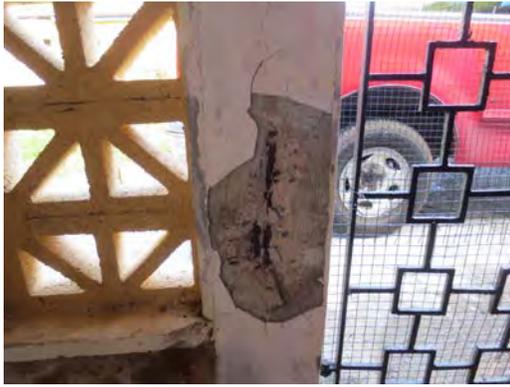
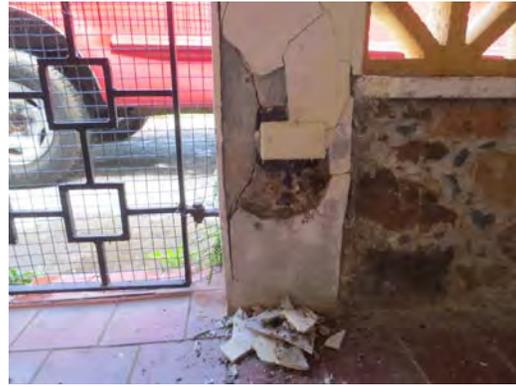
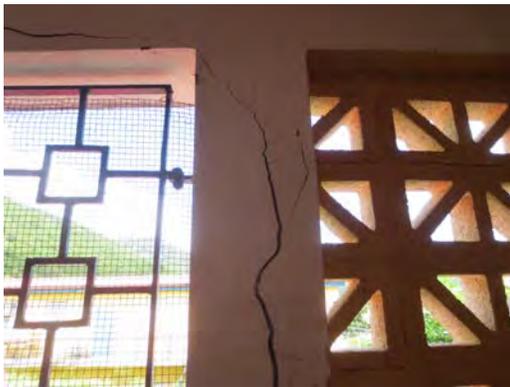
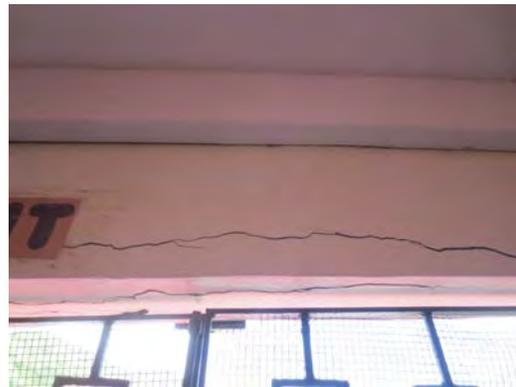
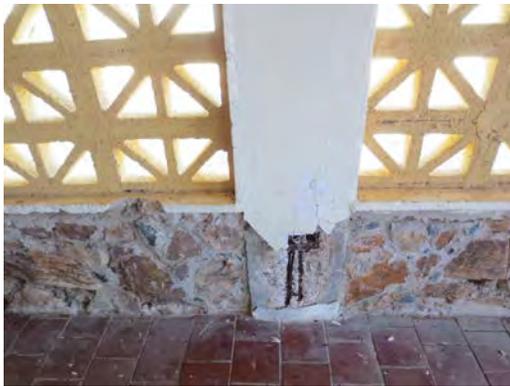
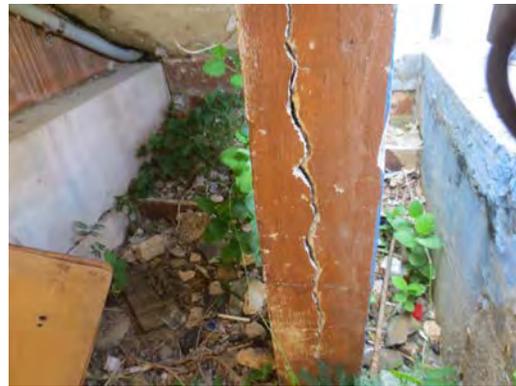
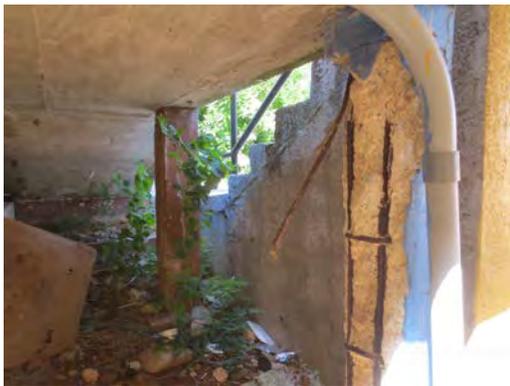
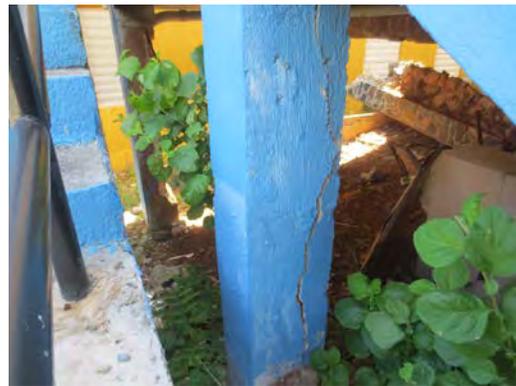
CHARLOTTE AMALIE HIGH SCHOOL BUILDING 20

Building 20 (Cottage) is a one-story building with a wood framed gable roof. Reinforced concrete beams and columns support the gravity loads from the wood-framed roof. Columns are typically 24 inches square. Foundations for the columns are below grade. Since the building is located on a sloped site, the columns on the south side of the building extend below the first floor of the building. Spalls with exposed reinforcing were observed at several of the concrete columns. On the North portion of the buildings (on-grade backyard porch), the spalls appear to be initiated by corrosion of electrical metal boxes (at receptacles) and metal conduits. In one case, the cracks and spalls in the columns extend to a header beam over a door opening. No exposed reinforcing was observed in this area of the building. On the south portion of the building (suspended front walkway), three columns were observed to be severely damaged. Here, concrete has spalled leaving reinforcing exposed. At one of the three columns (corner column), the cross section of the column has been reduced to less than 50% of its original size. In the front portion of the building, damage to the columns appears to be the result of insufficient clear cover to the reinforcing.

- 01 At the north portion of the building (on-grade backyard patio), chip and remove metal electrical boxes and conduit at damaged concrete columns. Install new PVC receptacles and conduit as required.

- 02 At the north portion of the building (on-grade backyard patio), fill all concrete cracks and patch all concrete spalls in columns and beams per approved concrete repair procedures. Fill all cavities resulting from the removal of electrical boxes and conduit per approved concrete repair procedures.

- 03 At the south portion of the building (suspended front walkway), shore walkway concrete beams as required at locations where the concrete columns have experienced a loss in cross section due to severe spalling.

- 05 A licensed structural engineer shall design all concrete repair/replacement details and prepare all required specifications.

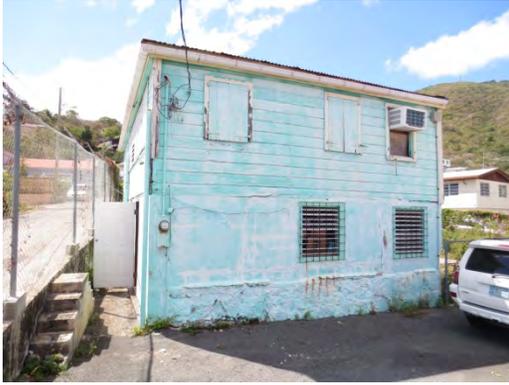
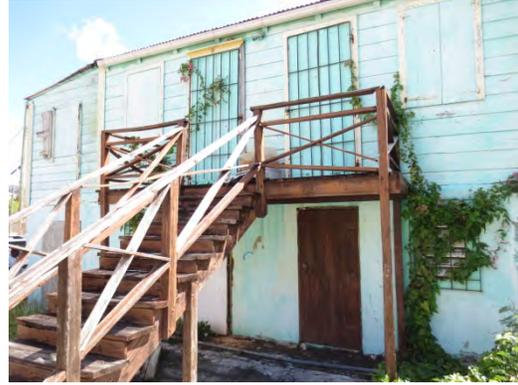
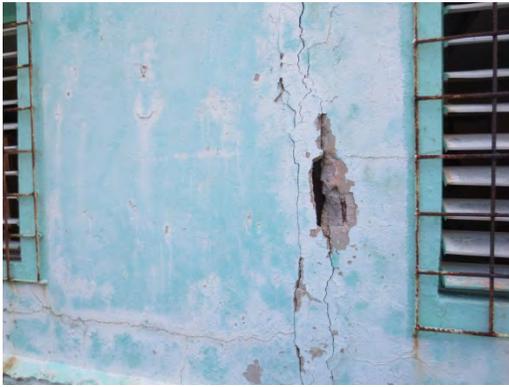
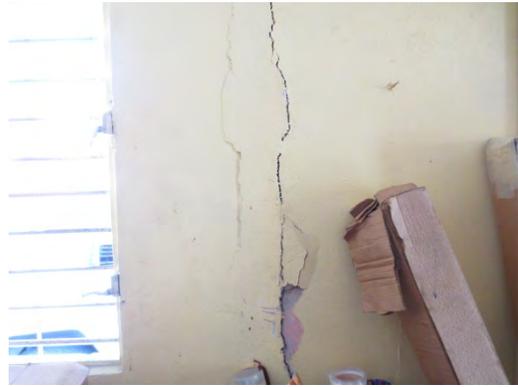
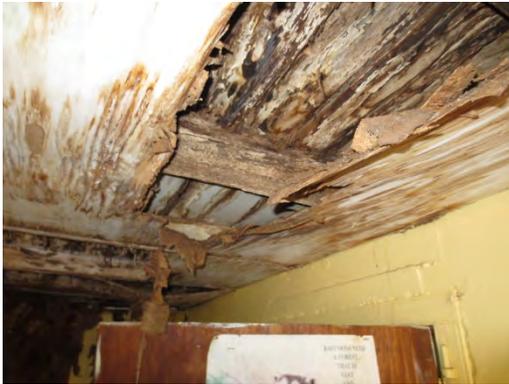
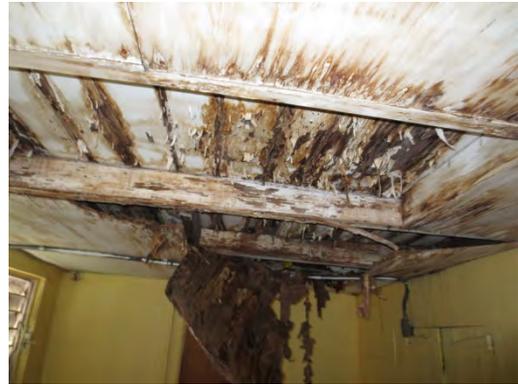
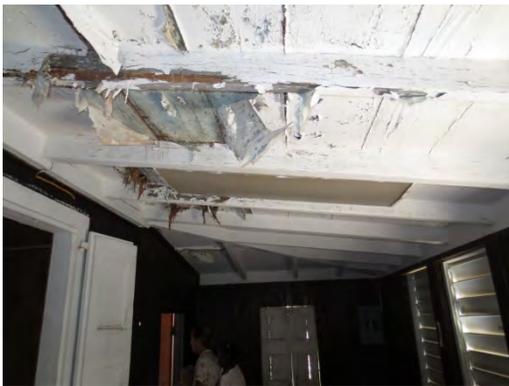
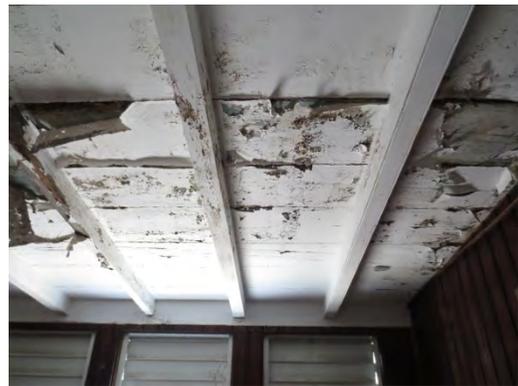
JANE E. TUITT ELEMENTARY SCHOOL BUILDING 2

It was observed that this building is in an overall detrimental condition. Large cracks and spalls were observed on the exterior masonry walls on the south and east portions of the structure. The second floor framing, particularly on the south portion of the building, was in poor condition due to wet rot of the wood joists and decking. The floor framing was observed to have excessively deflected and a small portion of the framing near the interior stair had partially collapsed. The roof framing over the south portion of the building was also observed to be in poor condition. Several portion of the roof deck exhibit severe wet rot and rainwater is free to infiltrate the interior of the building (the leaks in the roof have likely caused the damage to the second floor framing). Over the original portion of the building, damage to the floor and roof framing was much less extensive than that observed at the south and east extensions to the original building.

- 01 If the building is not classified as a historic structure, it is recommended that it be demolished instead of repaired. This recommendation is based on the high repair cost of the damaged structural members (as well as extensive repairs to non-structural components) with respect to the total cost of the building.

- 02 In the case the building is classified as a historic structure, repair/replacement of all damaged wood members will be required. It would be of interest to determine if the building extensions on the south and east sides of the structure are classified as part of the historic structure or not. If not, it may be more economically viable to demolish these areas instead of repairing them (note that the worst damage is concentrated on the add-ons to the south and east of the building).

- 03 A licensed structural engineer shall perform all surveys, design all wood and masonry repair details, and prepare all required specifications.

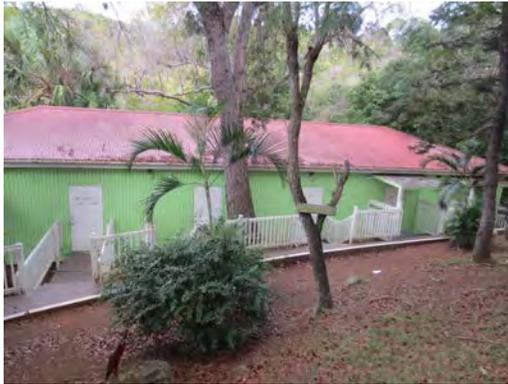
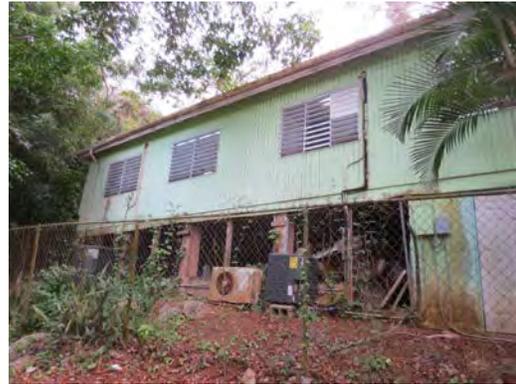
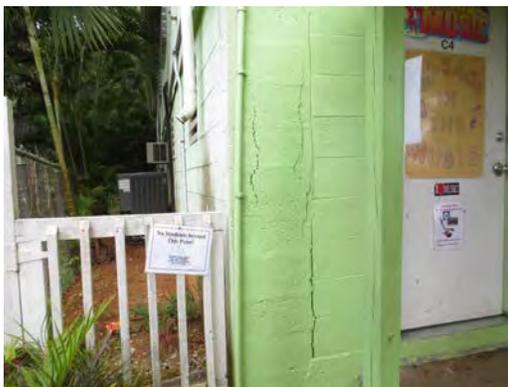
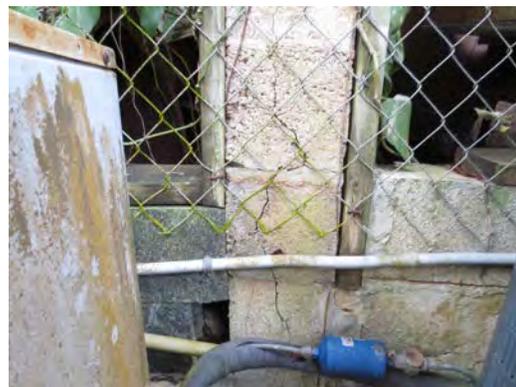
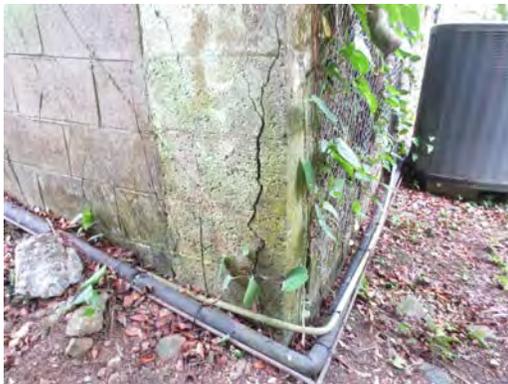
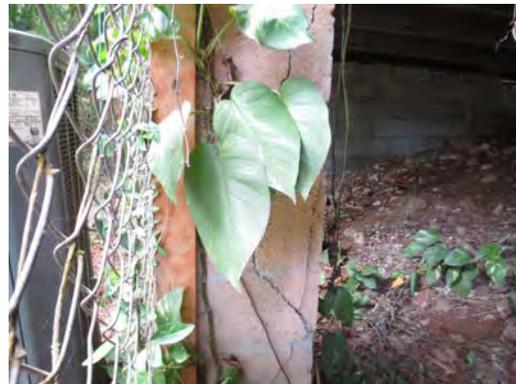
JOSEPH SIBILY ELEMENTARY SCHOOL BUILDING 9

The single-block CMU columns on the west were observed to have severe cracking that extends across the majority of the cross section. It is unknown whether the columns are grouted. Since these are single-block columns, the extensive cracking is considered a life safety item.

- 01 Provide shoring as required at the second floor cold-formed steel joist and beams at locations where CMU columns exhibit cracking.
- 02 Replace existing 8"x16" single-block CMU columns with new 16-inch square CMU columns: Demolish existing column from top of foundation to underside to underside of second floor framing. Install vertical reinforcing dowels at top of foundation. Use acrylic-based adhesive to install reinforcing dowels. Install new column longitudinal and transverse reinforcing bars (longitudinal reinforcing bars to lap with vertical reinforcing dowels). Erect and grout new column (use running bond for placing blocks).

- 03 Alternatively, replace the existing 8"x16" single-block CMU columns with cast-in-place reinforced concrete columns of equal size. See item #2 above for additional information.

- 04 Connect existing cold-formed steel joists and beams to top of new column with metal connectors (clips, straps, etc.).
- 05 A licensed structural engineer shall design all column replacement details and prepare all required specifications.

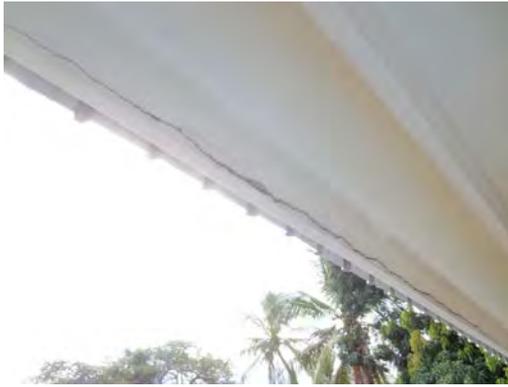
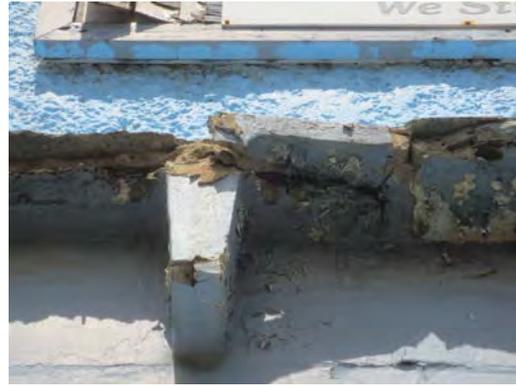
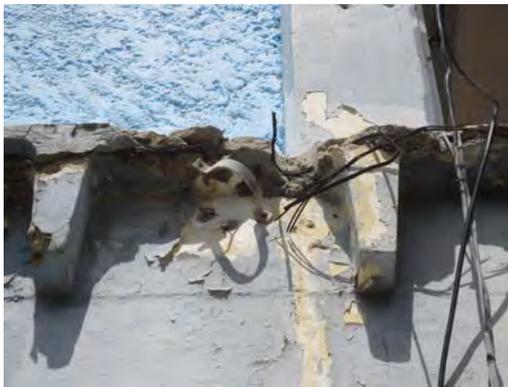
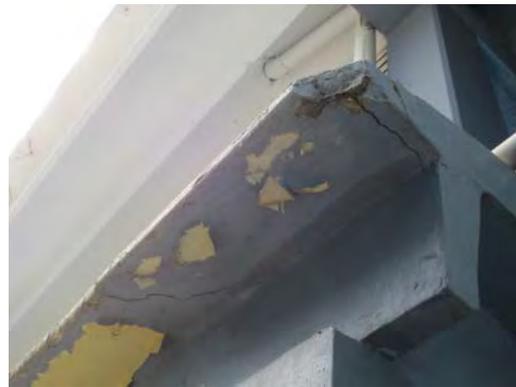
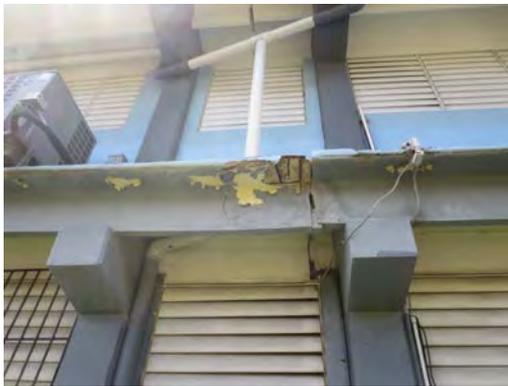
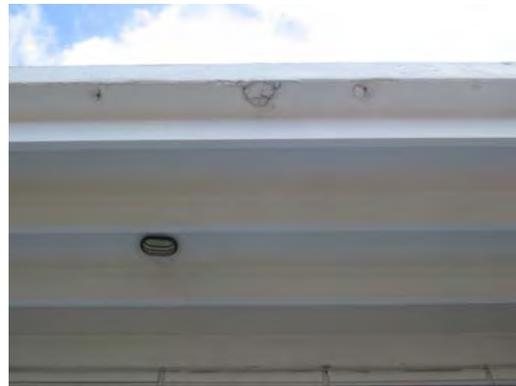
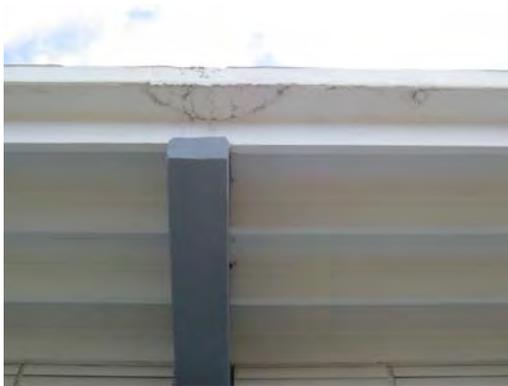
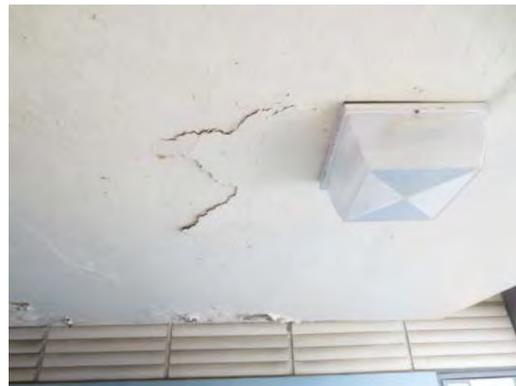
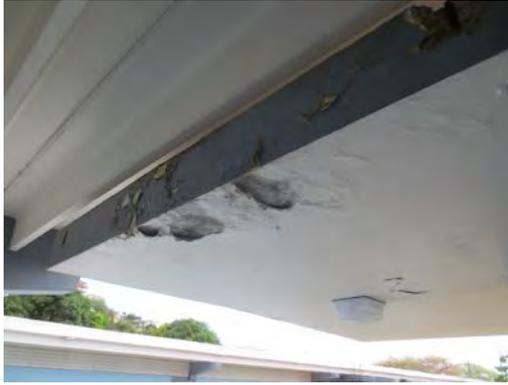
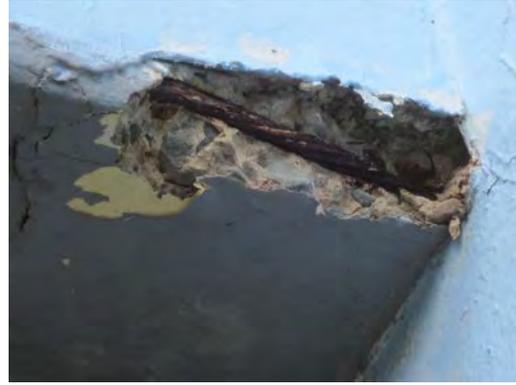
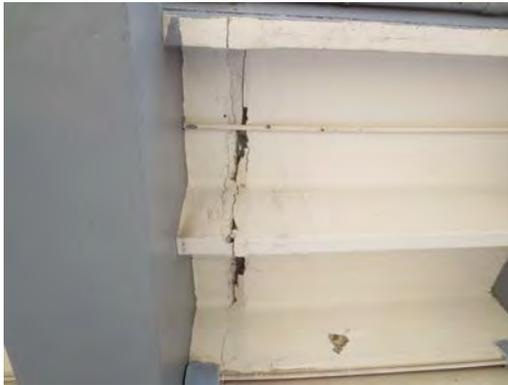
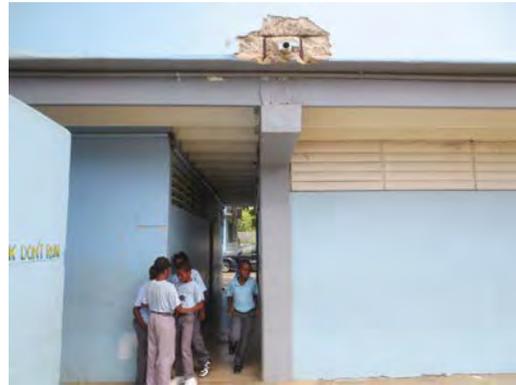
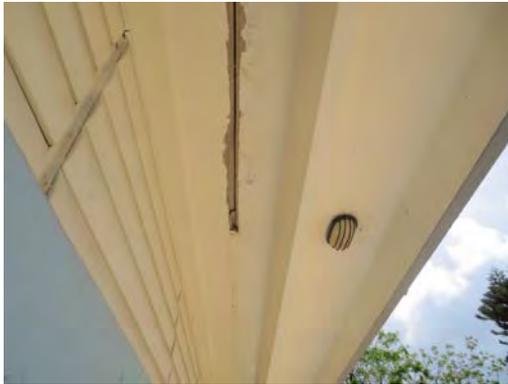
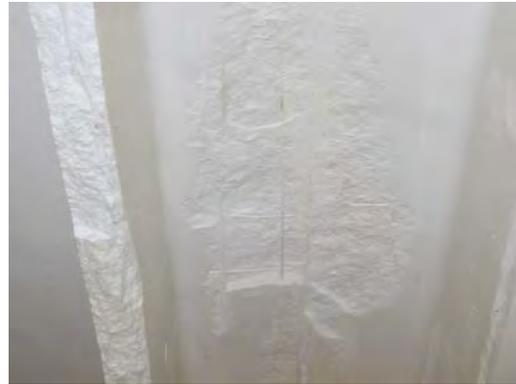
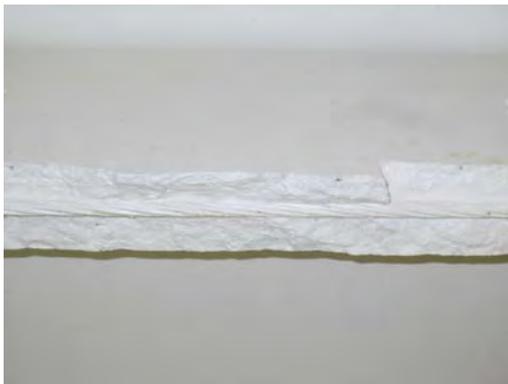
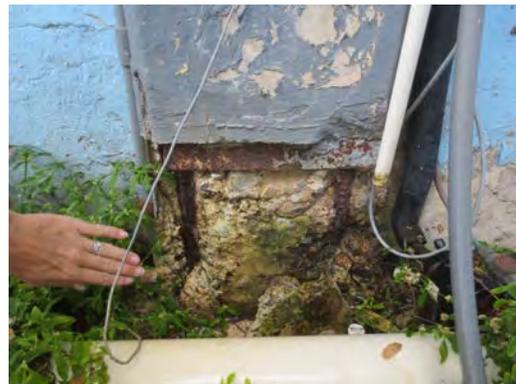
ULLA MULLER ELEMENTARY SCHOOL BUILDINGS 3 AND 4

Moderate to severe spalls were observed at the precast tees at the second floor and at the roof. The spalls are for the most part concentrated on areas where the tees are exposed to weather: at the walkways and at a short overhang around the perimeter of the buildings. In some cases, exposed reinforcing was observed. Closed or partially closed spalls on the underside and on the sides of concrete members are considered a life safety concern for they can detach unexpectedly and fall on building occupants. At the underside of the tees, it was also observed that at the joint between adjacent precast tees, the tooled joint filler has cracked and in some cases fallen. This loose material is also considered a falling hazard and should hence be treated as a life safety issue.

At the precast tees, exposed pre-stressing tendons were observed at two locations on Building 3. It appeared that the concrete had spalled from the underside of the tee's web leaving approximately 4-foot long portions of the tendons exposed. It was not possible to verify the condition of the exposed tendon for the areas around the spall and the tendon itself have been painted white.

Spalls (open and closed) were also observed on the concrete wall that serves as a railing to the second floor walkway that provides access to the classrooms. It was reported by a teacher that a large spall had recently detached from this wall and fallen down to the grounds below.

Spalls were also observed at the bottom of exterior concrete columns near grade. The spalls were moderate, with exposed reinforcing in some cases. Damage to the columns was typically observed to be a result of improper drainage of air conditioning units (water from the units drains directly on to the base of the column).

- 01 Conduct a structural survey of all exposed precast and cast-in-place concrete elements. The survey shall document the type, location, size, and extent of all cracks and spalls (open and closed). The survey shall also document the location, extent, and condition of exposed pre-stressing tendons in precast pre-stressed concrete tees.
- 02 Fill all cracks and patch all spalls in cast-in-place concrete columns, walls, and beams per approved concrete repair procedures.
- 03 Fill all cracks and patch all spalls in precast pre-stressed concrete tees per approved concrete repair procedures.

- 04 Thoroughly clean and remove all rust from exposed pre-stressing tendons in precast pre-stressed tees. Patch the areas around the exposed tendons per approved concrete repair procedures. If it is determined that loss of pre-stressing force in the tendon has occurred, additional reinforcing may be required. A suggested form of additional reinforcing is in the form of glass or carbon fiber sheets bonded to the underside of the web of the affected tee.
- 05 Remove all loose and cracked joint fill material from the underside of joints between precast pre-stressed tees. Install new joint filler at all joints.
- 06 A licensed structural engineer shall perform all surveys, design all concrete repair details, design all pre-stressing tendon repair details, and prepare all required specifications.

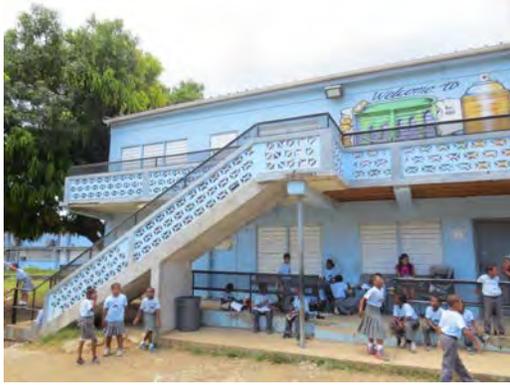
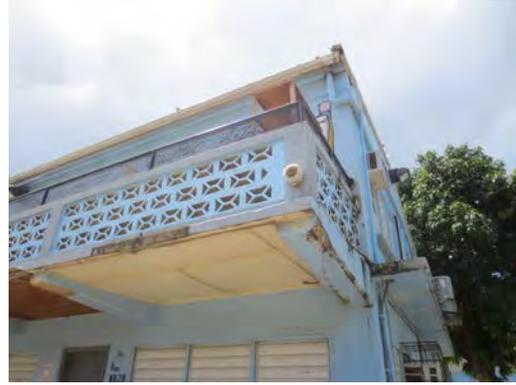
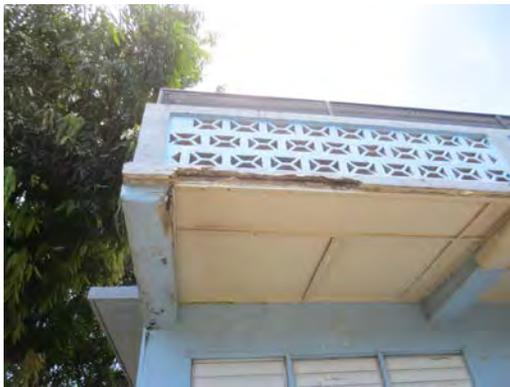
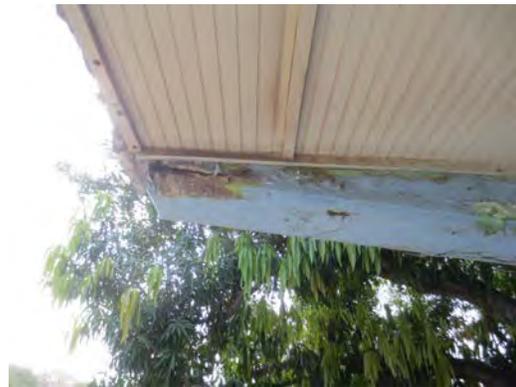
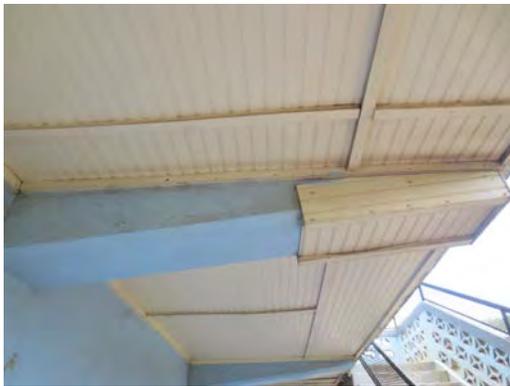
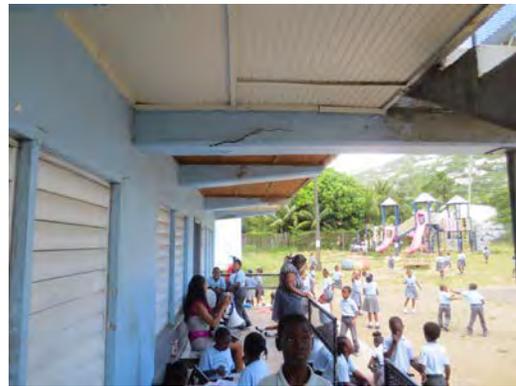
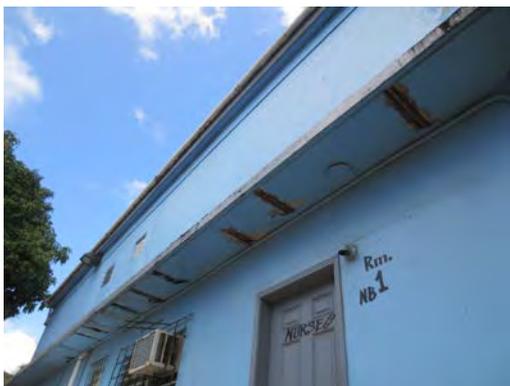
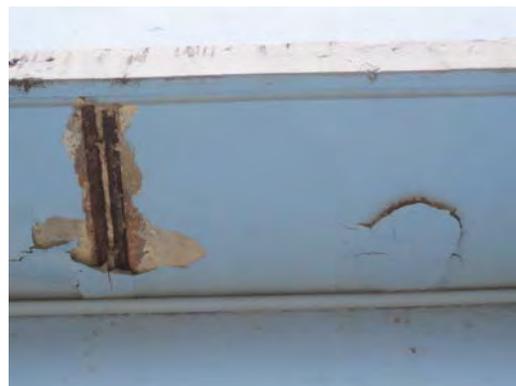
ULLA MULLER ELEMENTARY SCHOOL BUILDING 5

On the east side of the building, the second floor framing cantilevers beyond the perimeter of the building to create a walkway for access to the second floor classrooms. Cantilever concrete beams of varying depth typically provide support for this second floor walkway. These cantilever beams were observed to be in poor condition due to severe and widespread spalls with exposed reinforcing. In some cases, the spalls are on the underside of the beam creating a life safety concern (falling hazard).

At one location, a simple-span concrete beam instead of a cantilever beam supports the second floor walkway. This simple-span beam spans between the perimeter of the building and a concrete wall supporting an exterior concrete stair. A large diagonal crack extending through most of the cross section was observed near the middle third of the span of this concrete beam. The crack appears to be a shear crack and given the brittle and unexpected nature of a shear failure, the damage on this beam is considered a life safety issue.

On the north, south, and west sides of the building, the second floor concrete slab cantilevers beyond the perimeter of the building to create a short awning. At the underside of this overhang, there are open and closed spalls that coincide with the spacing of what appears to be either reinforcing bars or some type of metal fitting. It has been reported that a large piece of concrete recently detached from the underside of this overhang and fell on top of the entrance to the nurse's room. It was also observed that the underside of the second floor slab at the walkway has been covered up with plywood. It is unknown whether the plywood was added as a protective measure against falling debris from spalled concrete.

- 01 Provide shoring as required at the second floor walkway slab and beams.
- 02 Remove plywood sheathing from the underside of second floor walkway slab. Patch all concrete spalls, if any, per approved concrete repair procedures.
- 03 Fill all cracks and patch all spalls at the cantilever portions of the second floor slab (awning on north, south, and west sides of the building) per approved concrete repair procedures.
- 04 Fill all cracks and patch all spalls at the cantilever concrete beams supporting the second floor walkway slab per approved concrete repair procedures.
- 05 Repair, reinforce, and/or replace the second floor walkway concrete beam spanning between building wall and stair wall.
