Grounds Maintenance Primer

Insular Schools Assessment of Buildings and Classrooms, Phase 3, Year 2

US VIRGIN ISLANDS

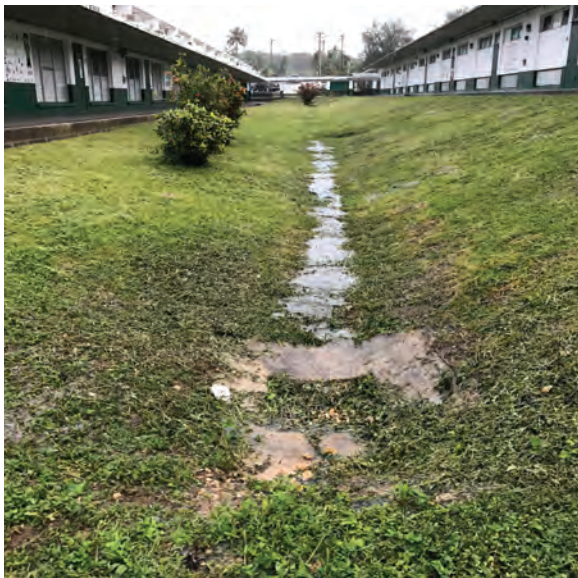
Figure 1: Grass Swale (swales may also be concrete construction)

The following images show the different types of storm drainage structures on school campuses.

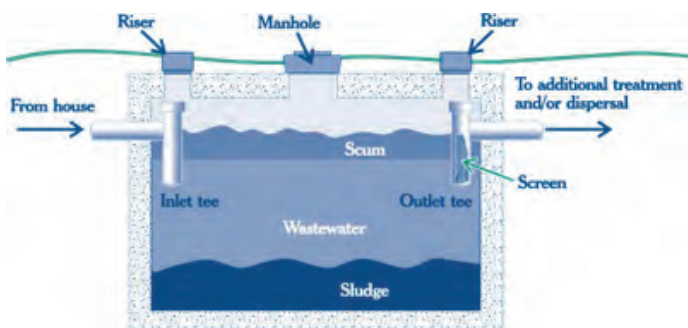
Figure 12: Sludge and scum levels in septic tanks should be routinely monitored.

The typical septic system should be inspected once a year and pumped every 2 to 3 years or when the total depth of the sludge and scum exceeds one third of the liquid depth of the tank (Figure 12). Contracting a service provider to perform routinely scheduled site visits and inspections is one way to ensure adequate maintenance. Septic service providers will inspect for leaks and check scum and sludge levels in the septic tank.

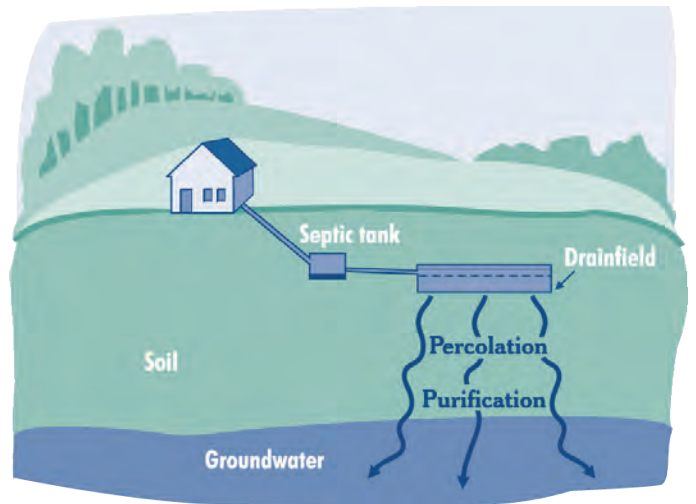
Figure 16: Overloading the leach field can cause contamination of groundwater sources.

Another important reason to properly maintain septic systems is that it can help prevent the spread of infection and disease. Fecal matter in septic systems contain disease-causing bacteria and viruses, nitrogen, and phosphorous. Inadequate wastewater treatment can leach into the groundwater and contaminate drinking water (Figure 15).

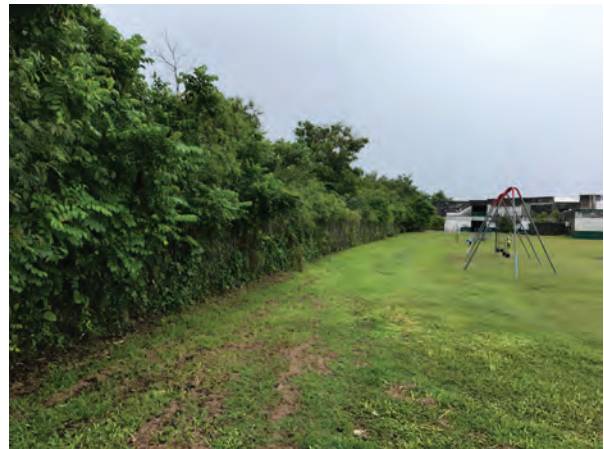
Figure 21: Vegetation has overgrown the existing perimeter chainlink fencing.

Clear and remove overgrown vegetation along the outside of the perimeter fencing to prevent the chain-link fencing from damage caused by the weight of the vegetation leaning on the fence as well as tree branches falling on the top rail of the fencing. An 8' to 10' wide clear area on the exterior perimeter of the fence should be maintained on a monthly basis by keeping the vegetation cut down to a manageable height. Keeping the fencing from any obstructions is beneficial for security and maintenance purposes. Fencing repairs will be easier to access and less expensive.

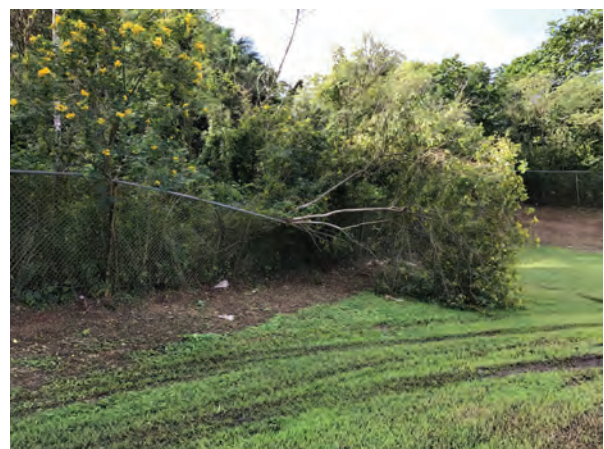
Figure 22: Fallen trees and overgrown vegetation has damaged section on perimeter chainlink fencing.

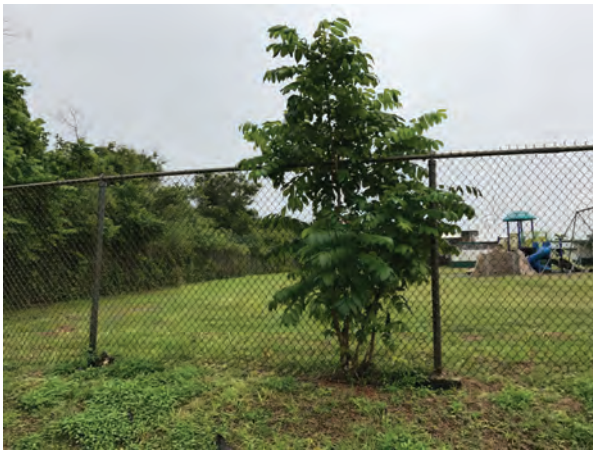
Figure 23: Young tree growing along the fence line will eventually damage the fence unless it is removed soon.

Removal of plant material that is growing in undesirable locations should be removed as soon as possible. There may be instances where a seed from a tree has germinated and is now growing right next to a building, fencing, drainage swale or sewer leaching field that will cause damage or flooding. Removing vegetation where it should not be growing is essential to reducing this type of maintenance and costly repairs. Do not allow the plant to grow into a tree. It is best to remove it when it is still in its juvenile stage of growth.

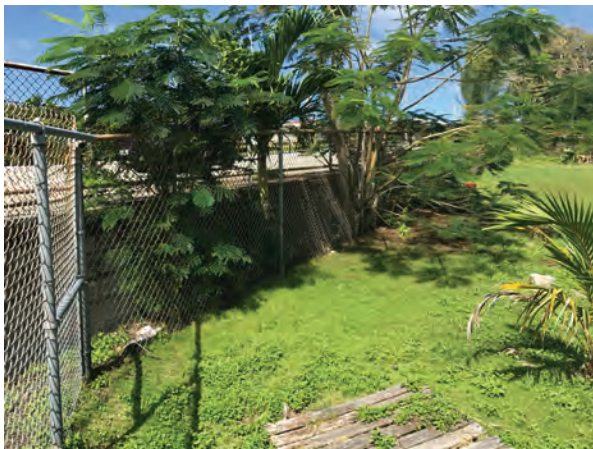
Figure 24: Trees growing along the fence also disrupt the drainage swale and should be removed.

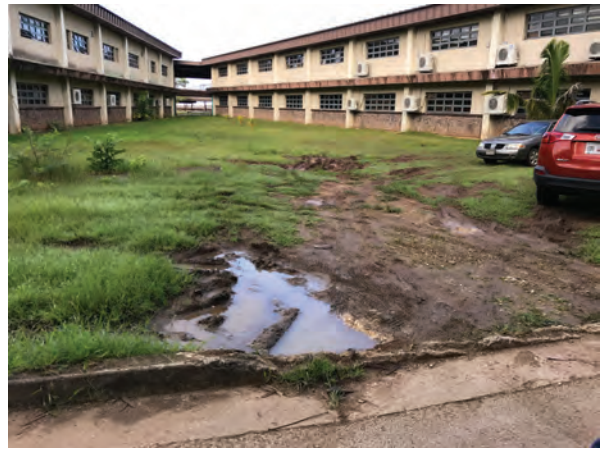
Figure 25: Vehicles parking on grassed areas damages the turf and creates potholes, which degrades site condition, causes erosion, and may create breeding habitat for mosquitoes.

Cars, trucks and other vehicles should not be allowed to park on or drive along, or cross pedestrian walkways, dedicated fire access lanes and drainage ways. Cars and trucks damage both the walkway pavement as well as adjacent grass and landscape areas. Drainage problems and standing water due to deep tire depressions can also breed mosquitoes. Barricades or posting of "NO CARS AND TRUCKS ALLOWED" or "KEEP VEHICLES OFF THE GRASS" may help in deterring people from driving where they should not be driving.

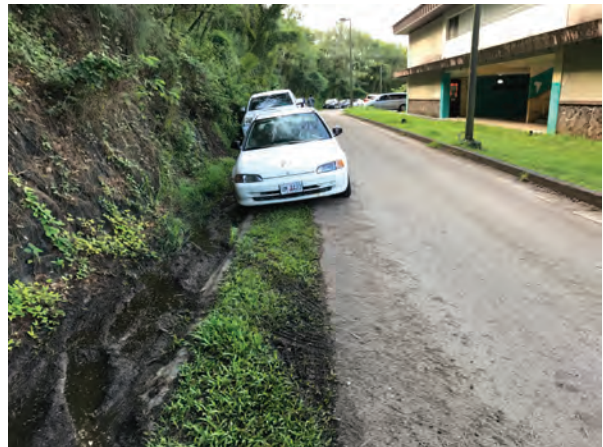
Figure 26: Vehicles parked within a drainage structure damages the planned function of the swale and causes storm water to backup and flood to other areas of campus. These parked cars are also blocking the fire access lane.

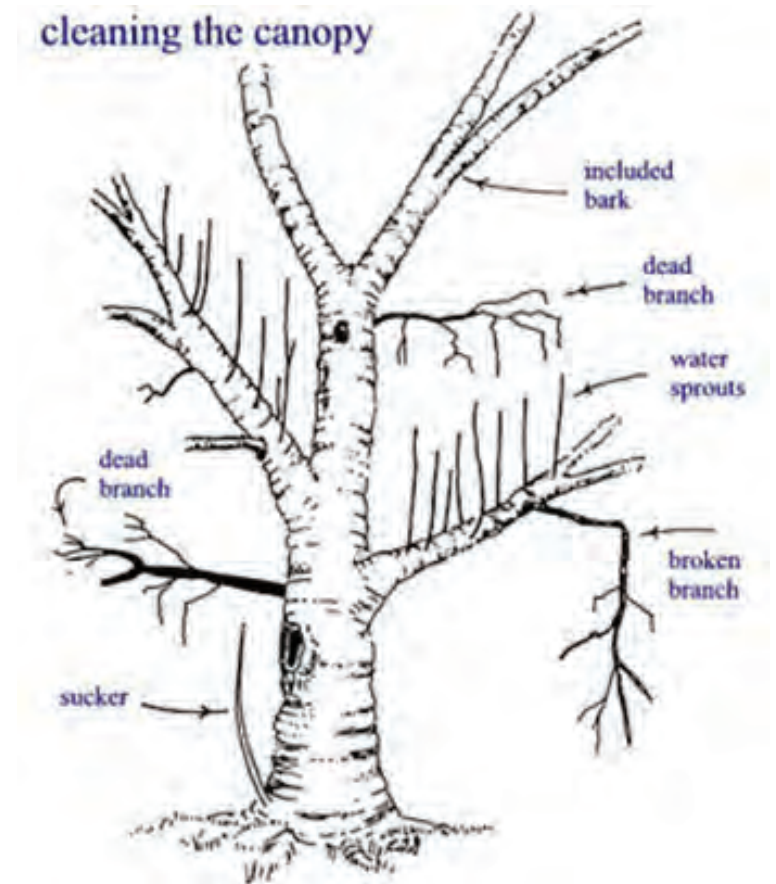
Figure 29: Example of a tree in need of Crown Cleaning.

- (a) Hazard Reduction Pruning (HRP); the primary objective is to reduce the danger to a specific target caused by visibly defined hazards in a tree such as a dead or damaged branch hanging over utility lines, walkways, roadways or buildings.
- (b) Maintenance Pruning (MP); the primary objective is to maintain or improve tree health and structure, and includes hazard reduction pruning.

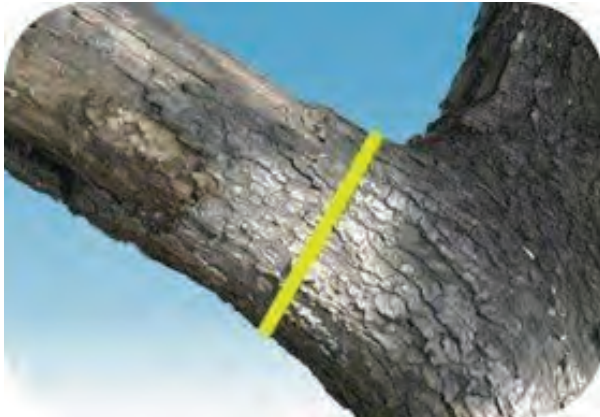
Figure 31: The branch collar is the point where a branch joins the trunk or another branch. This is the area the arborist chooses to make a proper cut.

- (a) Always cut branches just beyond the branch collar and not flush with the trunk.
- (b) Avoid leaving a stub beyond the edge of the branch collar, which can result in decay spreading into the trunk of the tree.
- (c) Avoid topping a tree.
- (d) Avoid pruning the trunk of a tree, unless the tree is being removed entirely.
- (e) Always use sharp tools to make clean cuts.
- (f) Always disinfect pruning equipment after pruning, even when moving to other plants in the same area, to prevent the spread of disease organisms.
- (g) Always wear appropriate PPE including eyewear, footwear, head protection and gloves.

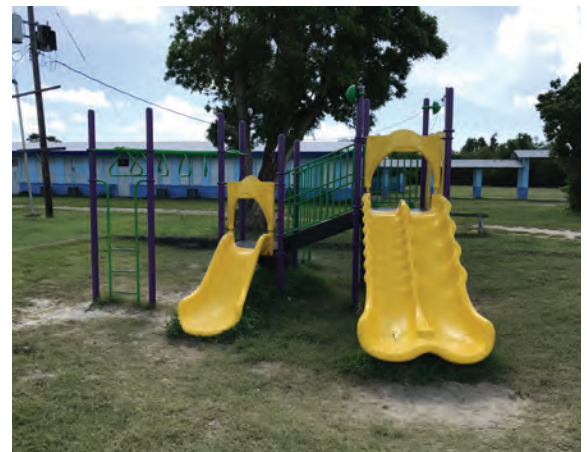
Figure 40: Sand or grass is not a safe surfacing for fall protection; a certified resilient play surface is recommended.

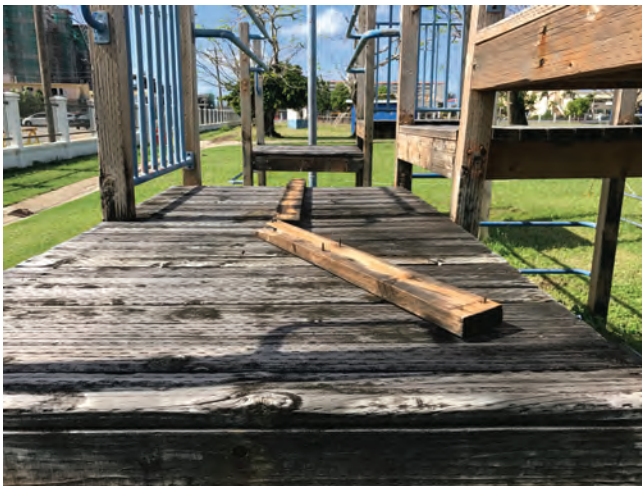
Figure 41: Play structure is compromised by extensive wood rot. Exposed nails are a safety hazard and should be removed immediately. Grass is not a safe surfacing for fall protection; a certified resilient play surface is recommended.

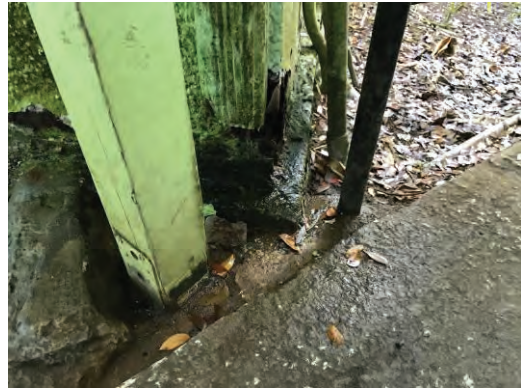
- b. The downspout located at the west end of Building No. 5 should be moved to the south end corner to re-direct the surface flow to drain towards the south. The same goes for Building No. 4.

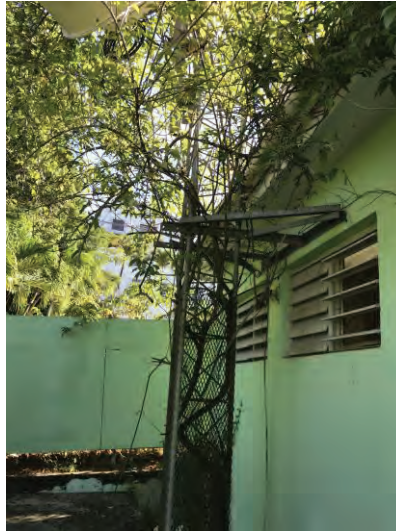
- d. Remove (by hand shovel and wheel barrels) excess soil build-up along the low concrete walls along Buildings No. 9, 10, & 11 by at least 12 to 18 inches and swale surface runoff towards the north direction in lieu of a diversion ditch as previously noted in the February 2015 site assessment. Remove dead leaves and re-establish shade tolerant groundcover to minimize future runoff from re-occurring.

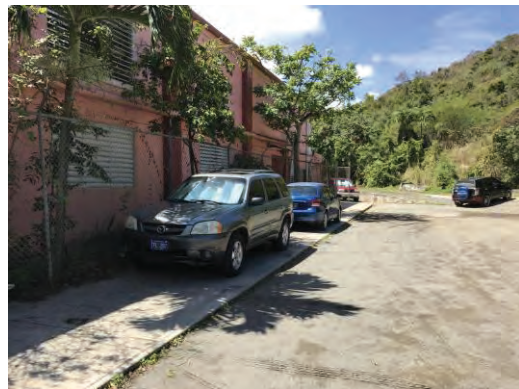
- f. Repair pot holes in the AC pavement or resurface entirely.

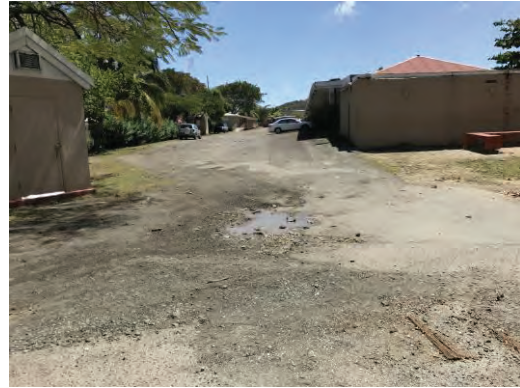
- c. Some of the catch basin are filled with debris and should be cleaned out and the drain lines flushed with water to clear any clogged condition.

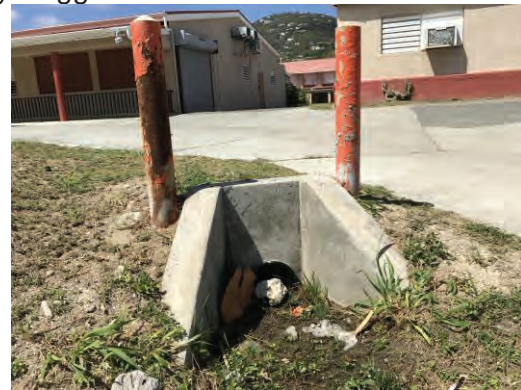
- d. The existing cisterns located at the north ends of the buildings collect the rain water from the roofs and the water that is stored is not being utilized for its intended purpose and consequently the cisterns overflow through the overflow pvc pipes.
- e. One of the overhead drain pipes that connect to the cistern located at Building No. 16 has been disconnected and the water spills onto the pavement directly in front of the entrance door to a classroom, causing flooding to the surrounding area. Either the drain line should be repaired and reconnected or be re-directed away from the building.

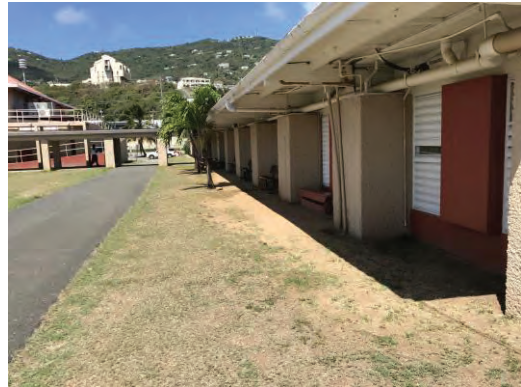
- g. Clean and maintain concrete drainage swales through the campus grounds to insure that surface water flows towards the intended location and not be backed up.

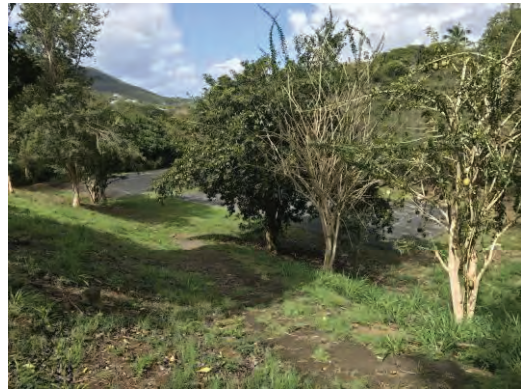
- f. Repair or replace damage fencing along the south and east side property line.

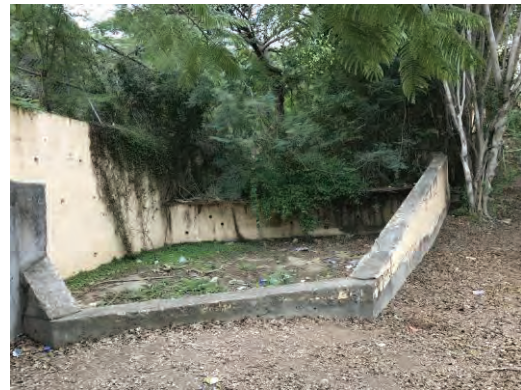
- d. At the northeast corner of Building No. 8 there is an existing drain inlet that has a concrete curb surrounding the drain inlet on three sides which needs to be removed to allow storm water to enter the drain.

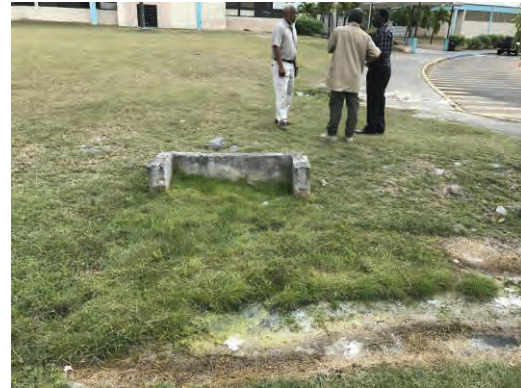
- i. The existing drain pipe is damaged and is leaking near the north entry drive into the school. The drain pipe needs to be cleaned, flushed out and repaired with a new section and lowered below finish grade.

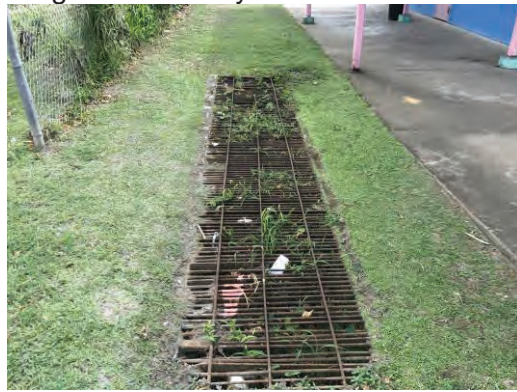
- i. Locate and connect a new drain line at the trench drain pipe outlet located on the edge of the covered walkway between Building No. 5 and No. 4. Connect new drain line into the existing concrete drain box beyond.

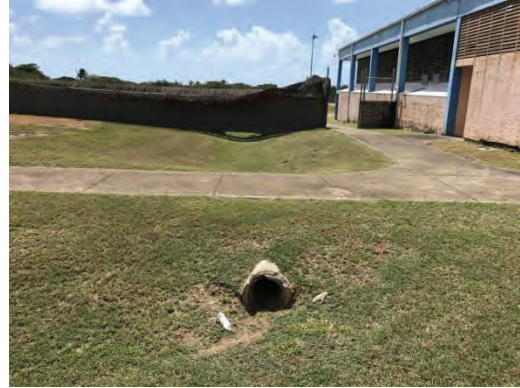
- b. Repair or replace damaged CMU headwalls in the same general location noted in item 'a.' above.
